# HIGHWAYS/PUBLIC WALKWAYS SCHEDULE OF CONDITION

Brunel Walk – Regeneration scheme – Replacing old  
Residential blocks for new Residential blocks

Prepared by: Tom Barker

Date: 08 January 2024

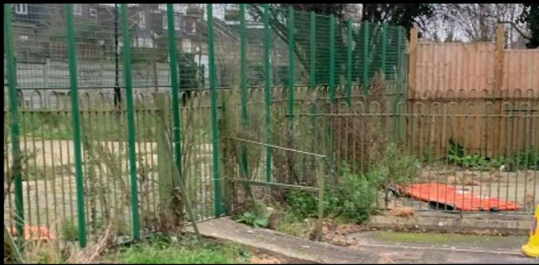
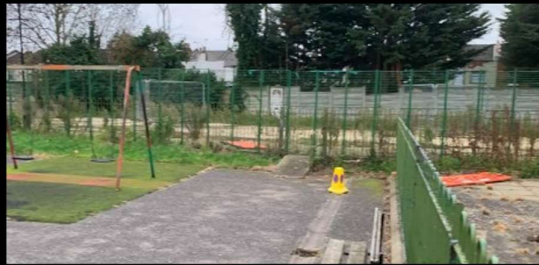
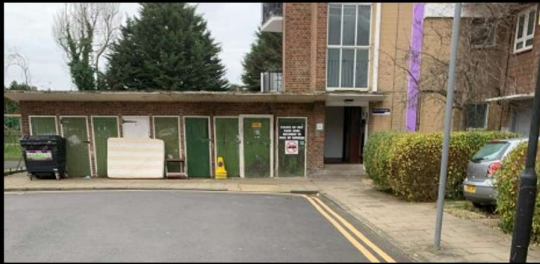
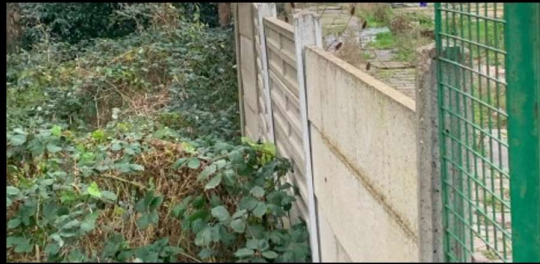
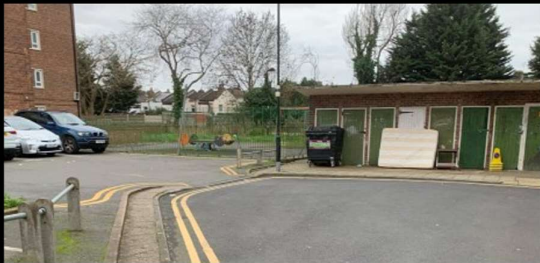
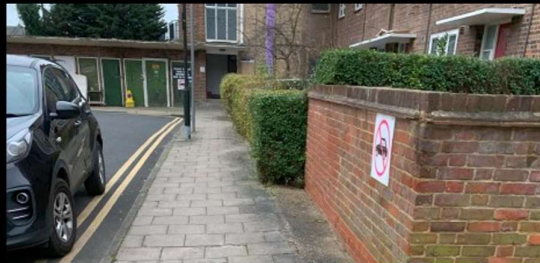
# SECTION 1

| Ref No | Location / Element | Decription | Defects/Condition and Comments | Photo Ref No |
|---|---|---|---|---|
| 1.1.1 | Footpath | Footpath comprises of a combination of Tarmac, concrete paving and concrete patching. | A heavily trafficked footpath showing general wear and tear on all elements. Some paving slabs loose and uneven with various araes being infilled with cement to repair. Kirbs well worn and chipped | Photos 1 - 13 |

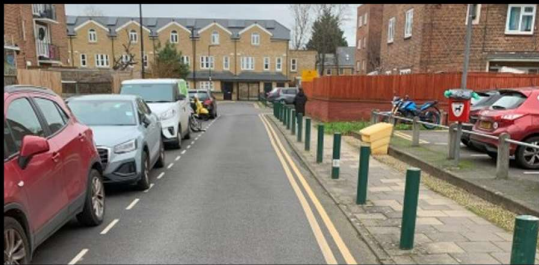
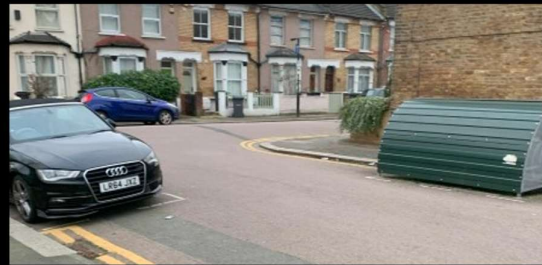
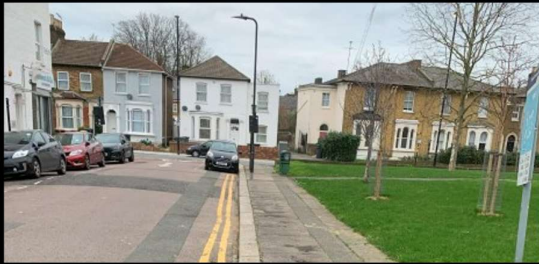
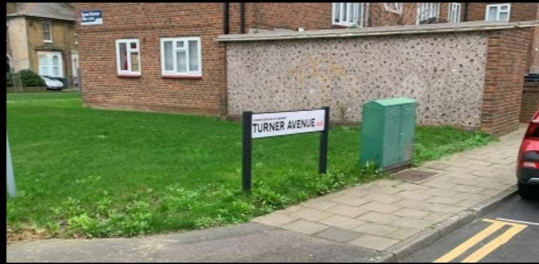
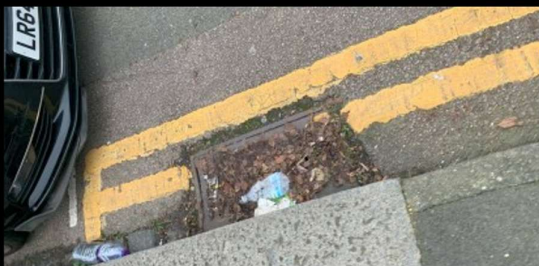
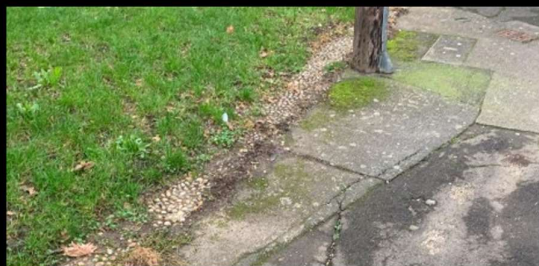
## SECTION 2

| Ref No | Location / Element | Decription | Defects/Condition and Comments | Photo Ref No |
|---|---|---|---|---|
| 1.2.1 | Footpath | Foot path consists of paving flags and Concrete patch repair | Showing general wear and tear, uneven paving flags and brocken contrete around BT covers | Photos 13 to 42 |

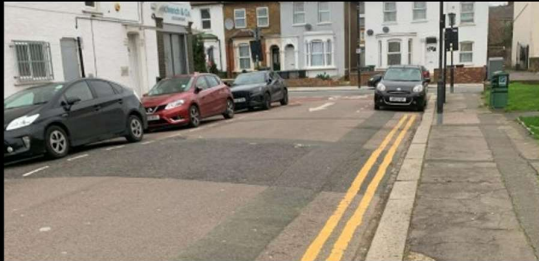
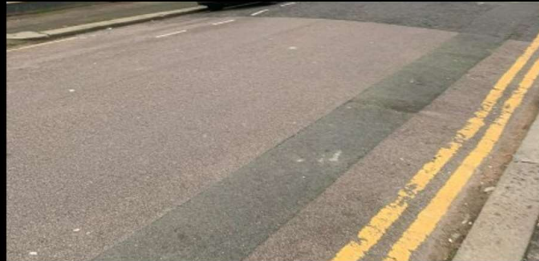
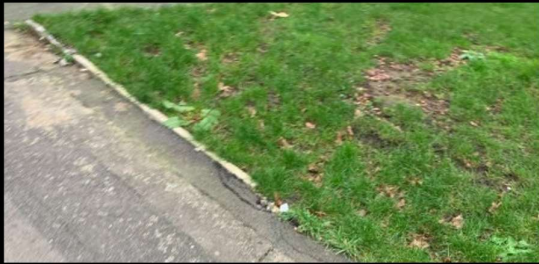
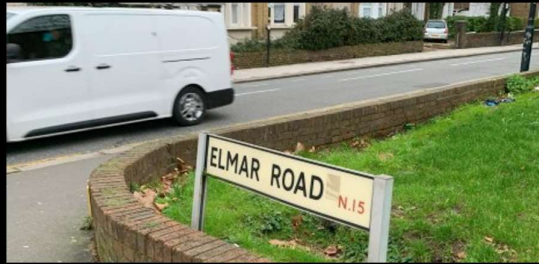
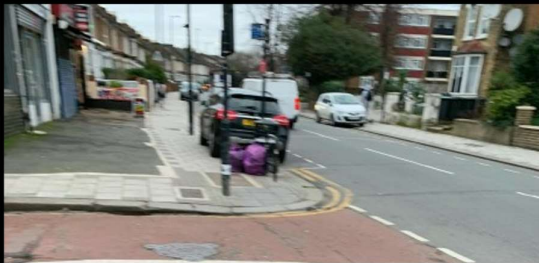
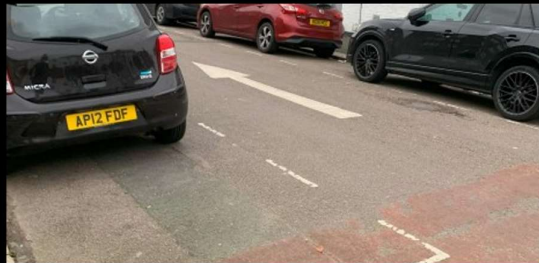
## SECTION 3

| Ref No | Location / Element | Decription | Defects/Condition and Comments | Photo Ref No |
|---|---|---|---|---|
| 1.3.1 | Footpath | Consisting of Tarmac and concrete paving flags and tactile paving | Some flags area cracked / Brocken. Tarmac has new and old sections showing ware and cracking. Tacktile paving flags are uneven and worn. | Photos 42 to 57 |

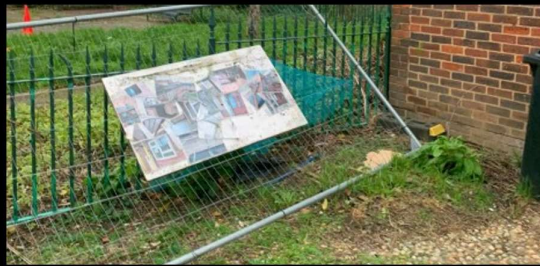
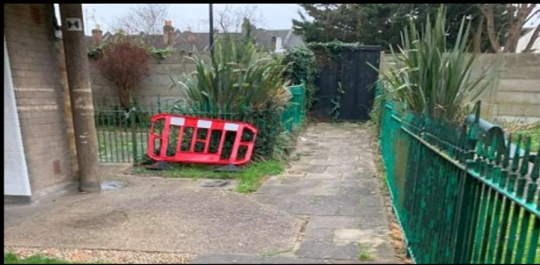
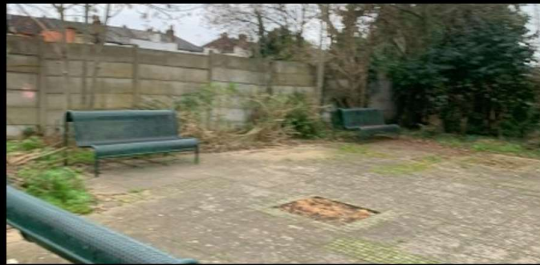
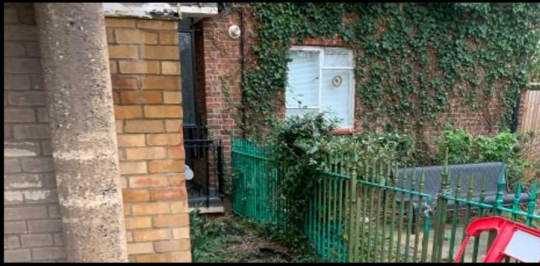
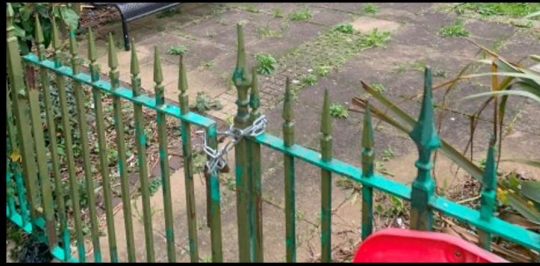
## SECTION 4

| 1.4.1 | Footpath | Consisting of Tarmac and concrete paving flags and pebble dash paving | Some flags area cracked / Brocken. Tarmac has new and old sections showing ware and cracking. | Photos 57 to 73 |
