**639 High Road, Tottenham**  
Design & Access & Heritage Statement  
Facade Remediation

**Application for facade remediation**

This document has been prepared by Freehaus for and on behalf of our client, The GLA, for the purpose of a Listed building consent application to Haringey Council. Heritage specialist architects Purcell have provided review of the Heritage Statement, review and commentary of the 2022 facade condition survey by PAYE, and produced an Outline Specification.

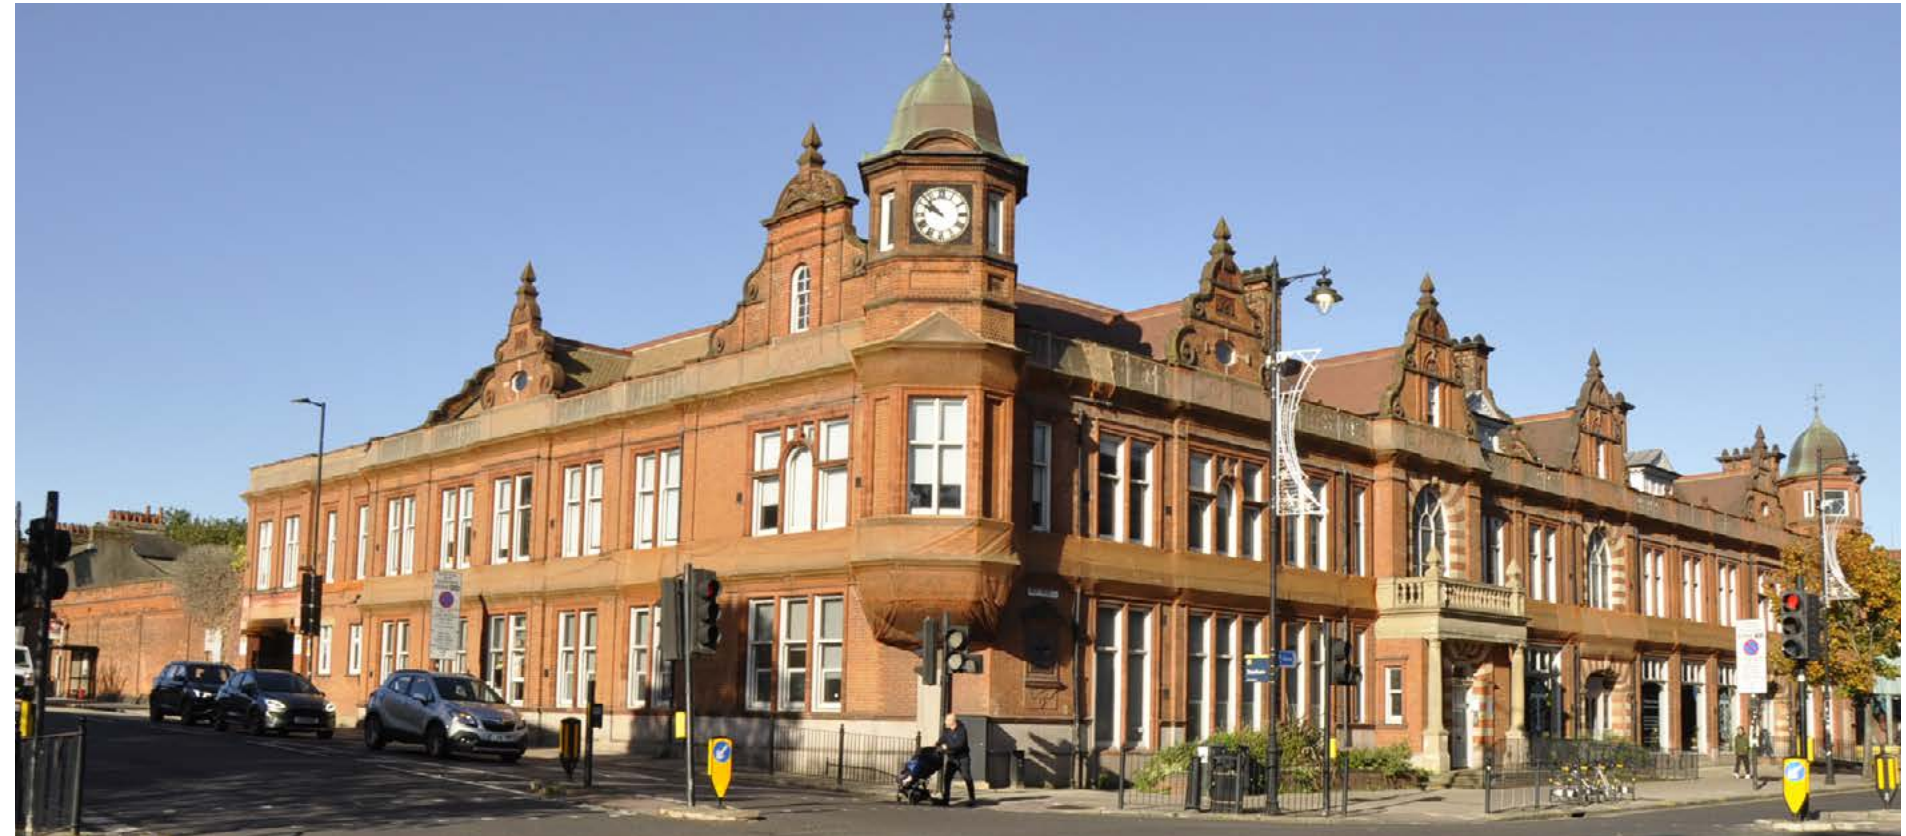
**Proposed masonry remediation works to the principal façades**

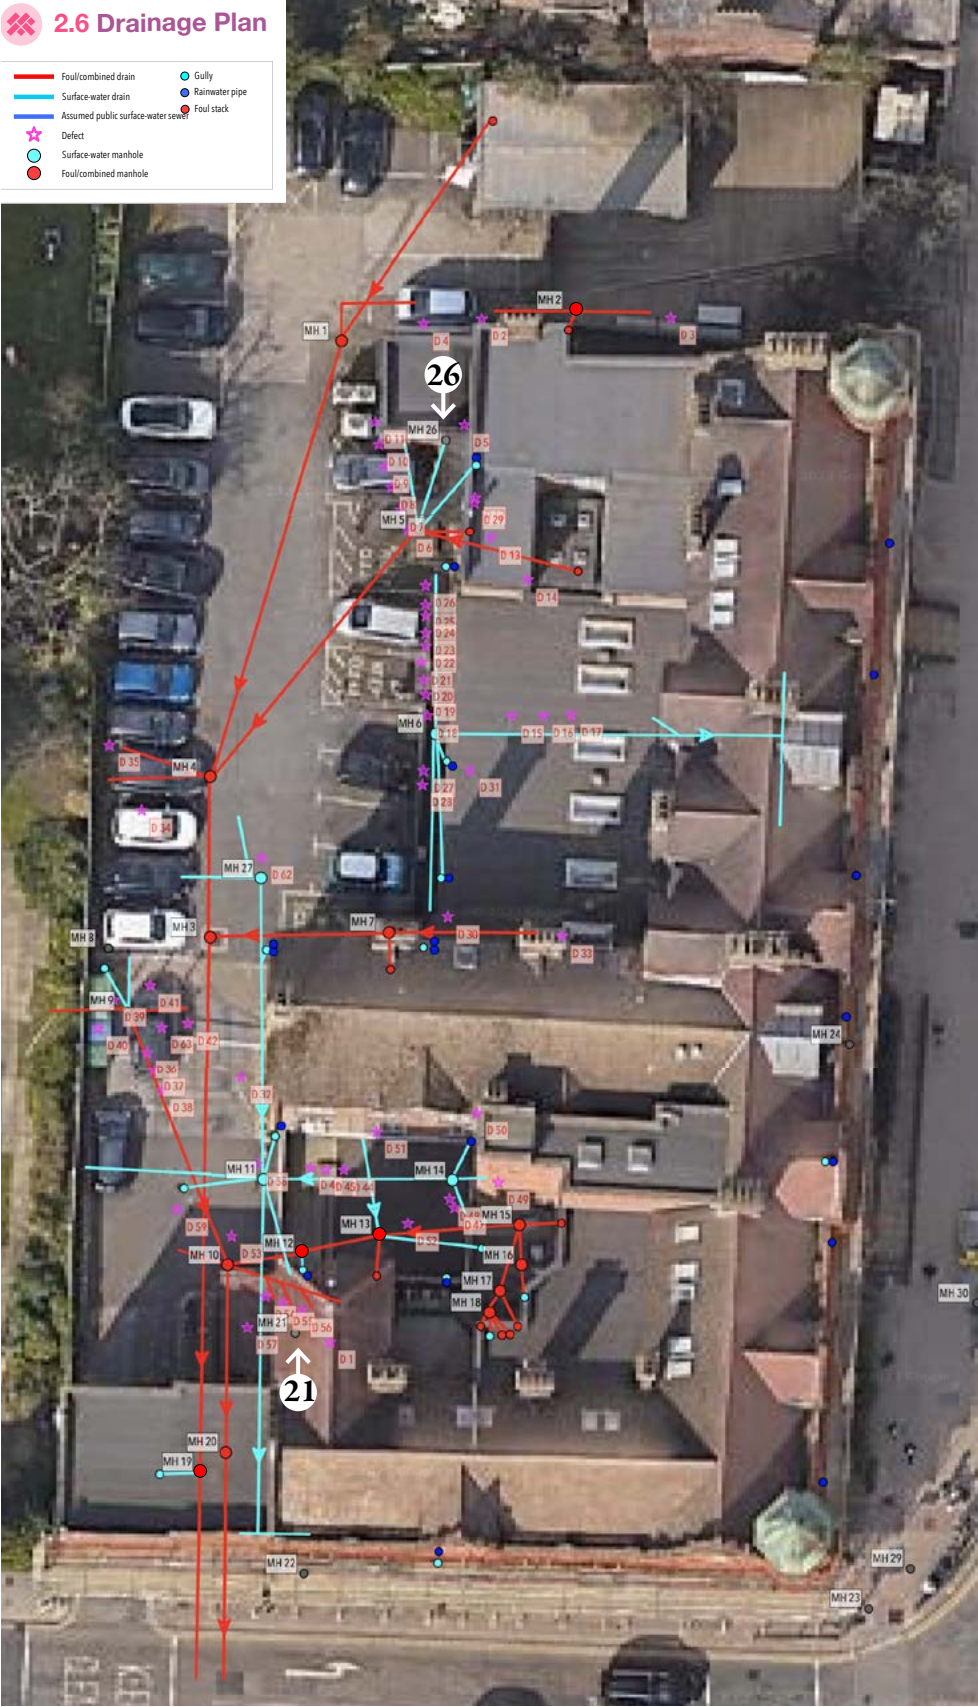
Two manholes identified in the WJ Shirley survey are currently not visible. There tarmac over MH21 and carpet/flooring over MH26.

WJ Shirley have clarified (meeting held 5th February 2024) that the scope of work required for the investigation is to break out the cover and frame of the manholes only to enable inspection of the condition of the chambers beneath.
