# Air Quality and Dust Management Plan (AQDMP)

**Client:** Base Contracts

**Project:** Printworks 819-829 Tottenham High Road

**Ref:** 15013

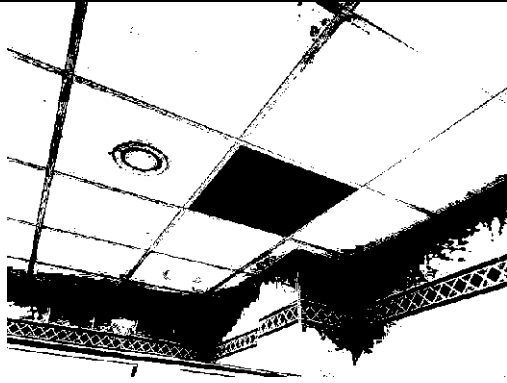
| Building | 819-821 | Item | Wall panel - Cement Product |
| Floor | Ground Floor | Amount | 2m <sup>2</sup> |
| Cement Product | - | C — Surface Treatment | D — Asbestos Type |

| RECOI II'4ENDATION: | | No recommendation required | |

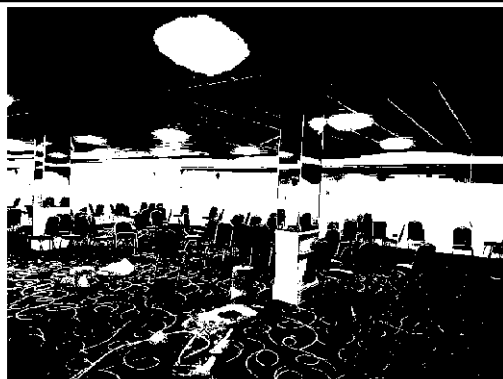
| Building | 819-821 | | Item | 500 m | |
| Textured Coating | - | - | - | - | - |

| RECOMMENDATION. | | No recommendation required | | | |

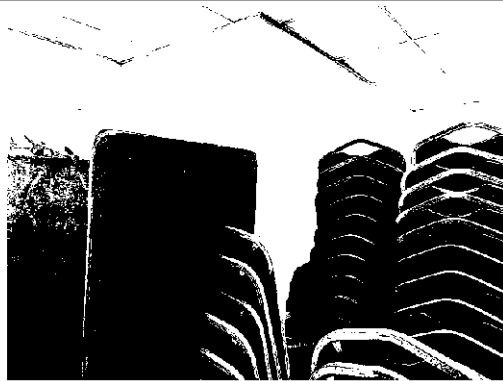
| Building | 819-821 High Road | Item | Ducting - Plastic Sealant |
| Floor | 1st Floor | Amount | Throughout |
| Mastic Sealant | - | 0 | NAD |

| RECOMMENDATION: | | No recommendation required | |

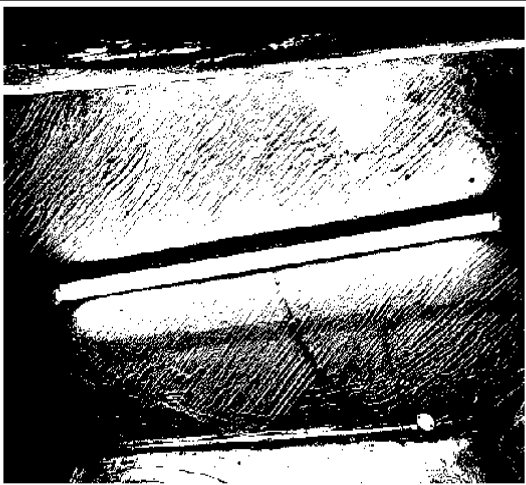
| Building | Unit 825 (La Royale Office) | .. | Ceiling - Textured Coating |
| Floor | Ground Floor | Amount | 2m <sup>2</sup> |
| Textured Coating | | - | |

| C — Surface Treatment | | D — Asbestos Type | |
| - | | - | |
| RECOMMENDATION: | | No recommendation required | |

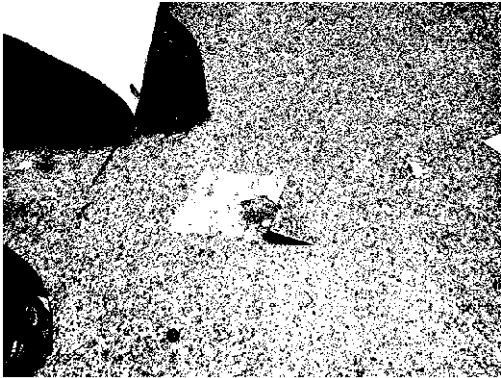
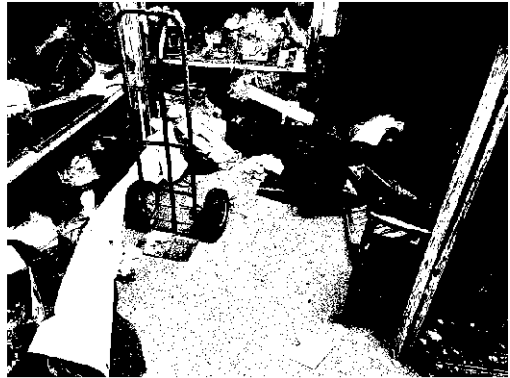
| Building | Unit 825 (La Royale Office) | | Sample No. | Floor - Woven Product | |
| Woven Product | - | - | - | - | - |

| RECOMMENDATION: | | No recommendation required | | | |

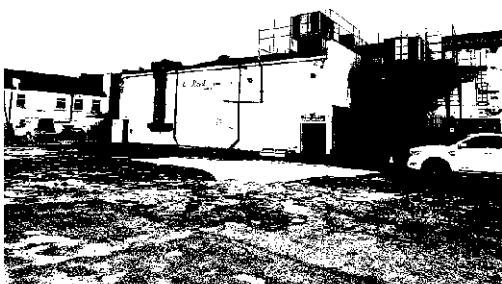
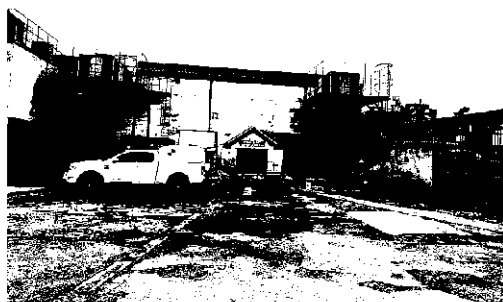
| Building | 819-821 | Item | Walls - Textured Coating |
| Textured Coating | - | 0 | NAD |

| RECOMMENDATION: No recommendation required | | | |

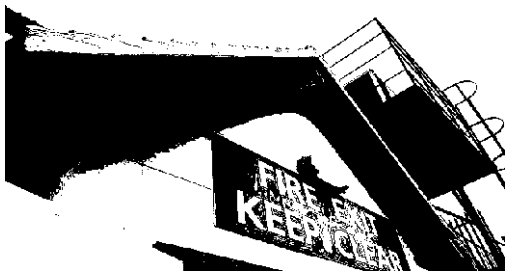
| Building | 819-821 | Item | Roof - Cement Product | | | | |
| Cement Product | - | | | | - | NAD | |

| RECOMMENDATION: | | No recommendation required | | | | | |

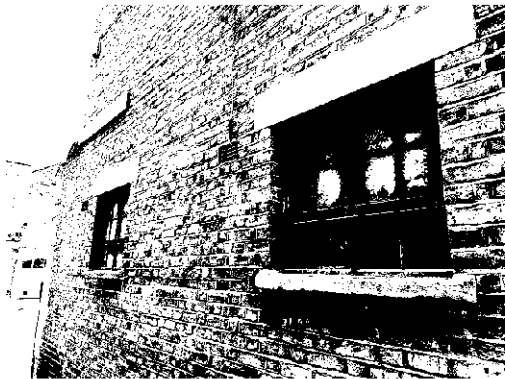
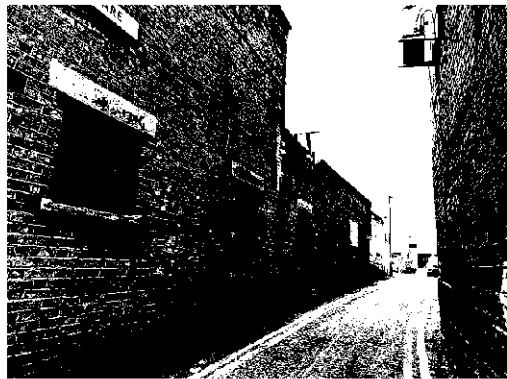
| Building | 819-821 | Item | Window - Nastic Sealant |
| Nastic Sealant | - | 0 | NAD |

| RECOMMENDATION: No recommendation required | | | |
