Project Number: 23002

Project: 41 Sheldon Avenue, N6

The information provided is relevant at the time of survey. The coding system in this report is based on the Manual of Sewer Condition Classification, 5th edition (MSCC5) domestic codes ( BS EN 13508-1:2003 ). This is the official standard for the water industry.

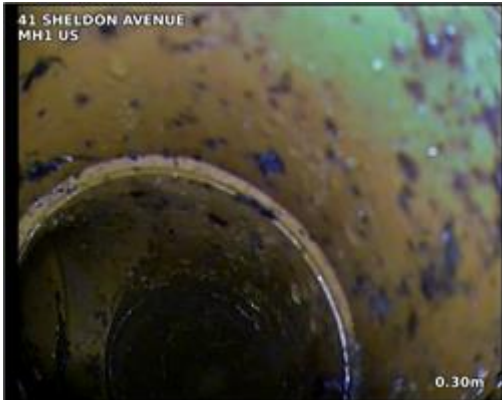
| Pos | Video Ref | Code | Description | Image |
|---|---|---|---|---|
| 00.30m | 0:00:07 | JN | Junction at 09 o'clock: 0mm Diameter | Image Provided - Ref: 0_3<br> |

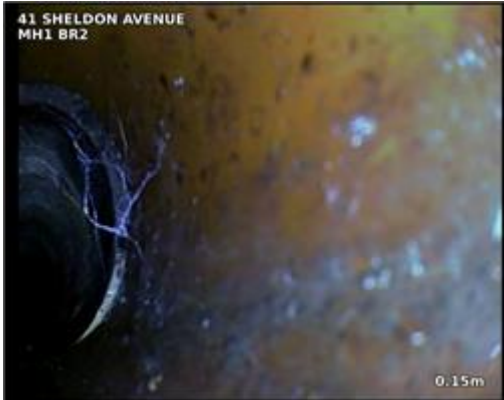
| Pos | Video Ref | Code | Description | Image |
|---|---|---|---|---|
| 00.20m | 0:00:02 | LLQ | Line of drain/sewer deviates left [quarter] | Image Provided - Ref: 2_2<br> |

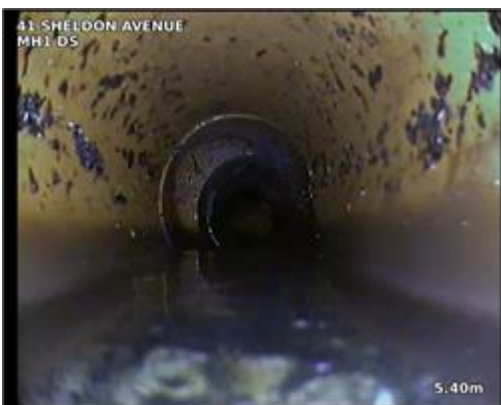
| Pos | Video Ref | Code | Description | Image |
|---|---|---|---|---|
| 05.40m | 0:01:27 | WL | Water level: 30% Height/Diameter | Image Provided - Ref: 4_11<br> |

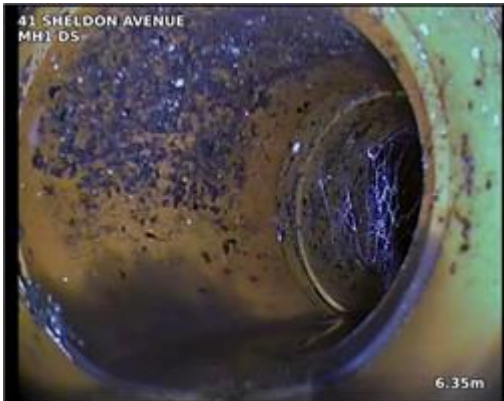
| Pos | Video Ref | Code | Description | Image |
|---|---|---|---|---|
| 06.40m | 0:01:45 | LRH | Line of drain/sewer deviates right [half] | <p>Image Provided - Ref: 4_13</p> |

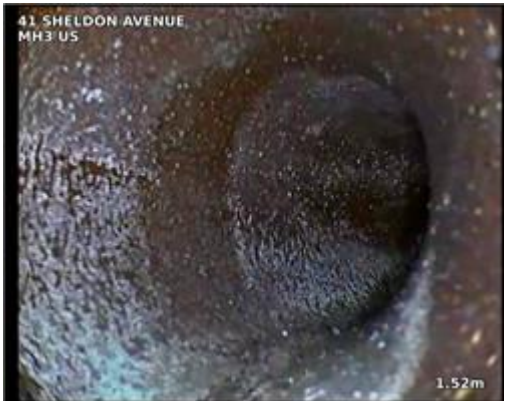
| Position | Code | Description | CD | Pic | Video Ref | |
|---|---|---|---|---|---|--|
| 01.60m | LRH | Line of drain/sewer deviates right [half] | | 5_5 | 0:00:24 | |

| Pos | Video Ref | Code | Description | Image |
|---|---|---|---|---|
| 01.60m | 0:00:24 | LRH | Line of drain/sewer deviates right [half] | Image Provided - Ref: 5_5<br> |

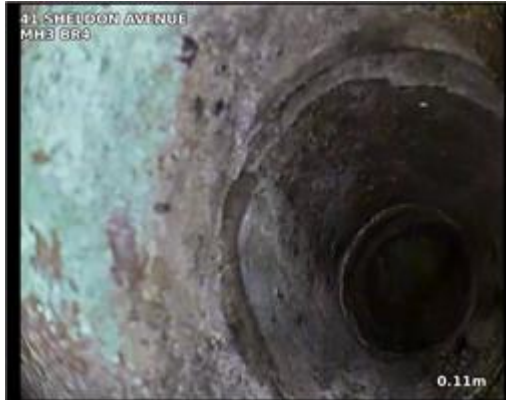
| Pos | Video Ref | Code | Description | Image |
|---|---|---|---|---|
| 00.20m | 0:00:01 | LRQ | Line of drain/sewer deviates right [quarter] | Image Provided - Ref: 8_2<br> A view looking down into the manhole. The concrete walls are visible, and the pipe continues downwards. Text in the top left corner reads '41 SHELDON AVENUE MH3 BR4'. A scale marker '0.11m' is in the bottom right corner. |

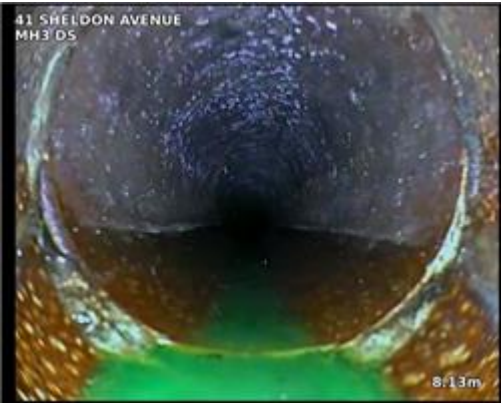
| Pos | Video Ref | Code | Description | Image |
|---|---|---|---|---|
| 08.20m | 0:01:28 | JDM | Joint displaced medium - Severity 3 | <p>Image Provided - Ref: 10_10</p> |

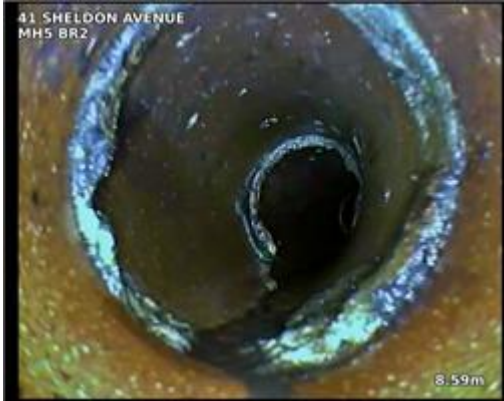
| Pos | Video Ref | Code | Description | Image |
|---|---|---|---|---|
| 08.60m | 0:02:09 | LRQ | Line of drain/sewer deviates right [quarter] | <p>Image Provided - Ref: 14_13</p> |

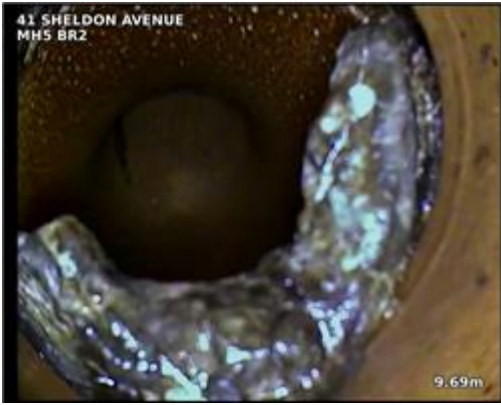
| Pos | Video Ref | Code | Description | Image |
|---|---|---|---|---|
| 09.70m | | BRF | Finish node type, major connection without manhole BR2 | <p>Image Provided - Ref: 14_9999</p> |

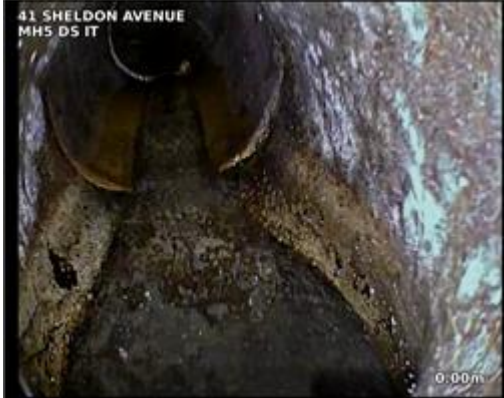
| Pos | Video Ref | Code | Description | Image |
|---|---|---|---|---|
| 00.00m | | MH | Start node type, manhole MH5 | Image Provided - Ref: 15_0<br> |

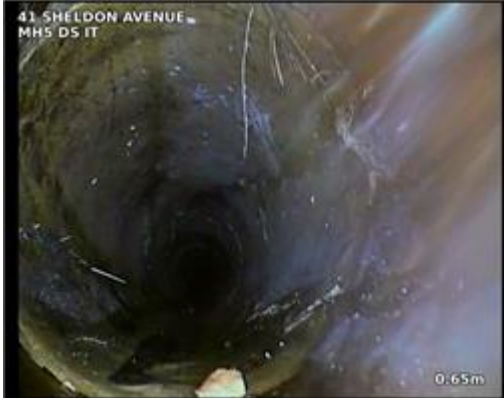
| Pos | Video Ref | Code | Description | Image |
|---|---|---|---|---|
| 00.70m | 0:00:06 | R | Roots - Severity 3 | Image Provided - Ref: 15_2<br> |

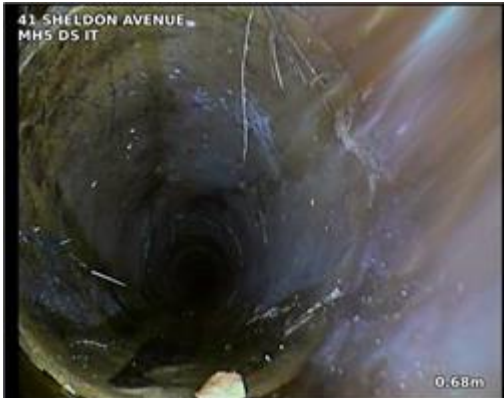
| Position | Code | Description | CD | Pic | Video Ref | |
|---|---|---|---|---|---|--|
| 00.70m | CR | Crack, radiates from 06 | | 15_8 | 0:00:06 | |

| Pos | Video Ref | Code | Description | Image |
|---|---|---|---|---|
| 00.70m | 0:00:06 | CR | Crack, radiates from 06 o'clock - Severity 1 | Image Provided - Ref: 15_8<br> |

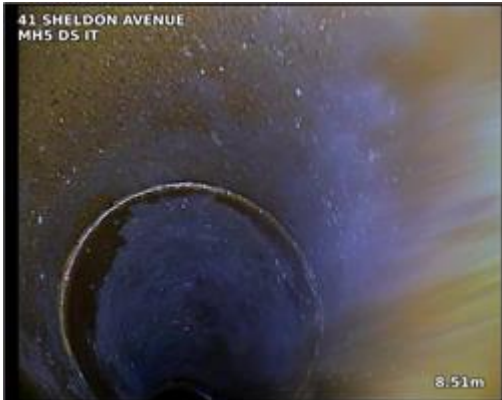
| Pos | Video Ref | Code | Description | Image |
|---|---|---|---|---|
| 08.60m | | BRF | Finish node type, major connection without manhole<br>DS SEWER- LINE DOWN TO SEWER | <p>Image Provided - Ref: 15_9999</p> |

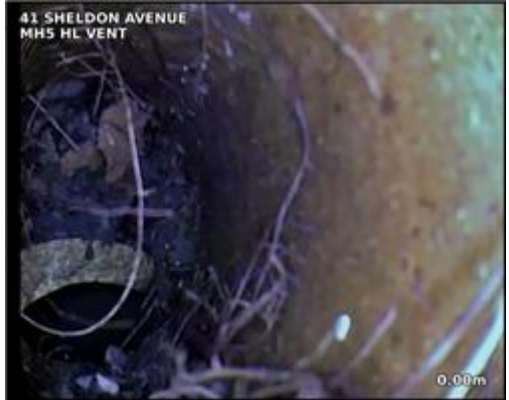
| Pos | Video Ref | Code | Description | Image |
|---|---|---|---|---|
| 00.00m | | MH | Start node type, manhole MH5 | Image Provided - Ref: 16_0<br> 0.00m |
| 00.00m | 0:00:02 | DER | Settled deposits coarse: 100% Cross sectional area loss - Severity 3 | |

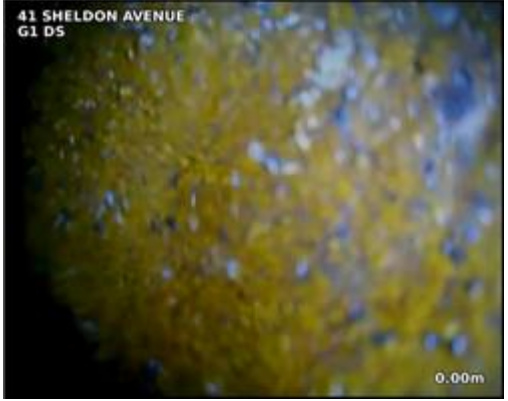
| Pos | Video Ref | Code | Description | Image |
|---|---|---|---|---|
| 00.00m | | MH | Start node type, manhole G1 | <p>Image Provided - Ref: 17_0</p> |
