## FLOOD RISK ASSESSMENT

41 SHELDON AVENUE  
LONDON  
N6 4JP

23135-SYM-XX-XX-RP-C-0001

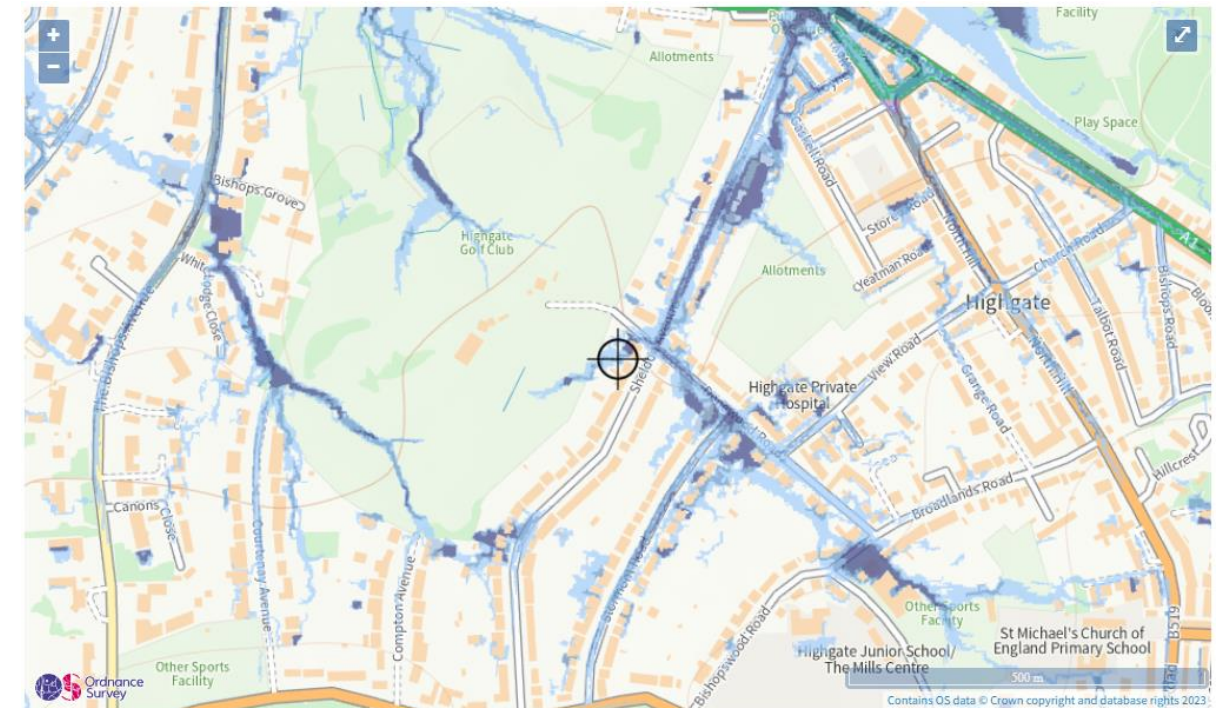
Figure 9: Surface Water Flooding – Extent (GOV.uk, 2023)

9.2.2 The Environment Agency's Risk of Flooding from Surface Water map for the proposed development, taken from the GOV.UK website, is shown in Figure 9. The figure shows minimal areas of the site at 'Medium Risk' with the majority of the site at 'Low' or 'Very Low' risk of flooding from surface water. The adjacent property has areas of 'High Risk'. Where the vehicle and pedestrian access are proposed, the risk of surface water flooding is 'Very Low'.

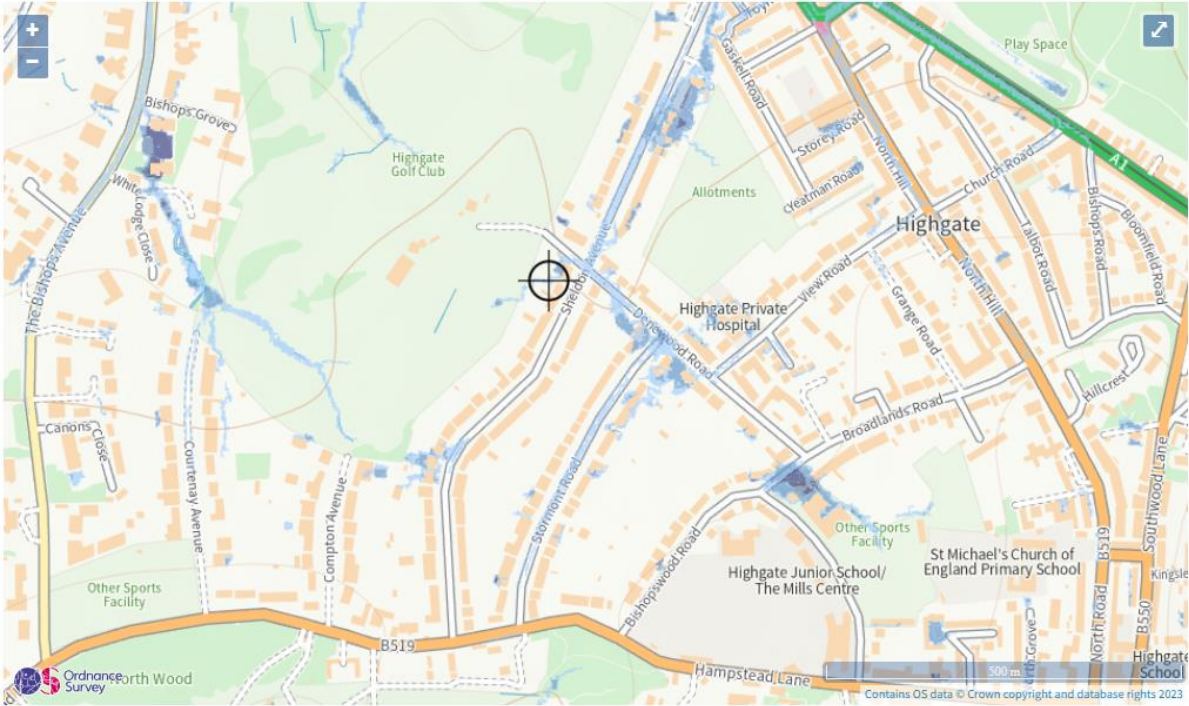
Figure 10: Surface Water Flooding – Medium Risk – Depths (GOV.uk, 2023)

9.2.4 Figure 10 shows that, for the Medium-risk scenario, the rear of the property would be subject to surface water flood depths would below 300mm. The rest of the property is at 'Very Low' flood risk.

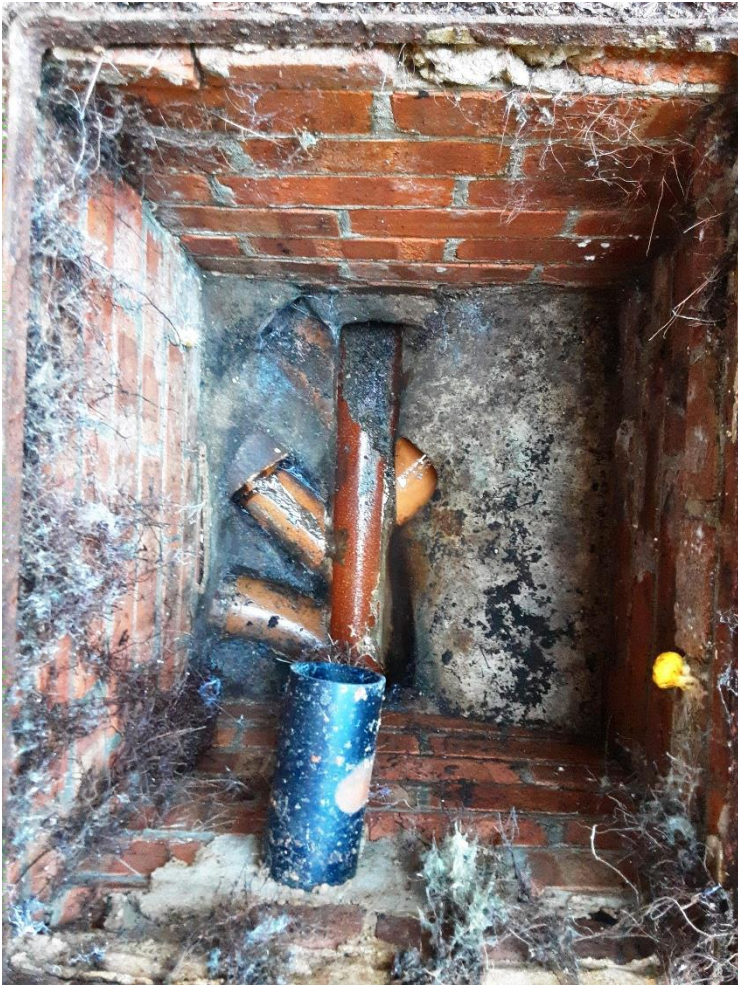
| MH Ref MH 3 | <p>Photo MH</p> |

| Roots in Chamber | |

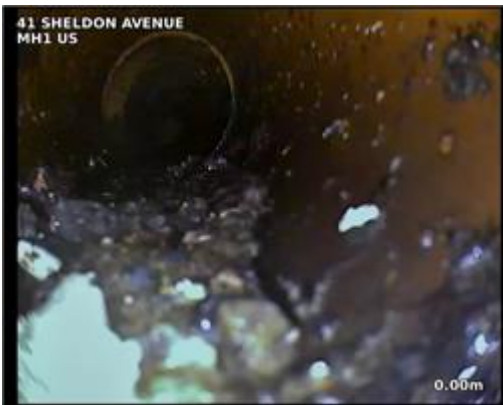
| Pos | Video Ref | Code | Description | Image |
|---|---|---|---|---|
| 00.00m | | MH | Start node type, manhole MH1 | Image Provided - Ref: 0_0<br> |

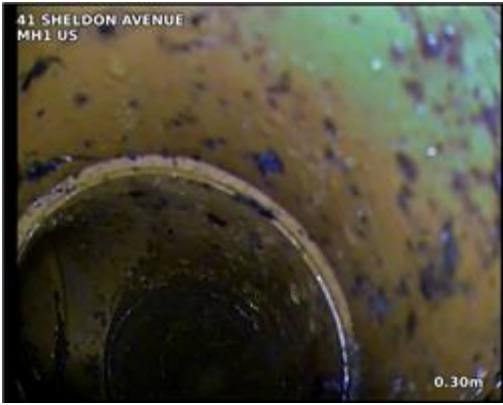
| Pos | Video Ref | Code | Description | Image |
|---|---|---|---|---|
| 00.30m | 0:00:07 | JN | Junction at 09 o'clock: 0mm Diameter | Image Provided - Ref: 0_3<br> |

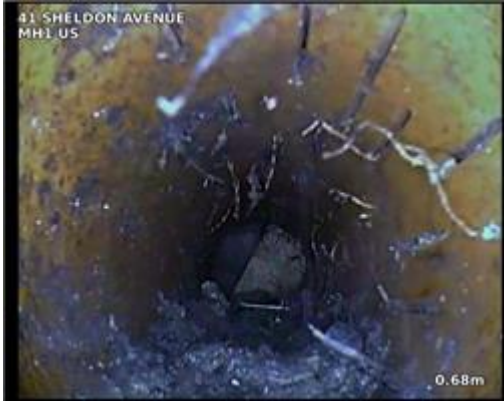
| Pos | Video Ref | Code | Description | Image |
|---|---|---|---|---|
| 00.70m | 0:00:16 | REM | General remark<br>Perforated pipe | Image Provided - Ref: 0_4<br> |

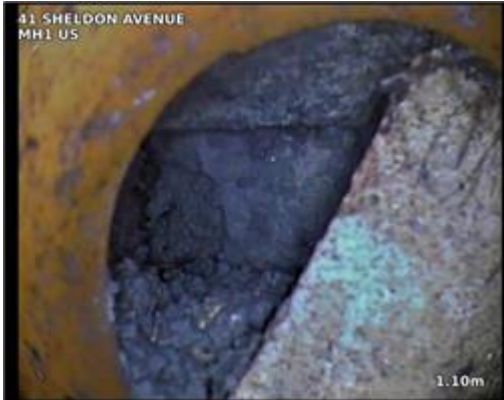
| Pos | Video Ref | Code | Description | Image |
|---|---|---|---|---|
| 01.10m | | WRF | Finish node type, major<br>connection without manhole<br>terminated pipe | Image Provided - Ref: 0_9999<br> |

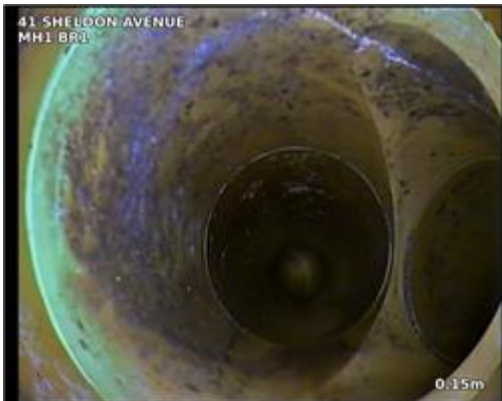
| Pos | Video Ref | Code | Description | Image |
|---|---|---|---|---|
| 00.20m | 0:00:03 | JN | Junction at 03 o'clock: 0mm Diameter | Image Provided - Ref: 1_2<br> 0.15m |

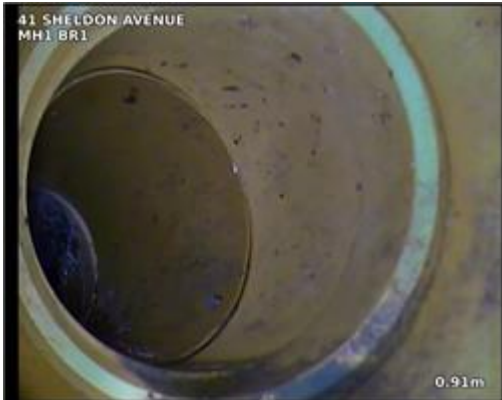
| Pos | Video Ref | Code | Description | Image |
|---|---|---|---|---|
| 01.00m | 0:00:19 | LLH | Line of drain/sewer deviates left [half] | <p>Image Provided - Ref: 1_3</p> |

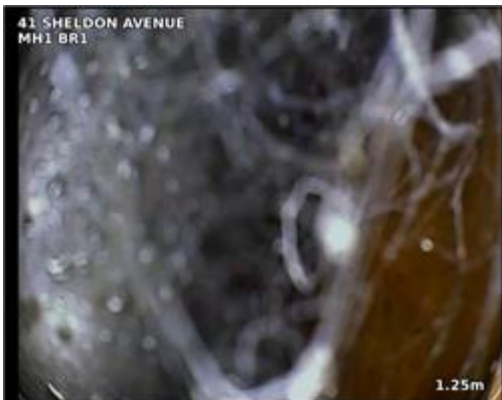
| Pos | Video Ref | Code | Description | Image |
|---|---|---|---|---|
| 01.30m | | GYF | Finish node type Gully BR1 | <p>Image Provided - Ref: 1_9999</p> |

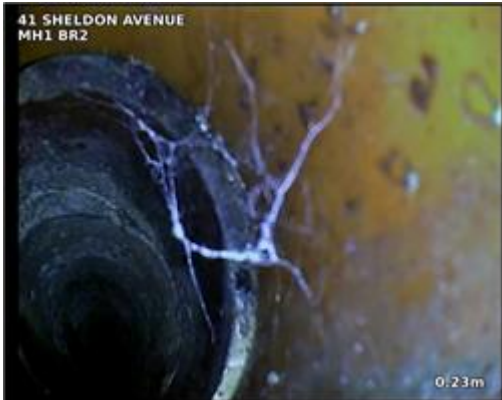
| Pos | Video Ref | Code | Description | Image |
|---|---|---|---|---|
| 00.30m | 0:00:03 | JDM | Joint displaced medium - Severity 3 | Image Provided - Ref: 2_3<br> |

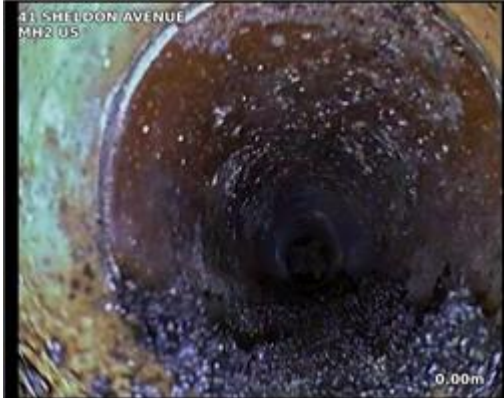
| Pos | Video Ref | Code | Description | Image |
|---|---|---|---|---|
| 00.00m | 0:00:00 | DES | Settled deposits fine: 20% Cross sectional area loss - Severity 3 | Image Provided - Ref: 3_2<br> |

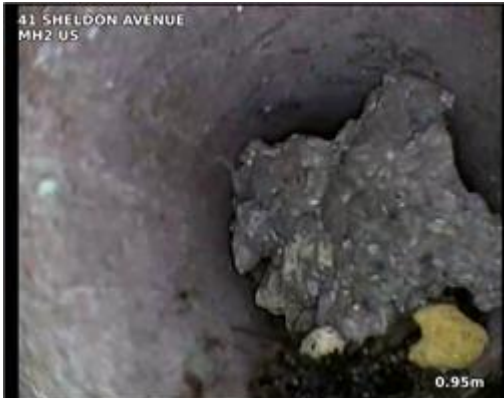
| Position | Code | Description | CD | Pic | Video Ref | |
|---|---|---|---|---|---|--|
| 01.00m | OB | Other obstacles 80% | | 3_3 | 0:00:18 | |

| Pos | Video Ref | Code | Description | Image |
|---|---|---|---|---|
| 01.00m | 0:00:18 | OB | Other obstacles: 80% Cross sectional area loss - Severity 3 concrete | Image Provided - Ref: 3_3<br> |

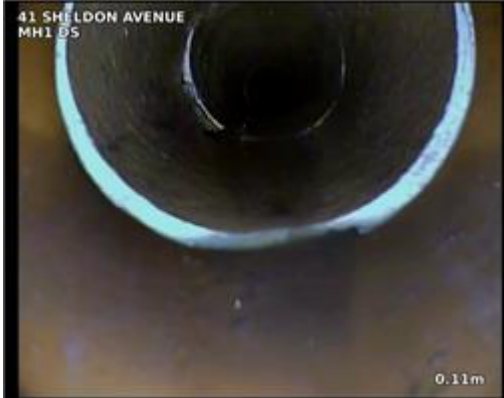
| Pos | Video Ref | Code | Description | Image |
|---|---|---|---|---|
| 00.20m | 0:00:08 | JDM | Joint displaced medium - Severity 3 | Image Provided - Ref: 4_2<br> |

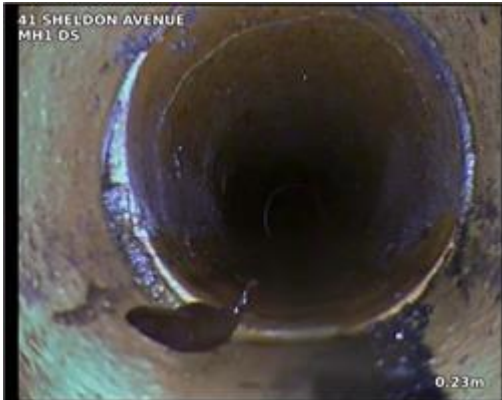
| Pos | Video Ref | Code | Description | Image |
|---|---|---|---|---|
| 00.30m | 0:00:14 | JDM | Joint displaced medium - Severity 3 | Image Provided - Ref: 4_4<br> |

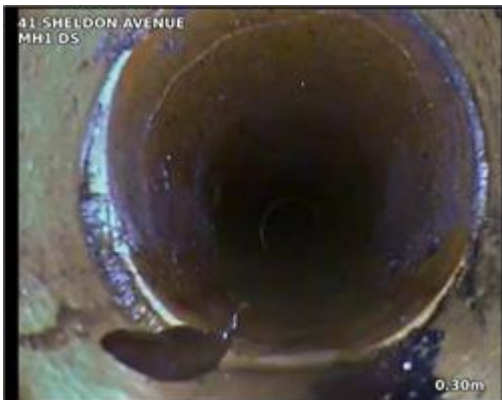
| Position | Code | Description | CD | Pic | Video Ref | |
|---|---|---|---|---|---|--|
| 00.30m | CC | Crack, circumferential 09-03 | | 4_5 | 0:00:14 | |

| Pos | Video Ref | Code | Description | Image |
|---|---|---|---|---|
| 00.30m | 0:00:14 | CC | Crack, circumferential from 09 o'clock to 03 o'clock - Severity 1 | Image Provided - Ref: 4_5<br> |

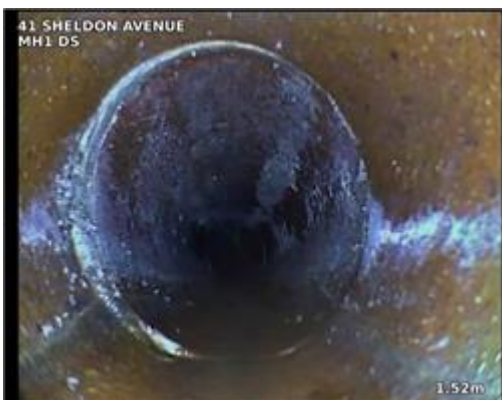
| Pos | Video Ref | Code | Description | Image |
|---|---|---|---|---|
| 01.60m | 0:00:31 | JDM | Joint displaced medium - Severity 3 | Image Provided - Ref: 4_6<br> |

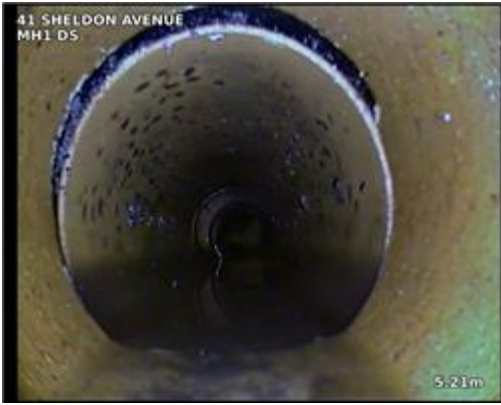
| Pos | Video Ref | Code | Description | Image |
|---|---|---|---|---|
| 05.30m | 0:01:20 | JDM | Joint displaced medium - Severity 3 | Image Provided - Ref: 4_10<br> |

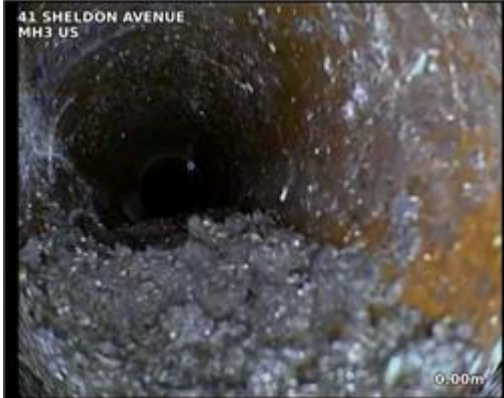
| Pos | Video Ref | Code | Description | Image |
|---|---|---|---|---|
| 00.00m | 0:00:00 | DES | Settled deposits fine: 30% Cross sectional area loss - Severity 3 | Image Provided - Ref: 5_2<br> |

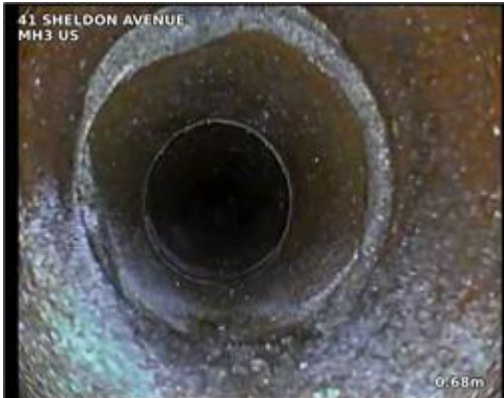
| Pos | Video Ref | Code | Description | Image |
|---|---|---|---|---|
| 00.70m | 0:00:08 | JDM | Joint displaced medium - Severity 3 | Image Provided - Ref: 5_3<br> |

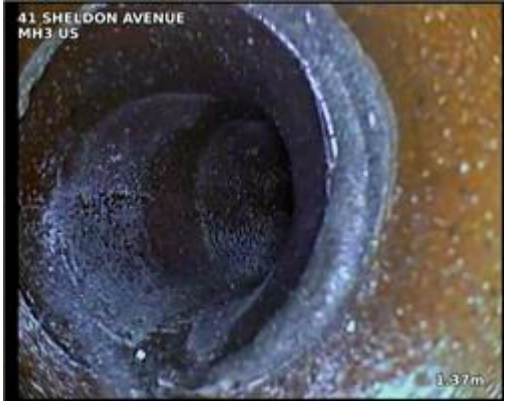
| Pos | Video Ref | Code | Description | Image |
|---|---|---|---|---|
| 01.40m | 0:00:22 | JDM | Joint displaced medium - Severity 3 | Image Provided - Ref: 5_4<br> |

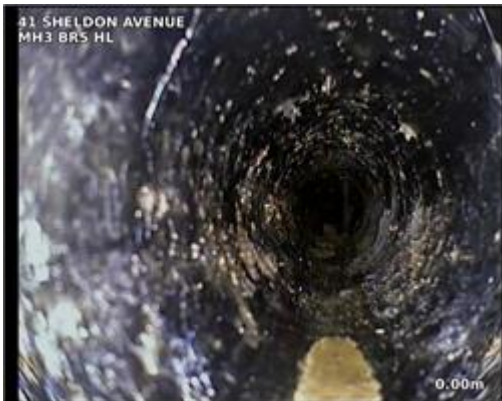
| Pos | Video Ref | Code | Description | Image |
|---|---|---|---|---|
| 00.00m | 0:00:02 | S1 DES | Settled deposits fine 0m - 1.2m: 10% Cross sectional area loss - Severity 3 | Image Provided - Ref: 9_2<br> |
| 01.20m | 0:00:02 | F1 DES | Settled deposits fine Defect End: 10% Cross sectional area loss - Severity 3 | |

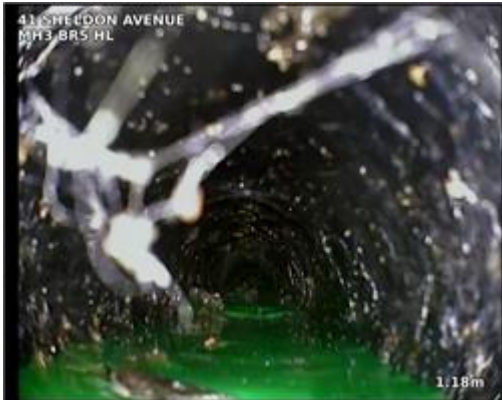
| Pos | Video Ref | Code | Description | Image |
|---|---|---|---|---|
| 01.20m | | SA | Survey abandoned camera unable to pass | Image Provided - Ref: 9_9999<br> |

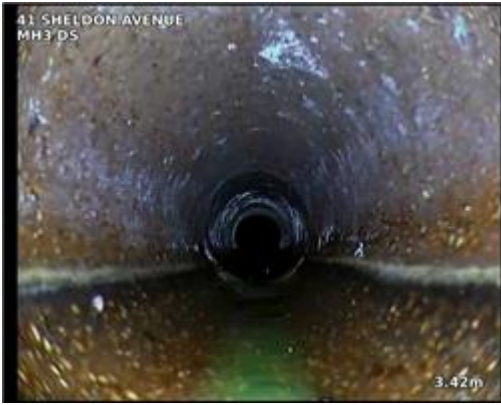
| Pos | Video Ref | Code | Description | Image |
|---|---|---|---|---|
| 03.50m | 0:00:33 | REM | General remark<br>general condition | <p>Image Provided - Ref: 10_4</p> |

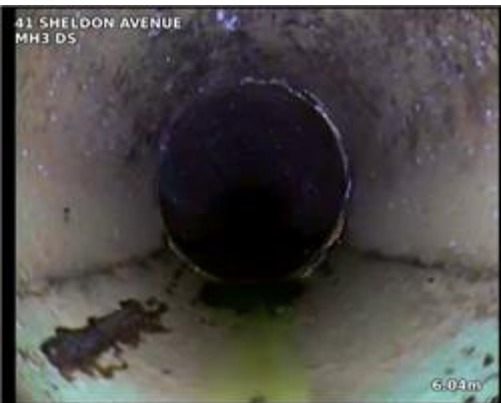
| Pos | Video Ref | Code | Description | Image |
|---|---|---|---|---|
| 06.00m | 0:01:08 | REM | General remark general condition | <p>Image Provided - Ref: 10_8</p> |

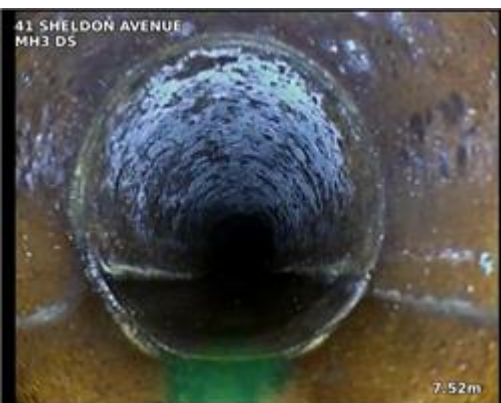
| Pos | Video Ref | Code | Description | Image |
|---|---|---|---|---|
| 07.60m | 0:01:22 | JDM | Joint displaced medium - Severity 3 | <p>Image Provided - Ref: 10_9</p> |

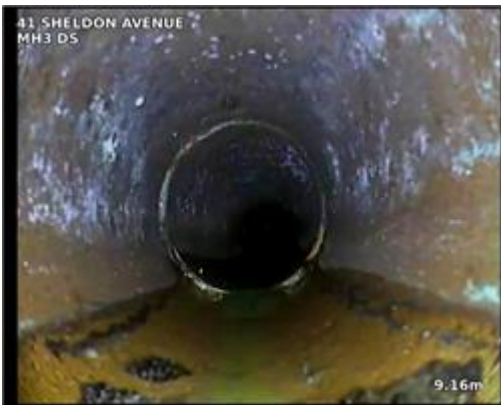
| Pos | Video Ref | Code | Description | Image |
|---|---|---|---|---|
| 09.20m | 0:01:39 | REM | General remark general condition | <p>Image Provided - Ref: 10_11</p> |

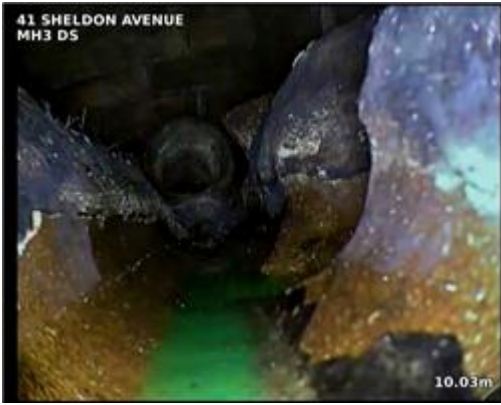
| Pos | Video Ref | Code | Description | Image |
|---|---|---|---|---|
| 10.00m | | MHF | Finish node type, manhole MH5 | <p>Image Provided - Ref: 10_9999</p> |

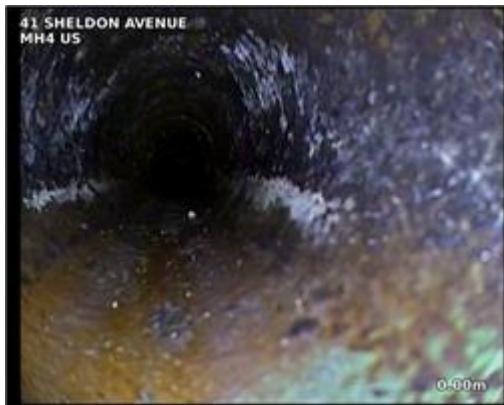
| Pos | Video Ref | Code | Description | Image |
|---|---|---|---|---|
| 00.00m | | MH | Start node type, manhole MH4 | Image Provided - Ref: 11_0<br> |

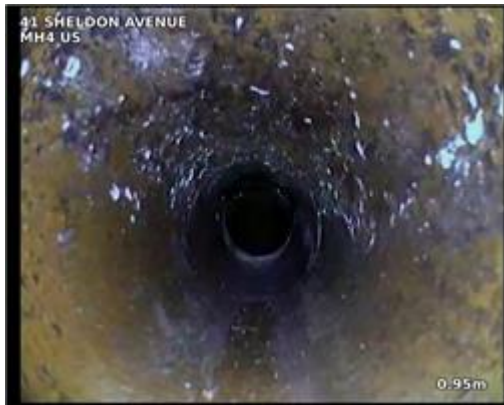
| Pos | Video Ref | Code | Description | Image |
|---|---|---|---|---|
| 01.00m | 0:00:14 | REM | General remark general condition | Image Provided - Ref: 11_4<br> |

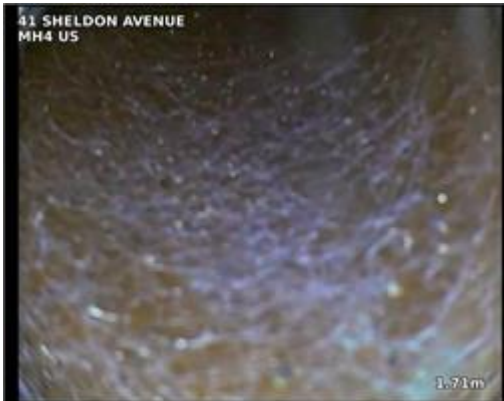
| Pos | Video Ref | Code | Description | Image |
|---|---|---|---|---|
| 01.80m | | BRF | Finish node type, major connection without manhole US | <p>Image Provided - Ref: 11_9999</p> |

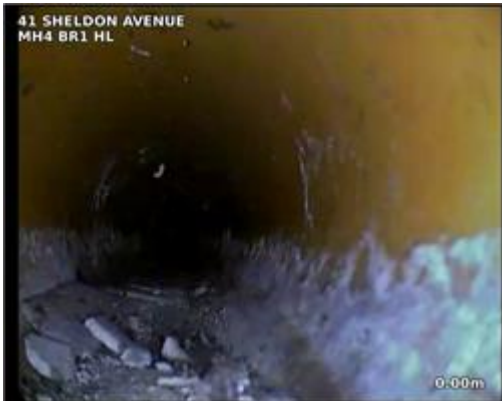
| Pos | Video Ref | Code | Description | Image |
|---|---|---|---|---|
| 00.00m | | MH | Start node type, manhole MH4 | Image Provided - Ref: 12_0<br> |

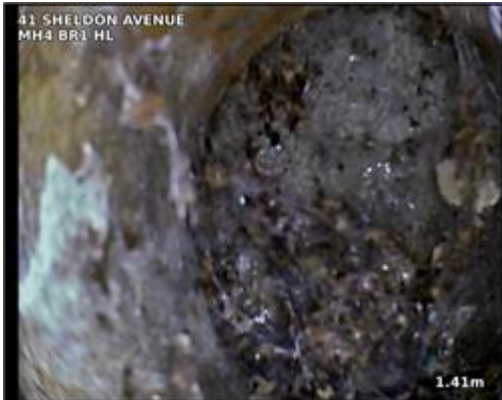
| Pos | Video Ref | Code | Description | Image |
|---|---|---|---|---|
| 01.50m | | GYF | Finish node type Gully BR1 HL | Image Provided - Ref: 12_9999<br> |

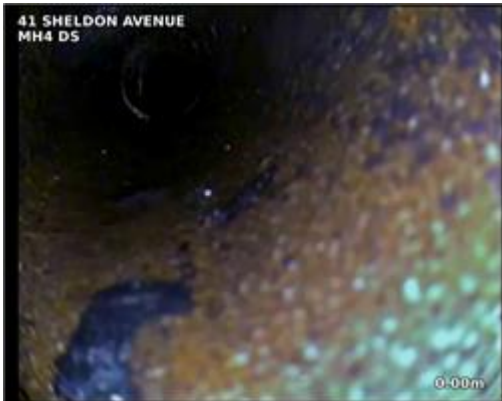
| Pos | Video Ref | Code | Description | Image |
|---|---|---|---|---|
| 00.00m | | MH | Start node type, manhole MH4 | Image Provided - Ref: 13_0<br> |

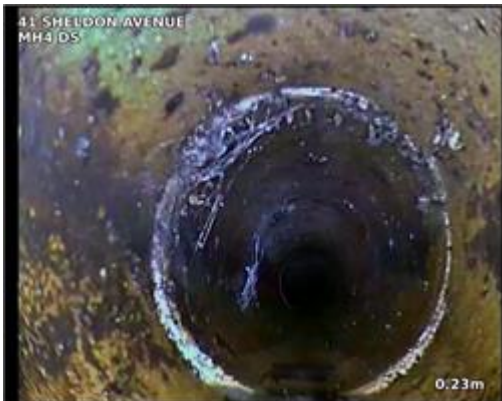
| Pos | Video Ref | Code | Description | Image |
|---|---|---|---|---|
| 00.30m | 0:00:07 | JDM | Joint displaced medium - Severity 3 | Image Provided - Ref: 13_2<br> |

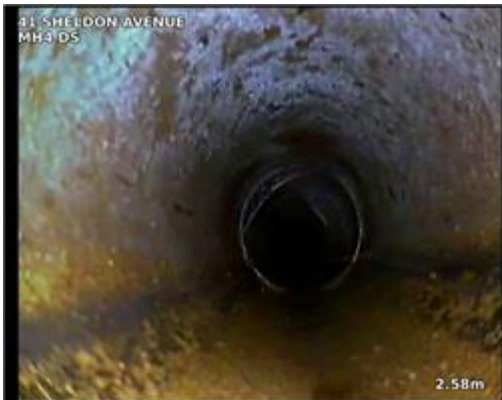
| Pos | Video Ref | Code | Description | Image |
|---|---|---|---|---|
| 02.60m | 0:00:40 | REM | General remark general condition | Image Provided - Ref: 13_3<br> |

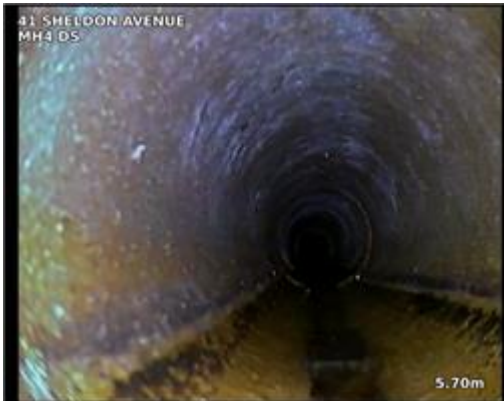
| Pos | Video Ref | Code | Description | Image |
|---|---|---|---|---|
| 05.70m | 0:01:09 | REM | General remark general condition | <p>Image Provided - Ref: 13_5</p> |

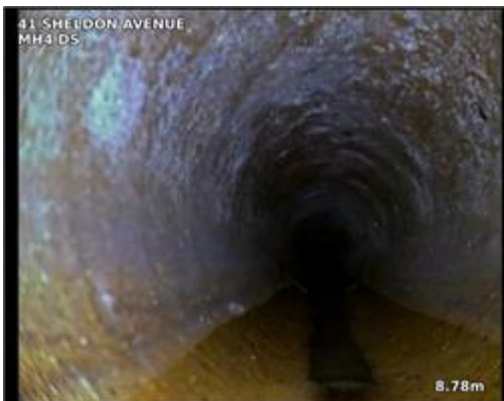
| Pos | Video Ref | Code | Description | Image |
|---|---|---|---|---|
| 08.80m | 0:01:35 | REM | General remark general condition | <p>Image Provided - Ref: 13_6</p> |

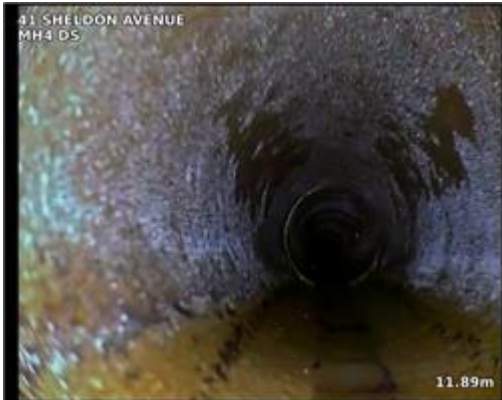
| Pos | Video Ref | Code | Description | Image |
|---|---|---|---|---|
| 11.90m | 0:02:05 | REM | General remark<br>general condition | <p>Image Provided - Ref: 13_7</p> |

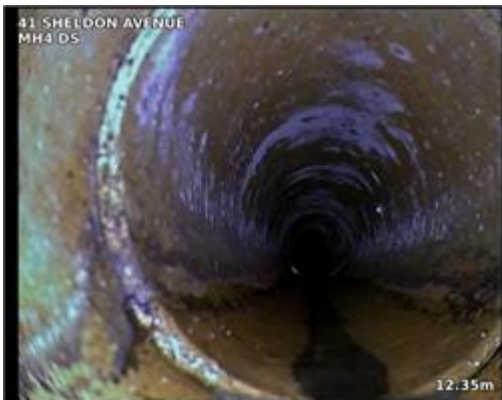
| Pos | Video Ref | Code | Description | Image |
|---|---|---|---|---|
| 12.40m | 0:02:09 | JDM | Joint displaced medium -<br>Severity 3 | <p>Image Provided - Ref: 13_8</p> |

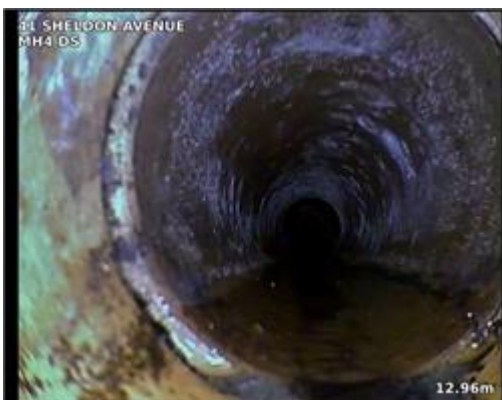
| Pos | Video Ref | Code | Description | Image |
|---|---|---|---|---|
| 13.00m | 0:02:15 | JDM | Joint displaced medium -<br>Severity 3 | <p>Image Provided - Ref: 13_9</p> |

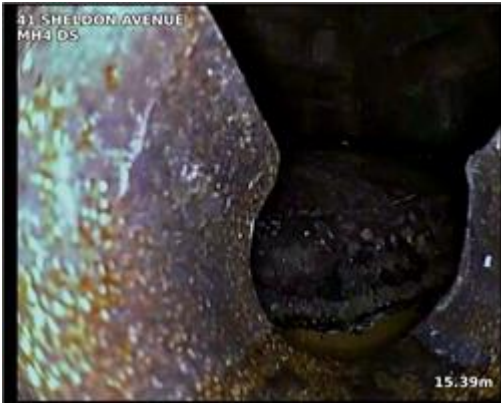
| Pos | Video Ref | Code | Description | Image |
|---|---|---|---|---|
| 15.40m | | MHF | Finish node type, manhole MH5 | <p>Image Provided - Ref: 13_9999</p> |

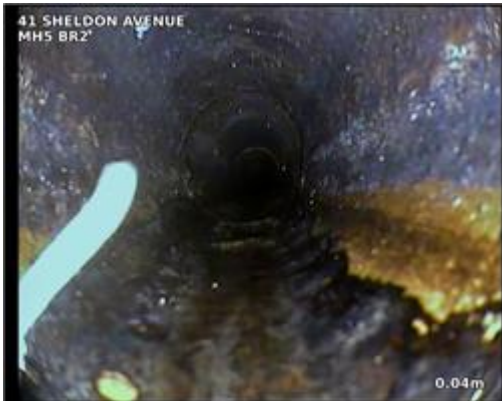
| Pos | Video Ref | Code | Description | Image |
|---|---|---|---|---|
| 00.00m | | MH | Start node type, manhole MH5 | Image Provided - Ref: 14_0<br> |

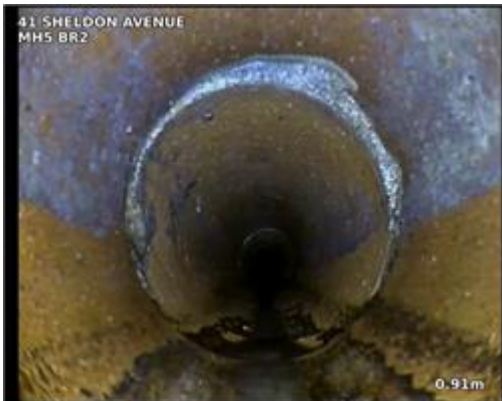
| Pos | Video Ref | Code | Description | Image |
|---|---|---|---|---|
| 01.00m | 0:00:16 | JDM | Joint displaced medium - Severity 3 | Image Provided - Ref: 14_2<br> |

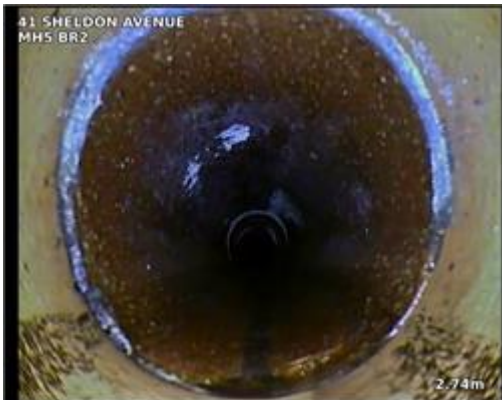
| Pos | Video Ref | Code | Description | Image |
|---|---|---|---|---|
| 02.80m | 0:00:35 | JDM | Joint displaced medium - Severity 3 | Image Provided - Ref: 14_3<br> |

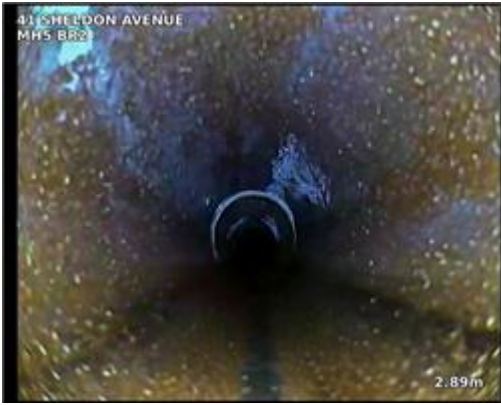
| Pos | Video Ref | Code | Description | Image |
|---|---|---|---|---|
| 02.90m | 0:00:37 | REM | General remark<br>general condition | <p>Image Provided - Ref: 14_4</p> |

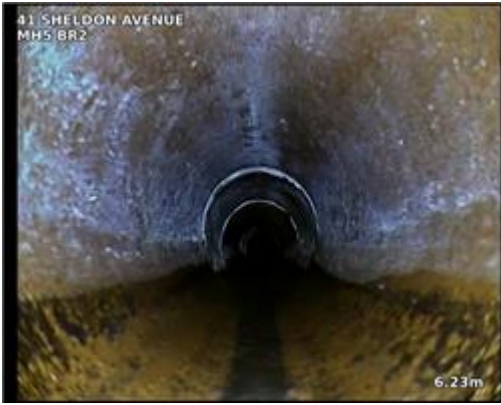
| Pos | Video Ref | Code | Description | Image |
|---|---|---|---|---|
| 06.30m | 0:01:13 | REM | General remark<br>general condition | <p>Image Provided - Ref: 14_7</p> |

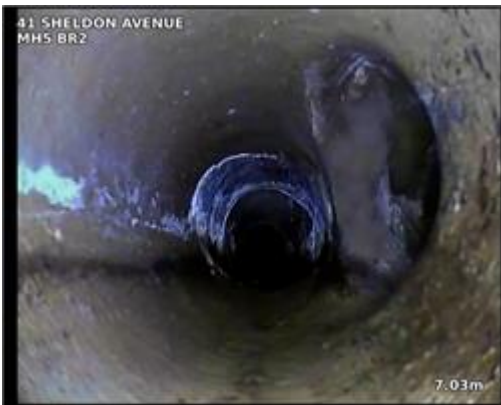
| Pos | Video Ref | Code | Description | Image |
|---|---|---|---|---|
| 07.10m | 0:01:22 | JN | Junction at 03 o'clock: 0mm<br>Diameter | <p>Image Provided - Ref: 14_8</p> |

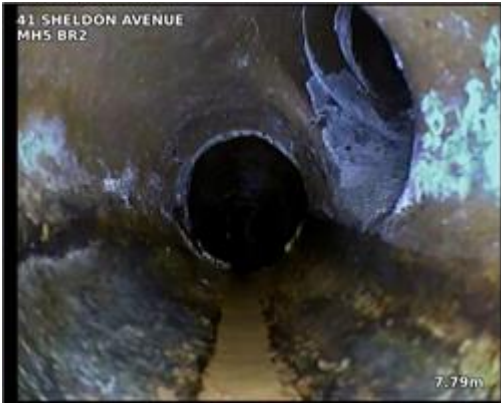
| Pos | Video Ref | Code | Description | Image |
|---|---|---|---|---|
| 07.80m | 0:01:50 | JN | Junction at 02 o'clock: 0mm Diameter | <p>Image Provided - Ref: 14_10</p> |

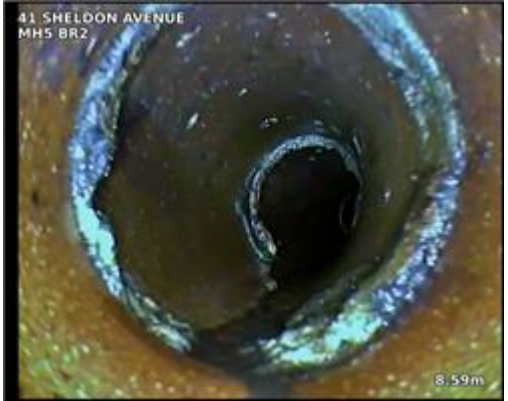
| Pos | Video Ref | Code | Description | Image |
|---|---|---|---|---|
| 08.60m | 0:02:09 | LRQ | Line of drain/sewer deviates right [quarter] | <p>Image Provided - Ref: 14_13</p> |

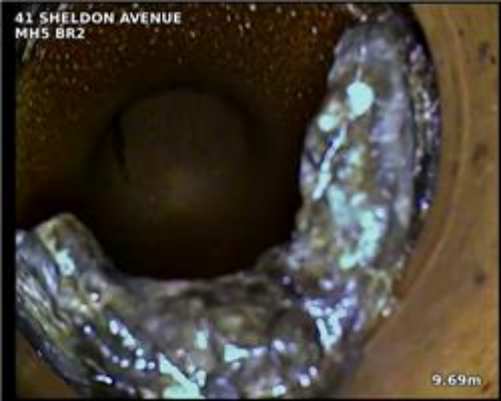
| Pos | Video Ref | Code | Description | Image |
|---|---|---|---|---|
| 09.70m | | BRF | Finish node type, major connection without manhole BR2 | <p>Image Provided - Ref: 14_9999</p> |

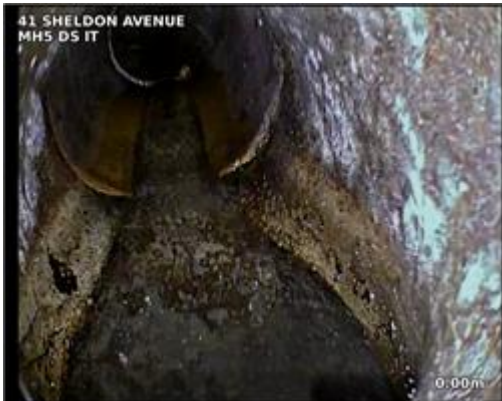
| Pos | Video Ref | Code | Description | Image |
|---|---|---|---|---|
| 00.00m | | MH | Start node type, manhole MH5 | Image Provided - Ref: 15_0<br> |

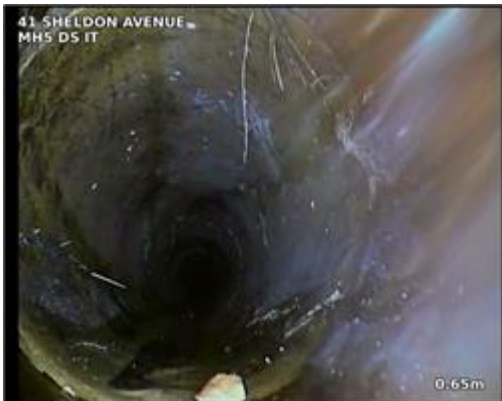
| Pos | Video Ref | Code | Description | Image |
|---|---|---|---|---|
| 00.70m | 0:00:06 | R | Roots - Severity 3 | Image Provided - Ref: 15_2<br> |

- The line to the sewer has a crack and longitudinal fracture and root ingress just downstream of the interceptor trap.

- Clean the foul and surface water pipes to remove settled deposits with high pressure jetting as necessary. Clear large coarse deposits present in pipe MH2 upstream.
- Monitor grade 1 or 2 cracks and line if they deteriorate.
- Points of root ingress are to be sealed and repair any cracks/fractures pipe by lining, this is necessary downstream of the interceptor trap.
- Any critical drainage dimensions should be checked prior to any works.

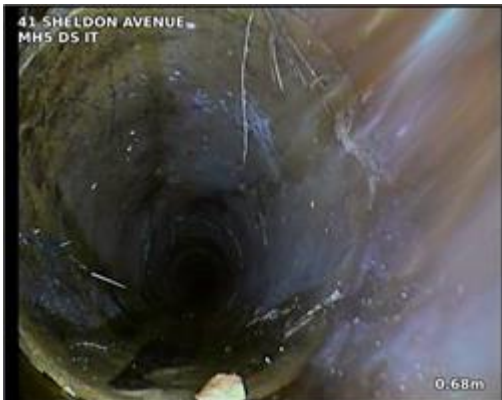
| Position | Code | Description | CD | Pic | Video Ref | |
|---|---|---|---|---|---|--|
| 00.70m | CR | Crack, radiates from 06 | | 15_8 | 0:00:06 | |

| Pos | Video Ref | Code | Description | Image |
|---|---|---|---|---|
| 00.70m | 0:00:06 | CR | Crack, radiates from 06 o'clock - Severity 1 | Image Provided - Ref: 15_8<br> |

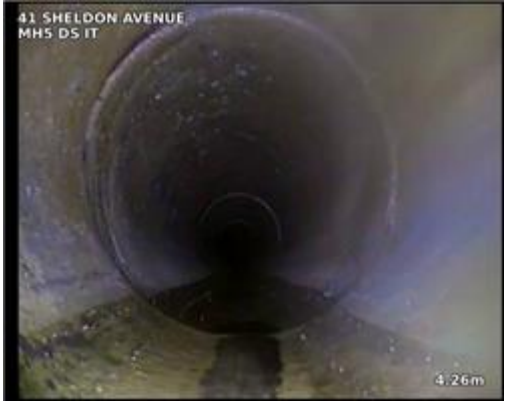
| Pos | Video Ref | Code | Description | Image |
|---|---|---|---|---|
| 04.30m | 0:00:41 | REM | General remark<br>general condition | <p>Image Provided - Ref: 15_5</p> |

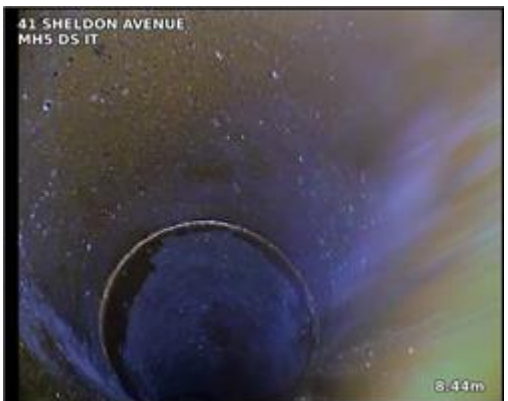
| Pos | Video Ref | Code | Description | Image |
|---|---|---|---|---|
| 08.50m | 0:01:07 | LDH | Line of drain/sewer deviates<br>down [half]<br>line down to sewer | <p>Image Provided - Ref: 15_7</p> |

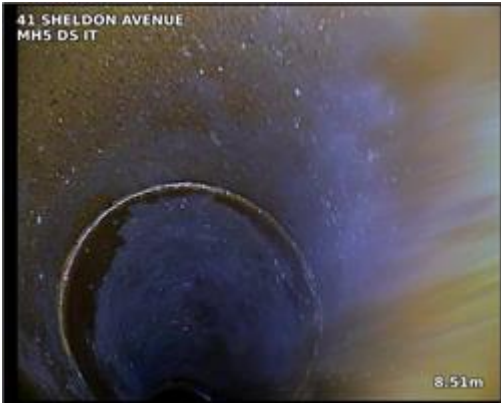
| Pos | Video Ref | Code | Description | Image |
|---|---|---|---|---|
| 08.60m | | BRF | Finish node type, major connection without manhole<br>DS SEWER- LINE DOWN TO SEWER | <p>Image Provided - Ref: 15_9999</p> |

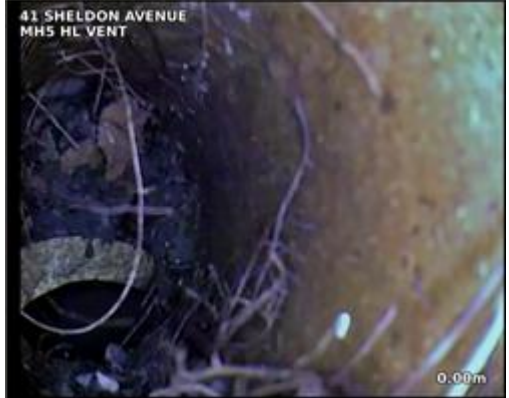
| Pos | Video Ref | Code | Description | Image |
|---|---|---|---|---|
| 00.00m | | MH | Start node type, manhole MH5 | Image Provided - Ref: 16_0<br> 0.00m |
| 00.00m | 0:00:02 | DER | Settled deposits coarse: 100% Cross sectional area loss - Severity 3 | |

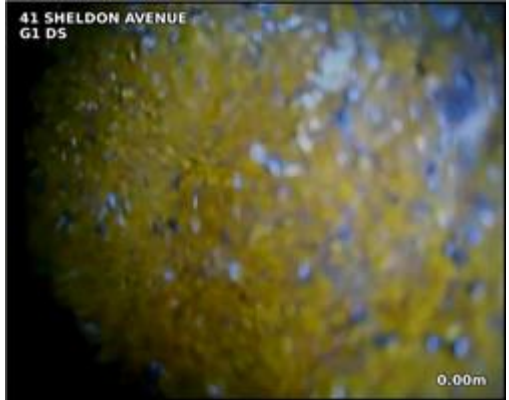
| Pos | Video Ref | Code | Description | Image |
|---|---|---|---|---|
| 00.00m | | MH | Start node type, manhole G1 | <p>Image Provided - Ref: 17_0</p> |

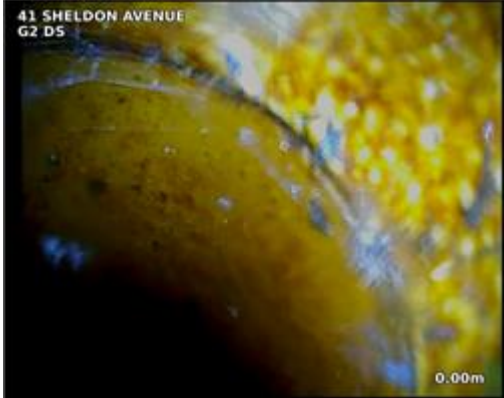
| Pos | Video Ref | Code | Description | Image |
|---|---|---|---|---|
| 00.00m | | MH | Start node type, manhole G2 | Image Provided - Ref: 18_0<br> |

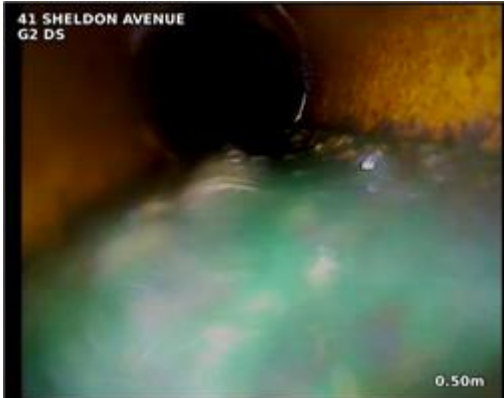
| Pos | Video Ref | Code | Description | Image |
|---|---|---|---|---|
| 00.50m | 0:00:25 | S1 DES | Settled deposits fine 0.5m - 1.8m: 20% Cross sectional area loss - Severity 3 | Image Provided - Ref: 18_2<br> |
| 01.80m | 0:00:25 | F1 DES | Settled deposits fine Defect End: 20% Cross sectional area loss - Severity 3 | |

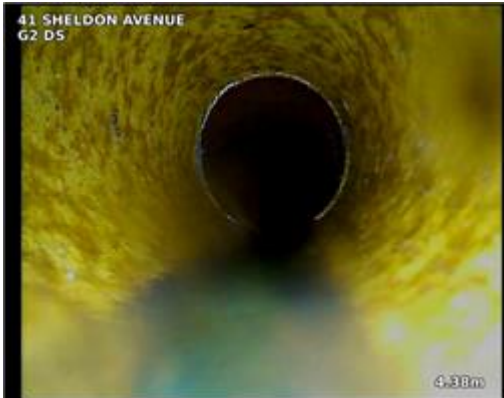
| Pos | Video Ref | Code | Description | Image |
|---|---|---|---|---|
| 04.40m | 0:01:23 | REM | General remark general condition | Image Provided - Ref: 18_3<br> |

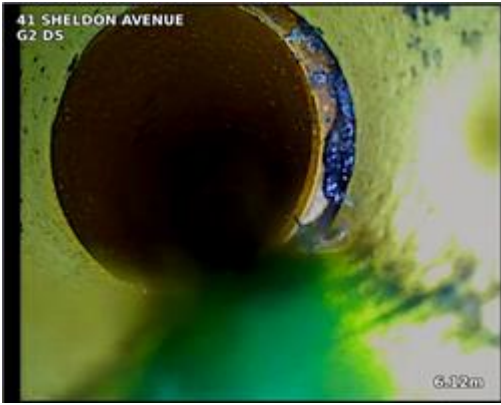
| Pos | Video Ref | Code | Description | Image |
|---|---|---|---|---|
| 06.20m | 0:01:47 | JDM | Joint displaced medium - Severity 3 | Image Provided - Ref: 18_4<br> |

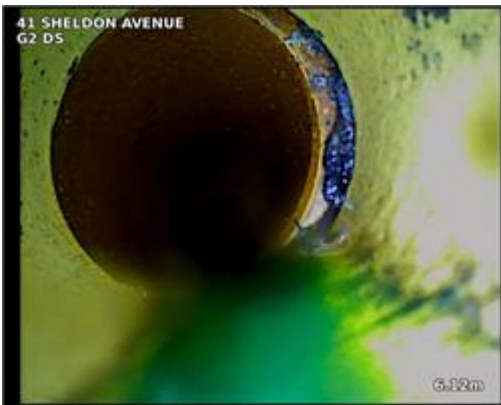
| Pos | Video Ref | Code | Description | Image |
|---|---|---|---|---|
| 06.20m | 0:01:47 | LLH | Line of drain/sewer deviates left [half] | Image Provided - Ref: 18_5<br> |

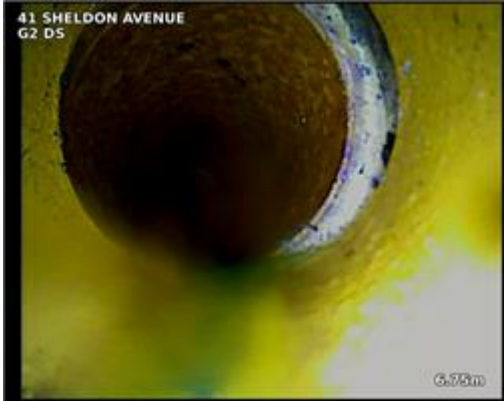
| Pos | Video Ref | Code | Description | Image |
|---|---|---|---|---|
| 06.80m | 0:01:55 | LLH | Line of drain/sewer deviates left [half] | <p>Image Provided - Ref: 18_7</p> |

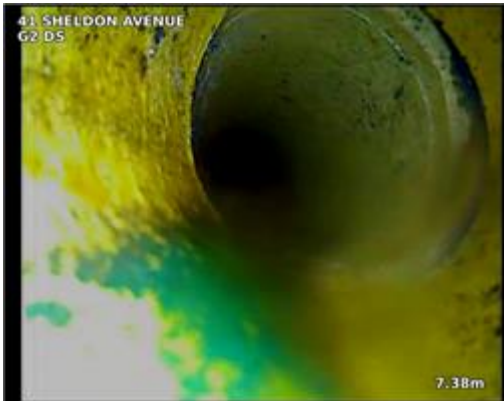
| Pos | Video Ref | Code | Description | Image |
|---|---|---|---|---|
| 07.40m | 0:02:06 | JDM | Joint displaced medium - Severity 3 | <p>Image Provided - Ref: 18_8</p> |

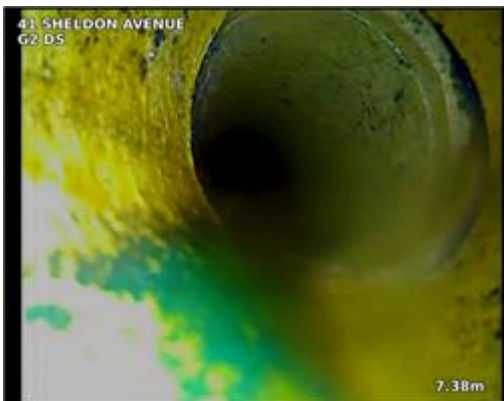
| Position | Code | Description | CD | Pic | Video Ref | |
|---|---|---|---|---|---|---|
| 07.40m | CC | Crack, circumferential 10-04 | | 18_9 | 0:02:06 | |

| Pos | Video Ref | Code | Description | Image |
|---|---|---|---|---|
| 07.40m | 0:02:06 | CC | Crack, circumferential from 10 o'clock to 04 o'clock - Severity 1 | <p>Image Provided - Ref: 18_9</p> |

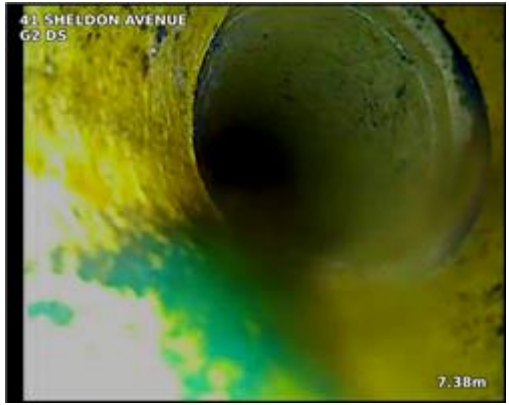
| Pos | Video Ref | Code | Description | Image |
|---|---|---|---|---|
| 07.40m | 0:02:06 | LLH | Line of drain/sewer deviates left [half] | <p>Image Provided - Ref: 18_10</p> |

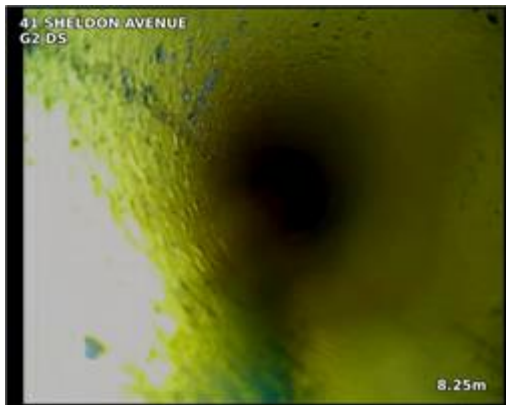
| Pos | Video Ref | Code | Description | Image |
|---|---|---|---|---|
| 08.30m | 0:02:18 | REM | General remark<br>general condition | <p>Image Provided - Ref: 18_11</p> |

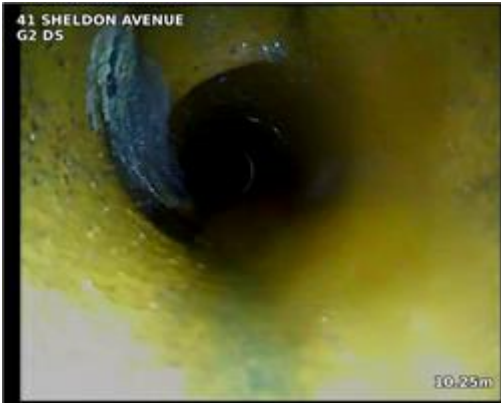
| Pos | Video Ref | Code | Description | Image |
|---|---|---|---|---|
| 10.30m | 0:02:57 | JN | Junction at 11 o'clock: 0mm Diameter | <p>Image Provided - Ref: 18_13</p> |

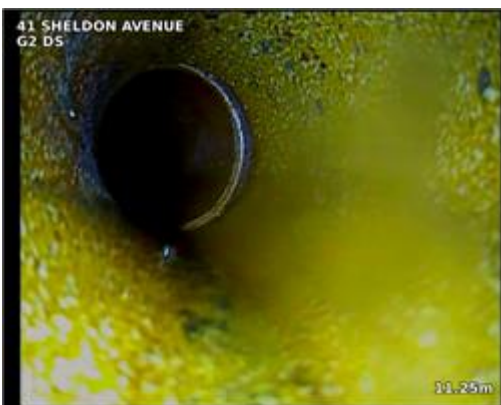
| Pos | Video Ref | Code | Description | Image |
|---|---|---|---|---|
| 11.30m | 0:03:25 | LLH | Line of drain/sewer deviates left [half] | <p>Image Provided - Ref: 18_15</p> |

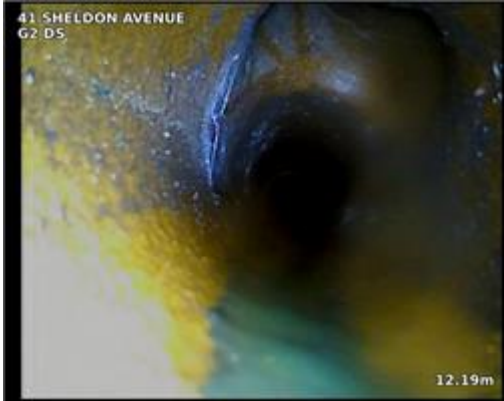
| Pos | Video Ref | Code | Description | Image |
|---|---|---|---|---|
| 12.20m | 0:03:38 | JN | Junction at 12 o'clock: 0mm Diameter | <p>Image Provided - Ref: 18_16</p> |

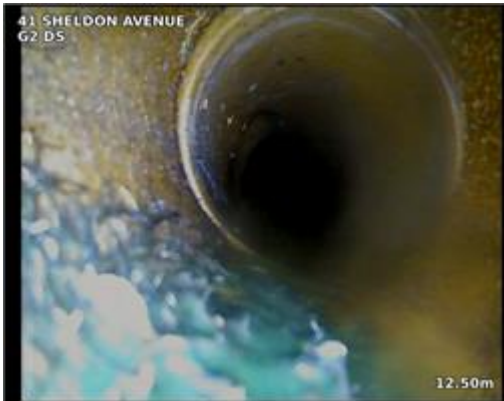
| Pos | Video Ref | Code | Description | Image |
|---|---|---|---|---|
| 12.50m | 0:03:47 | JDM | Joint displaced medium - Severity 3 | <p>Image Provided - Ref: 18_17</p> |

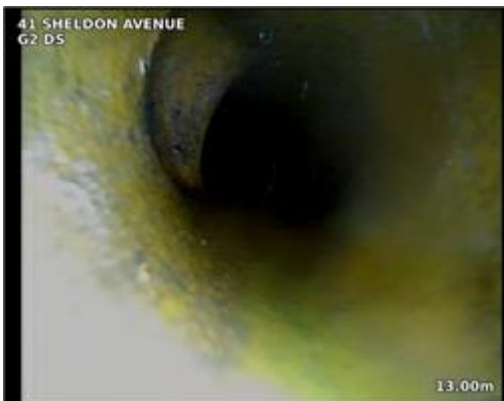
| Pos | Video Ref | Code | Description | Image |
|---|---|---|---|---|
| 13.00m | 0:03:50 | JN | Junction at 09 o'clock: 0mm Diameter | <p>Image Provided - Ref: 18_18</p> |

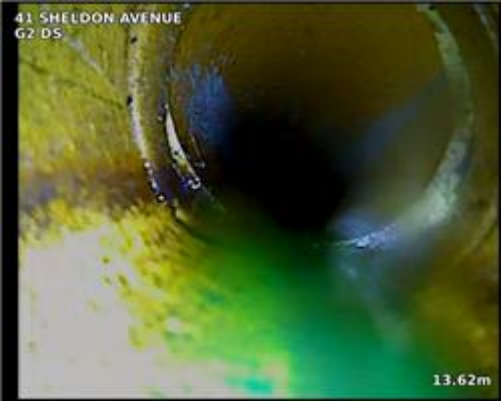
| Pos | Video Ref | Code | Description | Image |
|---|---|---|---|---|
| 13.70m | 0:03:59 | JDM | Joint displaced medium - Severity 3 | <p>Image Provided - Ref: 18_19</p> |

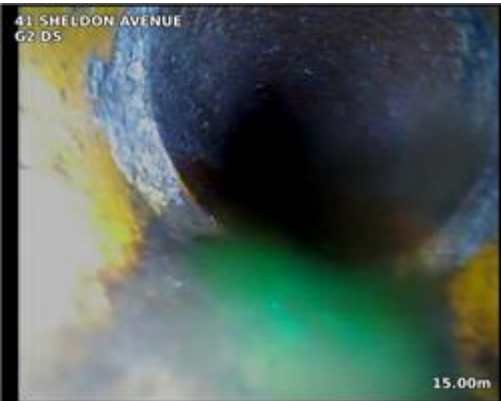
| Pos | Video Ref | Code | Description | Image |
|---|---|---|---|---|
| 15.00m | 0:04:20 | JDM | Joint displaced medium - Severity 3 | <p>Image Provided - Ref: 18_20</p> |

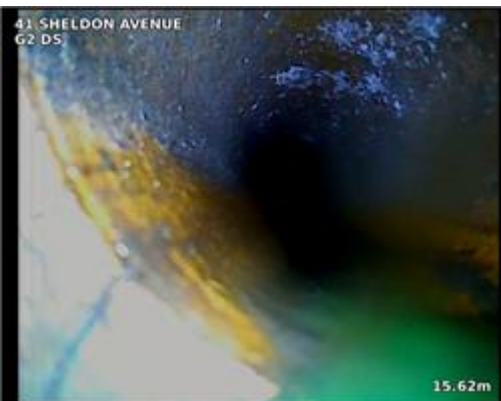
| Pos | Video Ref | Code | Description | Image |
|---|---|---|---|---|
| 15.70m | 0:04:39 | JDM | Joint displaced medium - Severity 3 | <p>Image Provided - Ref: 18_21</p> |

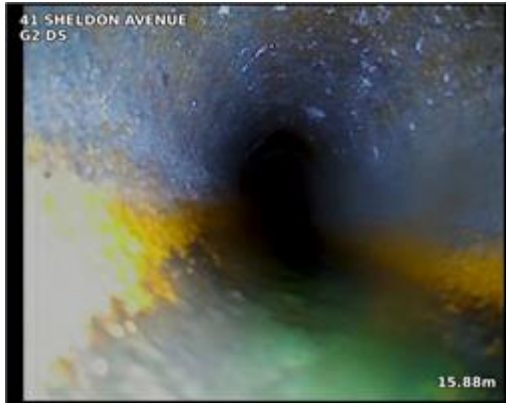
| Pos | Video Ref | Code | Description | Image |
|---|---|---|---|---|
| 15.90m | 0:04:41 | REM | General remark<br>general condition | <p>Image Provided - Ref: 18_22</p> |

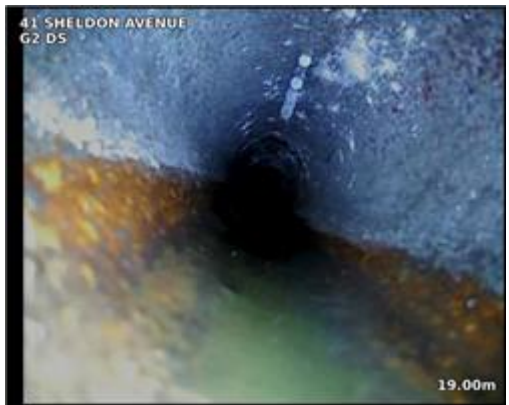
| Pos | Video Ref | Code | Description | Image |
|---|---|---|---|---|
| 19.00m | 0:05:48 | REM | General remark<br>general condition | <p>Image Provided - Ref: 18_23</p> |

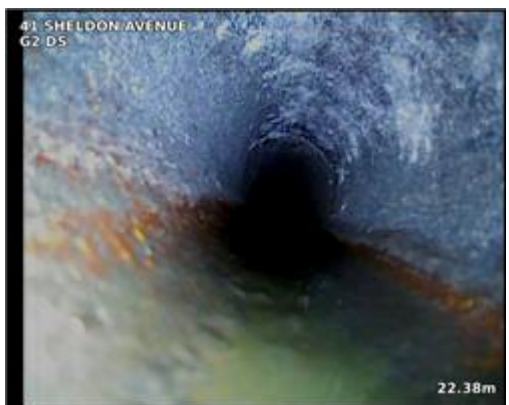
| Pos | Video Ref | Code | Description | Image |
|---|---|---|---|---|
| 22.40m | 0:07:16 | REM | General remark<br>general condition | <p>Image Provided - Ref: 18_24</p> |

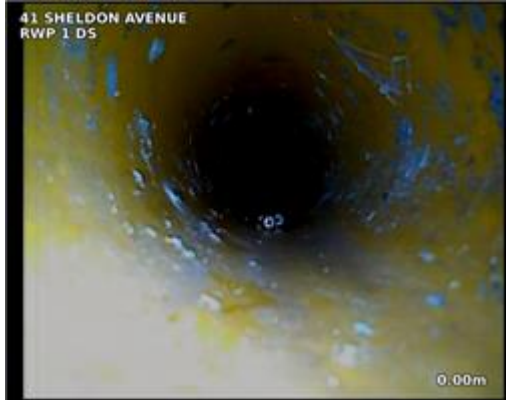
| Pos | Video Ref | Code | Description | Image |
|---|---|---|---|---|
| 00.00m | | MH | Start node type, manhole RWP 1 | Image Provided - Ref: 19_0<br> |

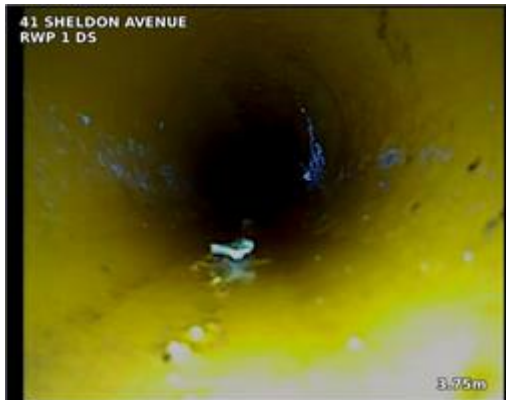
| Pos | Video Ref | Code | Description | Image |
|---|---|---|---|---|
| 03.80m | 0:00:21 | REM | General remark general condition | Image Provided - Ref: 19_3<br> |
