## FLOOD RISK ASSESSMENT

41 SHELDON AVENUE  
LONDON  
N6 4JP

23135-SYM-XX-XX-RP-C-0001

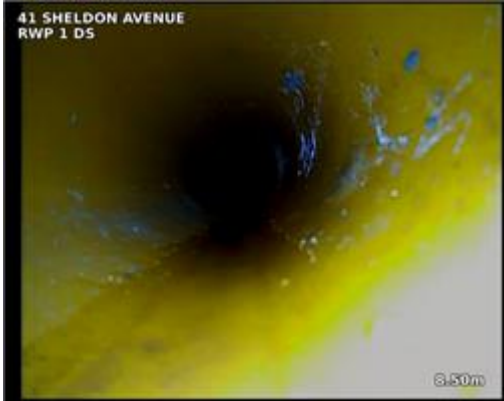
| Pos | Video Ref | Code | Description | Image |
|---|---|---|---|---|
| 08.50m | 0:00:38 | REM | General remark<br>general condition | <p>Image Provided - Ref: 19_4</p> |

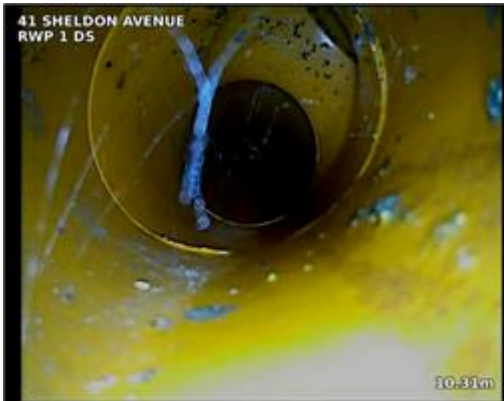
| Pos | Video Ref | Code | Description | Image |
|---|---|---|---|---|
| 10.30m | 0:00:46 | JN | Junction at 02 o'clock: 0mm<br>Diameter | <p>Image Provided - Ref: 19_5</p> |

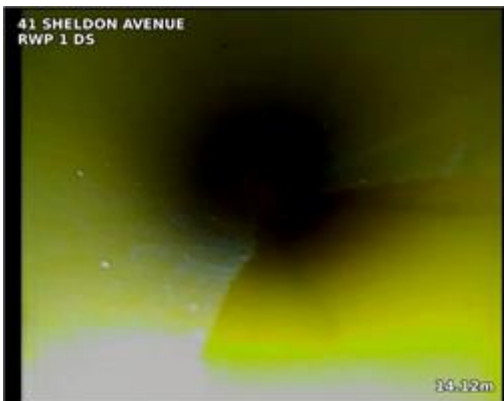
| Pos | Video Ref | Code | Description | Image |
|---|---|---|---|---|
| 14.10m | 0:01:02 | REM | General remark<br>general condition | <p>Image Provided - Ref: 19_6</p> |

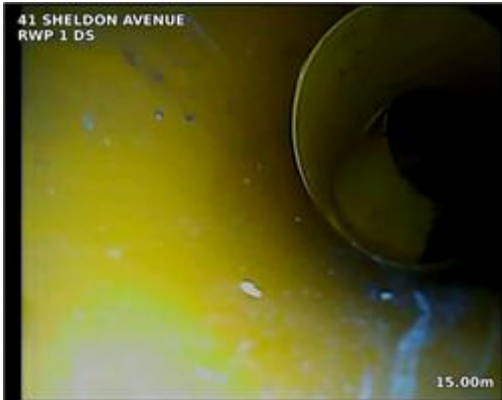
| Pos | Video Ref | Code | Description | Image |
|---|---|---|---|---|
| 15.00m | 0:01:06 | LRH | Line of drain/sewer deviates right [half] | <p>Image Provided - Ref: 19_7</p> |

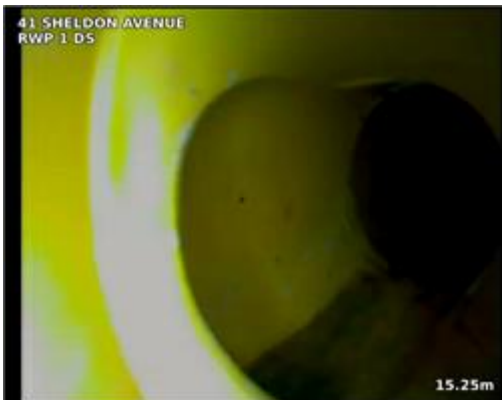
| Pos | Video Ref | Code | Description | Image |
|---|---|---|---|---|
| 15.30m | 0:01:14 | JN | Junction at 09 o'clock: 0mm Diameter | <p>Image Provided - Ref: 19_8</p> |

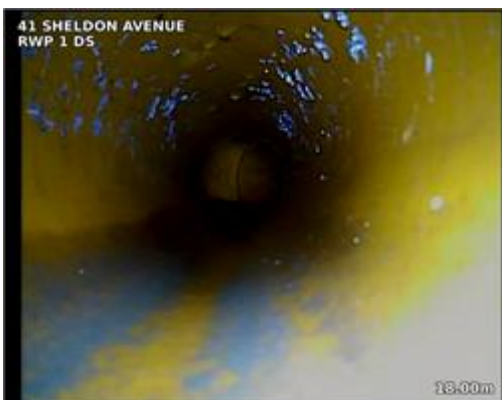
| Pos | Video Ref | Code | Description | Image |
|---|---|---|---|---|
| 18.00m | 0:01:38 | REM | General remark<br>general condition | <p>Image Provided - Ref: 19_9</p> |

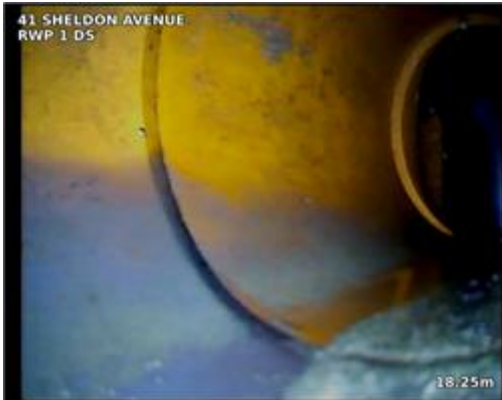
| Pos | Video Ref | Code | Description | Image |
|---|---|---|---|---|
| 18.30m | 0:01:41 | LRH | Line of drain/sewer deviates right [half] | <p>Image Provided - Ref: 19_10</p> |

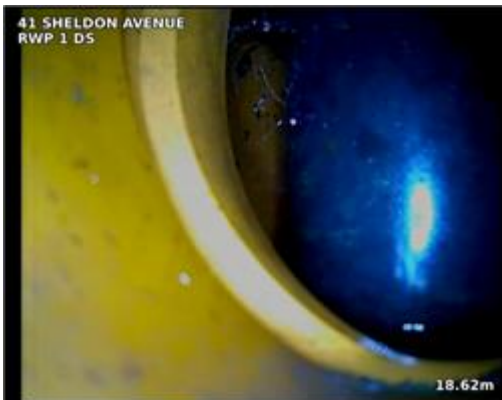
| Pos | Video Ref | Code | Description | Image |
|---|---|---|---|---|
| 18.70m | | GYF | Finish node type Gully DS | <p>Image Provided - Ref: 19_9999</p> |
