Treeworks Application

Land to the rear of 43 Langdon Park Road,  
London N6 5PT

22 March 2024

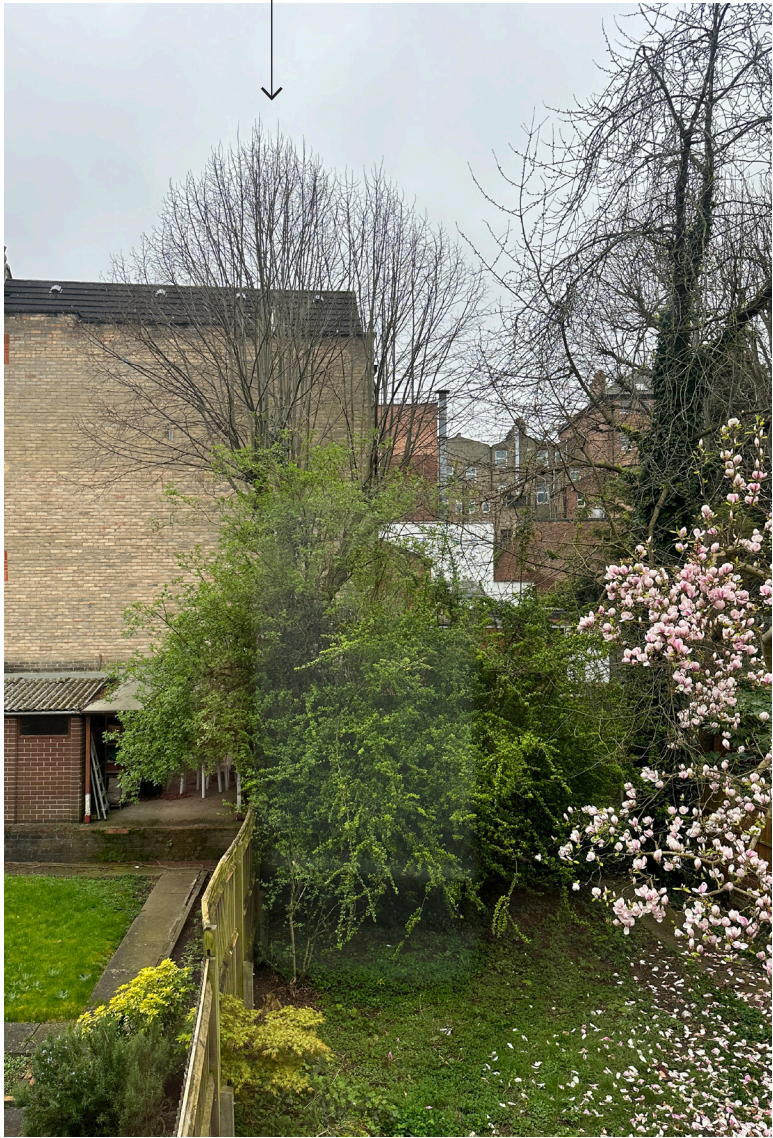
T001 Lime tree on boundary wall of 43 and 41 Langdon Park Road has a TPO and is in fair physiological and structural condition. This application proposes to lift and reduce the crown of the tree

View looking South West into rear garden of 43 Langdon Park Road and adjoining garden fence of 41 Langdon Park Road.
