Tower Surveys Associates

Section Inspection - 17/10/2023 - RE?

TSA-23-2537 Channing School for Girls CCTV Report\_303\_Issue01

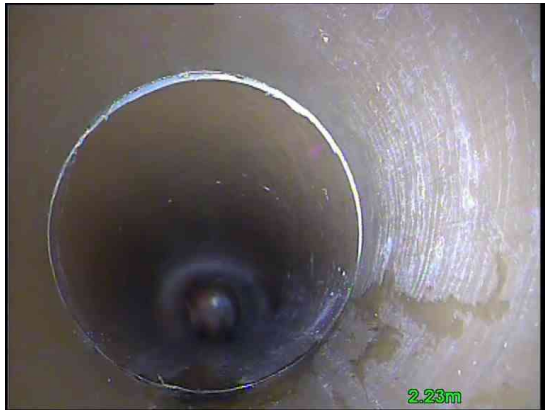
3, 00:00:13, 2.23 m  
Line deviates down

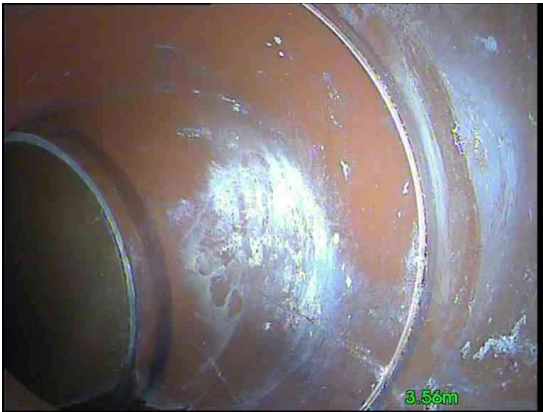
5, 00:00:17, 3.56 m  
Line deviates down

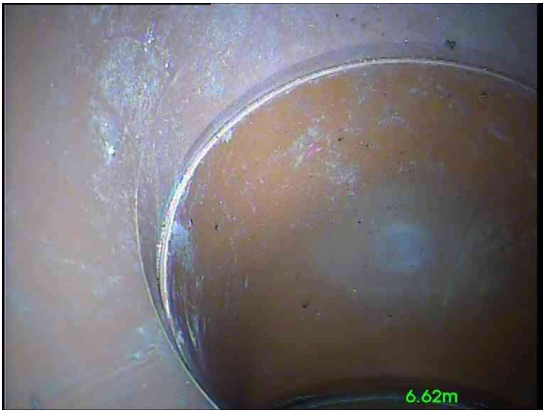
7, 00:00:34, 6.62 m  
Line deviates down

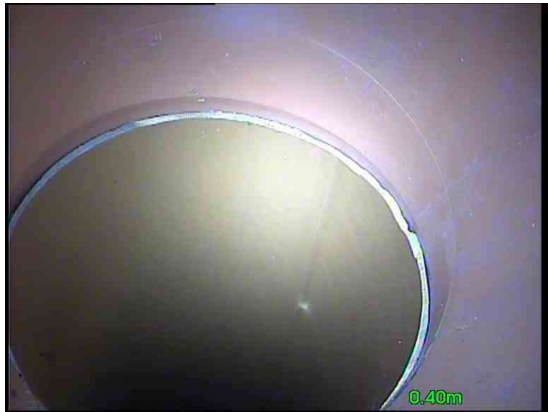
2, 00:00:10, 0.40 m  
General remark, Sewer levels out at this point

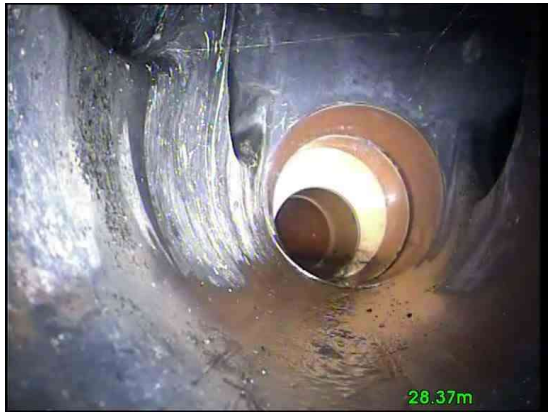
9, 00:01:34, 28.37 m  
Finish node, manhole, reference: MH11 UTL reached

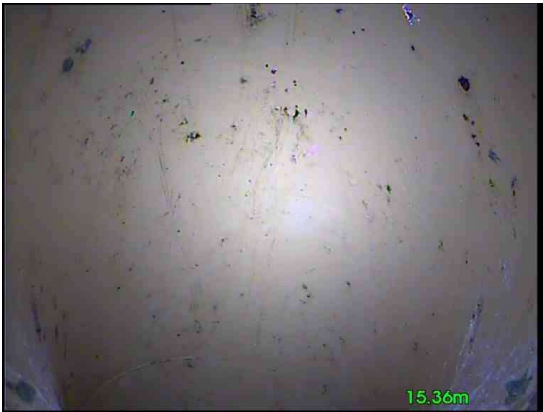
5, 00:00:44, 15.36 m  
Line deviates down

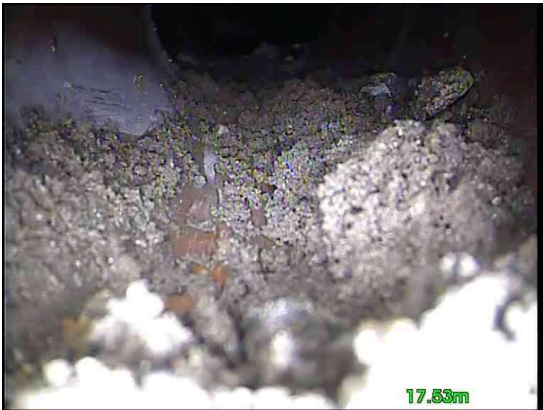
7, 00:01:28, 17.53 m  
Finish node, manhole, reference: MH7 reached

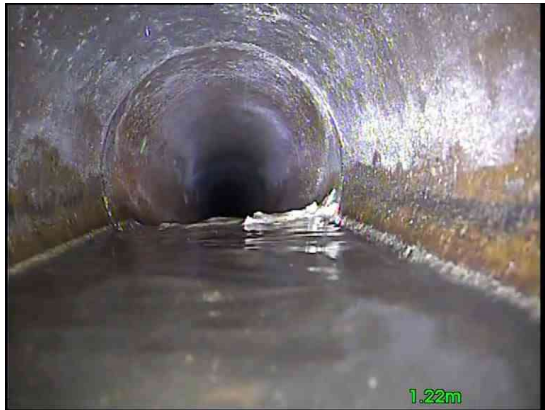
| | 1.22 | WL | | Water level, 20% of the vertical dimension: Water standing due to debris at joint | 00:00:10 | 3 | |

3, 00:00:10, 1.22 m  
Water level, 20% of the vertical dimension, Water standing due to debris at joint

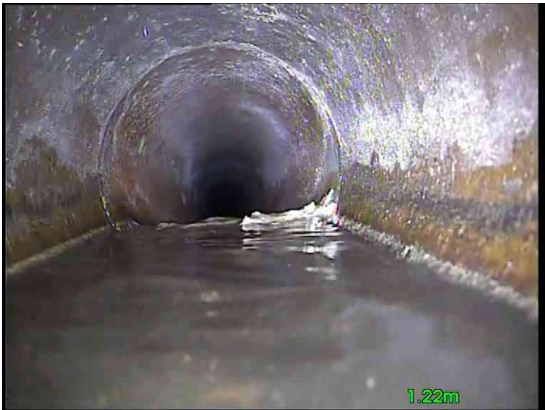
| | 1.22 | DECJ | | Settled deposits, hard or compacted at joint, 20% cross-sectional area loss | 00:00:10 | 4 | 4 |

4, 00:00:10, 1.22 m  
Settled deposits, hard or compacted at joint, 20% cross-sectional area loss

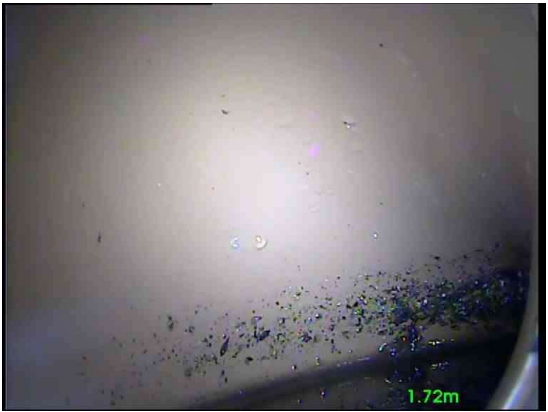
4, 00:00:19, 1.72 m  
Finish node, gully, reference: RWP reached

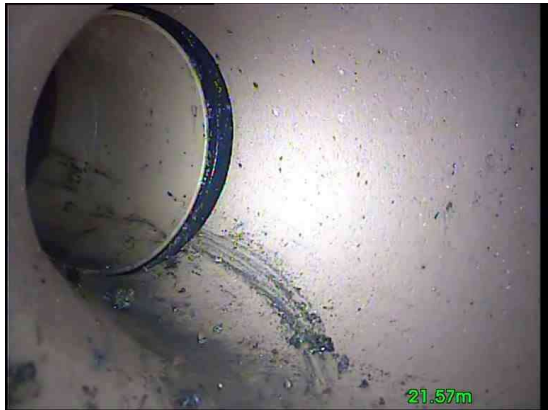
23, 00:02:27, 21.57 m  
Open joint, large

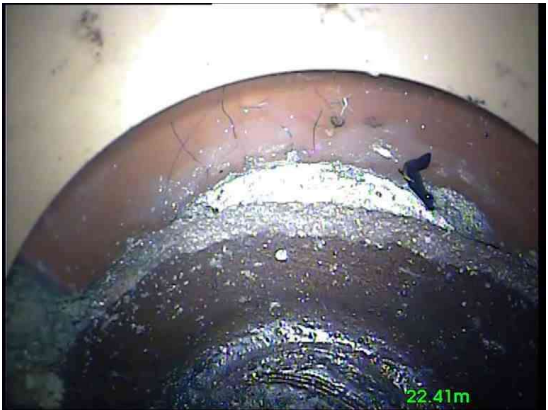
24, 00:02:38, 22.41 m  
Finish node, gully, reference: RWP reached

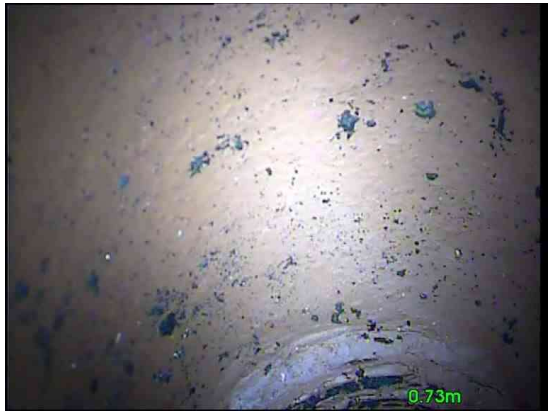
3, 00:00:11, 0.73 m  
Finish node, gully, reference: RWP reached

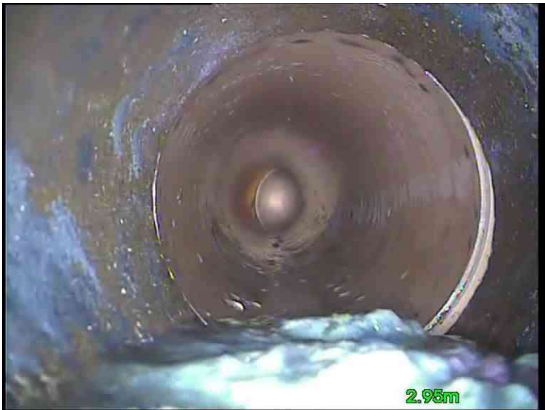
4, 00:00:26, 2.95 m

Pipe material changes to polyvinyl chloride at this point

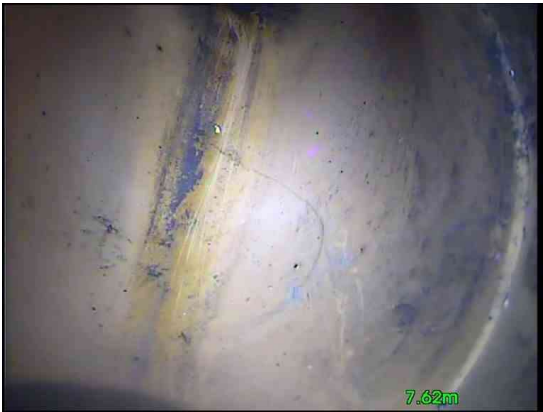
5, 00:00:54, 7.62 m  
Finish node, gully, reference: Gully reached

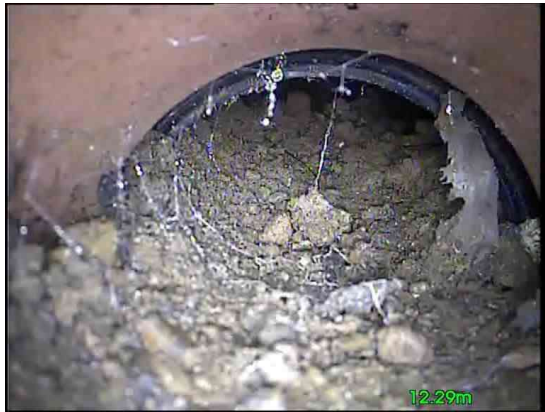
9, 00:00:53, 12.29 m  
Settled deposits, coarse, 75% cross-sectional area loss, change

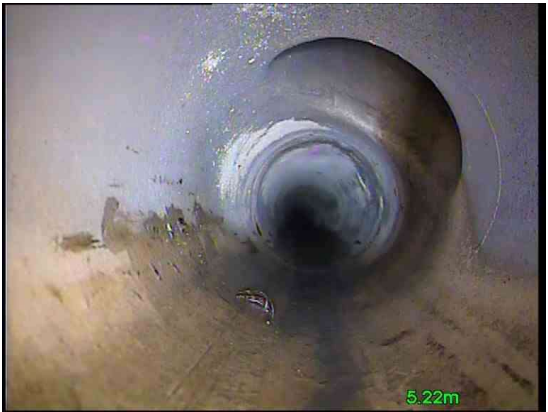
2, 00:00:24, 5.22 m  
Junction at 2 o'clock, 100mm dia

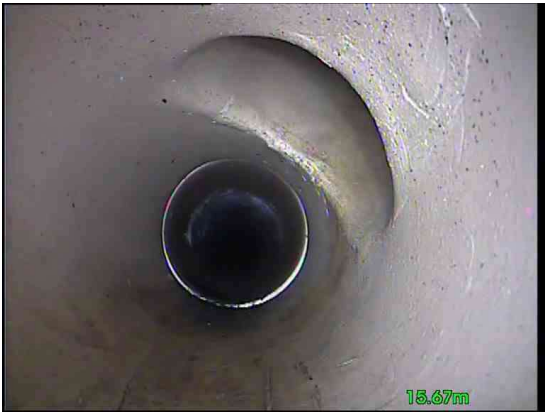
5, 00:01:01, 15.67 m  
Junction at 2 o'clock, 100mm dia

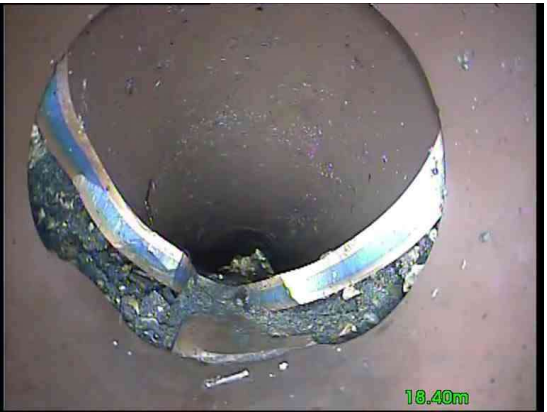
6, 00:01:09, 18.40 m  
Joint displaced, large

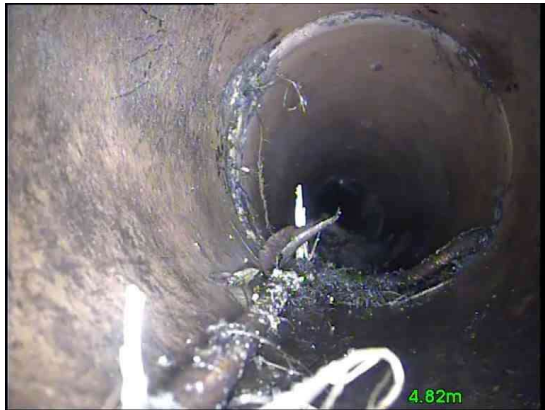
7, 00:00:45, 4.82 m  
Roots, tap at joint

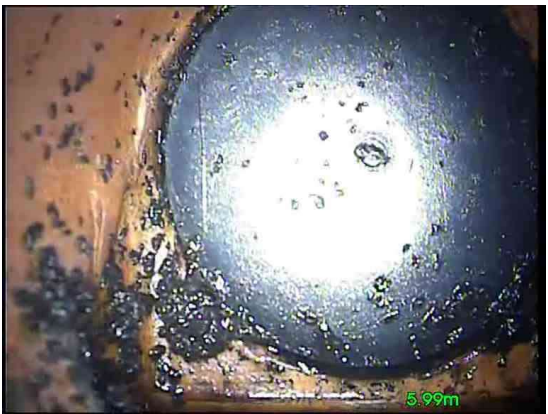
6, 00:00:42, 5.99 m  
Finish node, gully, reference: RWP reached

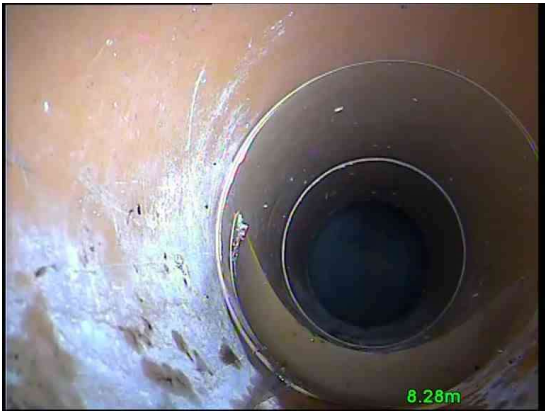
4, 00:00:38, 8.28 m  
Junction at 6 o'clock, 150mm dia, External Backdrop

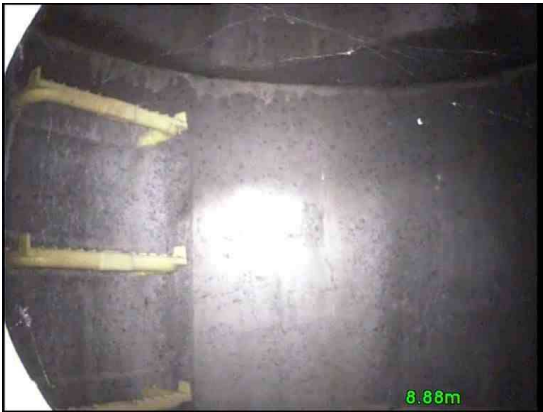
5, 00:00:52, 8.88 m  
Finish node, manhole, reference: MH26 reached

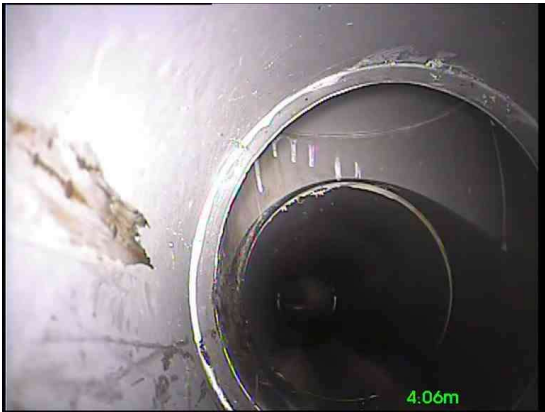
6, 00:00:34, 4.06 m  
Junction at 11 o'clock, 100mm dia

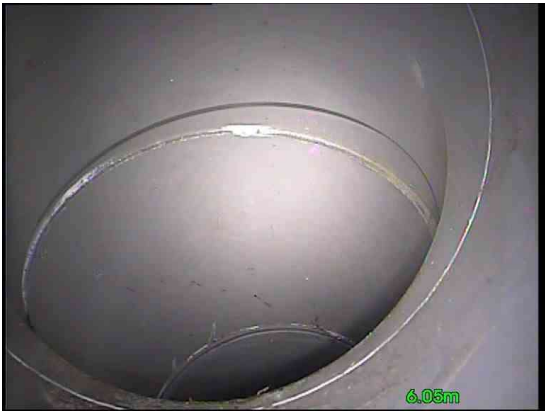
8, 00:00:50, 6.05 m  
General remark, Sewer levels out at this point

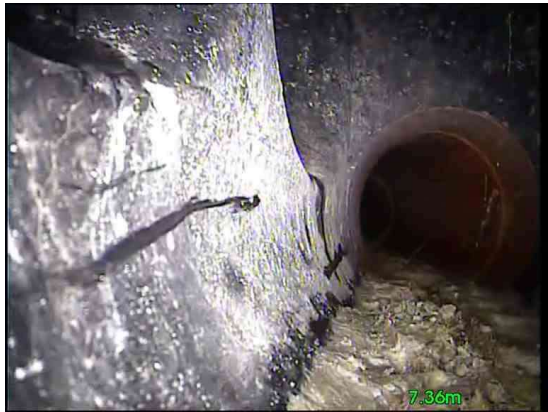
5, 00:00:30, 7.36 m  
Finish node, manhole, reference: MH27 reached

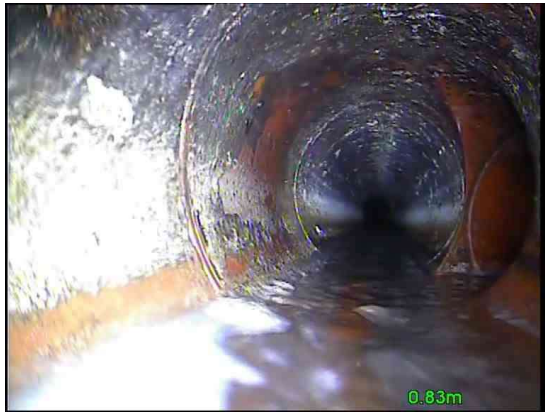
1, 00:00:10, 0.83 m  
Junction at 3 o'clock, 100mm dia

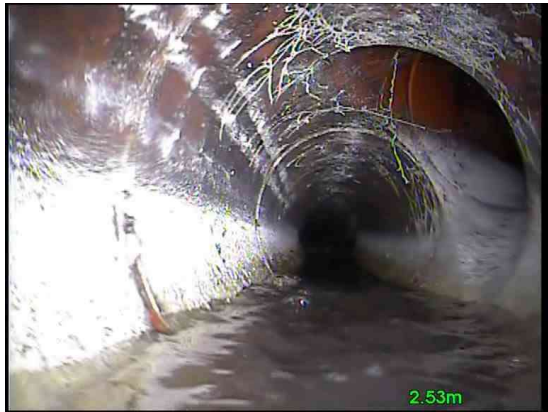
2, 00:00:17, 2.53 m  
Junction at 2 o'clock, 100mm dia

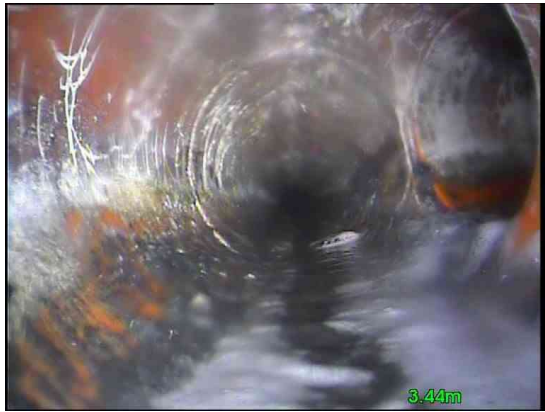
3, 00:01:53, 3.44 m  
Junction at 3 o'clock, 100mm dia

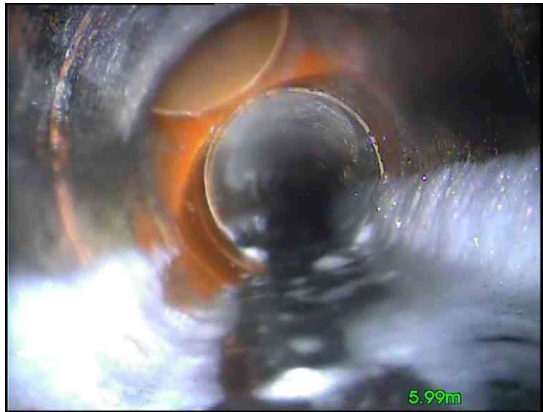
5, 00:01:37, 5.99 m  
Junction at 10 o'clock, 100mm dia

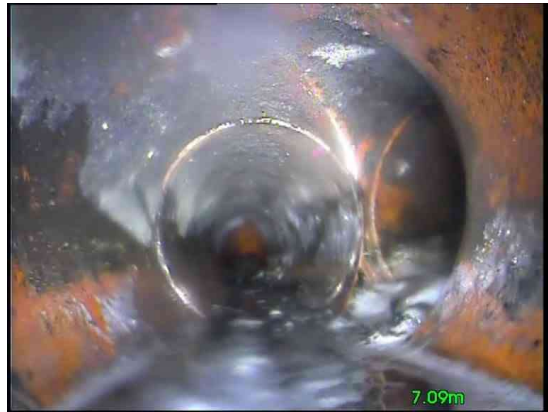
6, 00:01:31, 7.09 m  
Junction at 9 o'clock, 100mm dia

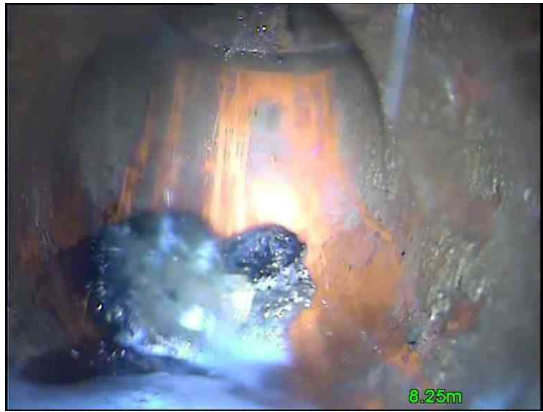
7, 00:01:18, 8.25 m  
Settled deposits, coarse, 5% cross-sectional area loss, At rest bend of internal downpipe

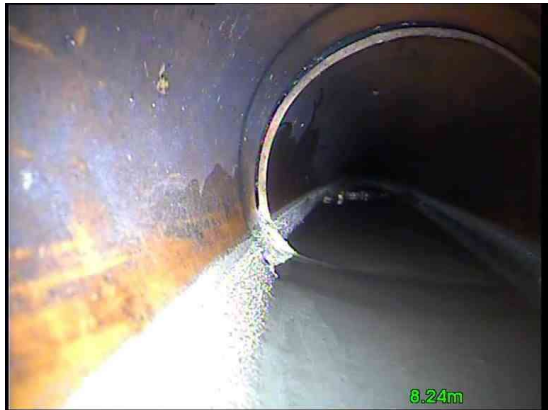
8, 00:00:40, 8.24 m  
Water level, 25% of the vertical dimension, Water standing in sewer at this point

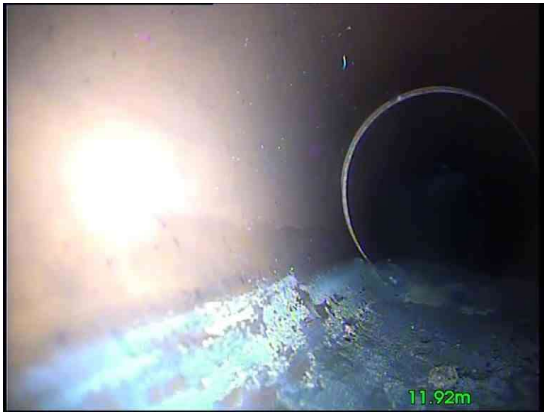
10, 00:00:57, 11.92 m  
Settled deposits, fine, 10% cross-sectional area loss, finish

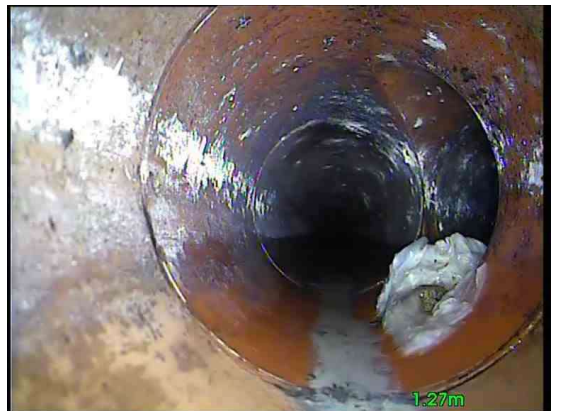
2, 00:00:08, 1.27 m  
Junction at 3 o'clock, 100mm dia

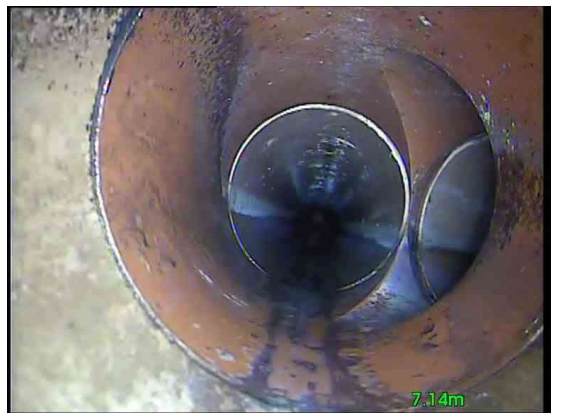
4, 00:00:31, 7.14 m  
Junction at 3 o'clock, 100mm dia

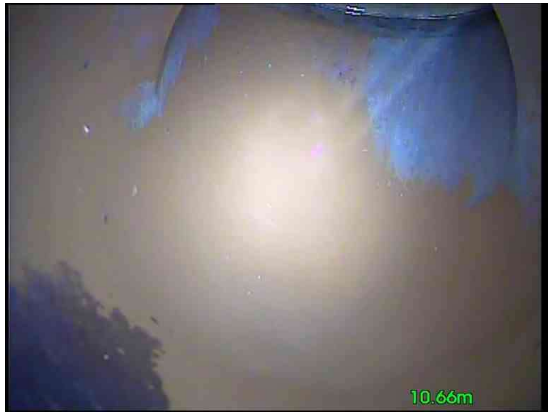
6, 00:00:47, 10.66 m  
Finish node, other special chamber, reference: Downpipe,  
Internal downpipe reached

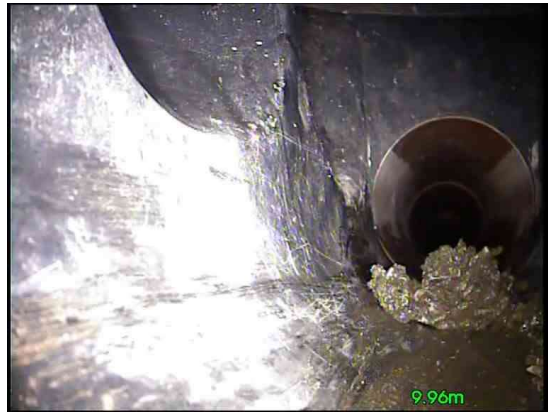
6, 00:00:46, 9.96 m  
Finish node, manhole, reference: MH35 reached

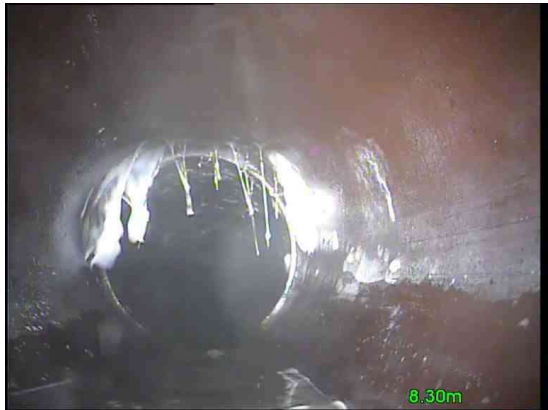
3, 00:02:23, 8.30 m  
Attached deposits, fouling at joint from 9 o'clock to 3 o'clock,  
5% cross-sectional area loss

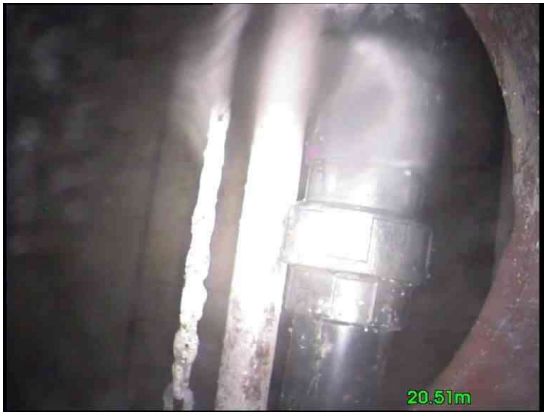
6, 00:01:50, 20.51 m  
Finish node, manhole, reference: MH38 (Pumping Station)  
reached

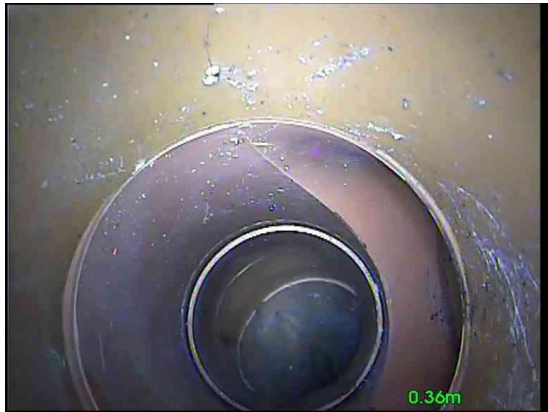
1, 00:00:09, 0.36 m  
Junction at 3 o'clock, 100mm dia
