## London Borough of Haringey

## Preliminary Flood Risk Assessment

**Channing School for Girls – Senior School**  
CCTV Condition Report

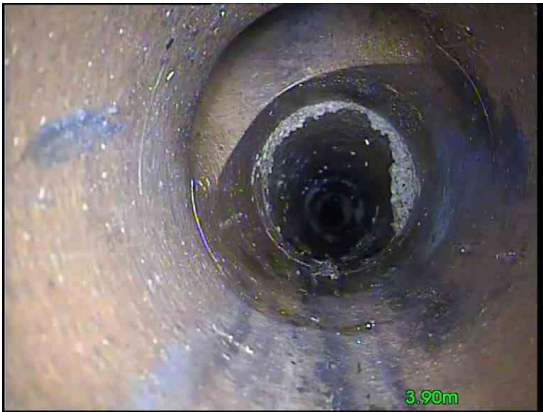
5, 00:00:30, 3.90 m  
Junction at 11 o'clock, 100mm dia

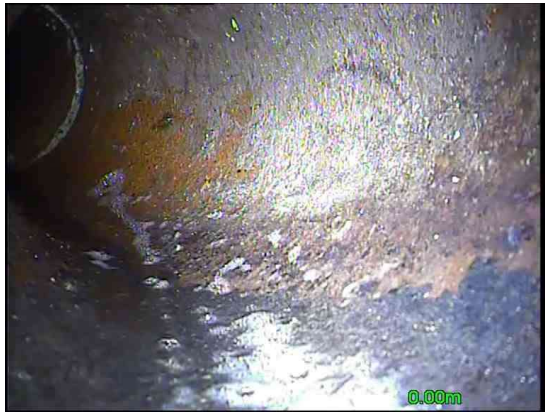
1, 00:00:02, 0.00 m  
Line deviates up

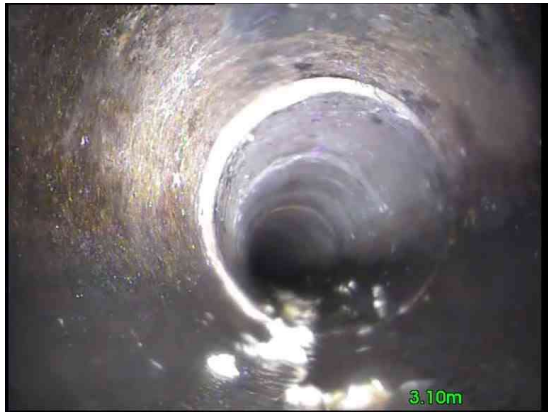
2, 00:03:45, 3.10 m  
Pipe material changes to vitrified clay at this point

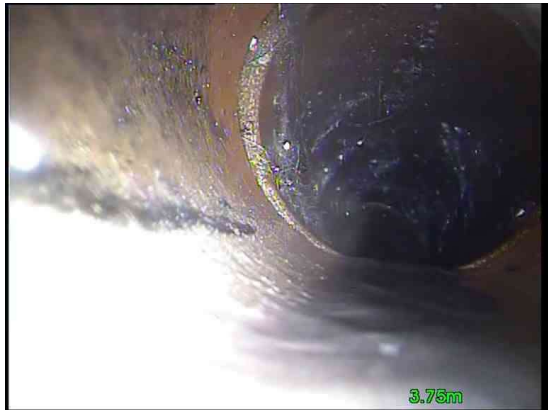
4, 00:01:03, 3.75 m  
Line deviates down

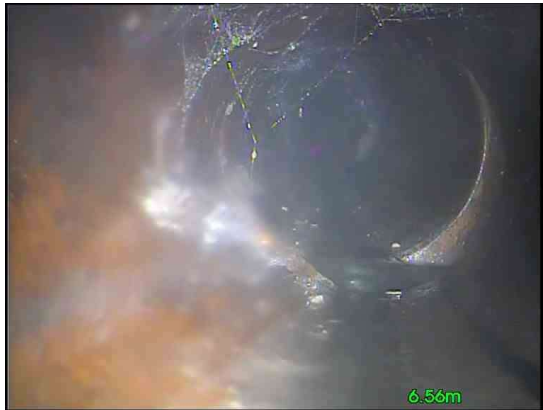
7, 00:05:01, 6.56 m  
Joint displaced, large
