## **Bruce Castle: West Boundary Wall Final Report on the Condition and Repairs**

**April 2024**

## **BRUCE CASTLE: West Boundary Wall**

### **Final Report on the Condition and Repair**

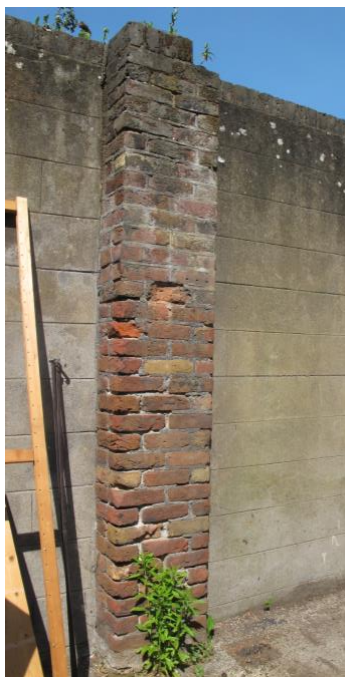
The vast majority of the east face of the wall, to the south of the change of height at the northern end, is flat in profile with regular buttress piers forming bays. The buttress piers are approximately 225 (one brick) x 450 (two bricks wide) in Flemish bond. They are not fully coursed or bonded with the wall, with areas where bricks are butted and straight jointed to the wall. The piers are a later addition to the wall. The buttress piers are in a lighter stock slightly larger brick than the main wall and have been laid in cement mortar (see image 4). This suggests that the piers were additions to the east face of the wall and at the earliest date from the beginning of the 20<sup>th</sup> century. The piers therefore are likely to be added at a time when the buildings along the eastern face of the wall were demolished. Alternatively, they could be a later 20<sup>th</sup> century repair to a wall that was failing. Documentary evidence confirms that the buildings were removed from the west boundary sometime between the 1913/15 and the 1935 OS mapping of the site. The buildings are still shown along this boundary (see image 5) on the 1913/15 OS maps, and their removal is related to the Local Authority early 20<sup>th</sup> century alterations and remodeling of the site.

Image 4: Buttress piers along east elevation

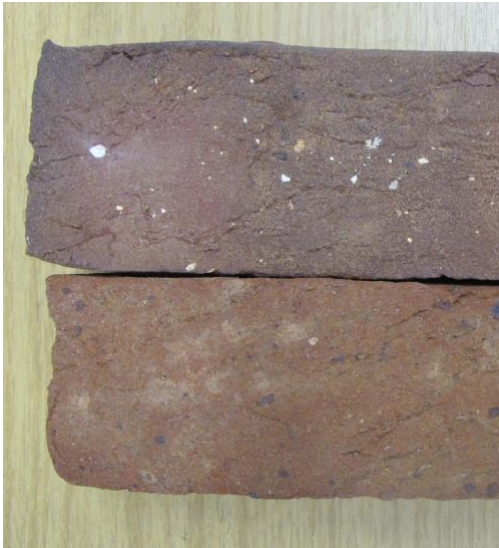
Image 14: Initial sample handmade bricks produced by Bulmer Brick and Tile to match existing

Rebuild brickwork bonded to core of wall using new and salvaged brick to match colour, texture and size of original brick. New bricks will be handmade bricks produced by Bulmer Brick and Tile to match existing bricks in size, colour and texture and initial samples have been sourced (see image 14). New bricks will be mixed with existing bricks in any area of rebuilding.
