**VISUAL STRUCTURAL APPRAISAL**

**24 CHOLMELEY CRESCENT**  
**LONDON**  
**N6 5HA**

**DATE: MARCH 2023**

**JOB No 23031**

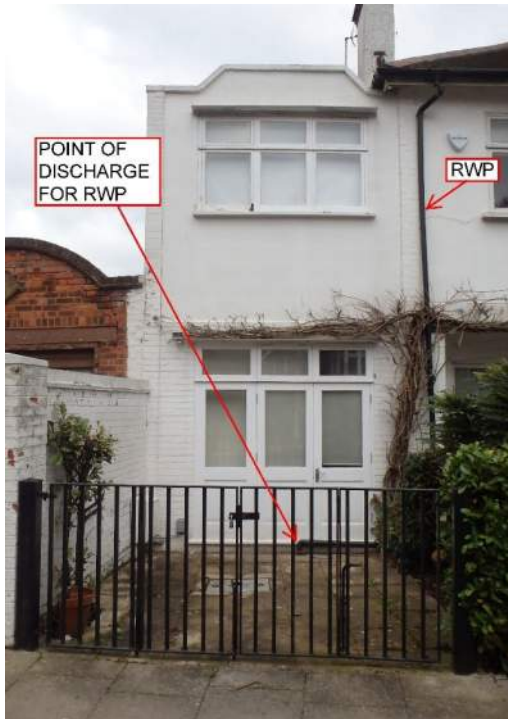
A further rainwater downpipe is located on the front elevation at the junction between the left-hand end of the original footprint of the property and the left-hand elevation.

The rainwater downpipe discharges horizontally to the left in to a gulley located beneath the door set entrance in to the left-hand extension.

The two-storey extension to the left-hand side of the property has a 3 bay French door opening at ground floor level and a window of similar width at first floor level. Refer to Figure 8 above.

A series of cracks were noted through the painted render finish at first floor level as follows:

- Running out from left hand end of first floor window head
- Similar crack below at level of transom
- Similar crack below approximately 300mm above sill level

- Line of diagonal crack running down from 300mm below left-hand end of first floor window sill
- Vertical crack from window sill down to ground floor window head on line of second mullion in from left
- Similar horizontal cracking to right hand side of first floor window
- Further minor diagonal cracks below right-hand end of first floor window sill

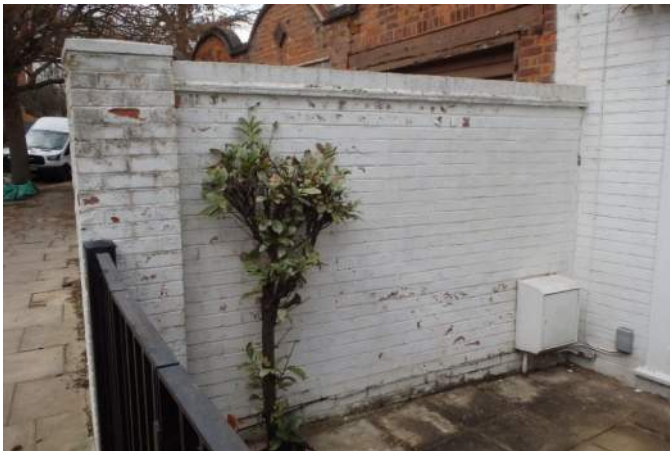
Figure 9

On the left-hand boundary to the front of the property, there is a 215mm thick brick garden wall, approximately 2m tall, painted white.

No significant signs of structural distress were noted to the garden wall.

The garden wall appears to have been built astride the centre line of the outside face of the extension to the property.

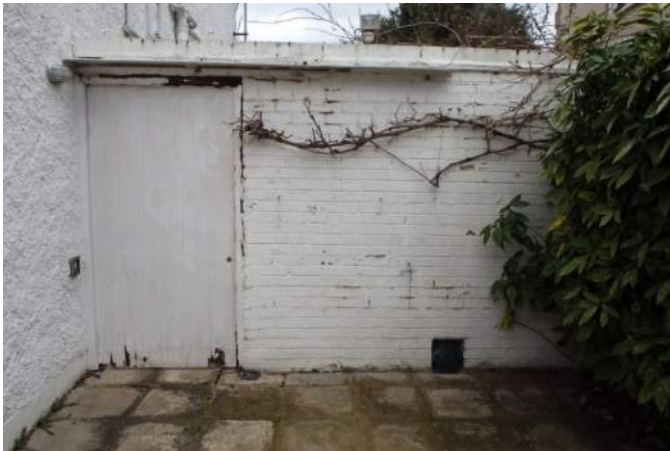
*Figure 10*

To the right of the property, at the rear of the parking area, there is a further 215mm thick brick garden wall, painted white, again approximately 2m tall.

No significant signs of distress were noted to the garden wall to the right of the property.

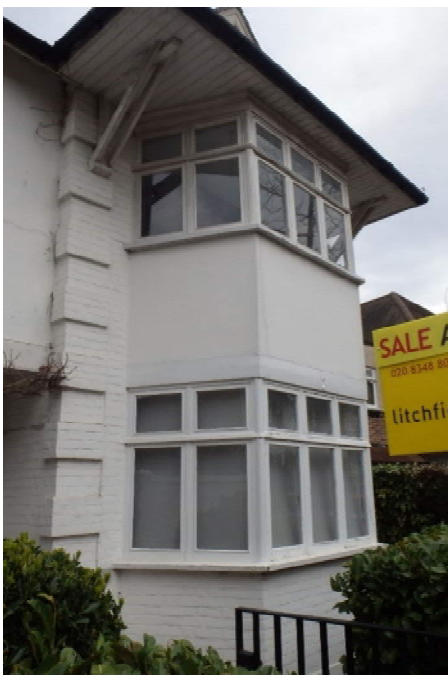
*Figure 15*

A bay window is located to the right-hand side of the elevation at ground and first floor level with a large projecting pitched roof over.

The following cracking was noted to the front elevations of the bay.

- Crack at junction between left-hand splayed wall to bay and white painted facing brick main elevation.
- Vertical crack on front wall to bay at left-hand side at junction with left-hand splayed wall, running from first floor window sill down to ground floor window head.
- Similar cracking noted to right-hand side of front wall to bay at first floor level at junction with right-hand splayed wall.

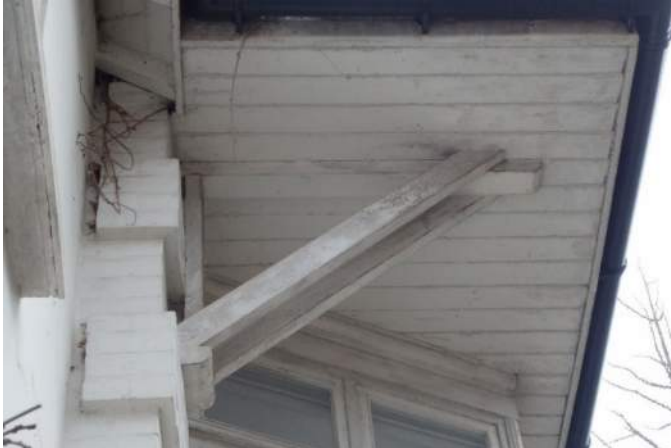
*Figure 17*

There is a large horizontal soffit to the projecting overhanging roof above the bay which is supported by a gallows bracket timber arrangement to the left and to the right-hand sides.

No significant signs of structural distress were noted to the projecting roof overhang or to the facing brickwork to the left- and right-hand sides of the bay window.

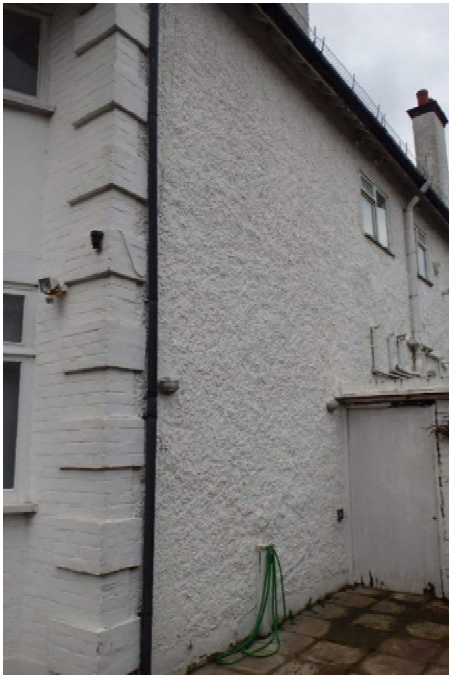
*Figure 20*

Cracking was noted to the rear section of the right-hand flank wall.

- Crack from ground level located approximately 1m to rear of steps down to ground level from French door in side elevation, with the crack rising up to the underside level of the boiler flue before appearing to peter out.

The surface of the render appears to have been cement filled previously, suggesting that the crack may have occurred previously and been refilled and then subsequently reappeared.

Other smooth surfaced patches of render were apparent in the overall rough cast appearance of the render attributable to historic cracking having been repaired prior to the most recent cycle of redecoration.

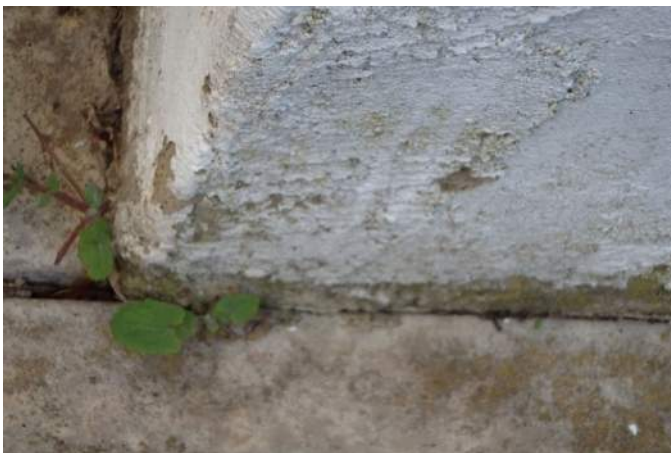
*Figure 25*

At the rear right hand end of the elevation, there is almost no open joint between the paved terrace and the base of the render skirt to the rear elevation.

At the rear left hand end of the terrace area, there is a significant open joint, perhaps 15-20mm wide, suggesting that the paved terrace area has moved laterally away, downslope from the rear elevation of the property at this end.

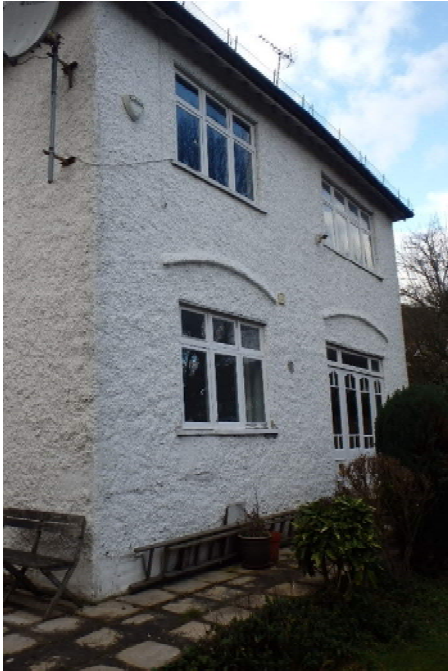
*Figure 28*

A patch repair to the pebble dash render is located beneath the left-hand side of the ground floor window sill of the window on the left-hand side.

A vertical crack is present through the pebble dash render running down from the right hand of the pair of mullions to the window to the left-hand side of the elevation, the crack extending from window sill level at ground floor level down to the base of the elevation.

Some patch repairs, unpainted, to the pebble dash render are located at the right-hand end of the ground floor window sill to the left-hand window, and also to infill what was probably an old flue opening in the rear wall from the kitchen.

Further patches of smooth finished render were apparent in the generally rough cast appearance of the render suggesting that cracking may have occurred to the render finish in the past, with repairs potentially having been undertaken, all prior to the most recent cycle of redecoration.

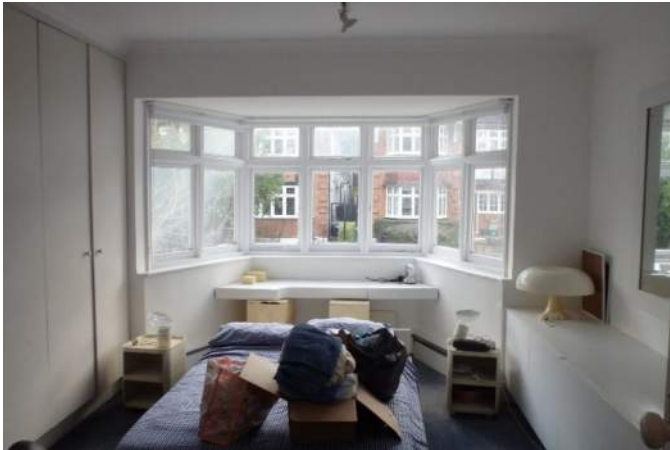
*Figure 34*

Cracking was noted in the room as follows:

- Diagonal crack running down from mitre joint in ceiling coving to front right of bay window when viewed internally, petering out before reaching bay recess.

- Further crack running vertically up from right hand side of head of bay recess.

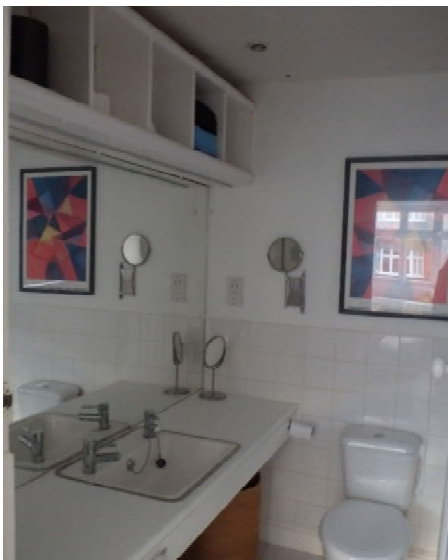
*Figure 36*

Cracking was noted at the junction between outside wall to right hand side of property and rear wall to bathroom.

No significant open cracking noted within shower room, although the tiled finishes are dilapidated.

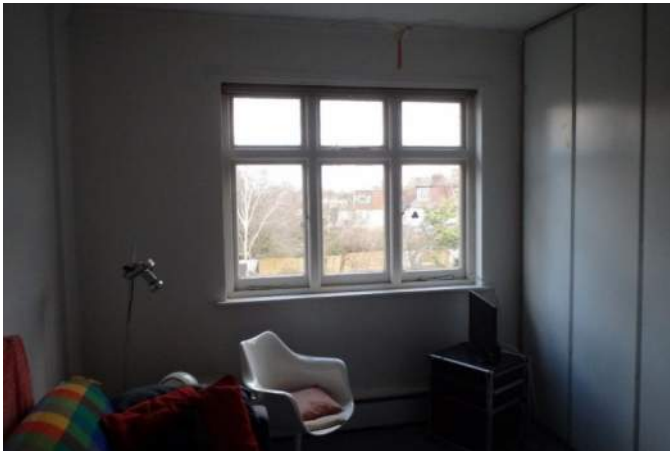
*Figure 37*

Cracking was noted in the room as follows:

- Open crack at junction between ceiling and head of cornice to rear wall to room.
- Crack noted generally at junction between head of cornice and ceiling to left-hand wall and front wall to room.

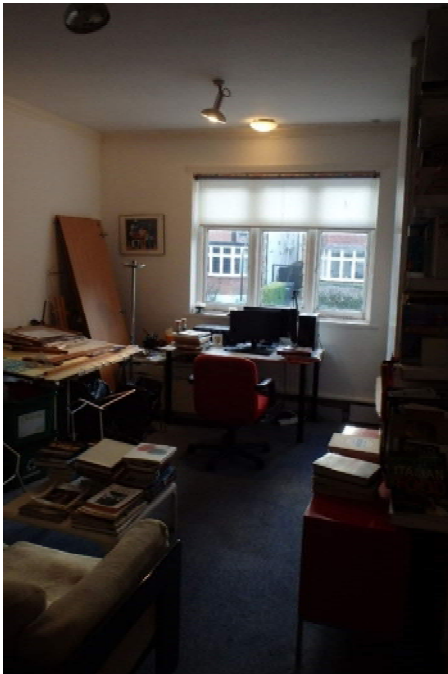
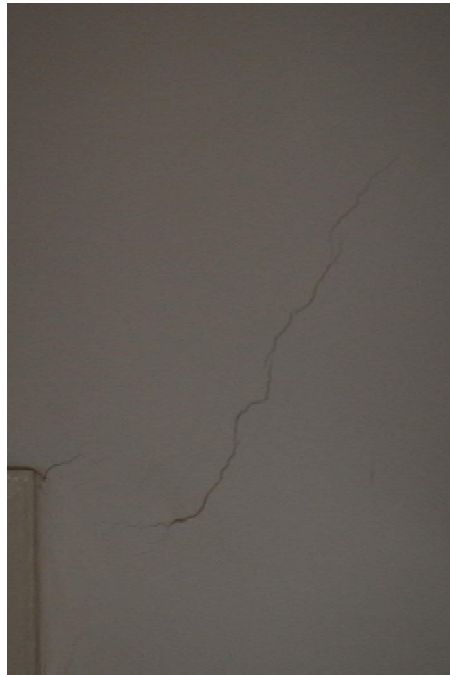
*Figure 41*

Cracking was noted as follows:

- Crack at junction between top of cornice to front wall and junction with ceiling
- Similar intermittent cracking at junction between cornice and ceiling to right hand side of room and to left hand side of room, and to rear of room at junction with ceiling
- Diagonal crack rising up from top right of door head out on to hallway.

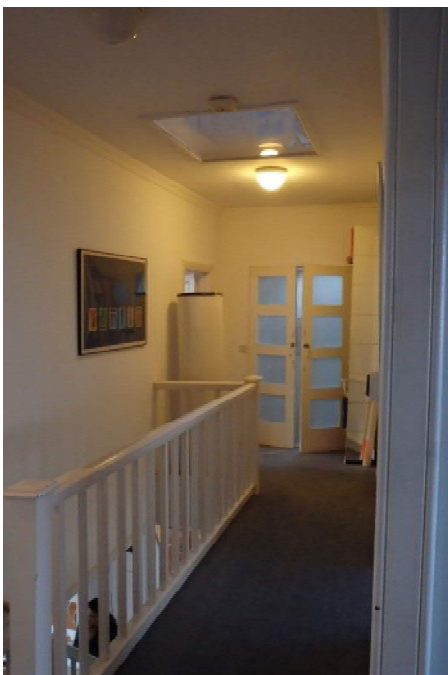
*Figure 43*

- A straight crack was noted in the ceiling running from side to side halfway across the hallway, corresponding to joints in plasterboard sheets.
- A diagonal crack was noted running out from the perimeter of the rooflight towards the front wall of the hallway.

- Cracking noted to mitre joints to ceiling cornice and at junctions between ceiling cornice and ceiling.
- Vertical crack rising up from top left of door head in to bedroom 3, the crack peters out before reaching ceiling cornice level.
- Diagonal crack running up from top left of door head in to office, petering out before reaching ceiling cornice.
- Further diagonal crack noted running down from ceiling cornice above centre of door opening through to office, petering out before reaching door head.

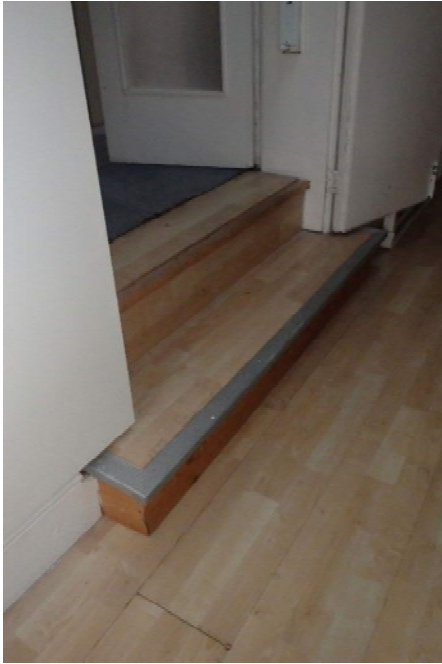
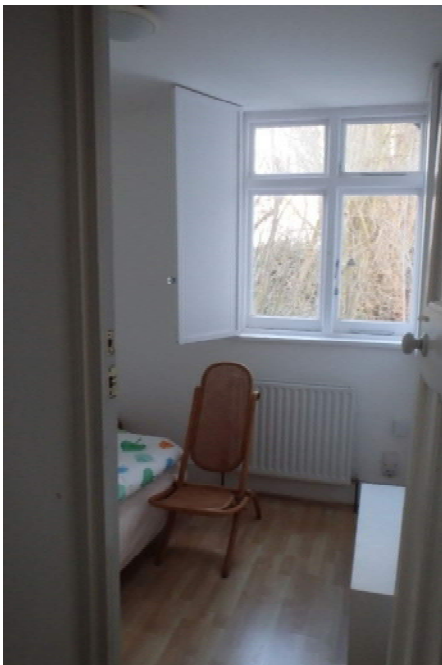
*Figure 45*

Cracking was noted as follows:

- Crack running up from top right of door opening out to hallway at front of bedroom, petering out before reaching ceiling level.
- Crack noted in external left-hand wall to bedroom, approximately 1m from front of room, running from ceiling level to floor level.
- Cracking noted around window opening in rear wall through plaster finishes.

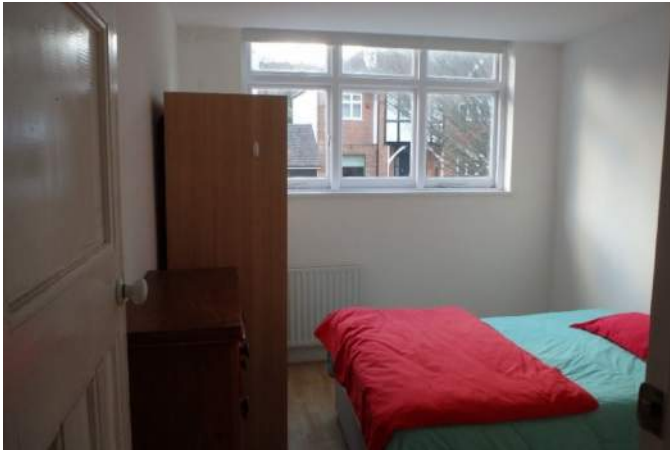
*Figure 48*

Cracking was noted as follows:

- Crack at junction between left-hand outside wall and ceiling, running from front to rear of room.

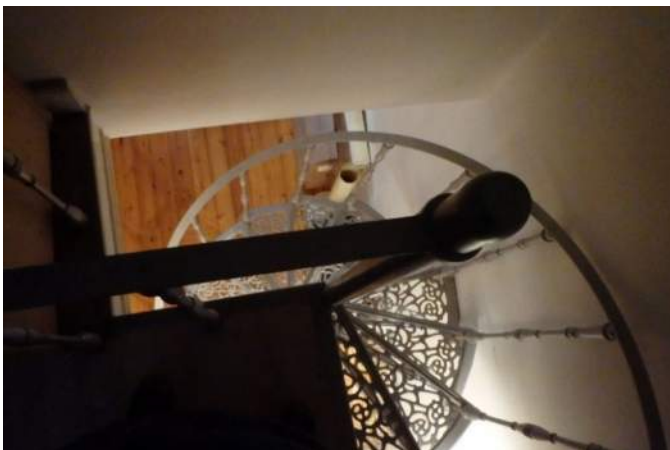
*Figure 49*

- Open jointing noted at junction between left-hand side wall to extension and partition wall between front bedroom and stairwell.

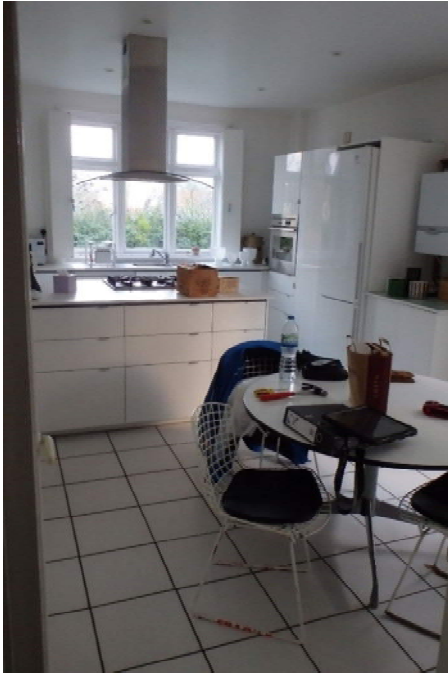
*Figure 50*

Cracking was noted as follows:

- Dry lined panel on right-hand side external wall with open jointing at junction between dry lined panel and wall and ceiling.
- Intermittent cracking at junction between wall and ceiling to front of room.

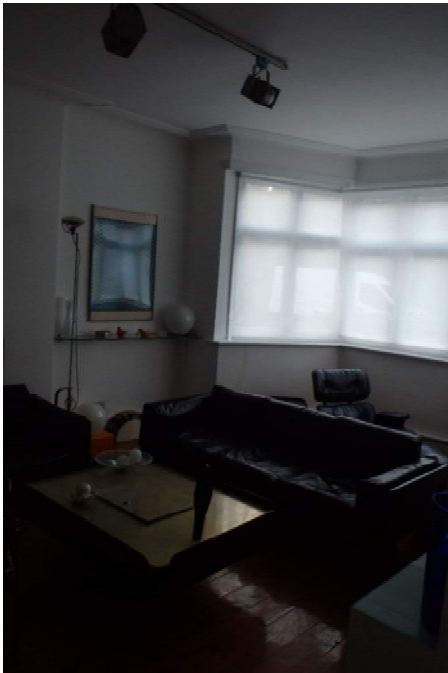
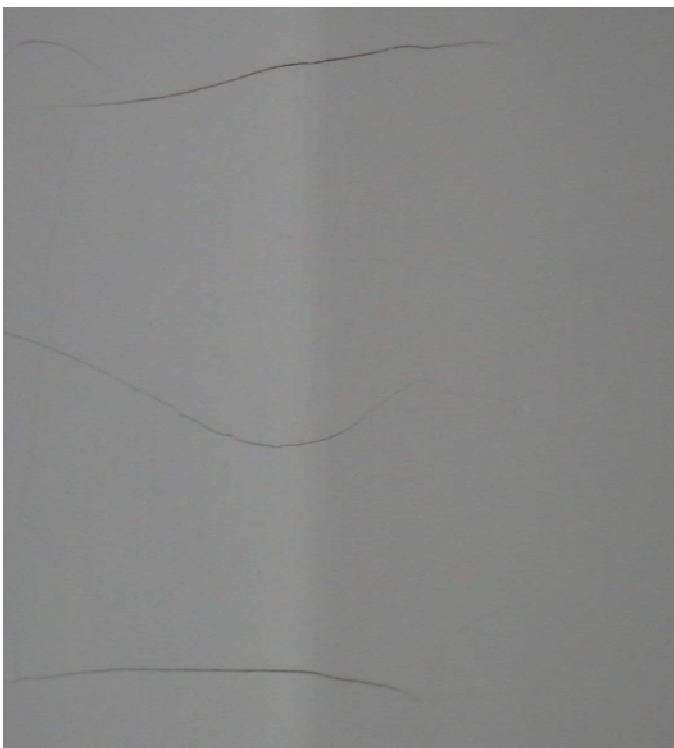
*Figure 53*

Cracking was noted as follows:

- Crack noted running through ceiling cornice to left-hand side of bay window when viewed from inside, running across to left-hand partition wall.
- Similar crack noted running through ceiling cornice to right-hand side of bay window when viewed from internally, running across diagonally to right-hand side of partition wall to room.
- Crack in ceiling, just to left of central lighting track when viewed from front.

- Crack running up from top left of door opening through to central hallway area, most likely on line of paper joint.
- Filled crack in bay window on left-hand side above double socket, running up to ground floor sill.
- Open joint at head of skirting to right-hand side wall when viewed from front to rear of chimney breast.
- Series of horizontal cracks through painted paper curved finish at rear corner of room

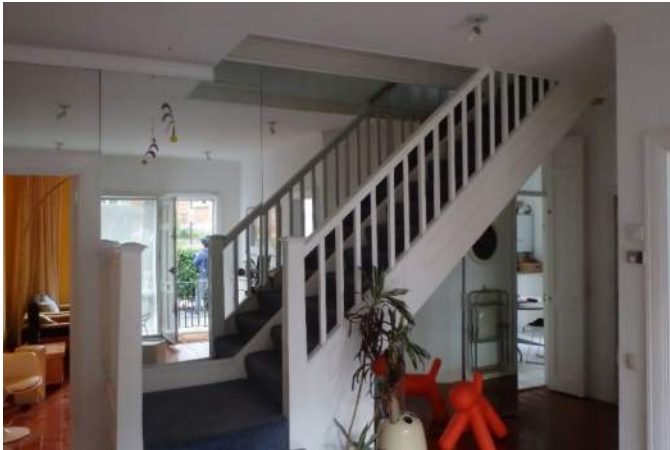
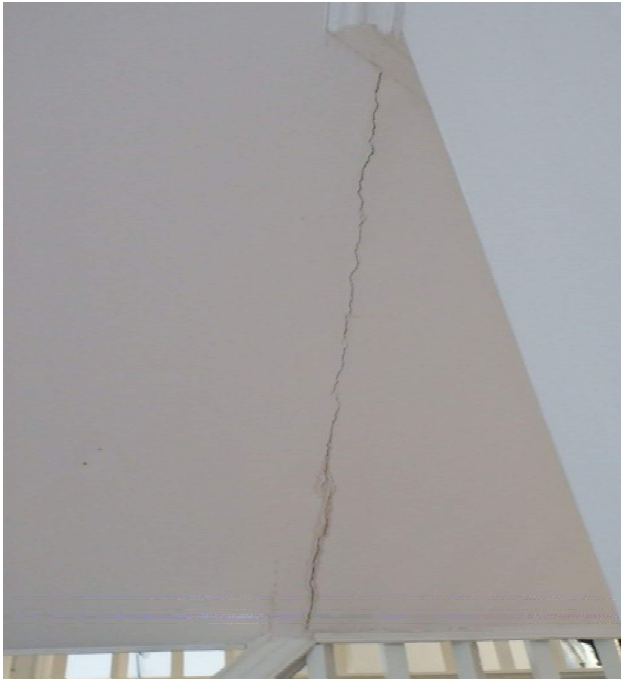
*Figure 55*

Cracking was noted as follows:

- Crack at junction between ceiling cornice and ceiling intermittently around perimeter of room.
- Straight crack running from front to rear of room, commencing above front door opening slightly to the left of centre, and running across to central stairwell opening up to first floor level.
- Open crack running across ceiling on line of partition wall between hallway and reception, extending to rear up to face of stair opening up to first floor level.

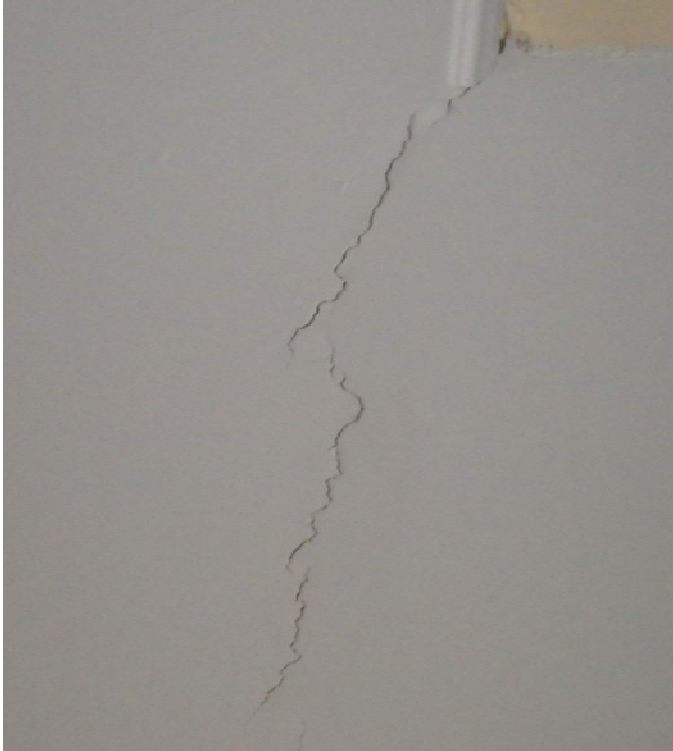
*Figure 58*

- Open crack running out from left-hand end of stairwell towards left-hand extension from corner of stairwell opening.

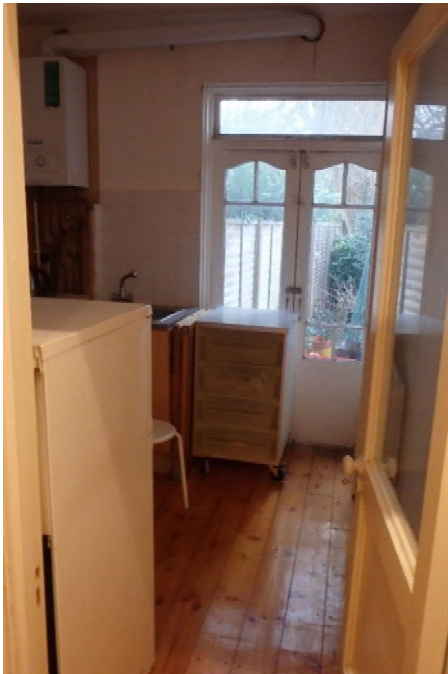
*Figure 59*

A small kitchen is present in the rear of the side extension.

The floor is finished with varnished floorboards.

Cracking was noted as follows:

- Open jointing above and to the side of rear French door opening, most likely on lines of paper joints to finishes.
- Damp staining noted in the ceiling and right-hand side wall above the French door opening out to the rear.

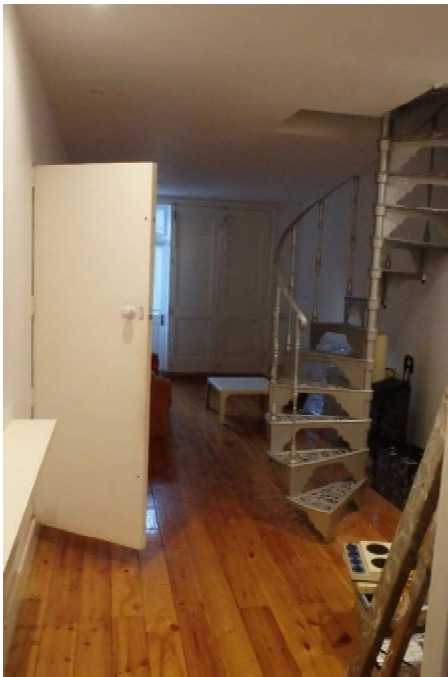
*Figure 60*

The front area is finished in a similar fashion to that noted at the rear.

The space contains a spiral stair up to first floor level.

Cracking was noted as follows:

- Intermittent open joint at junction between right-hand side wall (original side wall to main house) and ceiling.
- Line of previously filled vertical crack in left-hand external wall approximately 1m to front of spiral stair. Crack not currently open.
- Intermittent open joint at junction between ceiling and front wall to space.
- Vertical cracking noted to left-hand external wall adjacent to base of spiral stair, crack running from floor to ceiling.

There is a projecting boxing on the left-hand side wall to the rear of the spiral stair with some damp staining noted on the front face of the boxing and to the rear of the boxing.

Further patch staining noted to right-hand side of right-hand side wall to space, just to front of door through to communal hallway in main part of house.
