**VISUAL STRUCTURAL APPRAISAL**

**24 CHOLMELEY CRESCENT**  
**LONDON**  
**N6 5HA**

**DATE: MARCH 2023**

**JOB No 23031**

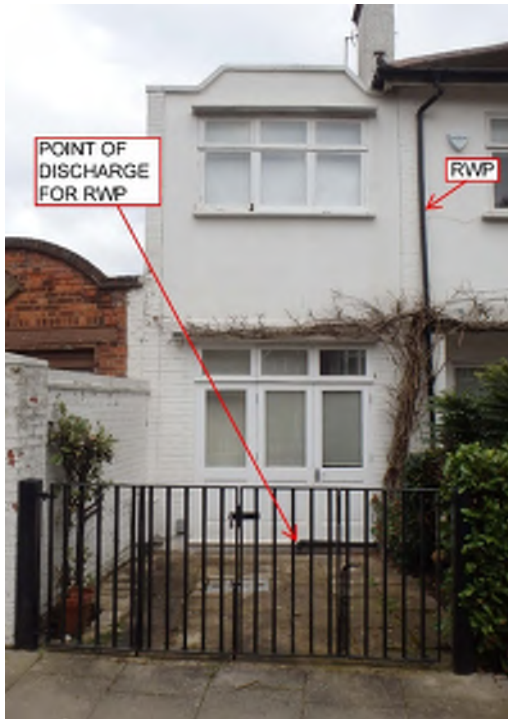
*Figure 8*

A further rainwater downpipe is located on the front elevation at the junction between the left-hand end of the original footprint of the property and the left-hand elevation.

The rainwater downpipe discharges horizontally to the left in to a gulley located beneath the door set entrance in to the left-hand extension.

The two-storey extension to the left-hand side of the property has a 3 bay French door opening at ground floor level and a window of similar width at first floor level. Refer to Figure 8 above.

A series of cracks were noted through the painted render finish at first floor level as follows:

- Running out from left hand end of first floor window head
- Similar crack below at level of transom
- Similar crack below approximately 300mm above sill level

- Line of diagonal crack running down from 300mm below left-hand end of first floor window sill
- Vertical crack from window sill down to ground floor window head on line of second mullion in from left
- Similar horizontal cracking to right hand side of first floor window
- Further minor diagonal cracks below right-hand end of first floor window sill

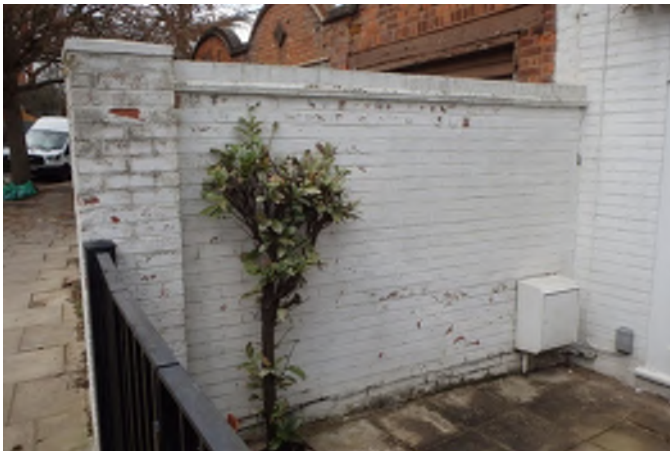
*Figure 9*

On the left-hand boundary to the front of the property, there is a 215mm thick brick garden wall, approximately 2m tall, painted white.

No significant signs of structural distress were noted to the garden wall.

The garden wall appears to have been built astride the centre line of the outside face of the extension to the property.

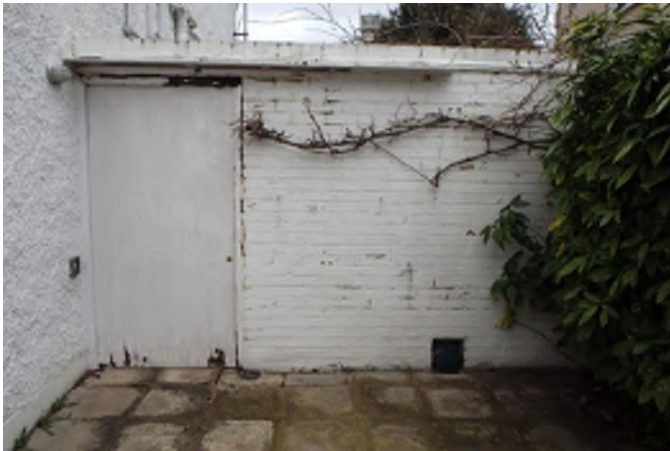
*Figure 10*

To the right of the property, at the rear of the parking area, there is a further 215mm thick brick garden wall, painted white, again approximately 2m tall.

No significant signs of distress were noted to the garden wall to the right of the property.

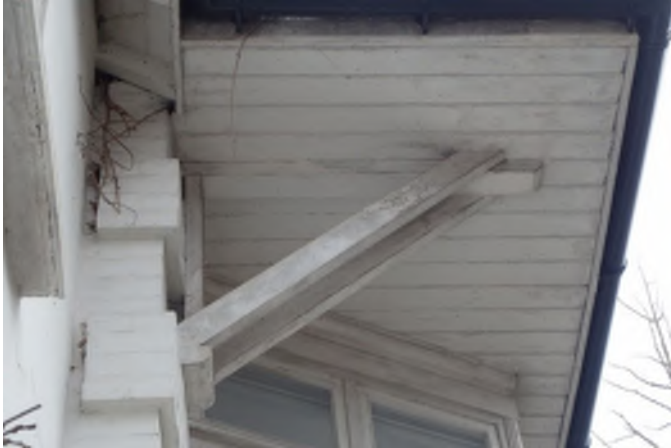
*Figure 17*

There is a large horizontal soffit to the projecting overhanging roof above the bay which is supported by a gallows bracket timber arrangement to the left and to the right-hand sides.

The gallows bracket arrangement is identical to gallows bracket arrangements to properties nearby.

No significant signs of structural distress were noted to the projecting roof overhang or to the facing brickwork to the left- and right-hand sides of the bay window.

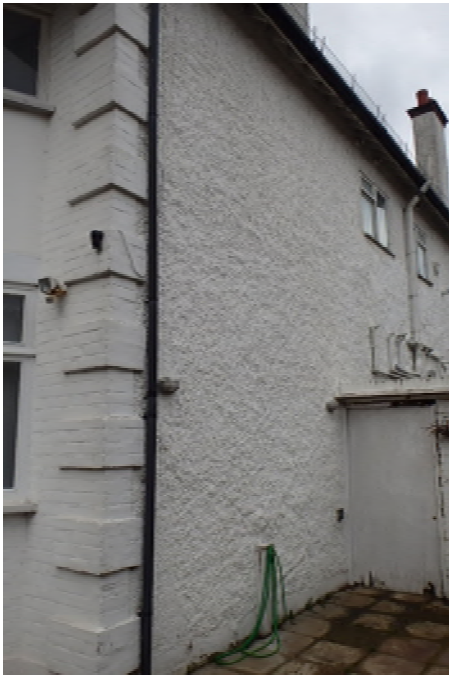
*Figure 20*

Cracking was noted to the rear section of the right-hand flank wall.

- Crack from ground level located approximately 1m to rear of steps down to ground level from French door in side elevation, with the crack rising up to the underside level of the boiler flue before appearing to peter out.

The surface of the render appears to have been cement filled previously, suggesting that the crack may have occurred previously and been refilled and then subsequently reappeared.

Other smooth surfaced patches of render were apparent in the overall rough cast appearance of the render attributable to historic cracking having been repaired prior to the most recent cycle of redecoration.

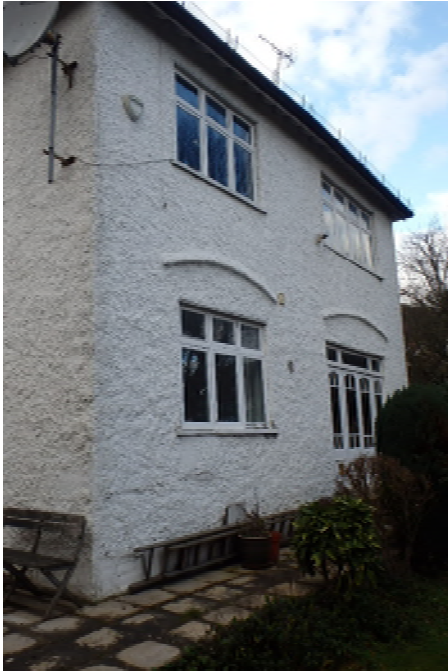
*Figure 28*

A patch repair to the pebble dash render is located beneath the left-hand side of the ground floor window sill of the window on the left-hand side.

A vertical crack is present through the pebble dash render running down from the right hand of the pair of mullions to the window to the left-hand side of the elevation, the crack extending from window sill level at ground floor level down to the base of the elevation.

Some patch repairs, unpainted, to the pebble dash render are located at the right-hand end of the ground floor window sill to the left-hand window, and also to infill what was probably an old flue opening in the rear wall from the kitchen.

Further patches of smooth finished render were apparent in the generally rough cast appearance of the render suggesting that cracking may have occurred to the render finish in the past, with repairs potentially having been undertaken, all prior to the most recent cycle of redecoration.

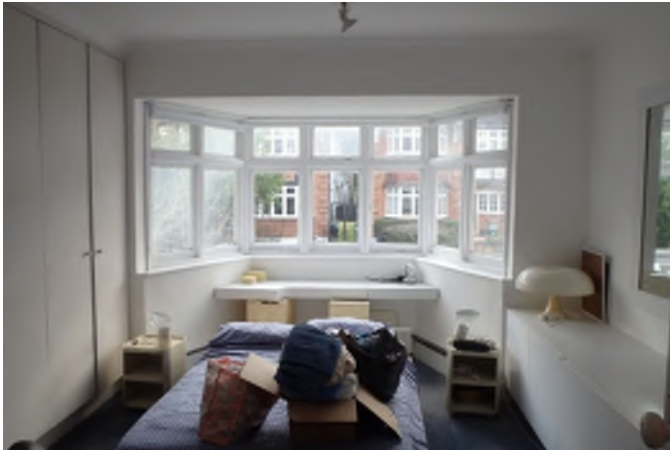
*Figure 34*

Cracking was noted in the room as follows:

- Diagonal crack running down from mitre joint in ceiling coving to front right of bay window when viewed internally, petering out before reaching bay recess.

- Further crack running vertically up from right hand side of head of bay recess.

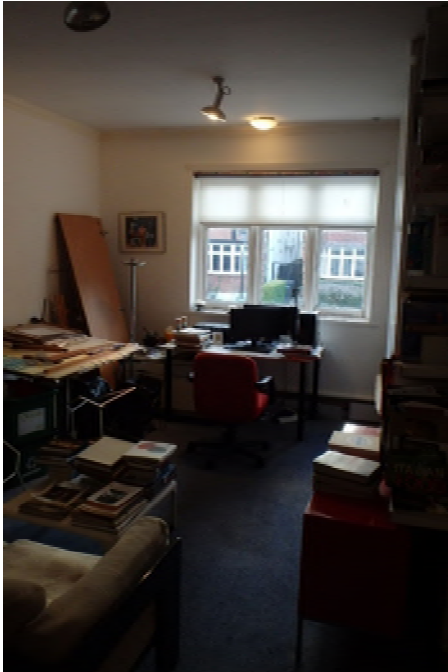
*Figure 41*

Cracking was noted as follows:

- Crack at junction between top of cornice to front wall and junction with ceiling
- Similar intermittent cracking at junction between cornice and ceiling to right hand side of room and to left hand side of room, and to rear of room at junction with ceiling
- Diagonal crack rising up from top right of door head out on to hallway.

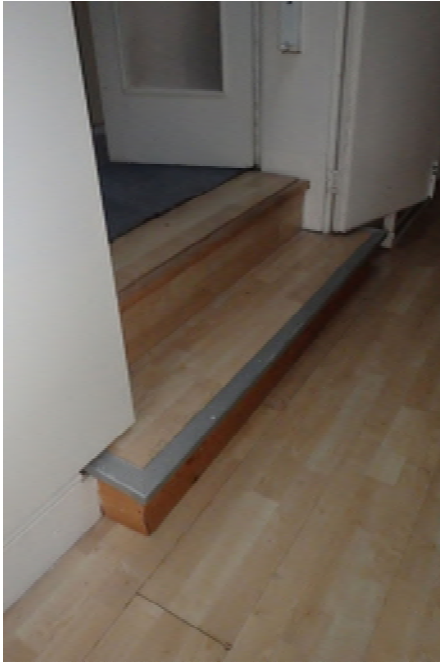
*Figure 45*

Cracking was noted as follows:

- Crack running up from top right of door opening out to hallway at front of bedroom, petering out before reaching ceiling level.
- Crack noted in external left-hand wall to bedroom, approximately 1m from front of room, running from ceiling level to floor level.
- Cracking noted around window opening in rear wall through plaster finishes.

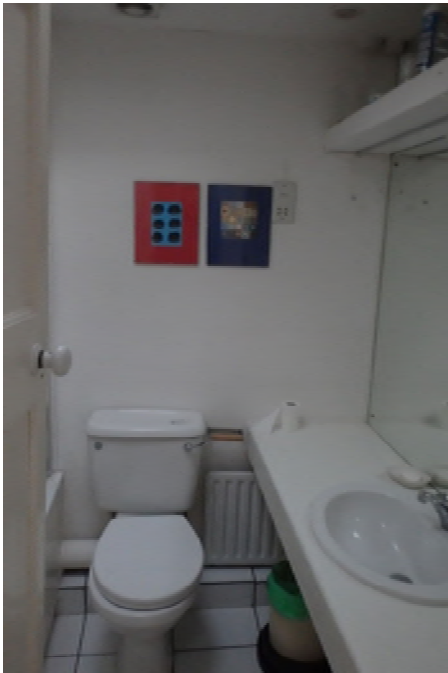
*Figure 47*

Cracking was noted as follows:

- Crack at junction between left-hand outside wall and ceiling, running from front to rear of room.

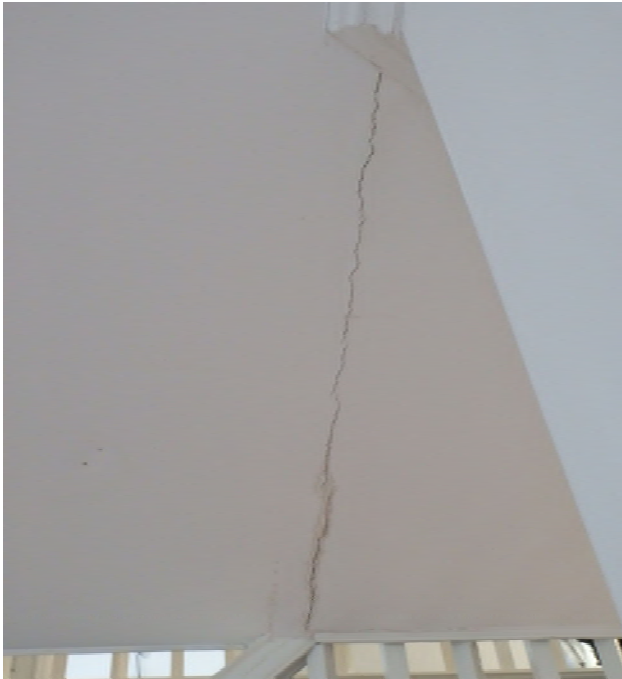
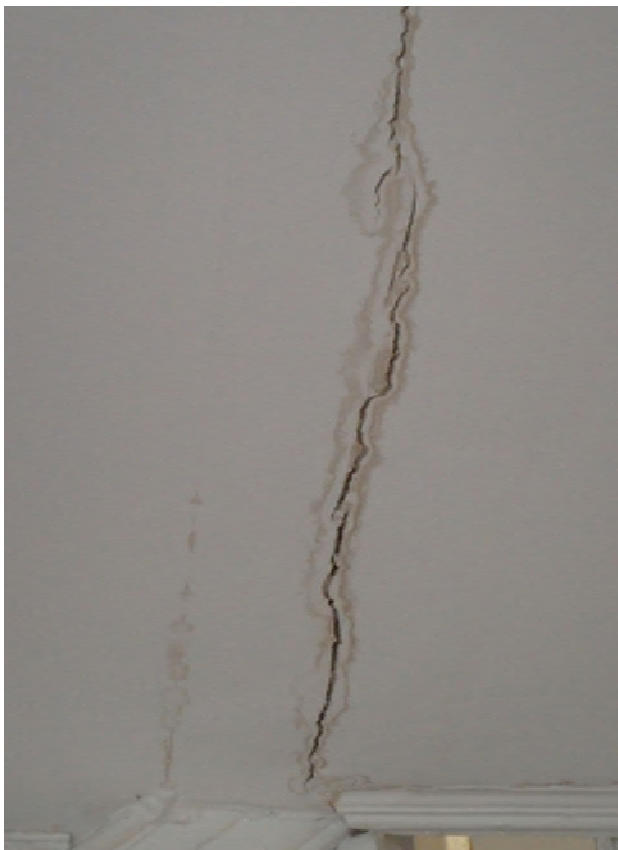
Cracking was noted as follows:

- Crack at junction between ceiling cornice and ceiling intermittently around perimeter of room.
- Straight crack running from front to rear of room, commencing above front door opening slightly to the left of centre, and running across to central stairwell opening up to first floor level.
- Open crack running across ceiling on line of partition wall between hallway and reception, extending to rear up to face of stair opening up to first floor level.

- Open crack running out from left-hand end of stairwell towards left-hand extension from corner of stairwell opening.
