52A, NORTH HILL,  
LONDON,  
N6 4RH

## HERITAGE NOTE:

Appendix I, Design & Access  
Report by ME Architects, April  
2024

Response to request for information for the above site ,  
a Grade II Listed former coach house in the Highgate  
Conservation Area, by the London Borough of Haringey

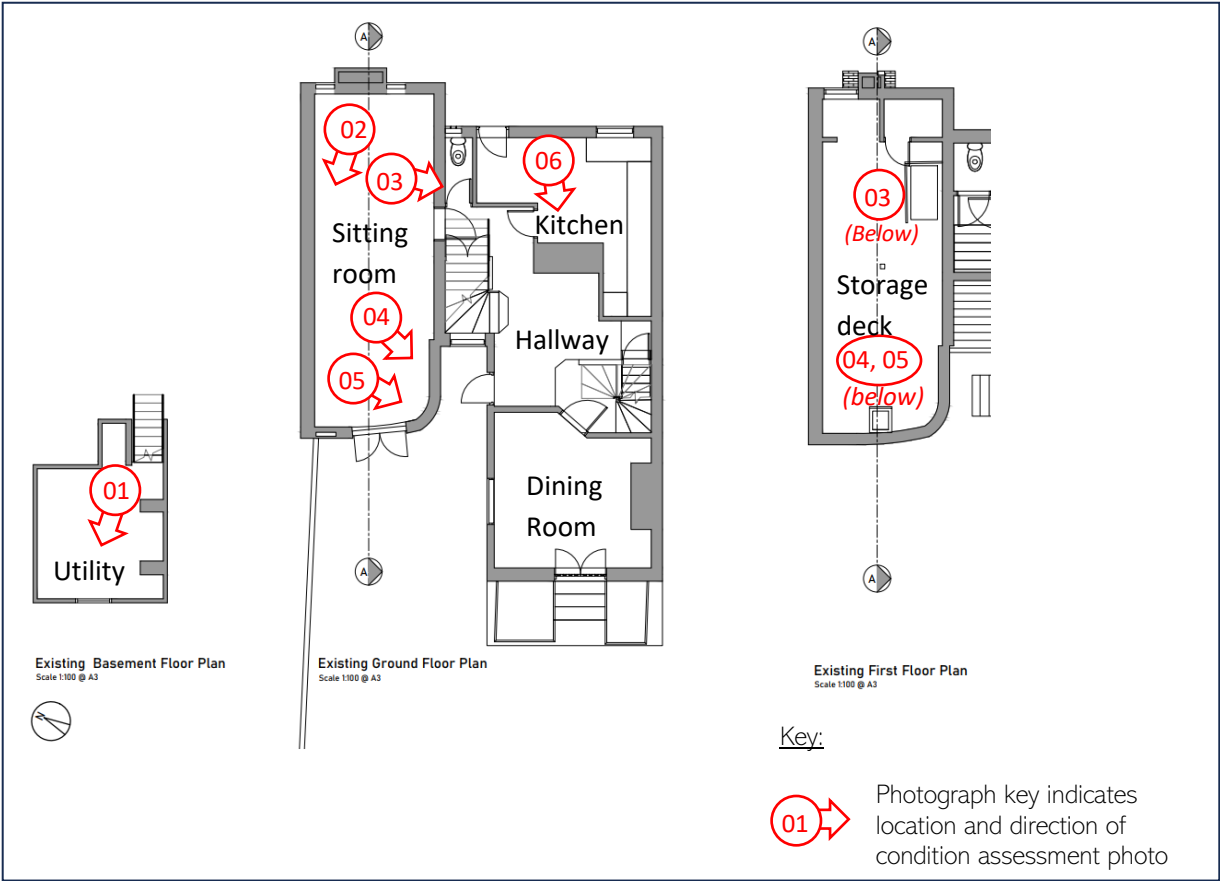
Figure 1 – Existing plans of the areas affected by damp. Key plan for the associated condition schedule.

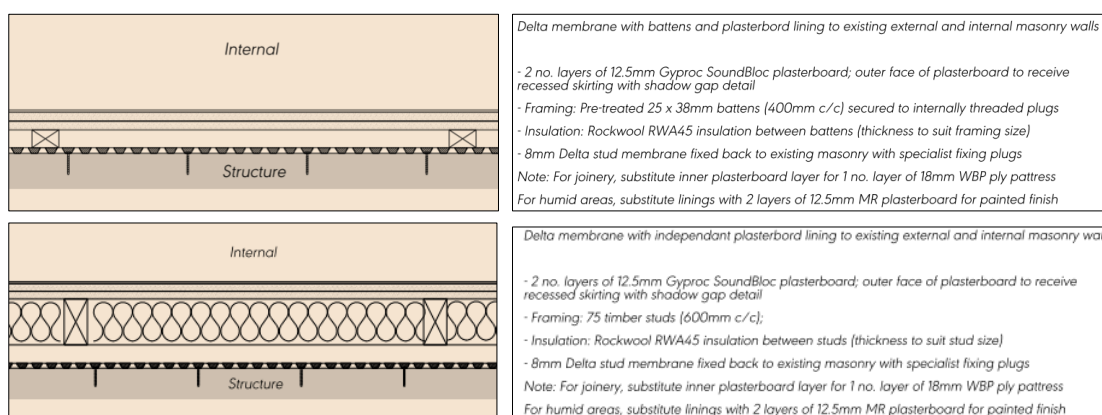
Figure 8 – typical damp membrane details (cavity system) *Drawings by others for illustrative purposes (public domain).*

For additional protection (to ensure the building's fabric is preserved), a damp proof membrane with additional dry lining / finishes is proposed to the basement. This system is non-invasive and has been approved in Grade I buildings (evidence can be provided).

The system (by Delta or equivalent) provides a fully-sealed membrane which prevents water penetrating beyond this layer into the internal spaces. This is a non-invasive system that will protect the building fabric.

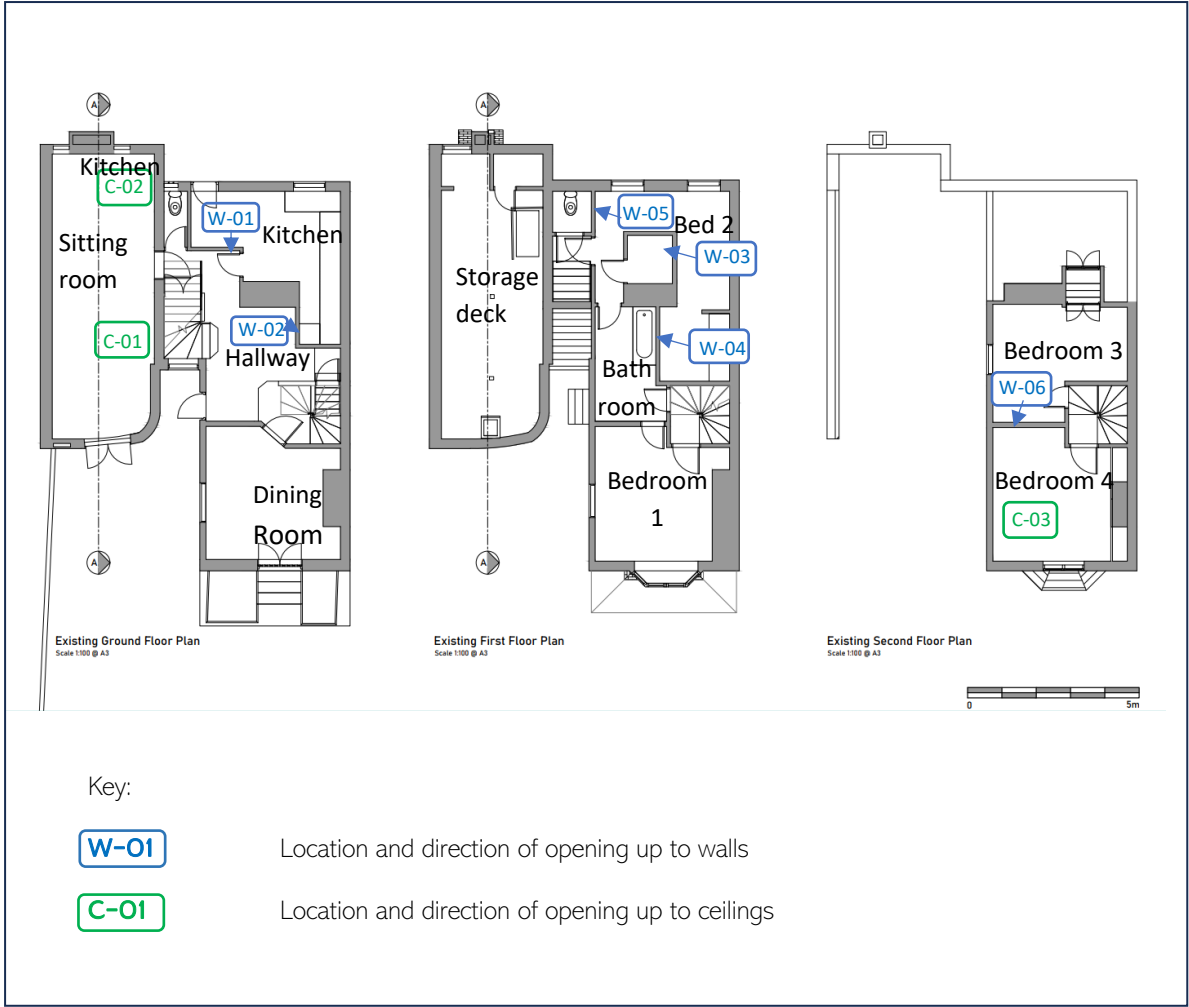
Ceiling (trial) openings are shown in green.

See key below on survey plans together with the interpretation table which has full explanation of each trial opening.

The proposal is for the plasterboard ceiling to be replaced – no historic timber will be removed.
