## Pre-Redevelopment Audit

For Planning

41 Sheldon Avenue

Mark Tognolini and Eva Stengaard

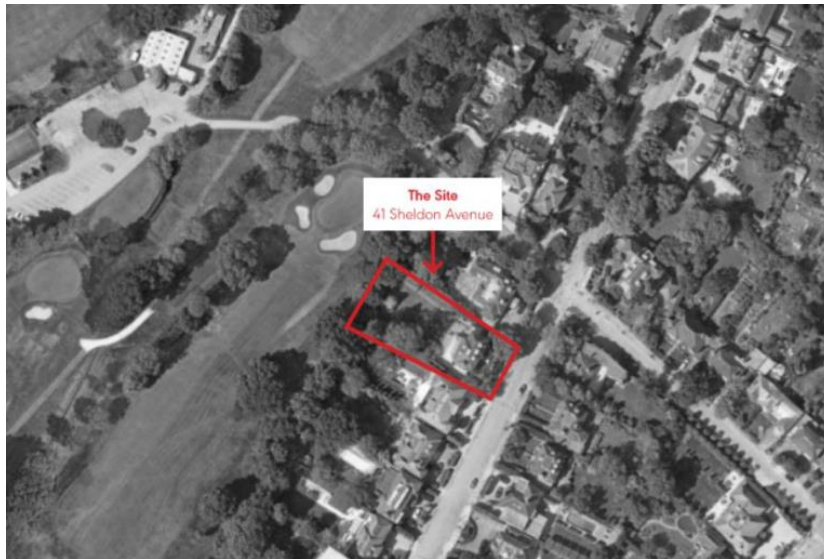
The following image indicates the area of this demolition which extends to all of the existing structures and façade.

This project proposed a full demolition of the development represent the removal of 100% of the total GIFA and around 100% of the total Mass.

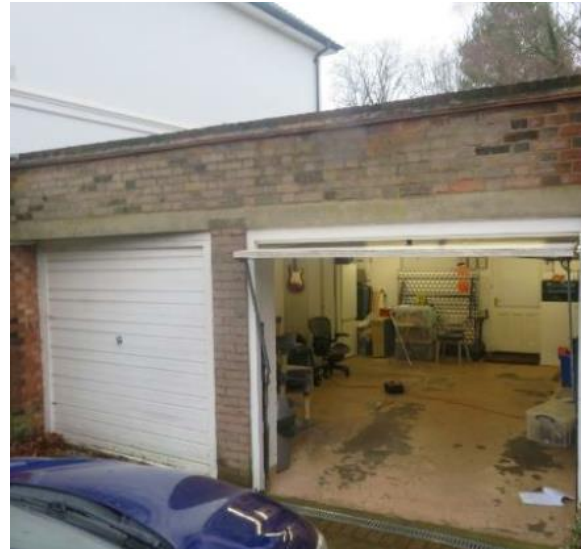
#### Garage

**Condition:** Not in good condition large crack observed

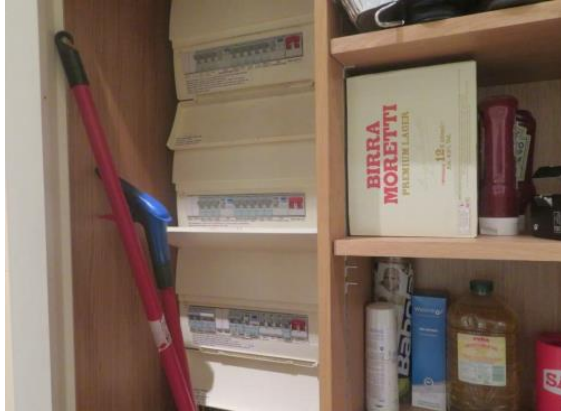
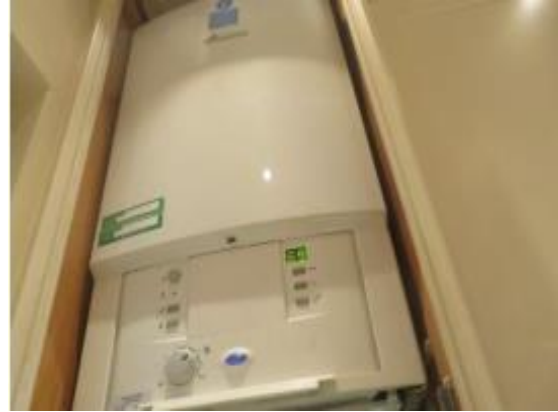
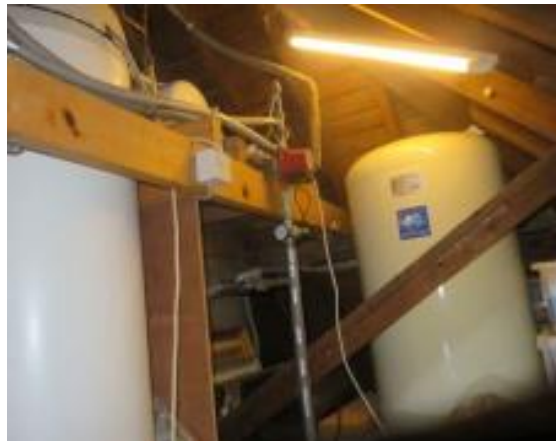
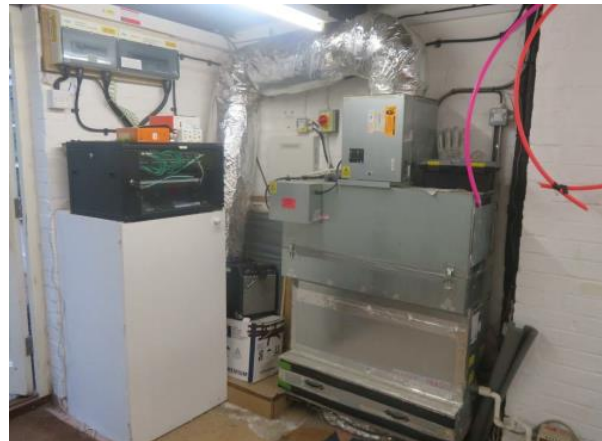
**MEP Service :** All services will need to be removed and are assumed to be recycled, the building uses an abnormal amount of energy to heat and cool, evident by the EPC rating. Plastic cabling is used instead of more modern metal products and wiring appears to be convoluted. It is also believed cast iron distribution pipework is used which would have to undergo a degree of re-plumbing if they were to be retained.

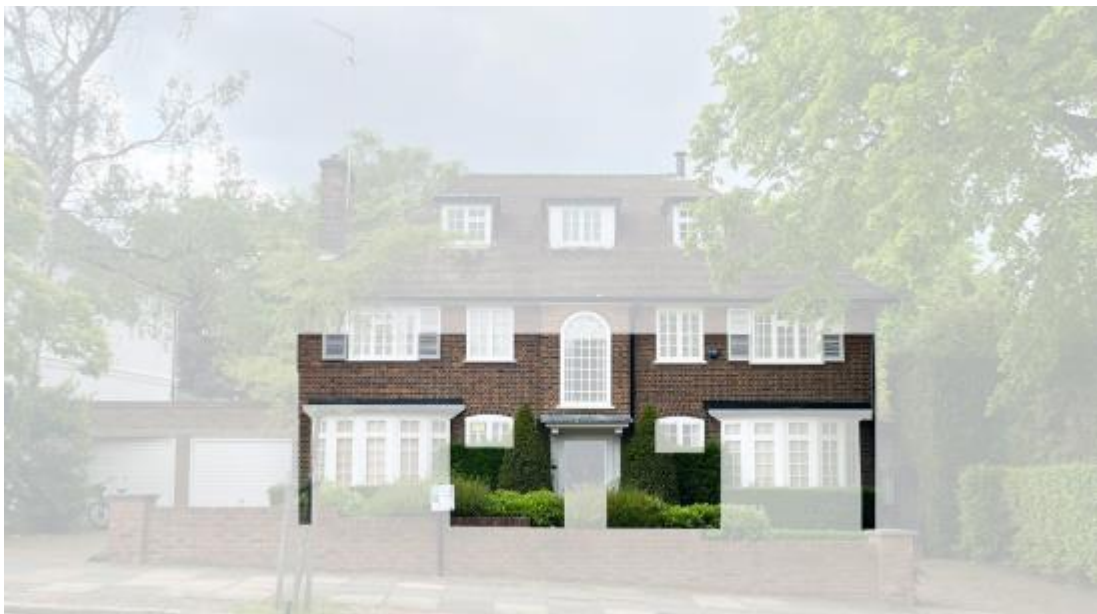
*Facade to be retained - after demolition, image by MWA*

- ❑ It would be difficult to retain the bay window of the front façade, will most likely need to be replace which also reduce the actual area can be retained and need new steel frame.

- ❑ There is some non-original brick on the front façade which will need to be replaced to match the retained façade. (further reduce the retainable area, diagram shown in the following page)

- ❑ The room size will be limited due to the Bay window which need to be centred along the room.

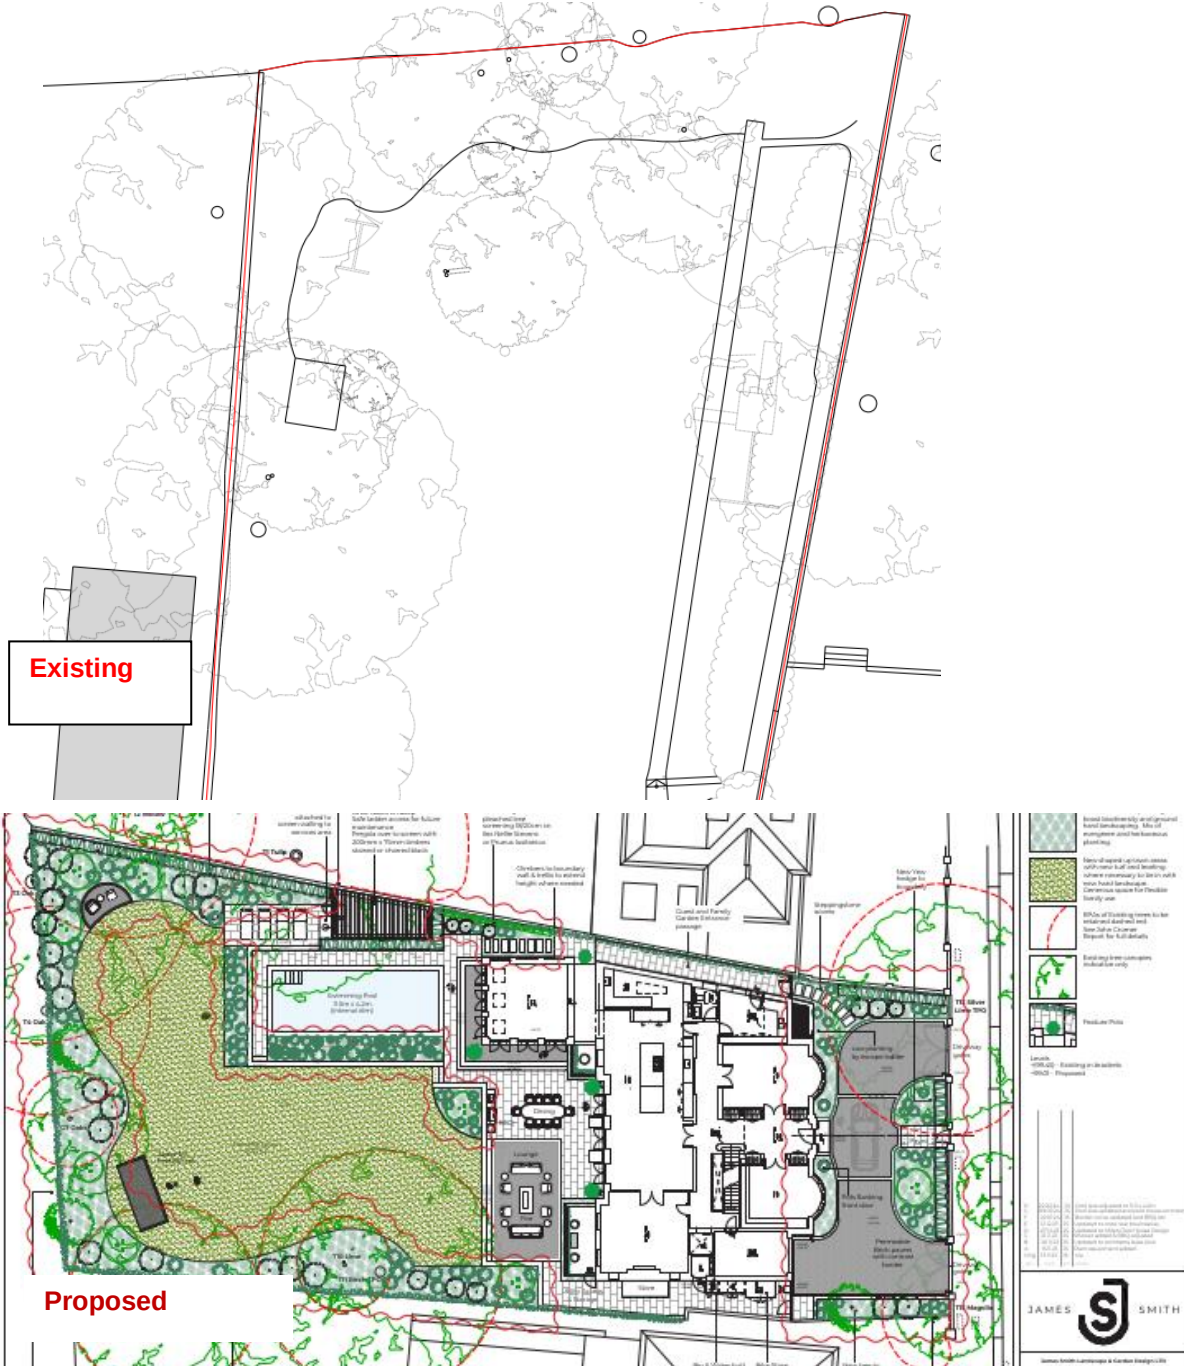
### 3.2. Hard Landscaping

The boundary walls of the property are in desperate need of repair which a major crack down the middle of the main boundary wall. The patio tiles are in adequate condition however minor cracks are beginning to form. The existing hard landscaping should therefore not be retained or re-used.

- ☐ **Conservatory:** All of the existing conservatory will be demolished, which includes timber frame double glazed windows, tiling and roof.
- ☐ **Garage and Brick Store:** All of the elements will be demolished, which included uninsulated brick wall, wooden frame roof and felt finishes.
- ☐ **Front Garden Wall:** All of the wall to be removed and possibly re-used.
