## **Project**

**Project Name:** CTS-MC 0129 20-21 Cranwood House  
**Project Description:** CCTV Survey Route Inspection  
**Project Status:** On Site  
**Project Date:** 08/06/2021  
**Inspection Standard:** MSCC5 Sewers & Drainage GB (SRM5 Scoring)

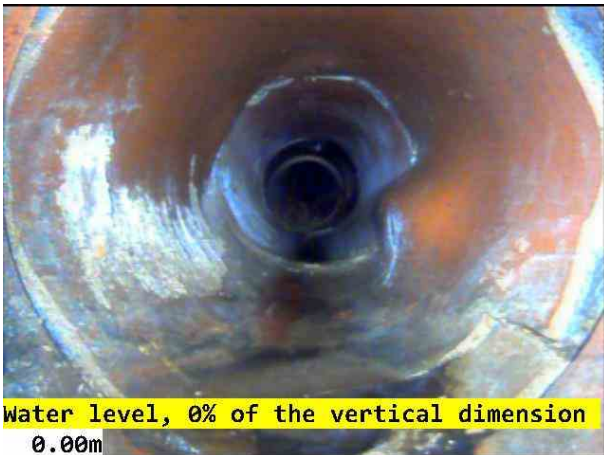
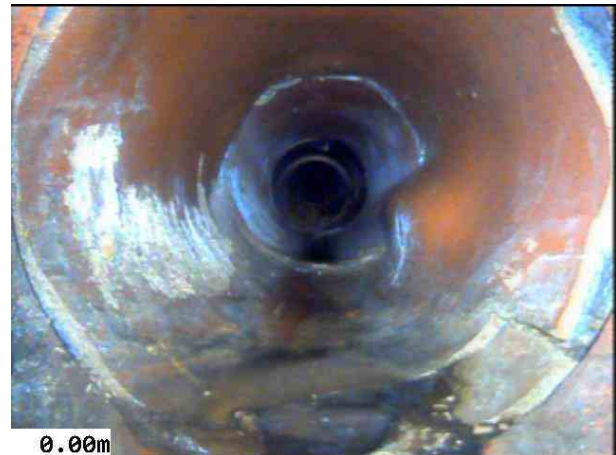
Garden  
1X\_7170d1f4-2883-49ab-aa33-b22bf1d24c8b\_20210608\_2129  
08\_236.jpg, 00:00:00, 0.00 m  
Water level, 0% of the vertical dimension

Garden  
1X\_c0a31266-2833-416d-85bc-7db716e4cd04\_20210608\_212  
913\_200.jpg, 00:00:00, 0.00 m  
Water level, 0% of the vertical dimension

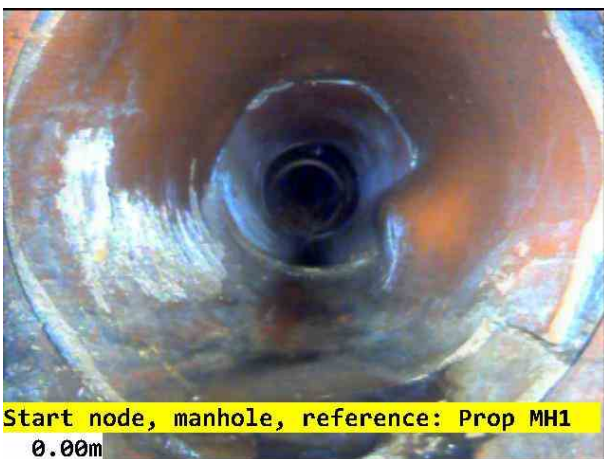
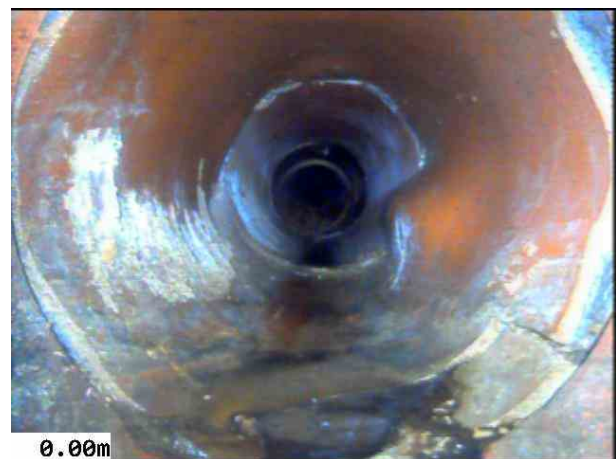
Garden  
1X\_bd2653fe-2538-464b-b275-6cc9fad63ed5\_20210608\_2128  
55\_708.jpg, 00:00:00, 0.00 m  
Start node, manhole, reference: Prop MH1, Start

Garden  
1X\_d8896931-0468-4495-b516-d9d9ac0b8949\_20210608\_212  
912\_178.jpg, 00:00:00, 0.00 m  
Start node, manhole, reference: Prop MH1, Start

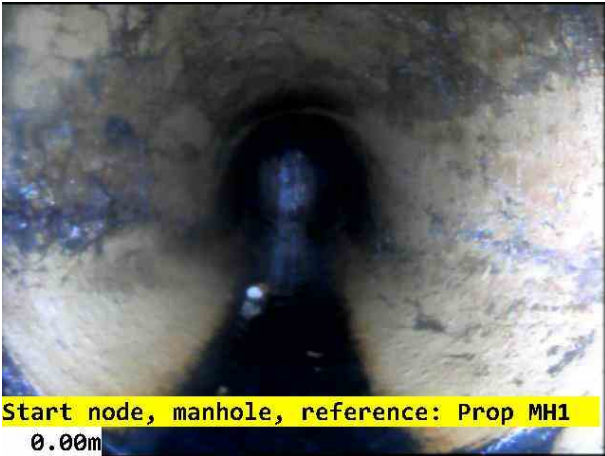
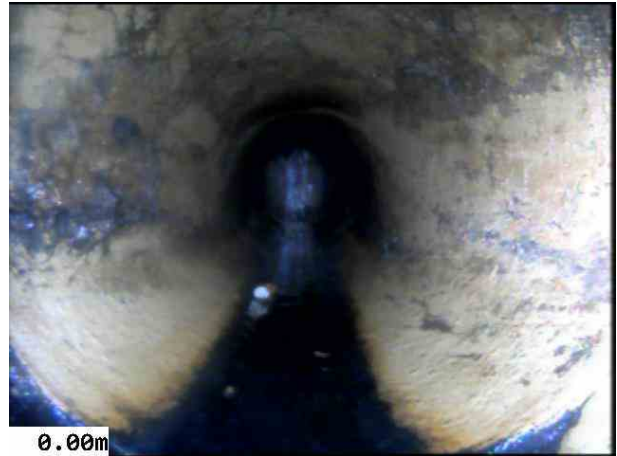
Prop  
MH2X\_04448ee3-2b99-48af-a5f7-3f29f4c71ea5\_20210608\_22  
3311\_452.jpg, 00:00:00, 0.00 m  
Start node, manhole, reference: Prop MH1, Start

Prop  
MH2X\_8bbac6b6-9597-4dd1-bdba-3164a1d55792\_20210608\_  
223317\_119.jpg, 00:00:00, 0.00 m  
Start node, manhole, reference: Prop MH1, Start

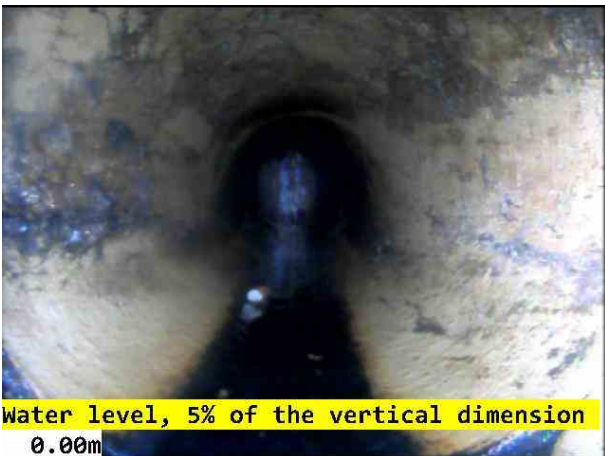
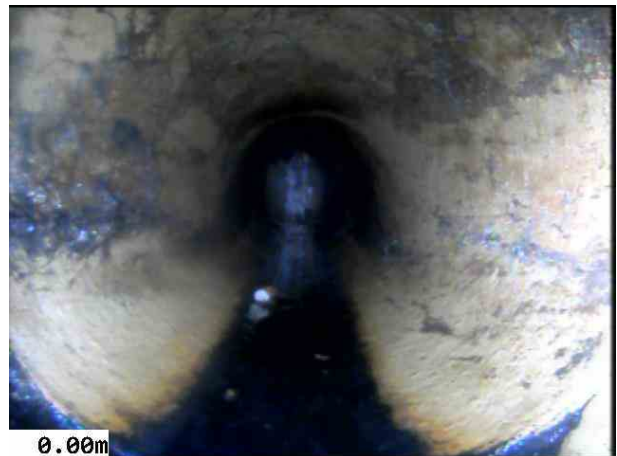
Prop  
MH2X\_b0971c87-47ae-4348-8f72-602ae474ae10\_20210608\_  
223345\_105.jpg, 00:08:25, 0.00 m  
Water level, 5% of the vertical dimension, live flowing water

Prop  
MH2X\_4a6eaf6a-dd9a-4830-9109-8b711409eb4a\_20210608\_  
223354\_478.jpg, 00:08:25, 0.00 m  
Water level, 5% of the vertical dimension, live flowing water

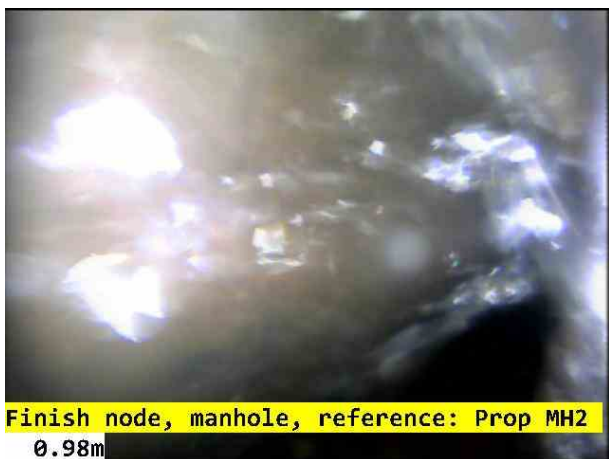
0.98m

Prop  
MH2X\_a44d1389-6f57-4374-85d4-358e90591ad8\_20210608\_  
223944\_438.jpg, 00:01:42, 0.98 m  
Finish node, manhole, reference: Prop MH2, finish

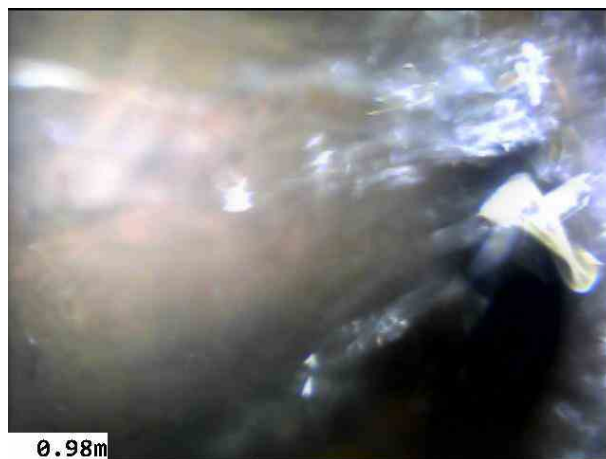
0.98m

Prop  
MH2X\_984aabe4-e69e-4fac-b79c-e0da79ed3f60\_20210608\_2  
23948\_903.jpg, 00:01:42, 0.98 m  
Finish node, manhole, reference: Prop MH2, finish

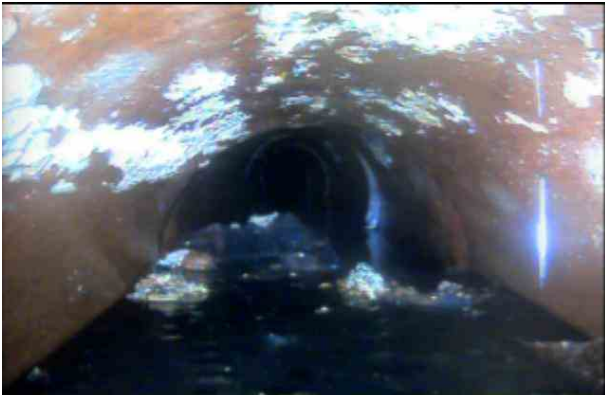
0.00m

Start node, manhole, reference: MH3101, start After Jetting

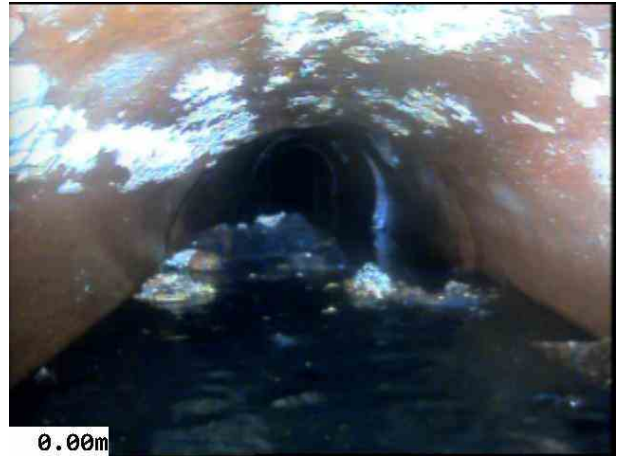
0.00m

Start node, manhole, reference: MH3101, start After Jetting

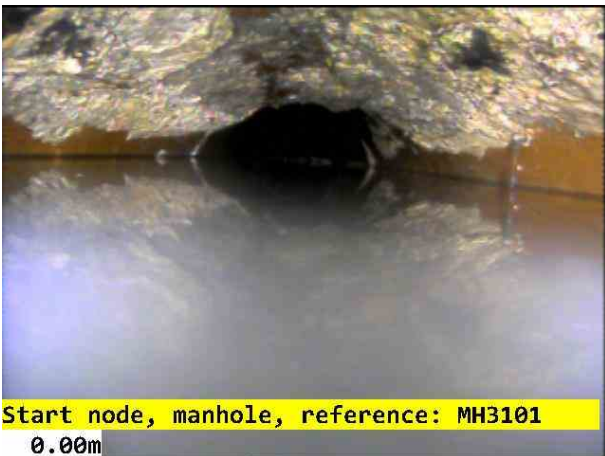
0.00m

Start node, manhole, reference: MH3101, Start

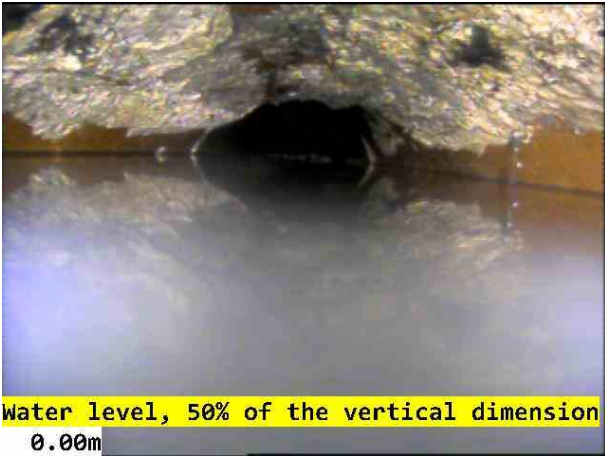
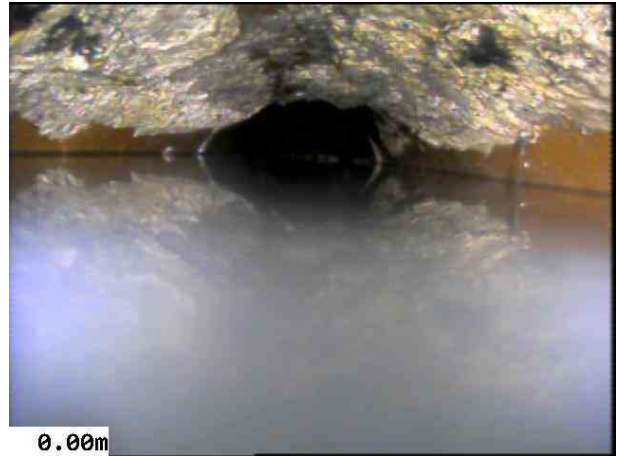
MH3101X\_4a2c18ac-9a63-4461-b9e5-7d72d19f9595\_20210608\_235326\_821.jpg, 00:00:00, 0.00 m  
Water level, 50% of the vertical dimension, Live flowing water

MH3101X\_313601f5-30ac-49b2-be58-6823ab299050\_20210608\_235331\_754.jpg, 00:00:00, 0.00 m  
Water level, 50% of the vertical dimension, Live flowing water
