**Project Name:** BRUNEL\_WALK\_14\_5\_24

**Project Description:** WinCan Import in Miraculix Standard

**Project Date:** 14/05/2024

**Company:** Selsdon Bulders  
**Street:** Brunel Walk  
**Town or City:** London  
**County:** N155HG

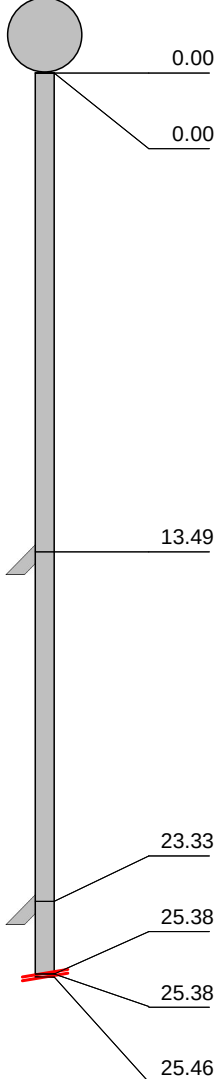
| Scale: 1:213 | Position [m] | Code | Observation | MPEG | Photo | Grade |
|---|---|---|---|---|---|---|
| | 0.00 | WL | Water level, 10% of the height | 00:00:04 | | A |
| | 13.49 | JN | Junction at 3 o'clock, diameter: 100mm | 00:00:50 | | A |
| | 23.33 | JN | Junction at 2 o'clock, diameter: 100mm | 00:02:40 | | A |
| | 25.38 | JDL | Large displaced joint | 00:03:21 | 20240514-113115-sn ap0000.jpg | C |
| | 25.38 | R | Roots | 00:03:32 | 20240514-113115-sn ap0001.jpg | B |
| | 25.46 | SA | Survey abandoned: CANT PASS | 00:04:24 | 20240514-113115-sn ap0002.jpg | A |

| <b>Pipe Condition Grade: C</b> | <b>Service Condition: Not Specified</b> |

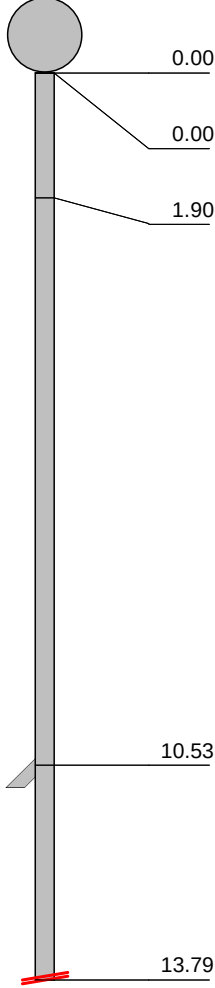
| Scale: 1:115 | Position [m] | Code | Observation | MPEG | Photo | Grade |
|---|---|---|---|---|---|---|
| <div>Depth: 0.10<br/>MH3</div> | | | | | | |

| Scale: 1:115 | Position [m] | Code | Observation | MPEG | Photo | Grade |
|---|---|---|---|---|---|---|
| | 0.00 | WL | Water level, 0% of the height | 00:00:05 | | A |

| Pipe Condition Grade: A | Service Condition: Not Specified |
