## Arboricultural Impact Assessment

The Mallinson Sports Centre  
Bishopswood Road  
Highgate  
London  
N6 4NY

Highgate School  
North Road  
London  
N6 4AY

Survey Date: 21<sup>st</sup> February 2025  
Report Date: 25<sup>th</sup> March 2025  
Project no: 380.1

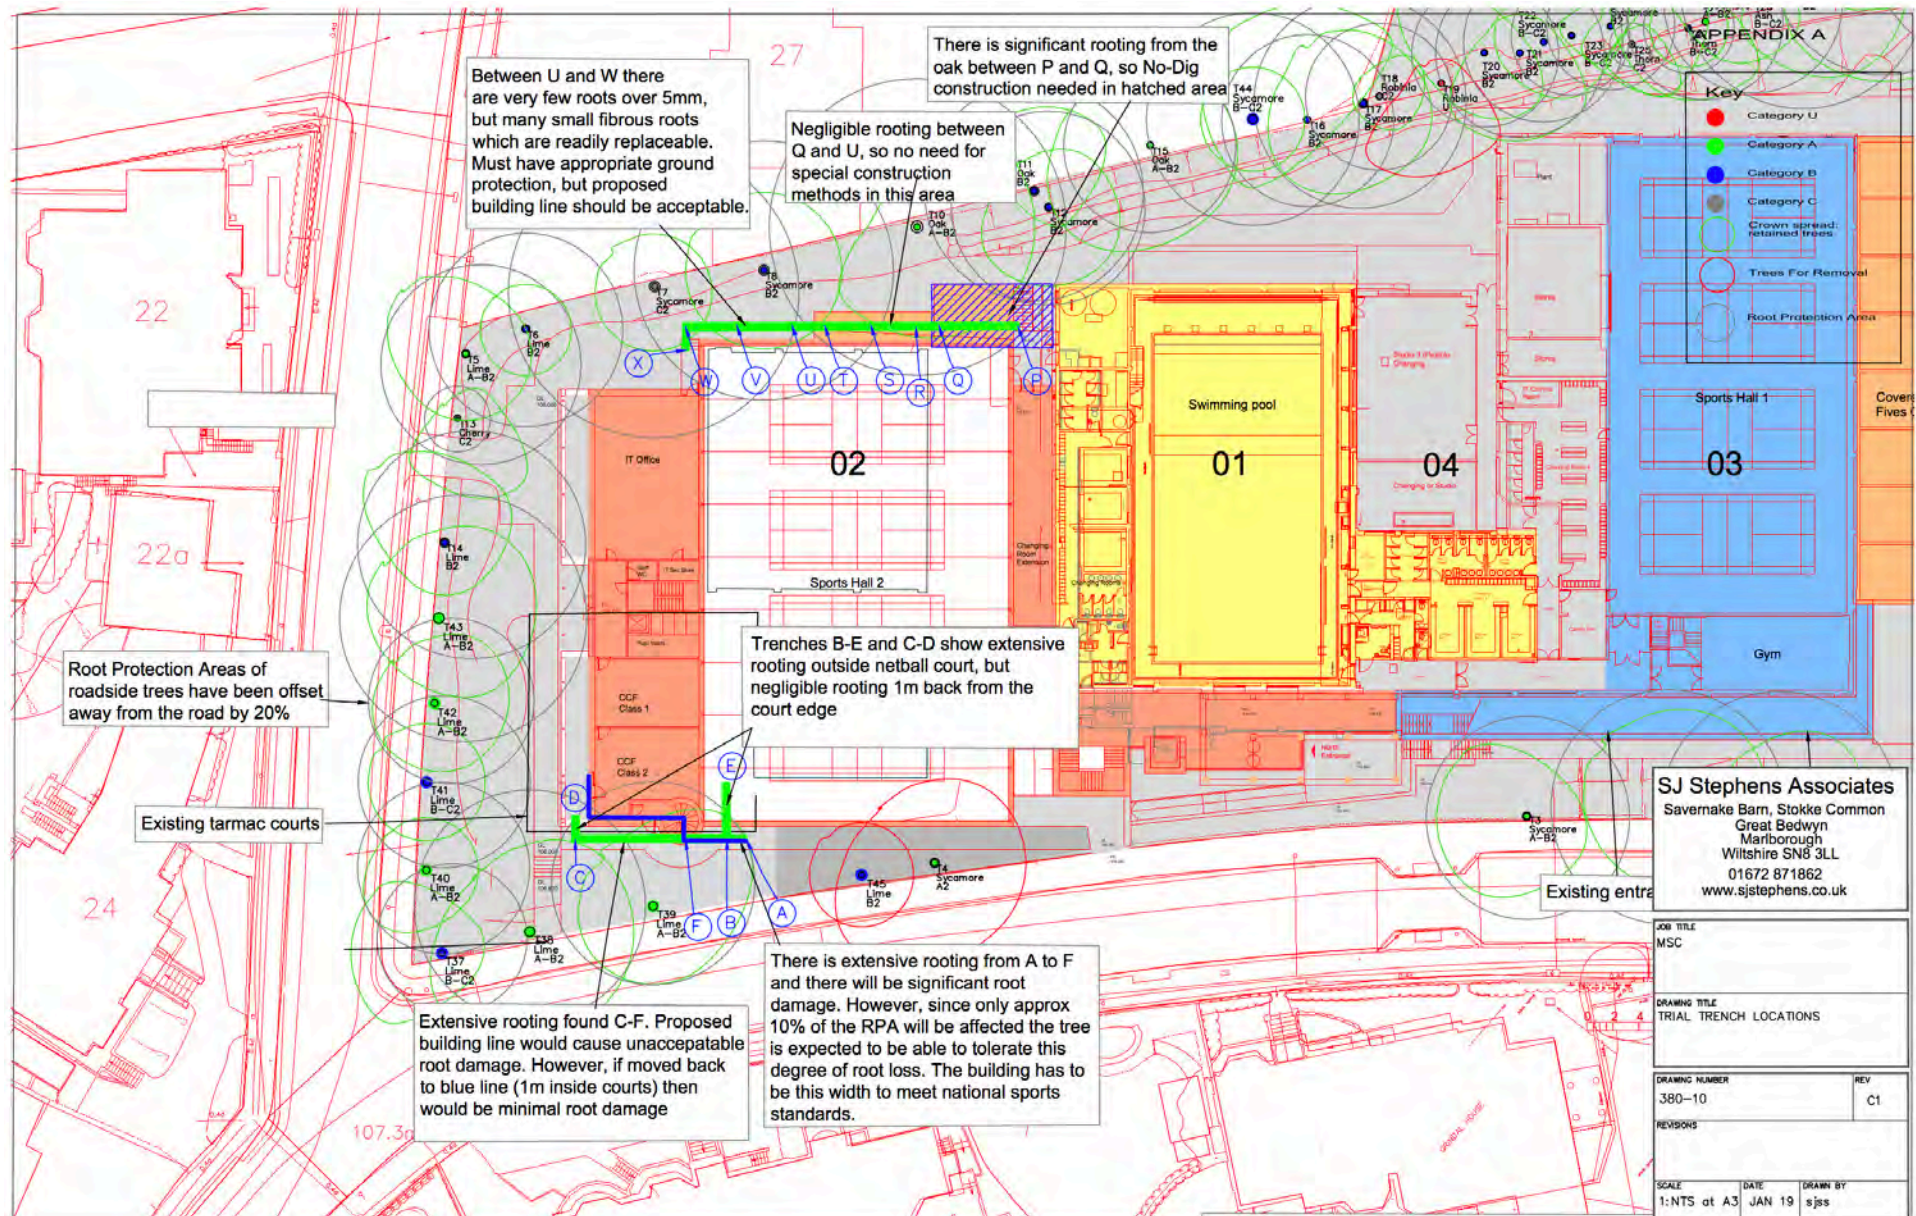
At X, burrowed under  
playground: almost no roots  
Found underneath
