37 NORTH ROAD

FAÇADE MASONRY CONDITION INVESTIGATION

JOB NO. 162-58

28 NOVEMBER 2024

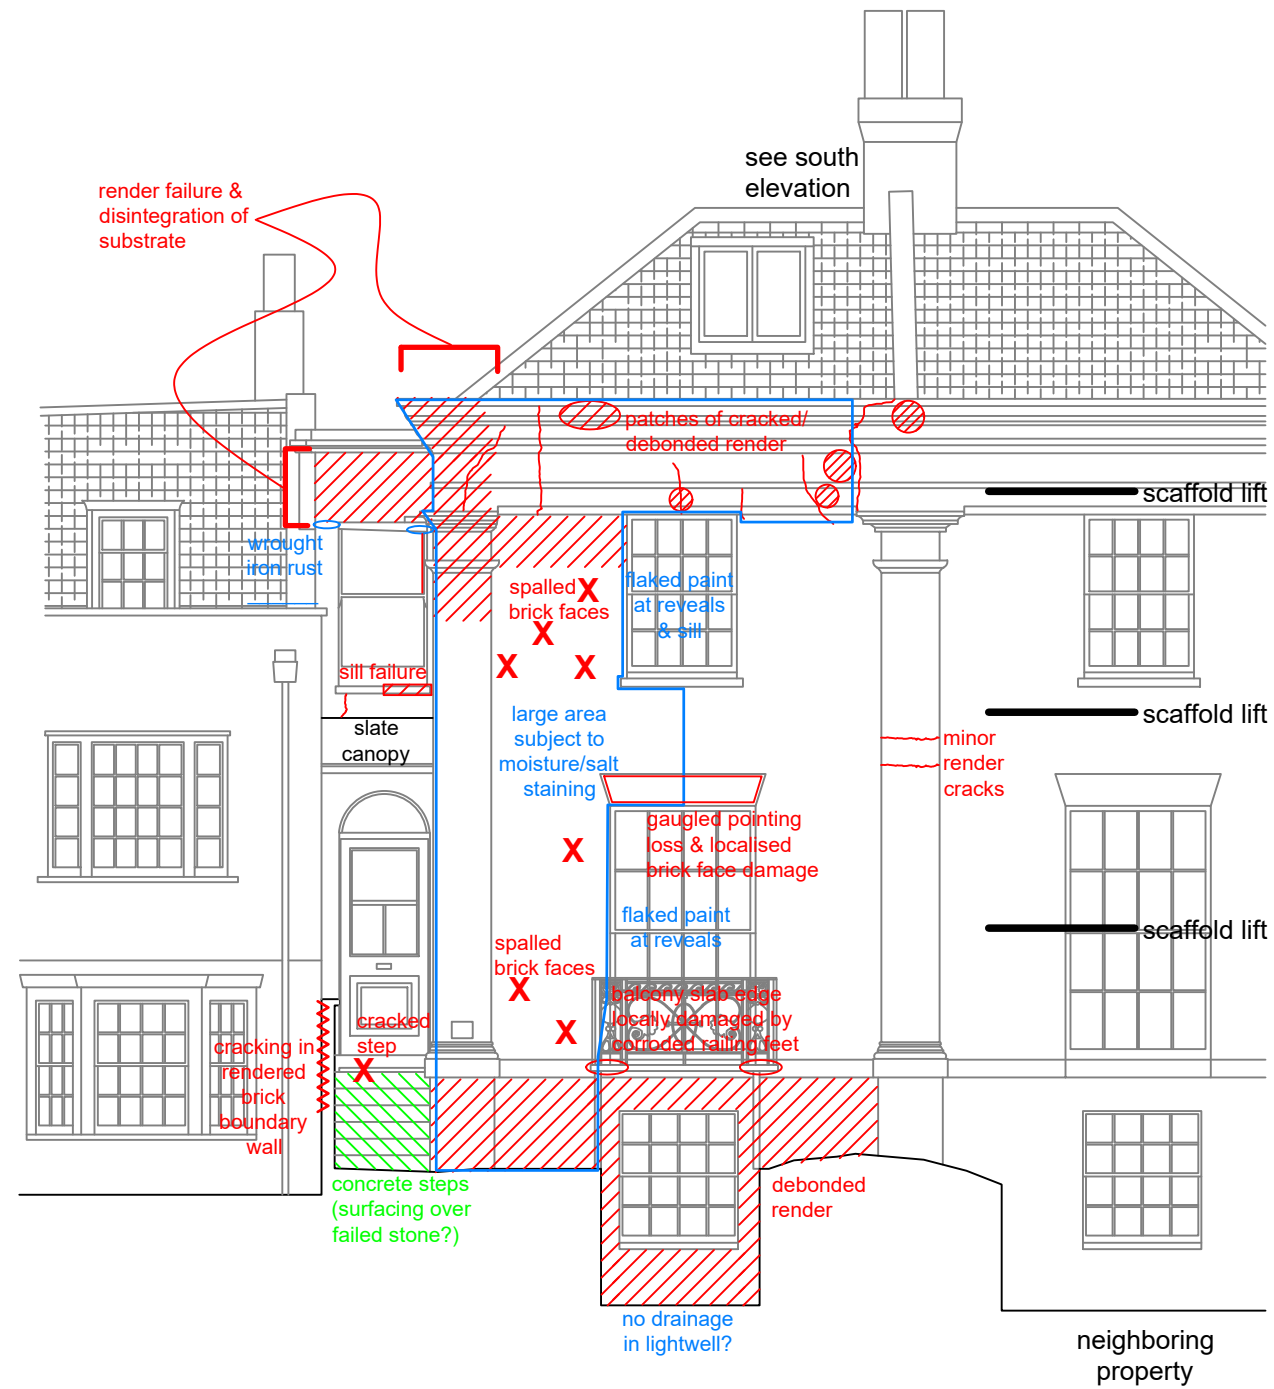
**37 North Road, N6 - Front (east) elevation**  
 Façade masonry condition investigation  
 28 November 2024

| REFERENCE | ITEM | OBSERVATIONS | RECOMMENDATIONS | CLIENT COMMENTS |
|---|---|---|---|---|
| <b>RPT.2.1</b> | East elevation<br>Wallhead and cornice | <p>As shown on drawings, the south end of the wallhead had suffered a history of render failure (exacerbated by modern cement repairs and acrylic paint). The severity of failure has resulted in disintegration of the substrate; this part of the wallhead was 'live' at time of survey. Note - render sample 2 was taken from this location</p> <p>The north end of the cornice was generally intact with only localised cracks and small patches of debonded render</p> <p>In general, the upper surface of the wallhead has previously been over-coated with cement and flashband which did not appear to be an ideal substrate for the lead capping and gutter lining</p> | <p><i>These sections of wall should be carefully dismantled, being sure to take photographic records during this process. It is important that the process of dismantlement is closely supervised and not allowed to progress excessively (although none of the historic mortars may be entirely 'solid', the dismantlement must stop after reaching a point where the wall is reasonably intact). Reconstruction should use the original materials where possible but the expectation should be that matching new replica materials will be needed. New brickwork to be laid in NHL5 lime mortar, new render to be a 'Prompt' product as mentioned above</i></p> <p><i>All paint to be removed using chemical paint softener and pressurised steam lance. Cracks to be filled with 'Prompt' mortar. Small debonded areas do not require remediation. Redecoration to be made using Keim Mineral Paint</i></p> <p><i>Allow to record and remove the leadwork forming gutter lining and wallhead capping. Underlying flashband and cement patches should be removed and made good using 'Prompt' mortar. Conservation leadworker to be consulted on their preferred substrate build-up for laying lead onto masonry; a timber substrate and/or underlay membrane is normally called for</i></p> | |
| <b>RPT.2.2</b> | East elevation<br>First floor | <p>As shown on drawings, the upper part of the south pilaster has debonded or been lost</p> <p>Adjacent to this, there was a large failed previous repair (dressed-back damaged brick faces clad with a red-coloured render to imitate brickwork). Elsewhere at first floor, there were isolated areas of spalled brick faces</p> <p>All of the first floor render above the entrance door canopy was in a state of failure, including a window sill composed of render</p> <p>The south corner of the elevation was badly stained by moisture/salt from many decades of parapet gutter leakage. Note that staining is liable to persist or worsen as drying-down eventually occurs (during and after roof repairs) due to the way in which moisture dries towards the surface and draws-out salts with it</p> <p>There was also some soiling by aerial roots/suckers of ivy</p> | <p><i>Loose material to be removed before making good by building-up coats of 'Prompt' mortar. Replication of the pilaster capital will likely need to be done off-site using a reverse-moulding taken from the remaining capital at the party wall (check that it is the same as that seen at the neighbouring property at the other end of the terrace), again this should be done using a 'Prompt' mortar. All of the pilaster and other painted render features should be stripped and re-decorated as described above</i></p> <p><i>Failed previous repairs to be removed. Bricks with spalled/damaged faces to be cut-out and replaced in a brick of matching type and imperial size. Pointing for these areas should replicate the surrounding (modern) cement profile because it would be excessively damaging to attempt replacing cement pointing throughout. Products such as 'dyebrick' can be used to tone-in brick and mortar to match</i></p> <p><i>This area of render should be replaced in a 'Prompt' mortar. The brick substrate (including sill and lintel) may be in need of repair/replacement</i></p> <p><i>Specialist cleaning contractor to be engaged to carry out cleaning trials. This may entail 'poultice' cleaning repeatedly to draw-out salts. The wall will require many months of drying and may be subject to recurring salt emergence</i></p> <p><i>Ivy suckers can be removed by careful use of flame gun</i></p> | |

| REFERENCE | ITEM | OBSERVATIONS | RECOMMENDATIONS | CLIENT COMMENTS |
|---|---|---|---|---|
| RPT.2.3 | East elevation<br>Ground floor and basement<br>lightwell | <p>All render below the string course was debonded from the substrate and in poor general condition. Original packing-out using clay tiles was evident</p> <p>There were isolated areas of spalled brick faces</p> <p>The entrance steps have been replaced or overcoated in cement/concrete (unknown if degraded stone structure remains below). The top step was cracked at a point of weakness created by the coal delivery chute</p> <p>The south corner of the elevation was badly stained by moisture/salt from many decades of parapet gutter leakage. Note that staining is liable to persist or worsen as drying-down eventually occurs (during and after roof repairs) due to the way in which moisture dries towards the surface and draws-out salts with it</p> <p>On the south-facing flank elevation, render was subject to general crazing and paint failure</p> <p>There was also some soiling by aerial roots/suckers of ivy</p> <p>The enamelled metal street number was degraded by corrosion</p> | <p><i>This area of render should be replaced in a 'Prompt' mortar</i></p> <p><i>These bricks to be replaced, as described above</i></p> <p><i>The steps are likely to remain serviceable in their current state. Only if desired, consideration and further exploration could be made as to potentially restoring the original stone steps</i></p> <p><i>Poultice cleaning is suggested, as described above</i></p> <p><i>All paintwork to be removed, cracks filled with 'Prompt' mortar and allowed to cure prior to re-decoration using 'Keim Mineral Paint', as described above. Within the range of products available from Keim, there are primer products which can provide a more even surface finish</i></p> <p><i>Ivy suckers can be removed by careful use of flame gun</i></p> <p><i>The sign could be restored by a specialist or replaced</i></p> | |
| RPT.2.4 | East elevation<br>Boundary walls etc. | <p>The historic boundary wall alongside the entrance steps was rendered brickwork. This was badly cracked and subject to general debonding of the render</p> <p>Further down the south boundary to the front garden was a modern brick wall which appeared intact</p> <p>The pavement boundary may have originally been iron railings fixed into a stone plinth but this appeared to have been lost many years ago</p> <p>The north boundary of the front garden was not reviewed, it was potentially missing/absent</p> | <p><i>This section of wall is likely to require replacement of the render and structural repair of cracks by helibar</i></p> <p>-</p> <p><i>Consider restoring a historically appropriate boundary</i></p> <p>-</p> | |

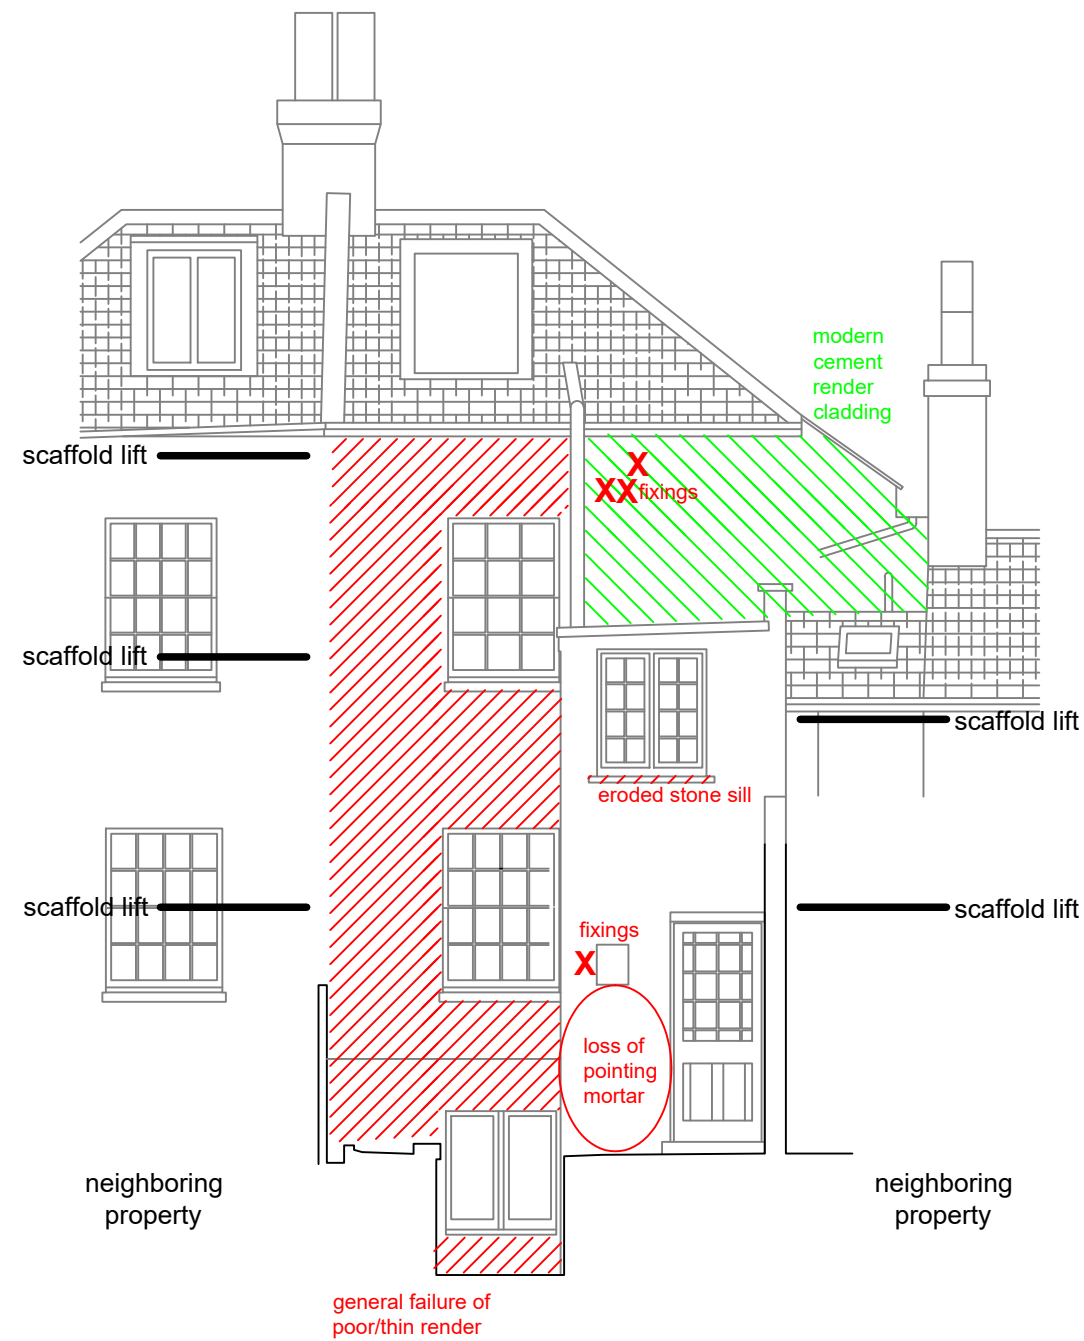
**37 North Road, N6 - Rear (west) elevation**  
 Façade masonry condition investigation  
 28 November 2024

| REFERENCE | ITEM | OBSERVATIONS | RECOMMENDATIONS | CLIENT COMMENTS |
|---|---|---|---|---|
| RPT.3.1 | General | <p>Vertical cracking at construction joint between modern closet wing extension and original rear elevation, crack opened-up by ~20mm</p> <p>Upper south corner has been re-rendered in modern Portland cement (appears to be associated with flying freehold area?)</p> <p>General failure of original render which appears to have always been a low quality (thin) coat of render and vulnerable to the effects of prevailing weather. Modern application of acrylic paint was likely deleterious to render. Render subject to various areas of collapse and widespread debonding</p> <p>Various redundant fixings and service runs/penetrations</p> <p>The rear garden boundaries were not reviewed, they appeared to be simple modern timber fencing</p> | <p><i>Structural Engineer to review this and other areas of cracking generally. It may be necessary to provide corner-ties using helibar or similar</i></p> <p><i>As a minimum, it is suggested that this area is decorated using Keim mineral paint for weathering protection</i></p> <p><i>Total replacement of this render is recommended using an NHL5 mortar</i></p> <p><i>To be made good using matching materials, following removal of all redundant items</i></p> <p>-</p> | |

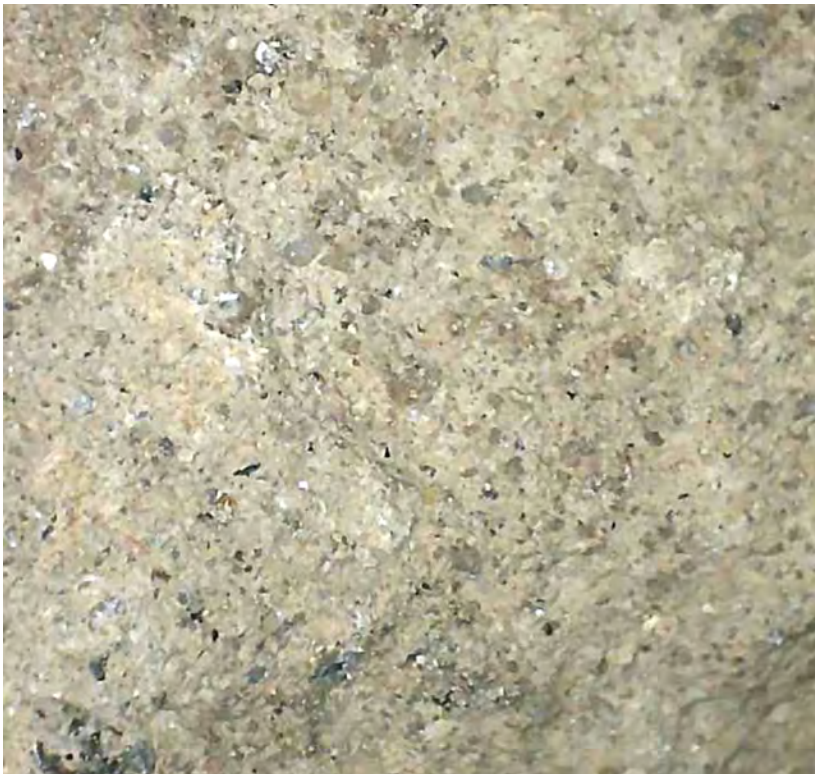
**Fig B:**

Sample 1, microscopic view

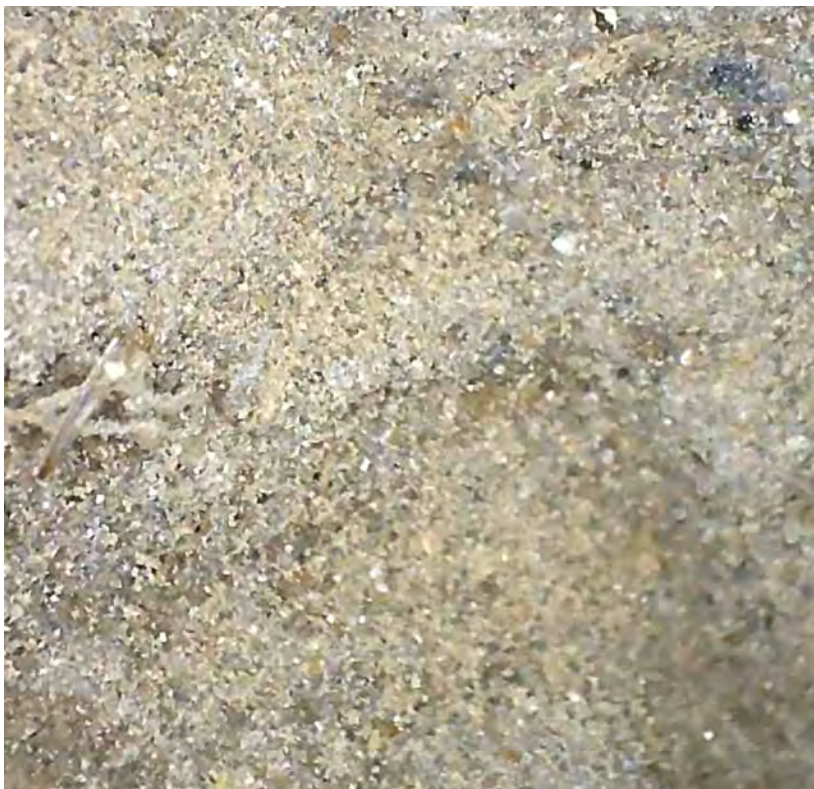
**Fig D:**

Note reasonable variation in aggregate size grading

Variation in aggregate colour suggested some mica inclusions (tbc)

Sample 1, microscopic view

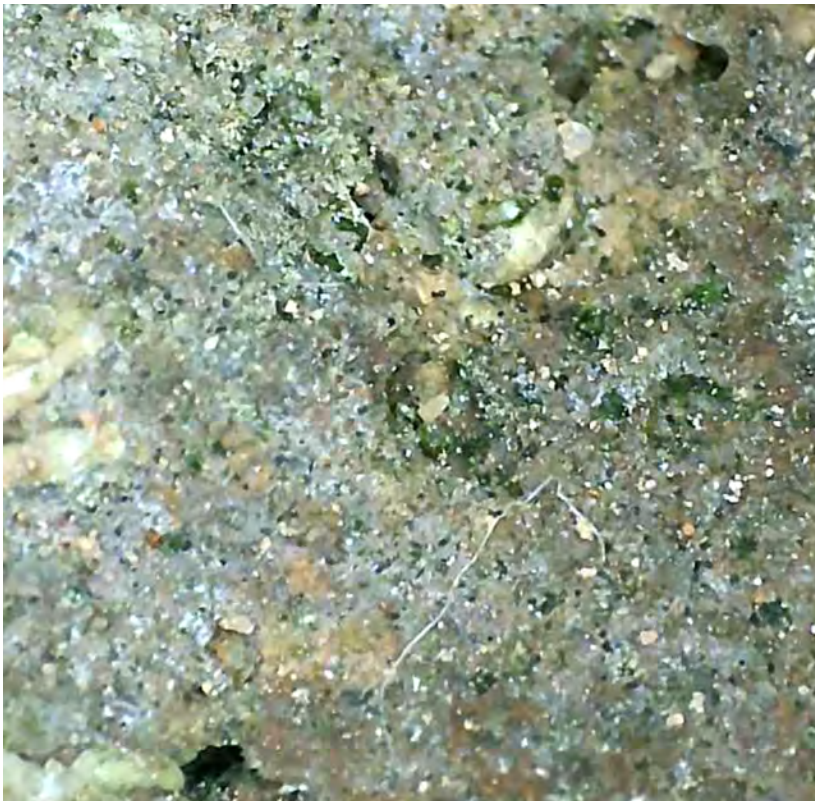
**Fig F:**

Note very well bonded aggregate matrix

There were no significant voids, pores or microcracks. This was consistent with what is understood of 'roman cement' (that it is a hard and fairly impervious material)

Sample 2, microscopic view

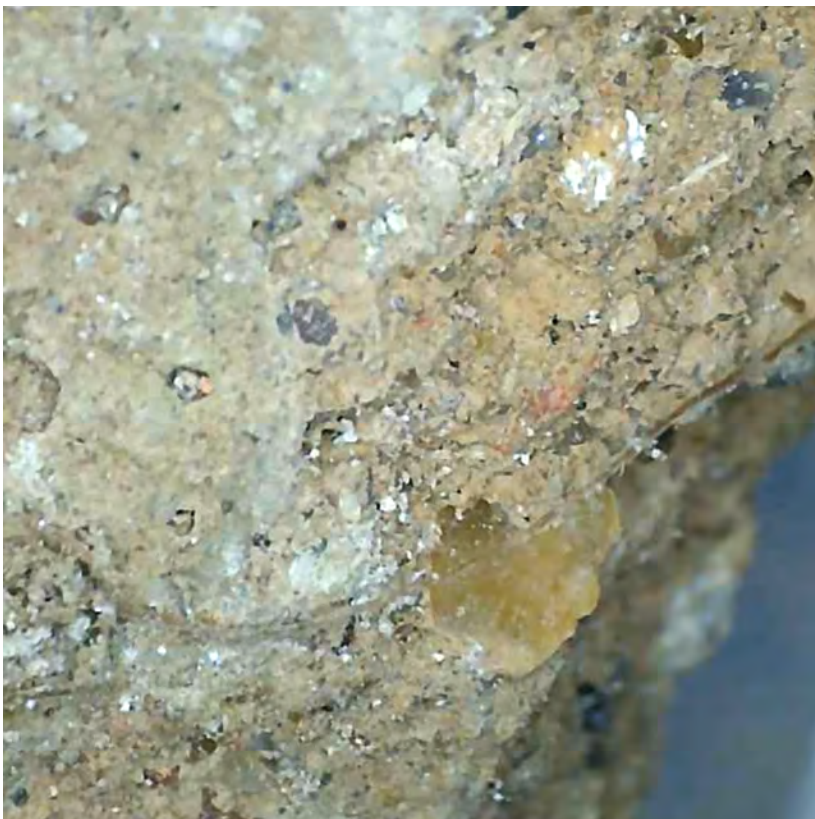
**Fig H:**

Note area of excessive fines associated with debonding failure

Sample 2, microscopic view
