HERITAGE STATEMENT FOR 37 NORTH ROAD, HIGHGATE FOR REMEDIATION  
OF DECAYED AND DRY ROT INFECTED TIMBERS AND REPAIRS TO EXTERIOR

JOB NO: 162-58

V.3 REPORT 18 JUNE 2025

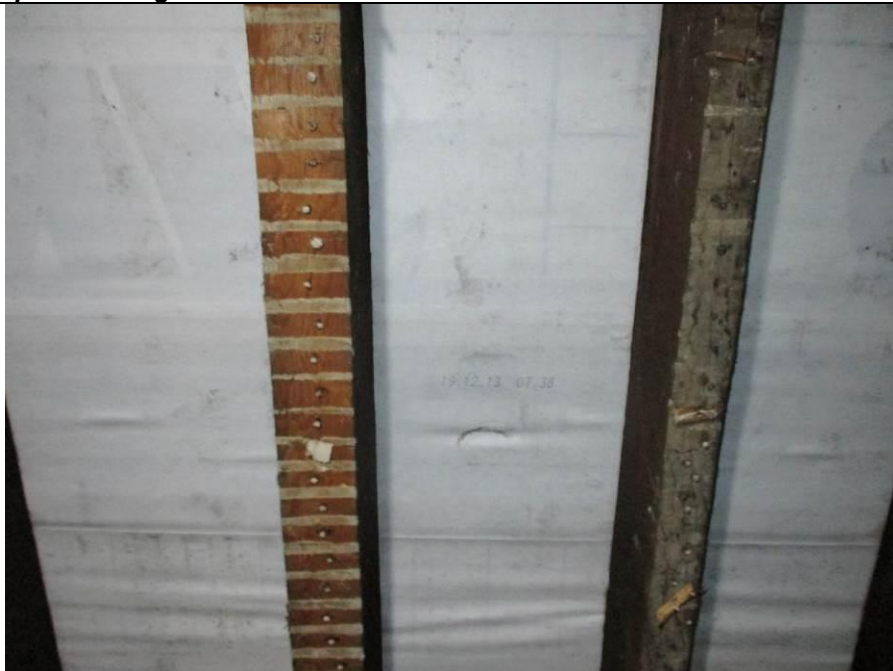
Room S1, showing the underside of south roof slope (east end) where rafters are overlaid by

an assume breather membrane with production date stamp 19/12/13.

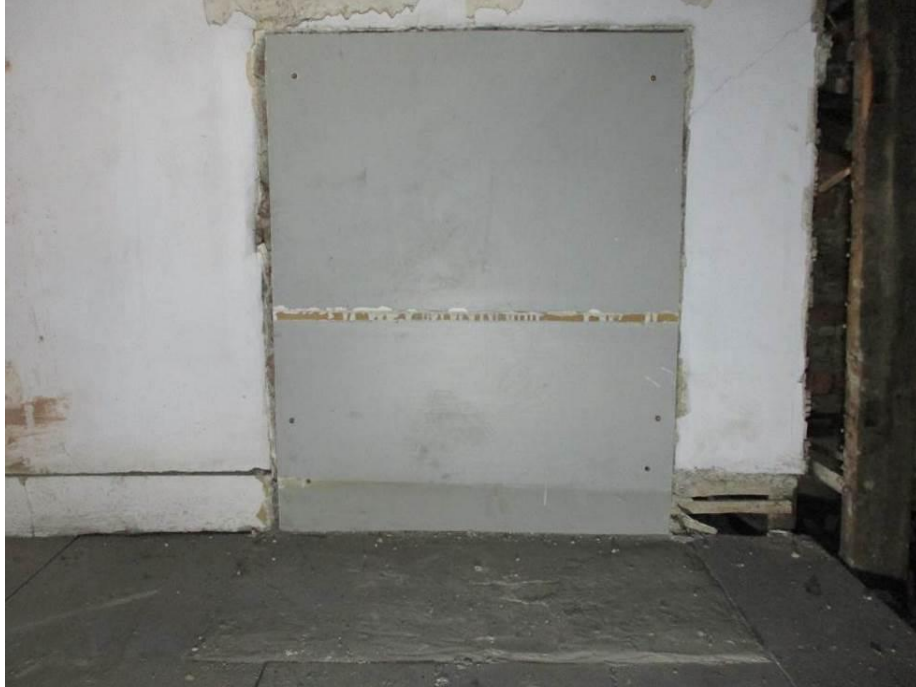
Room S1, showing the position of former fireplace within north party wall. The fireplace (surround and grate) has previously been removed although the hearth remains within the floor.

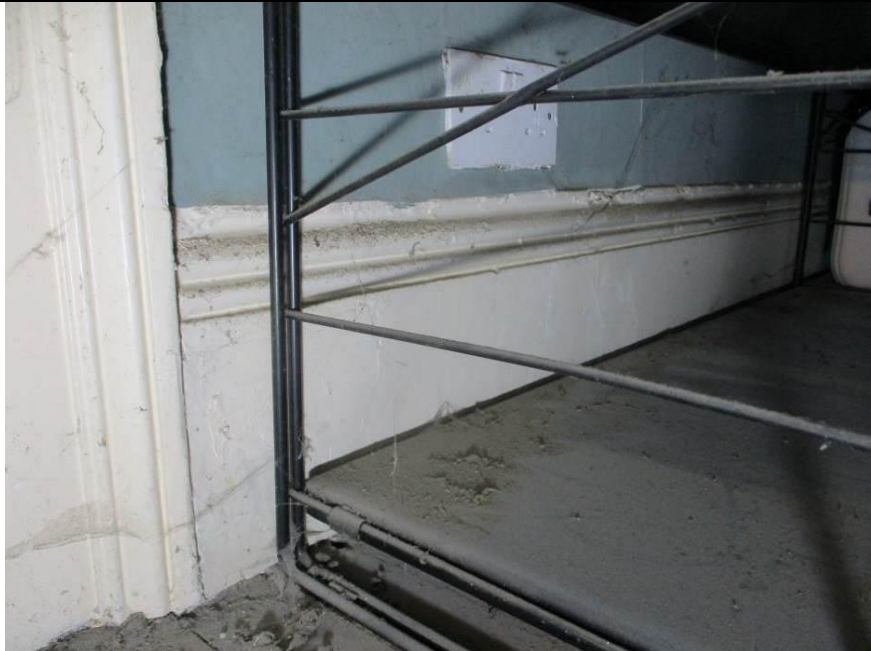
Room G3, showing skirting.

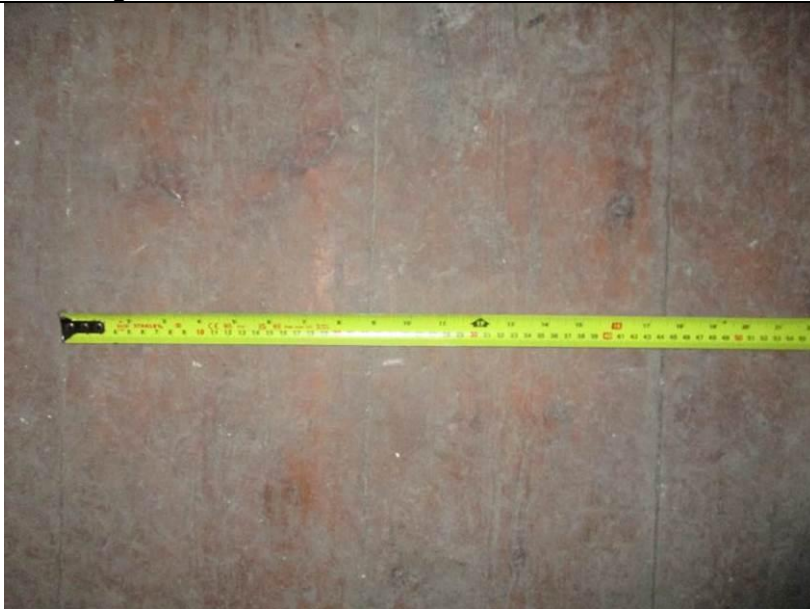
Room G3, showing floorboards.

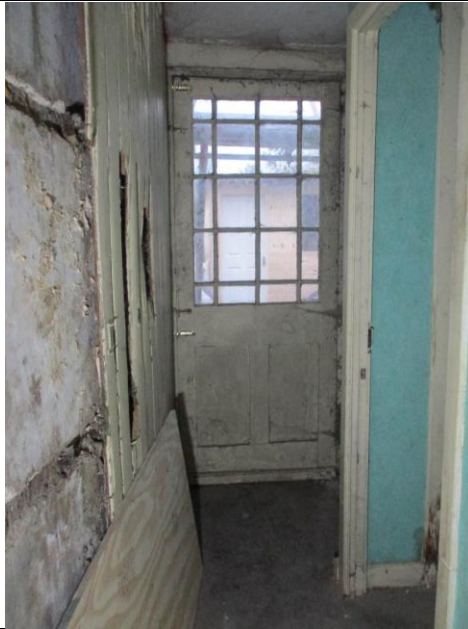
Room G4, looking west through back hallway.

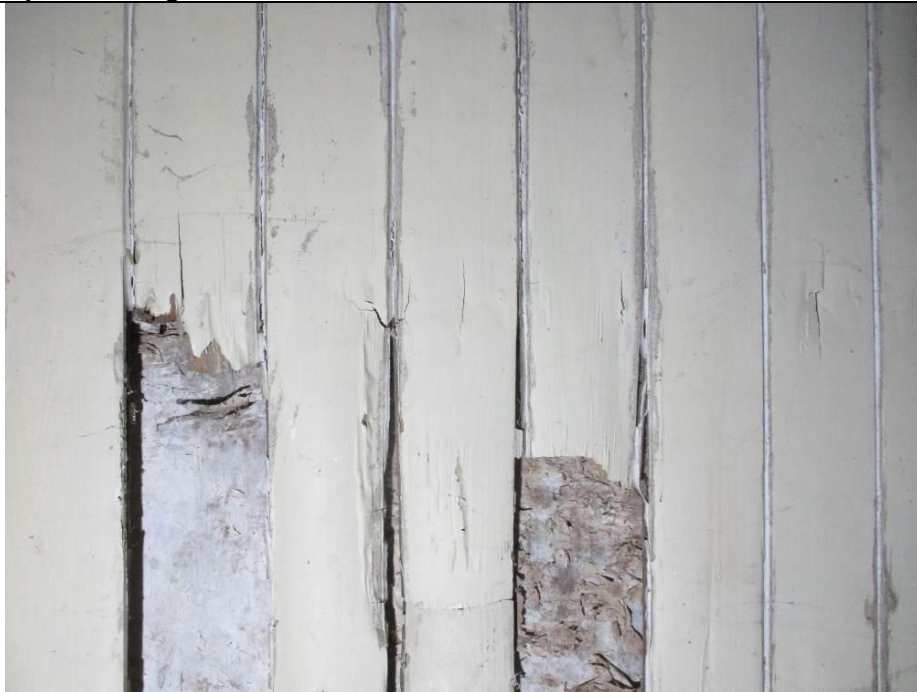
Room G4, showing wainscoting.

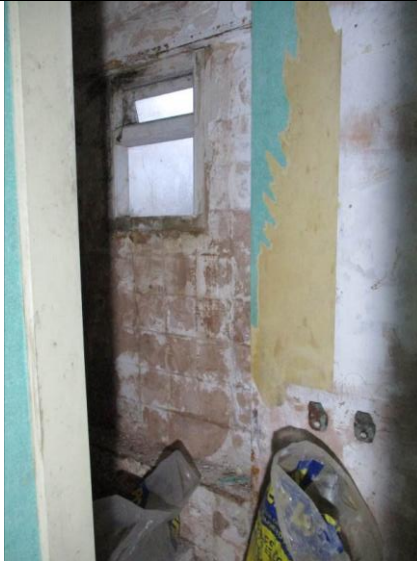
Room G5 looking into room from doorway.

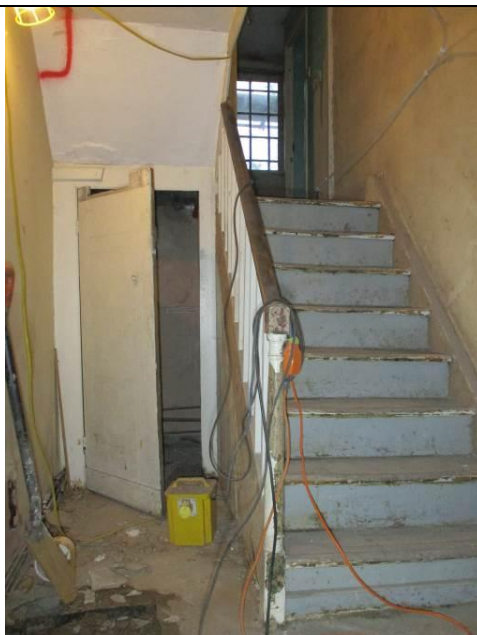
Room LG1, looking west towards staircase.

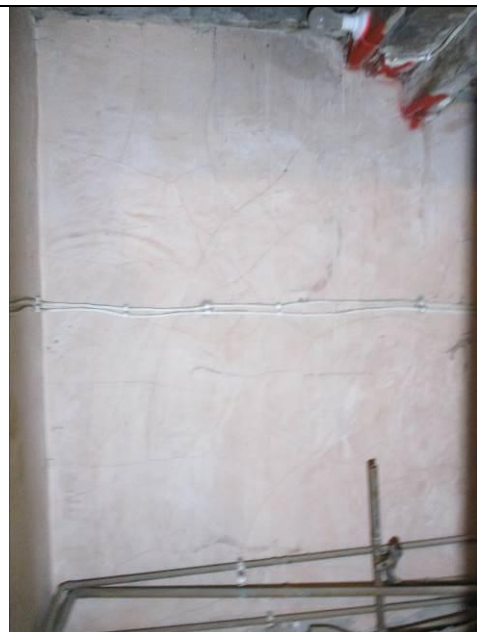
Room LG1a, looking into understairs cupboard.

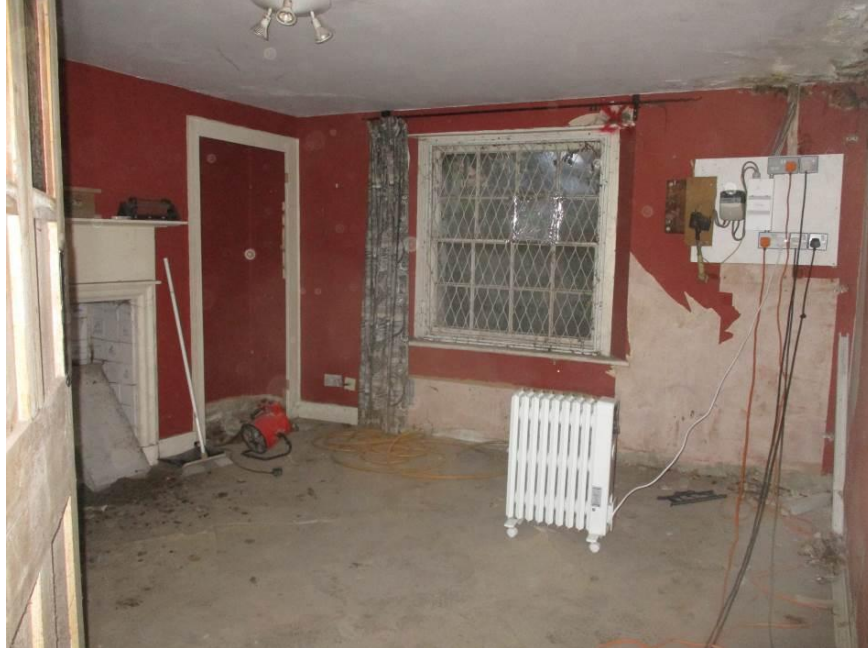
Room LG2, looking east through room.

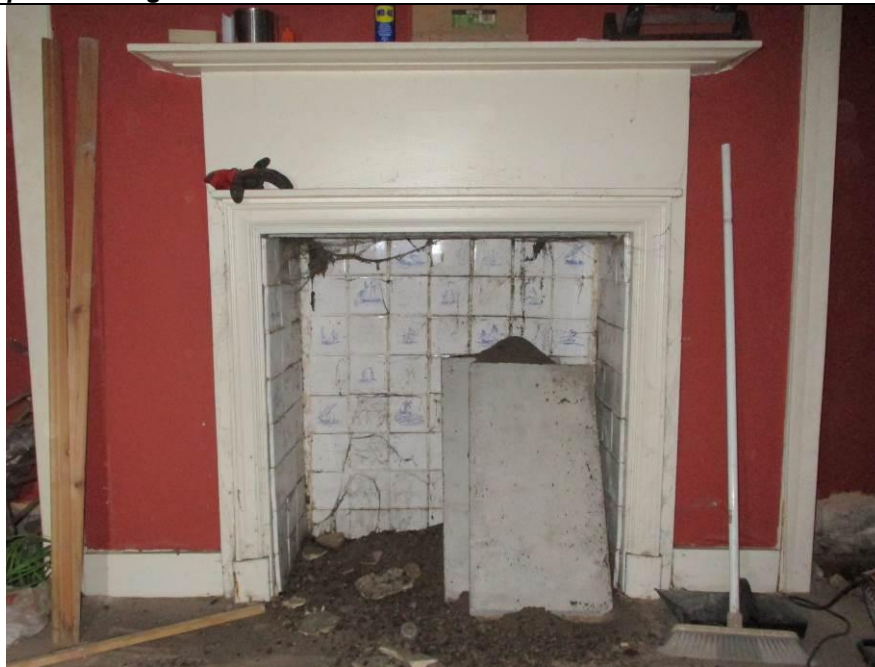
Room LG2, showing fireplace.

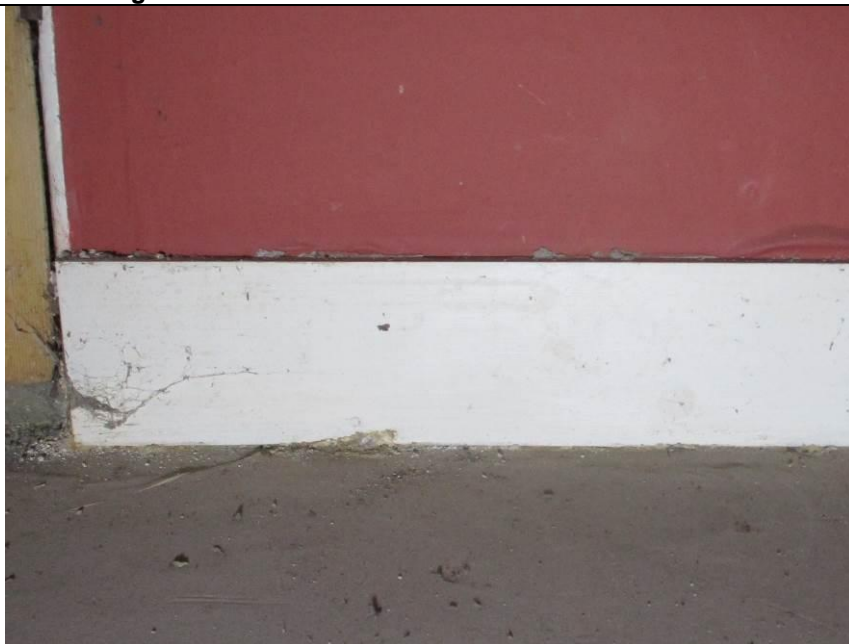
Room LG2 , showing plain skirting (without moulding).
