## LEVEL 2 HISTORIC BUILDING RECORD FOR 37 NORTH ROAD, HORNSEY

JOB NO. 162-58

DOUGLAS PASKIN, PKS ARCHITECTS

18 DECEMBER 2024

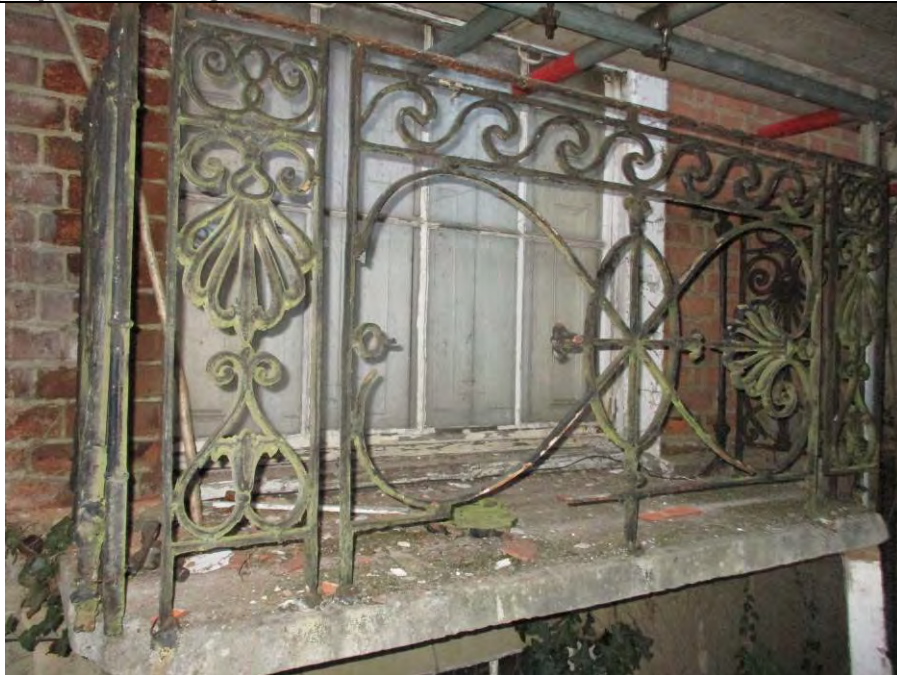
Front elevation, showing metal balconette to ground floor window.

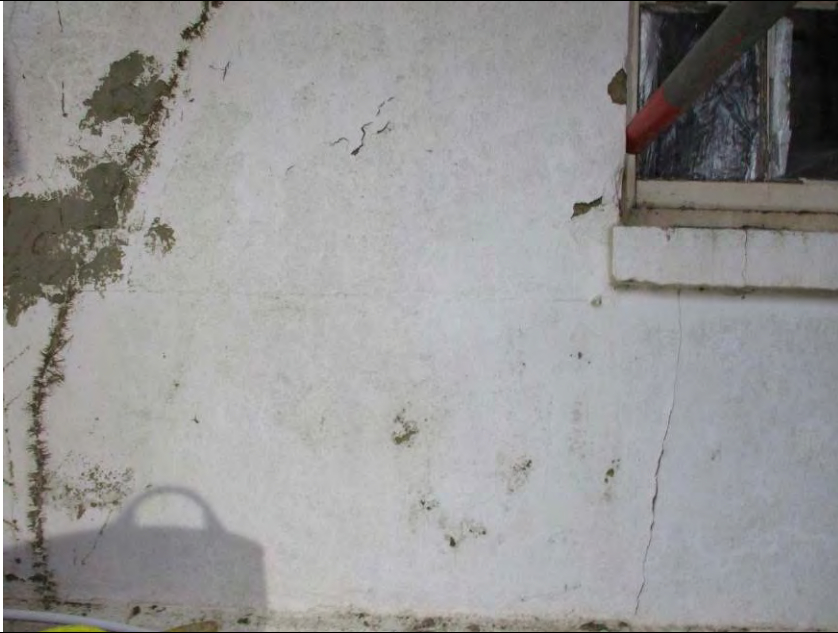
Rear (west) elevation. Painted render (assumed over brickwork). The faint lines of an incised detailing are visible within the render finish.

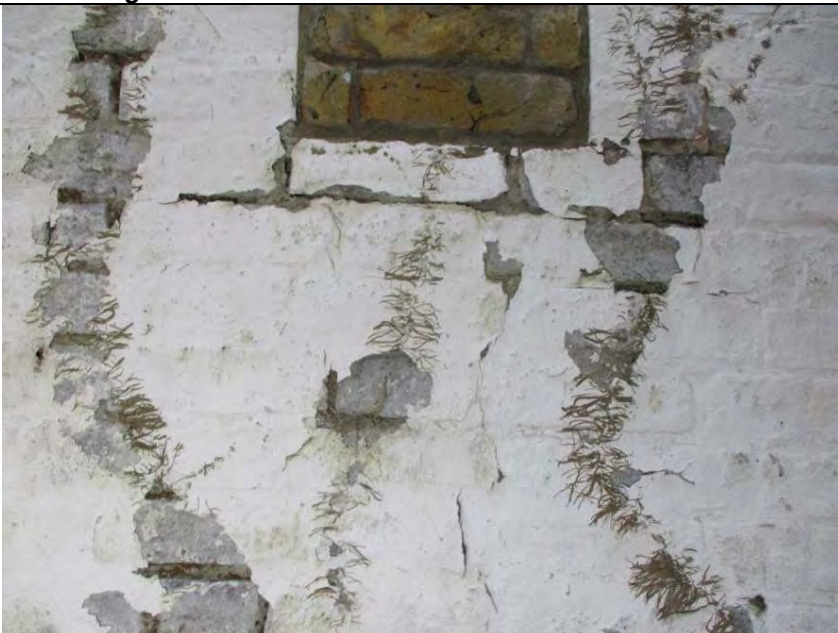
Rear (west) elevation showing the painted brickwork of the flat roof addition.

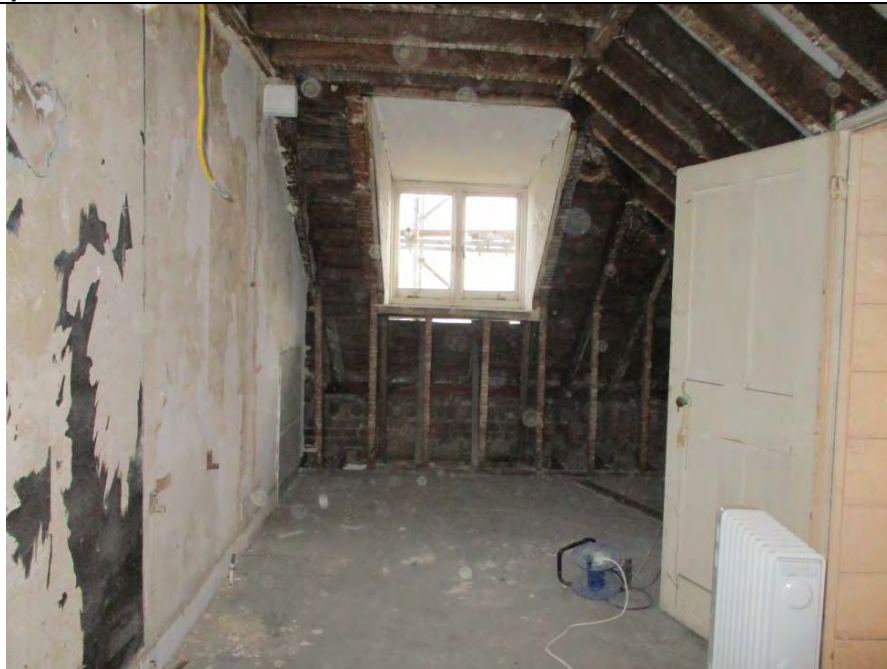
Room S1, looking east through room.

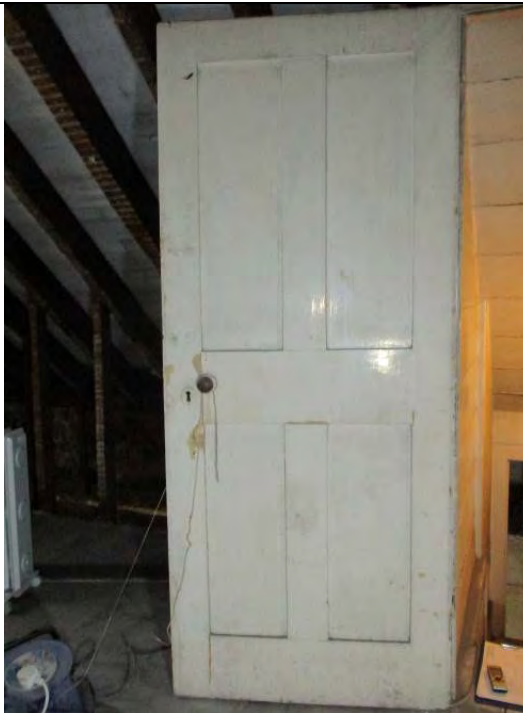
Room S1, showing four-panel internal door with key plate and handle to outer side of door.

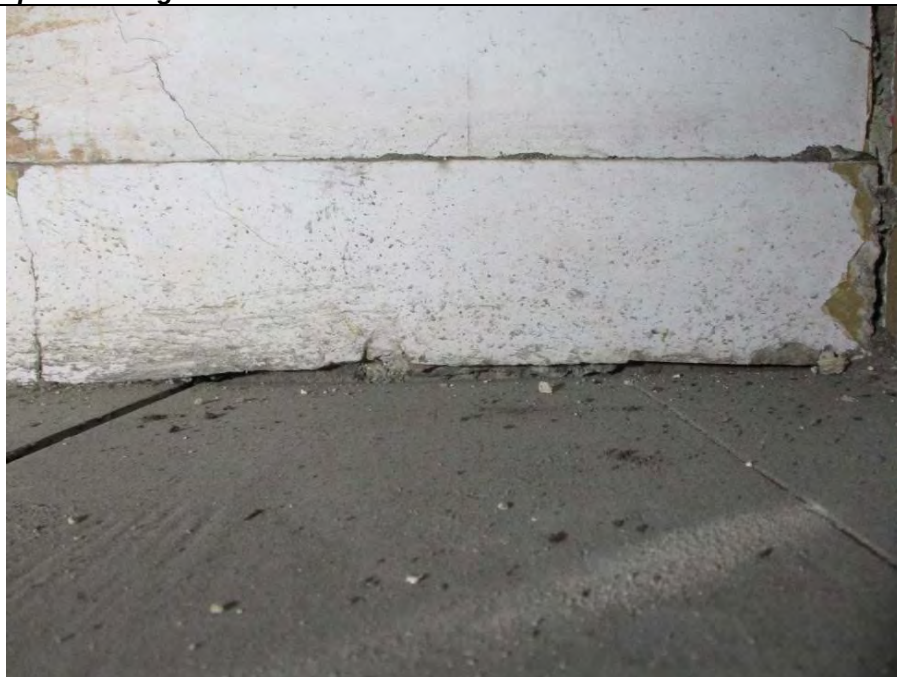
Room S1, showing plain (unprofiled) timber skirting.

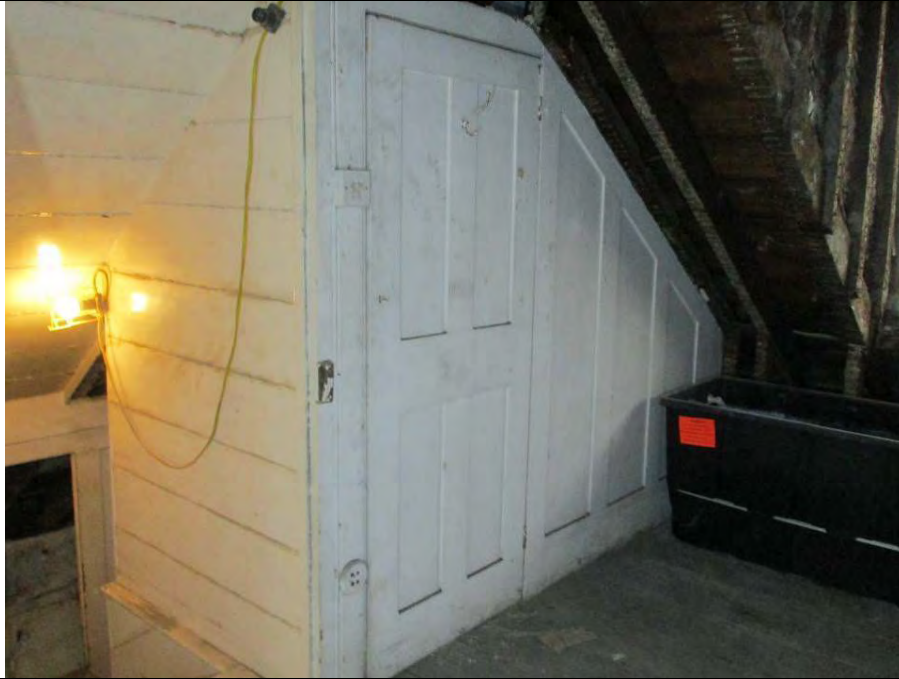
Room S1, showing room S1a as a timber built-in cupboard within the southwest corner of room.

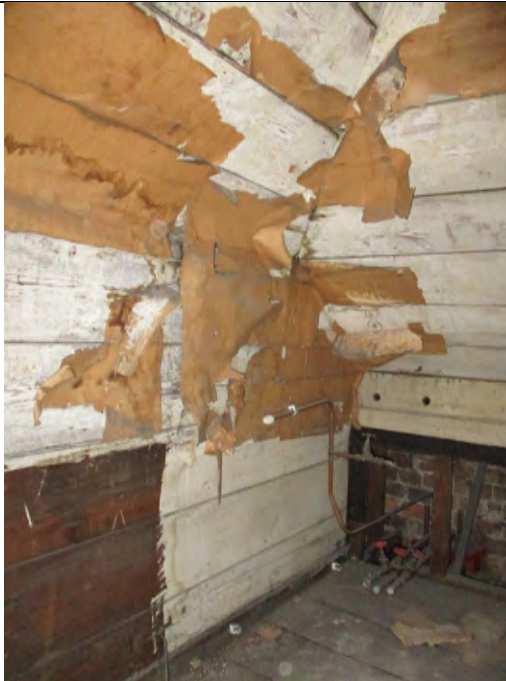
Room S1a, showing interior of cupboard which is lined with horizontal timbers. A lining paper had been stuck over the timbers and is peeling away.

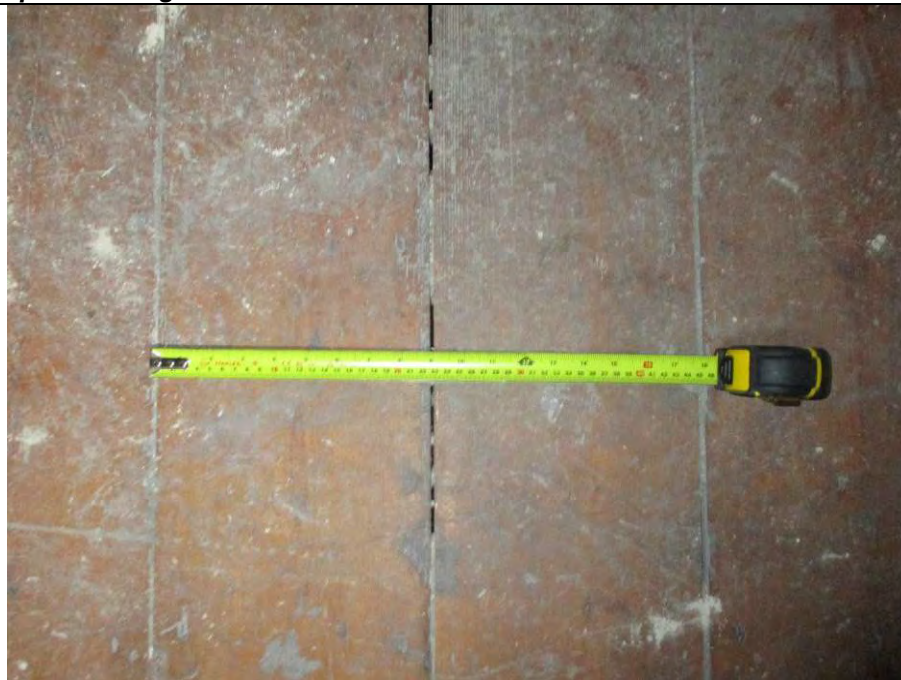
Room F1, showing floorboards. The width of the floorboards varies slightly being between 210mm-225mm (width).

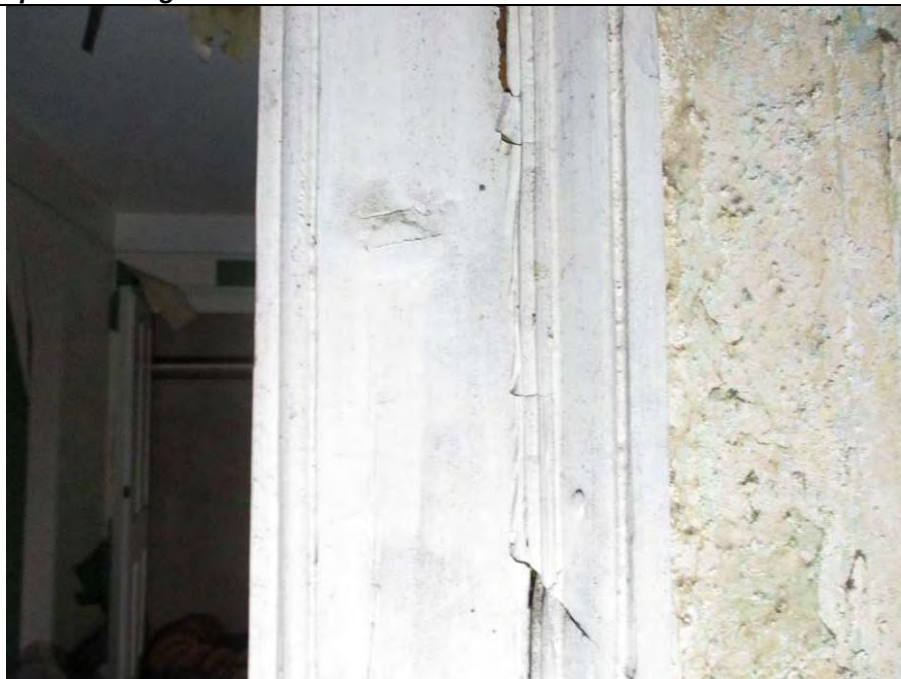
Room F1, showing the architrave detailing to the doorway into room F2. The architrave is formed of plain timber boards with applied beading.

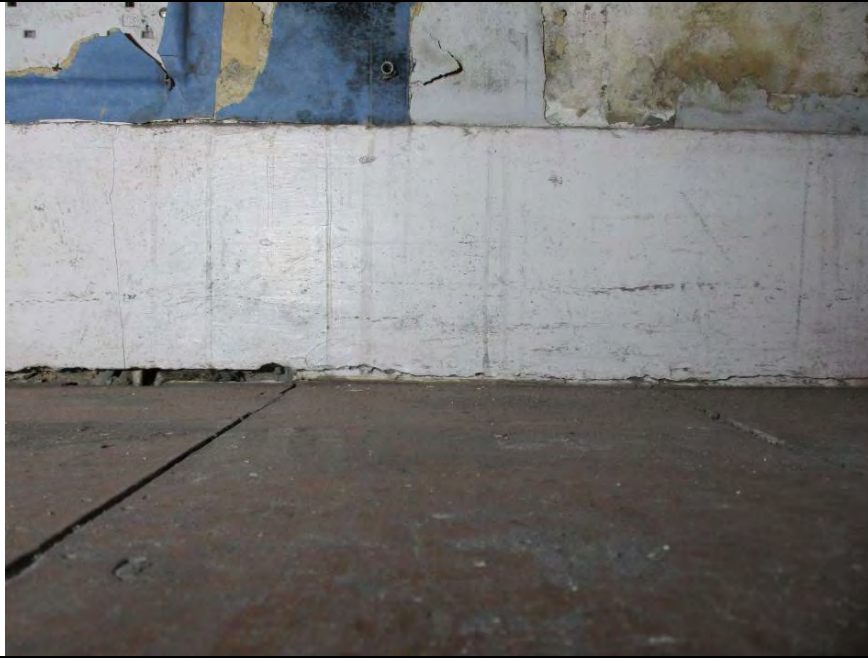
Room F1, showing skirting detail.

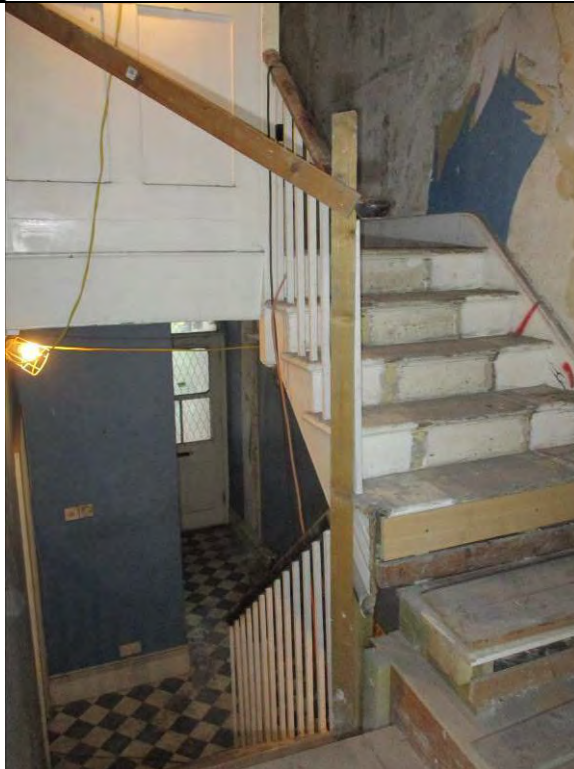
Room F1, showing the dogleg staircase of open string construction from the half landing up to the first floor.

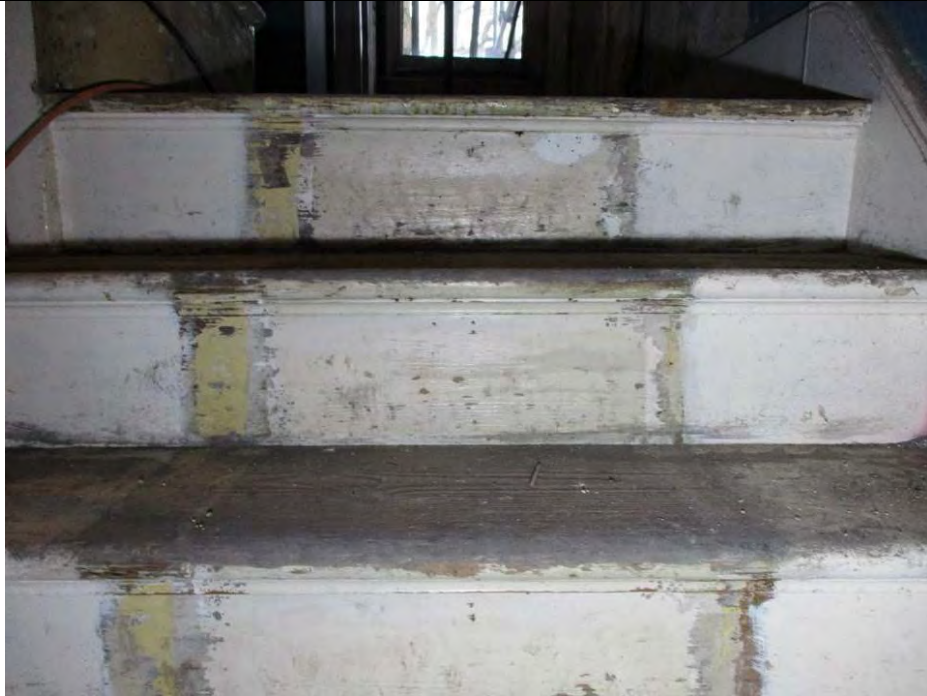
Room F1, showing the treads and risers to the staircase.

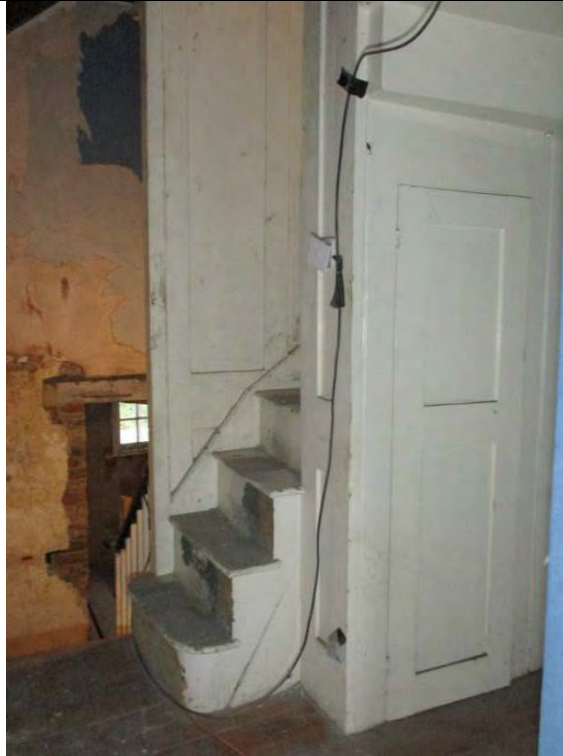
Room F1, showing the staircase between the first floor and attic (second) floor.

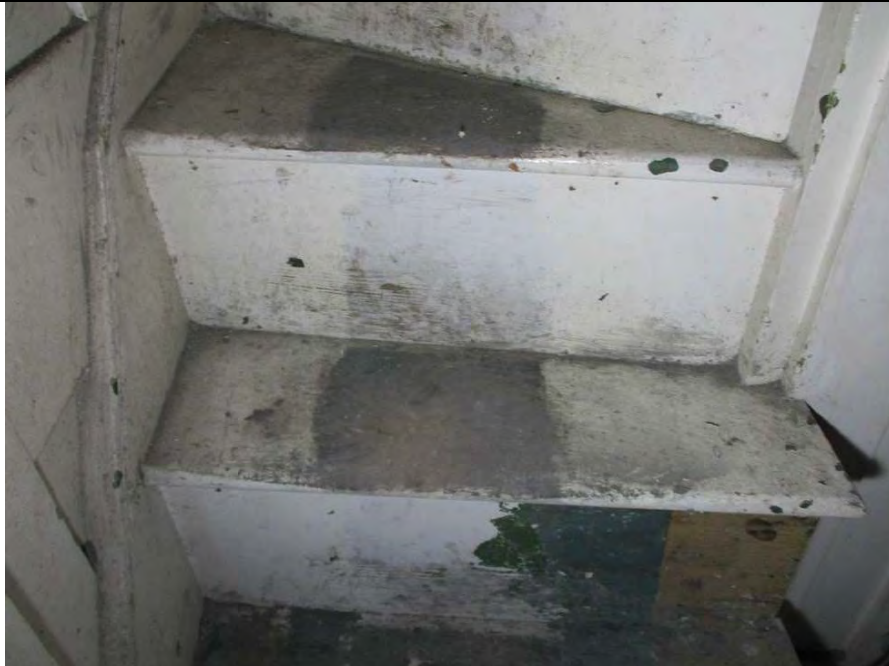
Room F1, showing the treads and risers to the staircase between first floor and attic (second) floor.

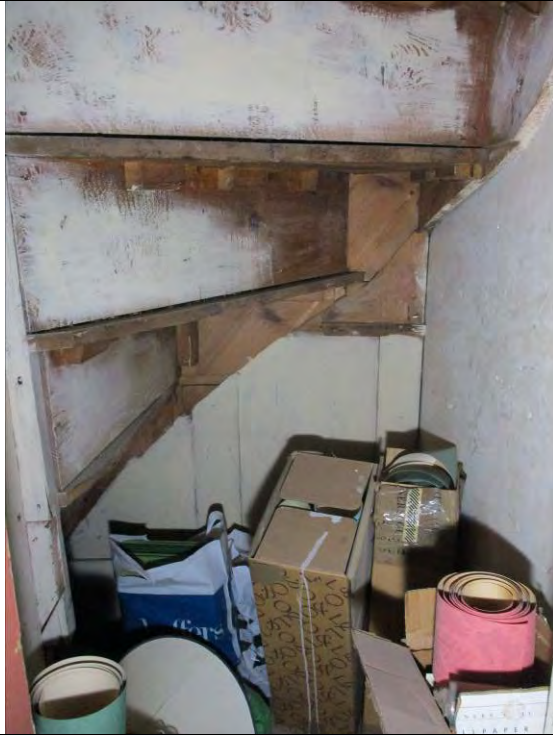
Room F1a, the cupboard under the staircase.

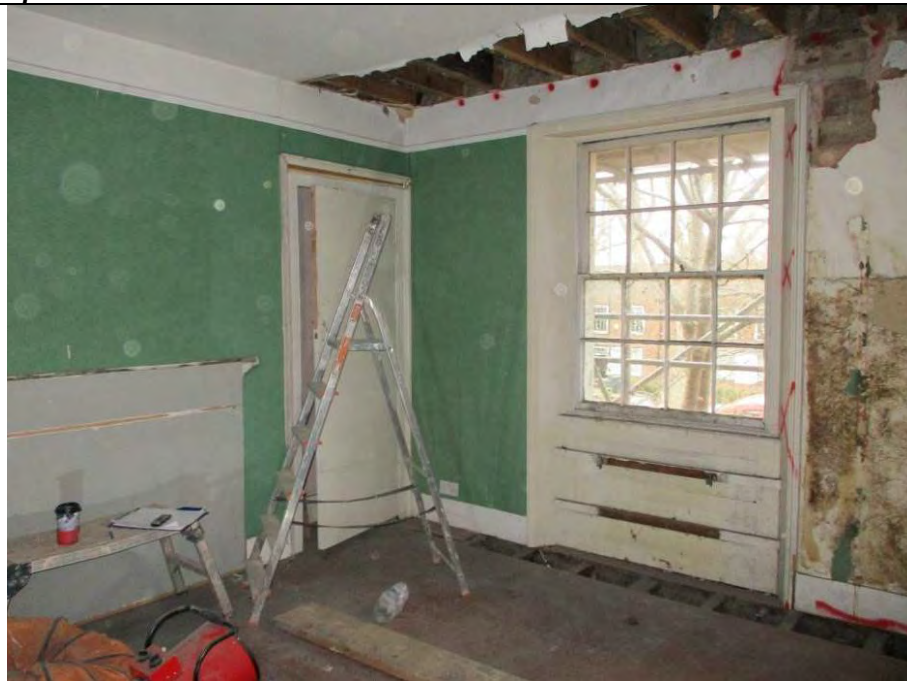
Room F2 looking west through room.

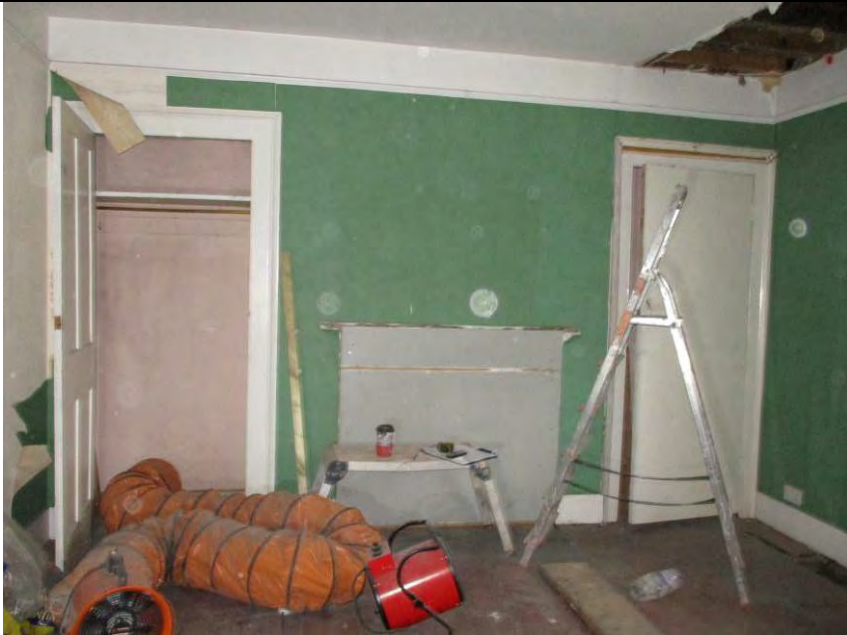
Room F2, looking north through room.

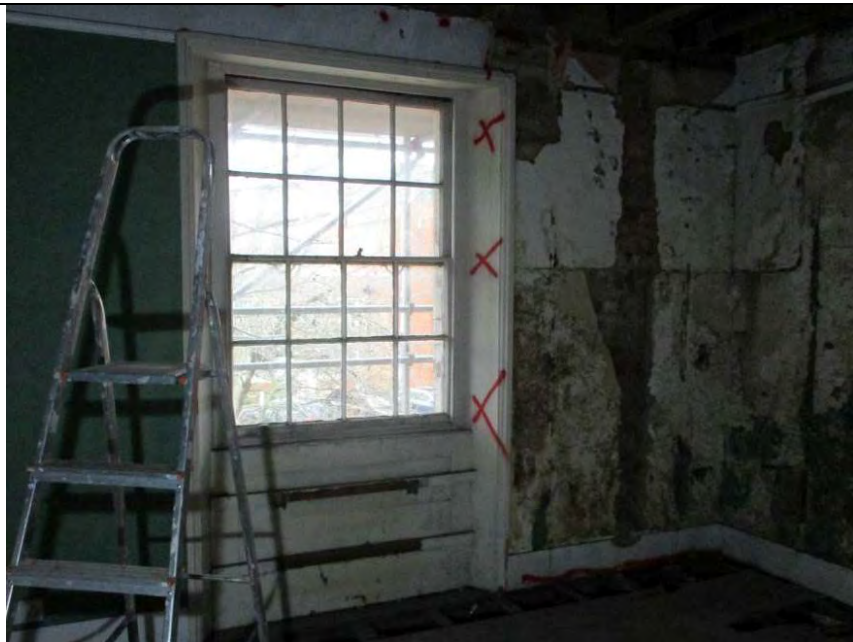
Room F2 looking east through room.

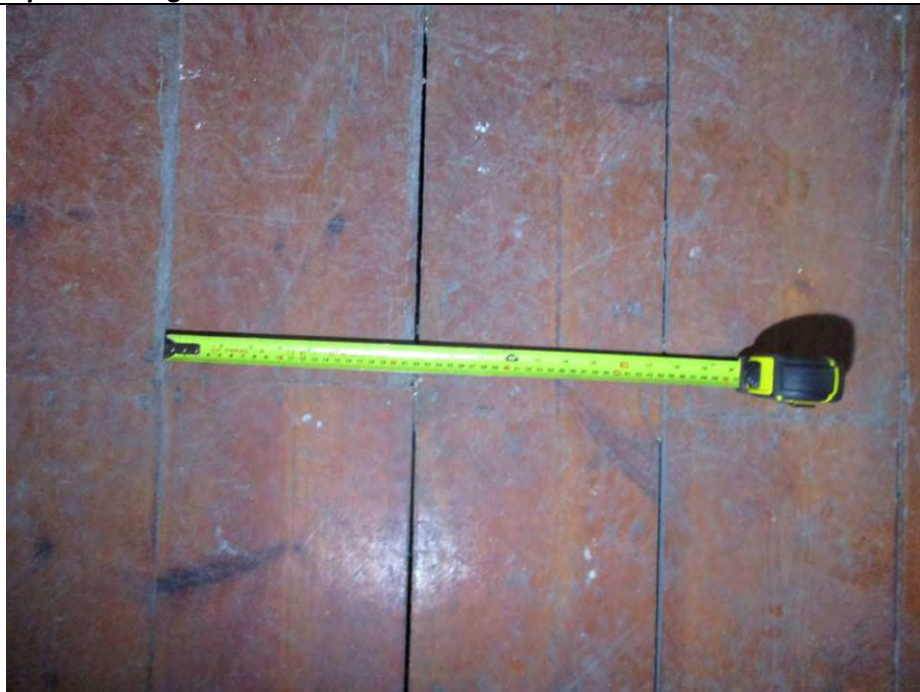
Room F2, showing floorboards.

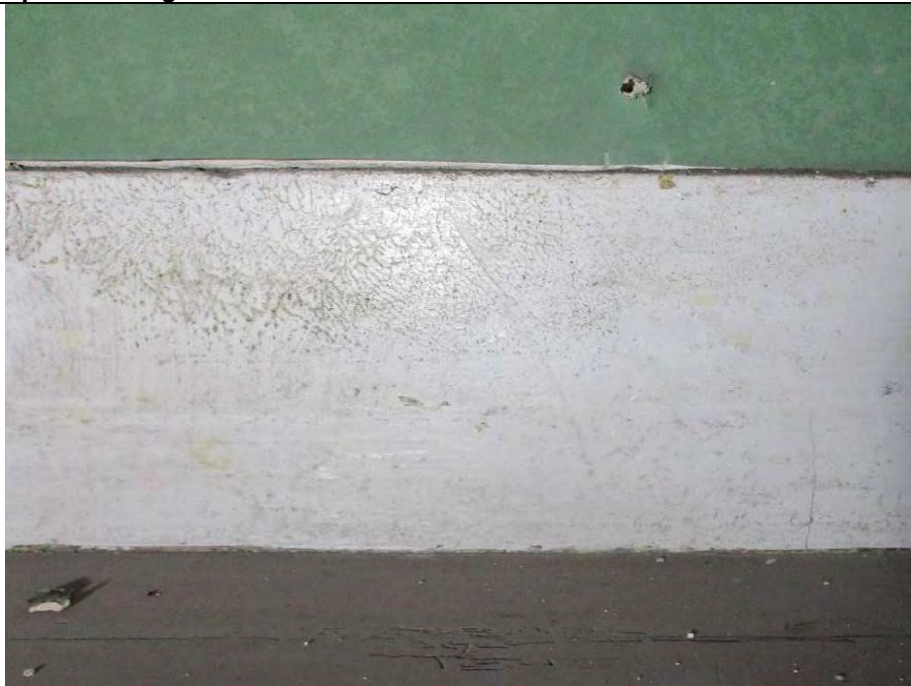
Room F2, showing skirting board detail.

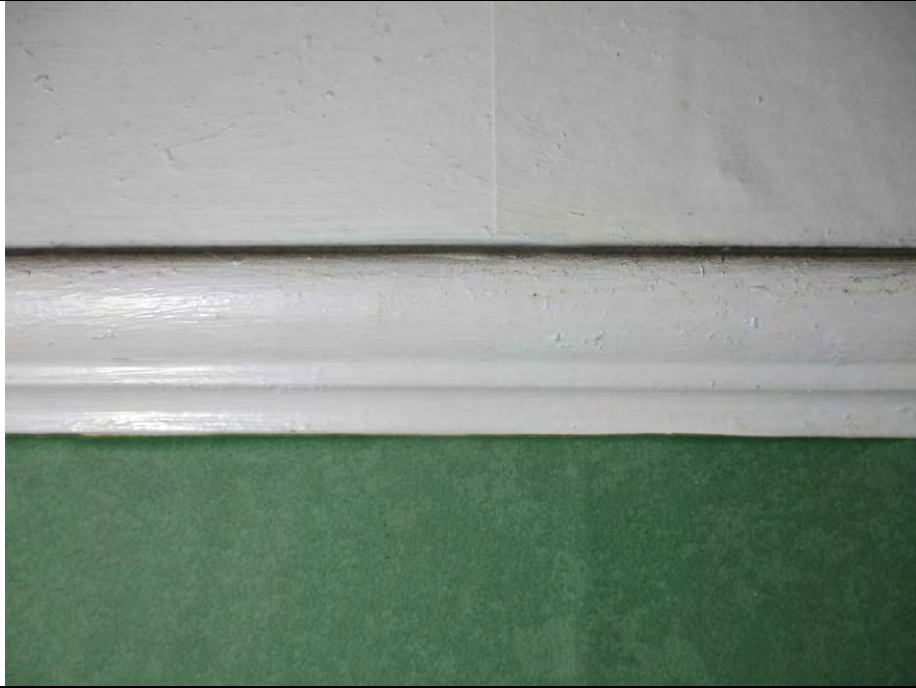
Room F2, showing picture rail detail.

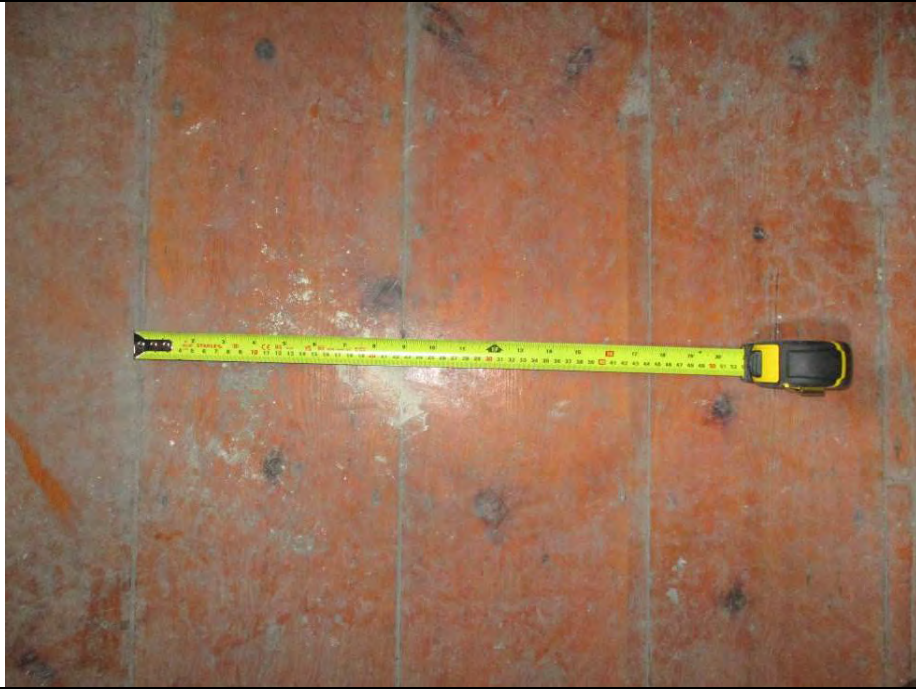
Room F3, showing floorboards

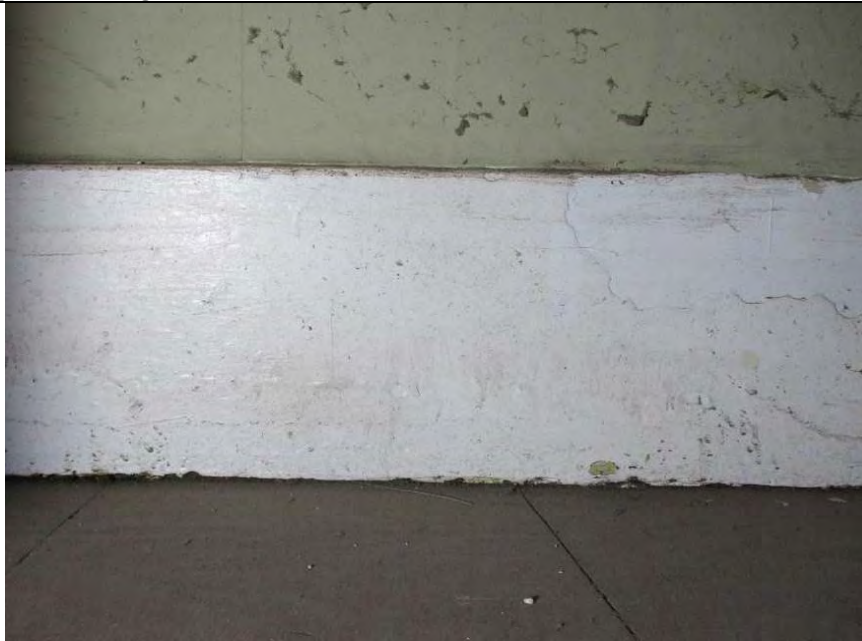
Room F3, showing skirting board.

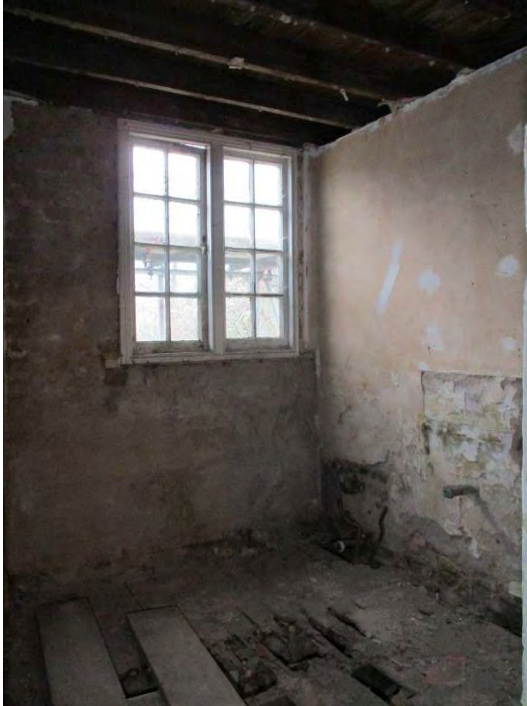
Room F4 looking west through room.

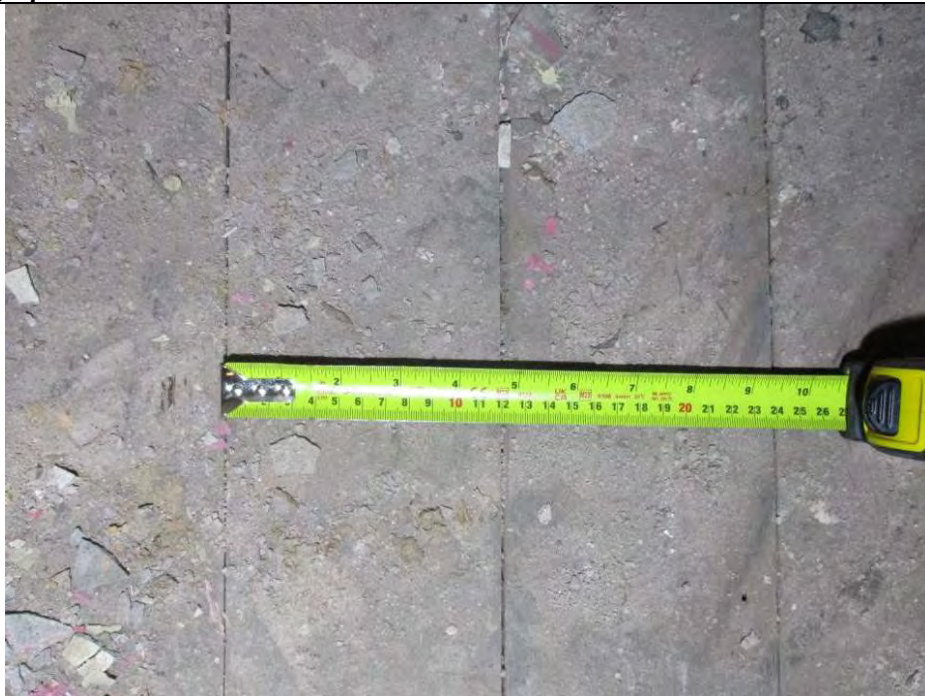
Room F4, showing floorboards.

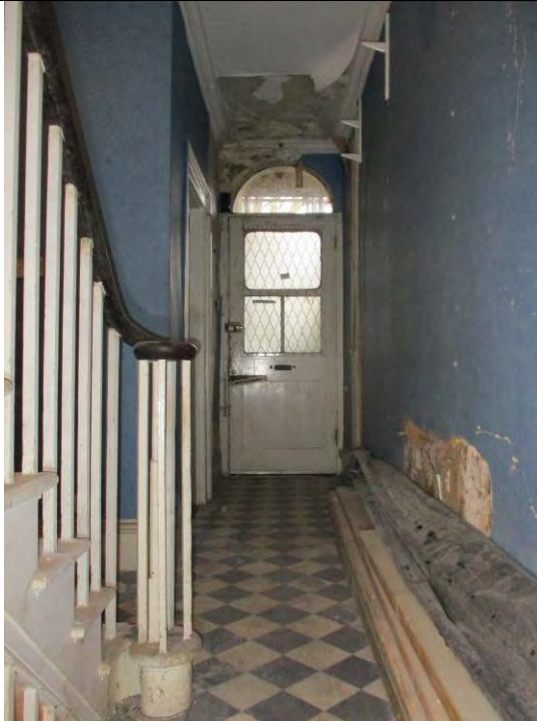
Room G1, looking east through hallway.

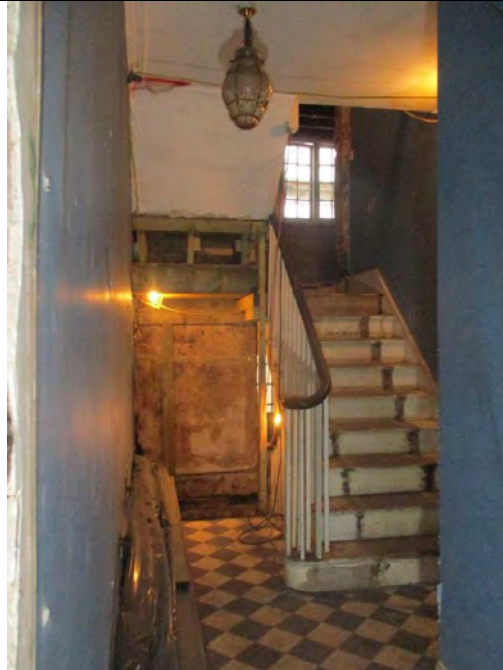
Room G1 looking west through hallway.

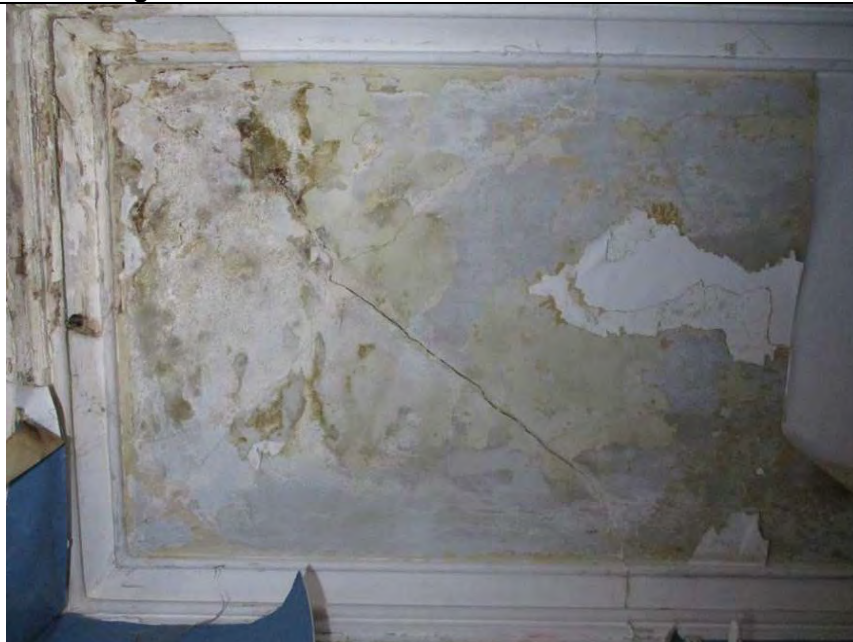
Room G1, showing plaster ceiling with cornice.

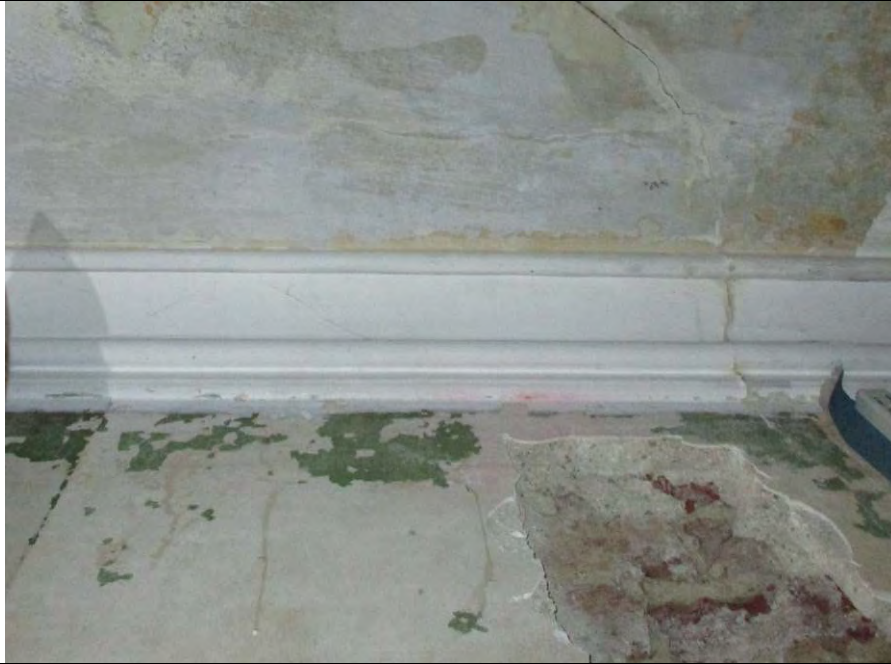
Room G1, showing cornice detail.

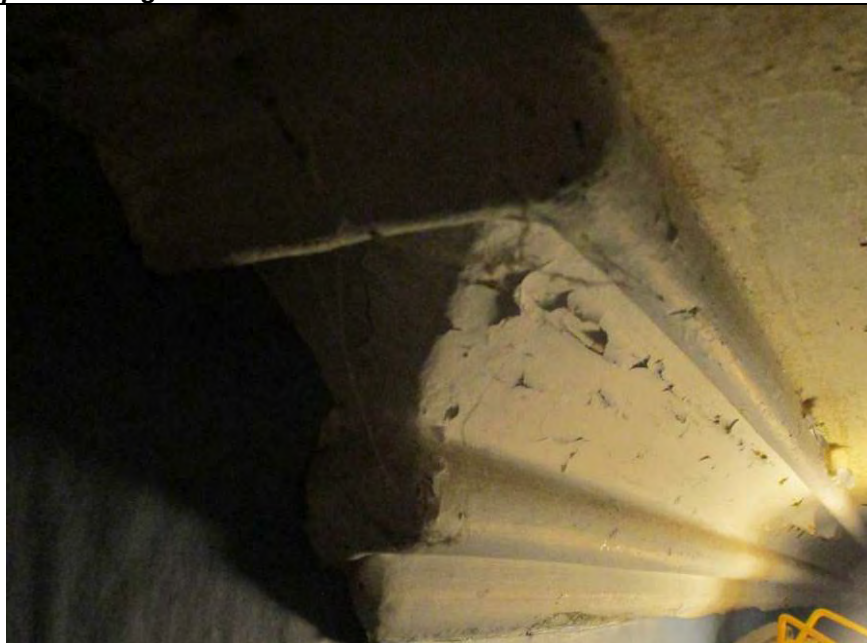
Room G1, showing cornice detail.

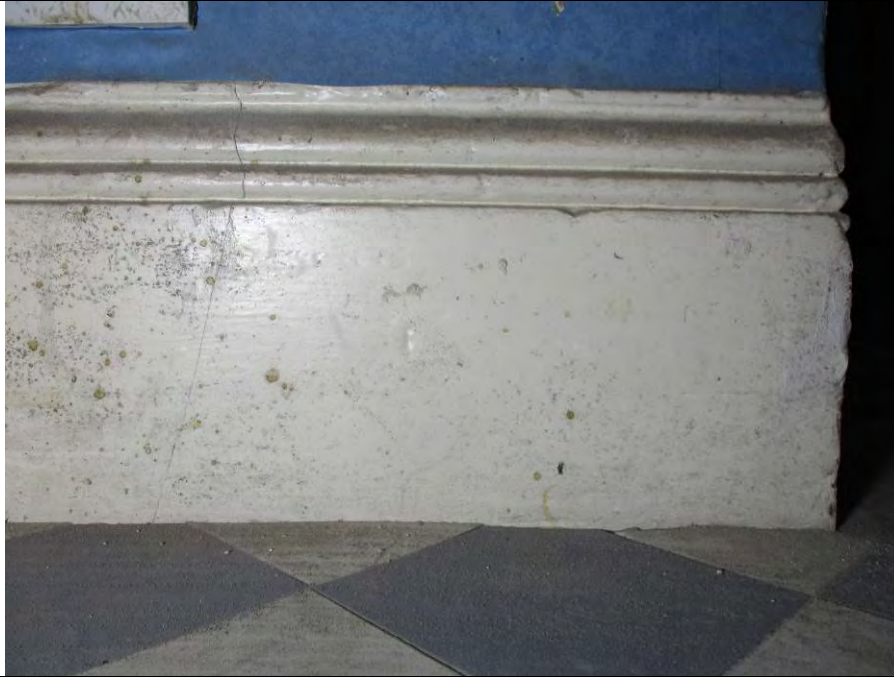
Room G1, showing profiled skirting.

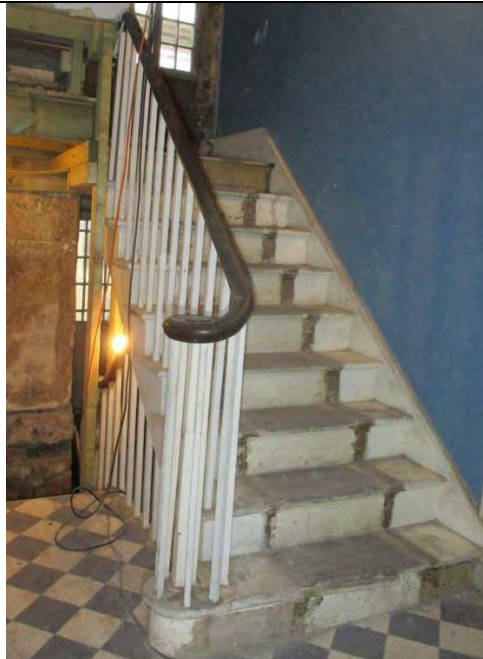
Room G1, showing staircase with curtail step to bottom of stair.

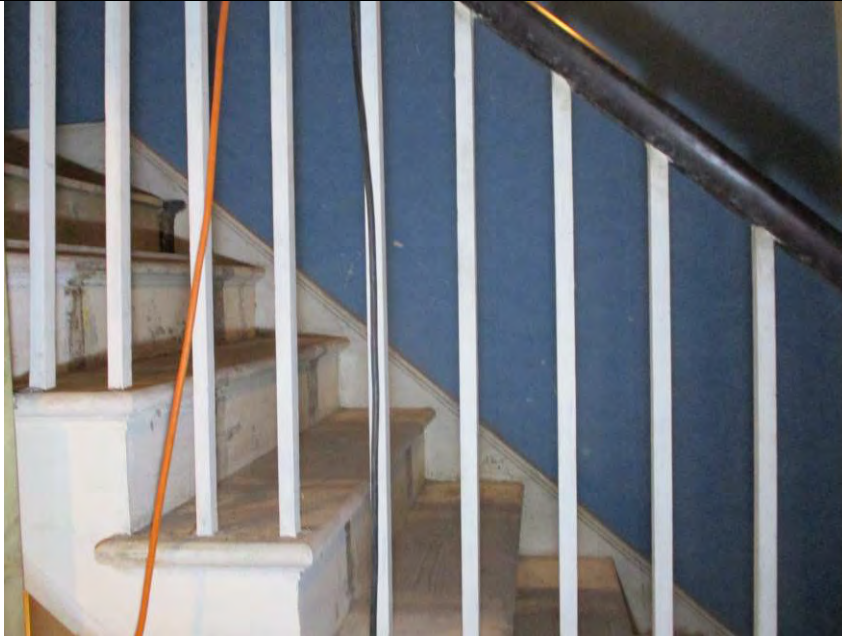
Room G1, showing open string staircase with stick spindles.

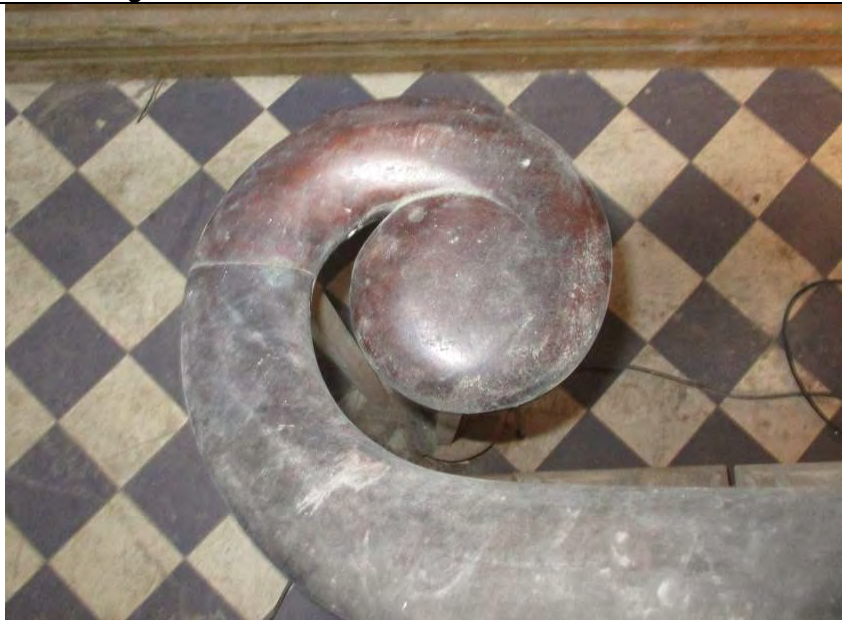
Room G1, showing the handrail detail at the curtail step.

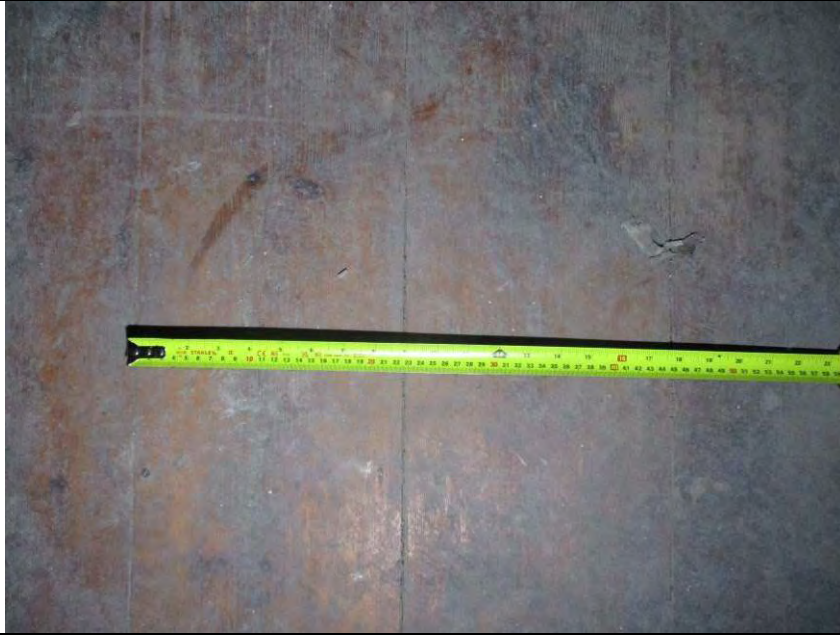
Room G2, showing floorboards.

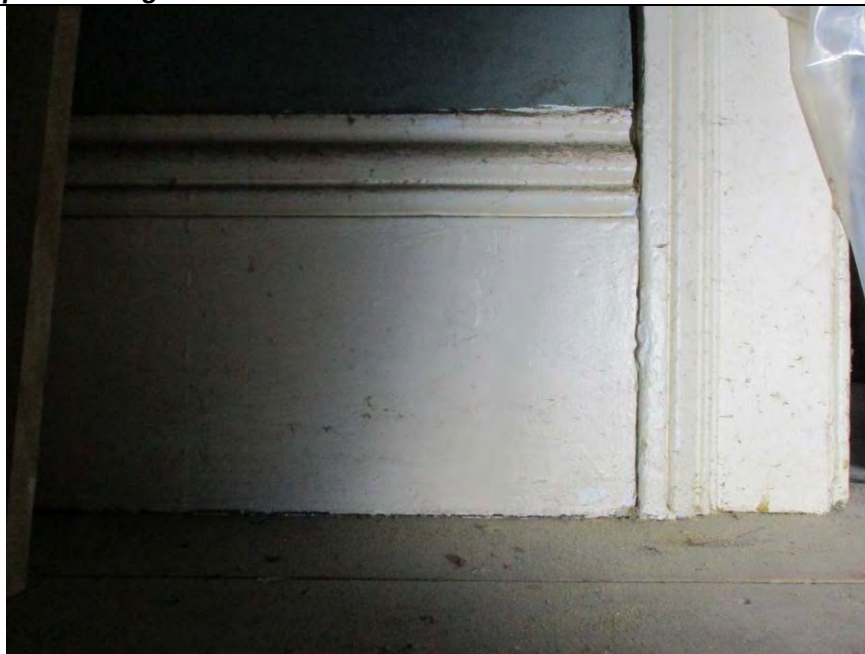
Room G2, showing the profiled skirting boards.

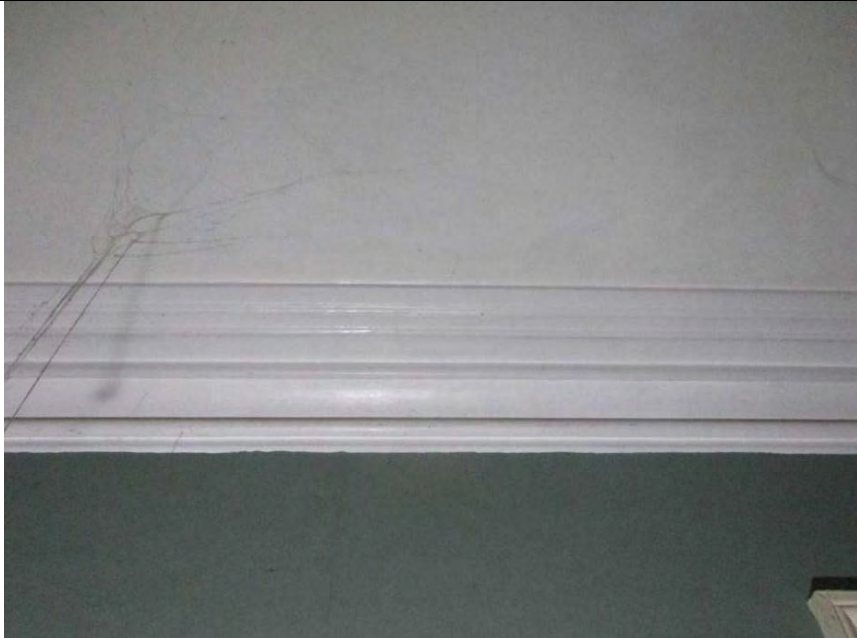
Room G2, showing cornice detail.

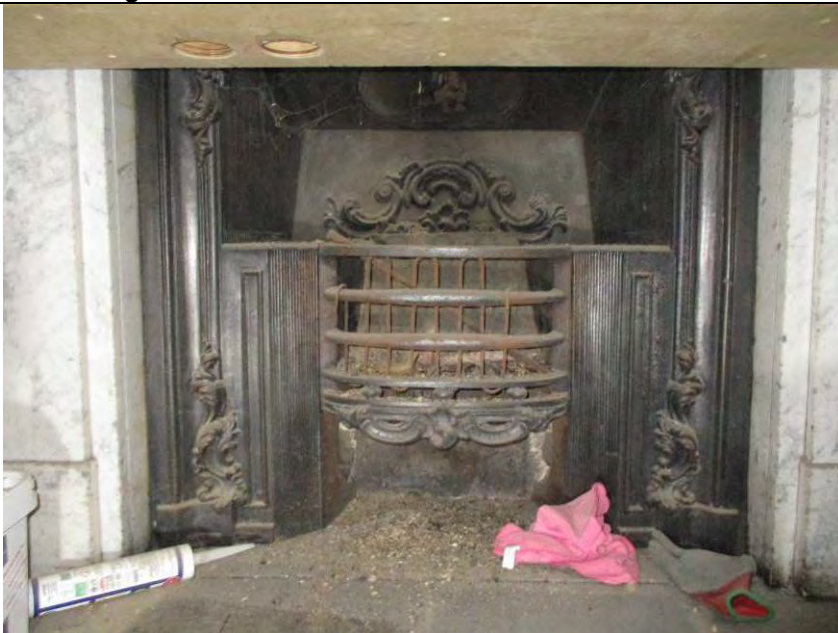
Room G2, showing cast-iron hob grate.

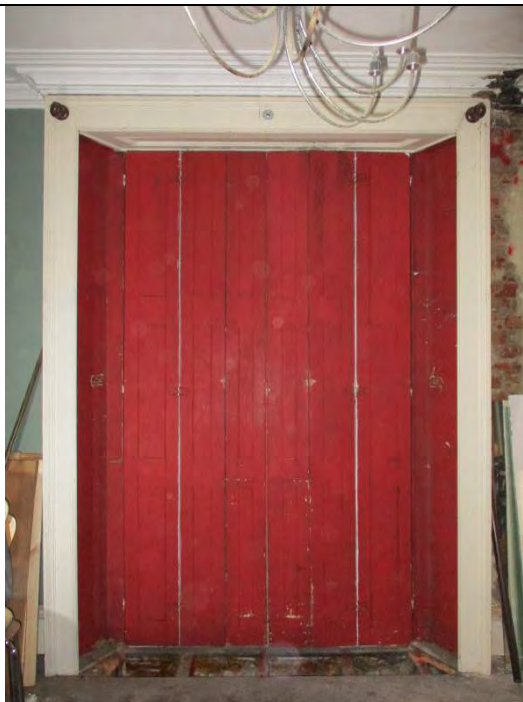
Room G2, showing panelled shutters to window.

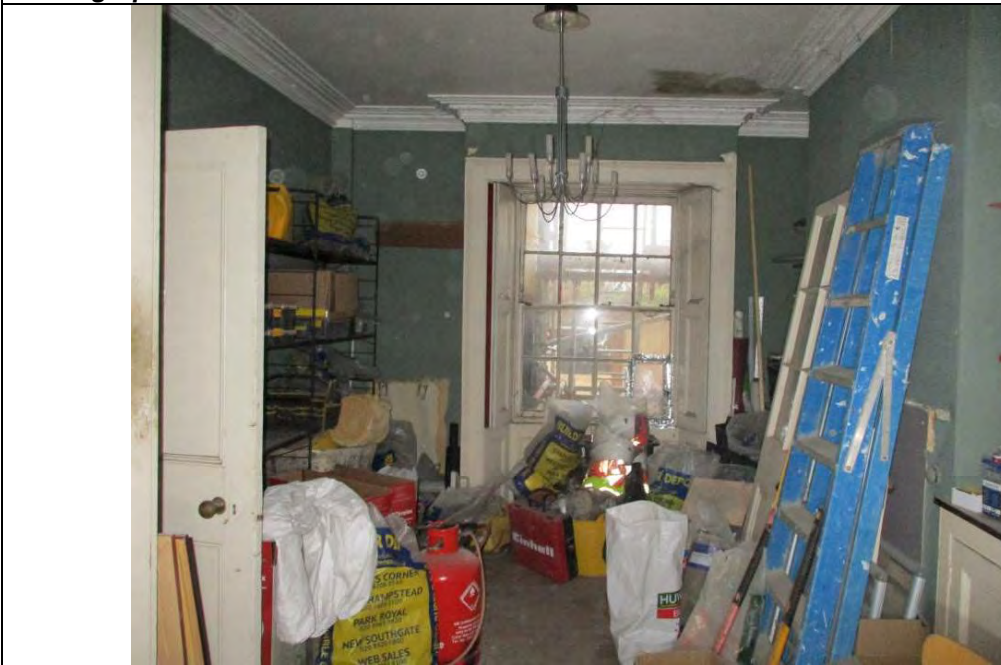
| <b>Additional comments</b> | Recorded in Winter 2024. The building has been vacant for around eighteen months and in a dilapidated and deteriorating state for at least a decade and this is reflected in the poor condition of internal fabric including damaged fabric.<br><br>Room difficult to record due to presence of stored items. |

Room G3, looking west through room.

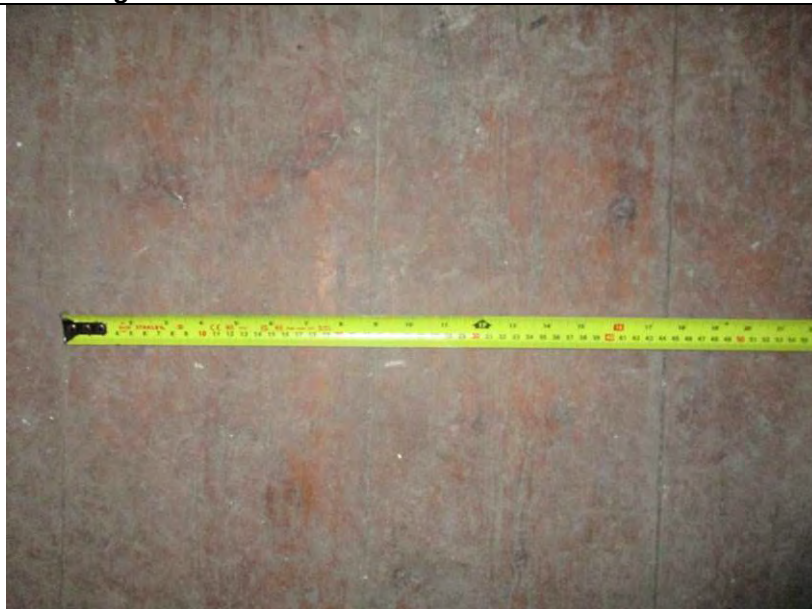
Room G3, showing floorboards.
