## LEVEL 2 HISTORIC BUILDING RECORD FOR 37 NORTH ROAD, HORNSEY

JOB NO. 162-58

DOUGLAS PASKIN, PKS ARCHITECTS

18 DECEMBER 2024

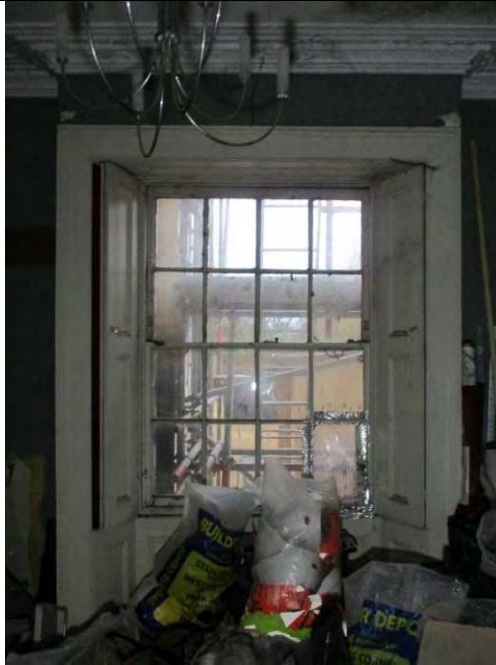
Room G3, showing window with splayed reveal and shutters.

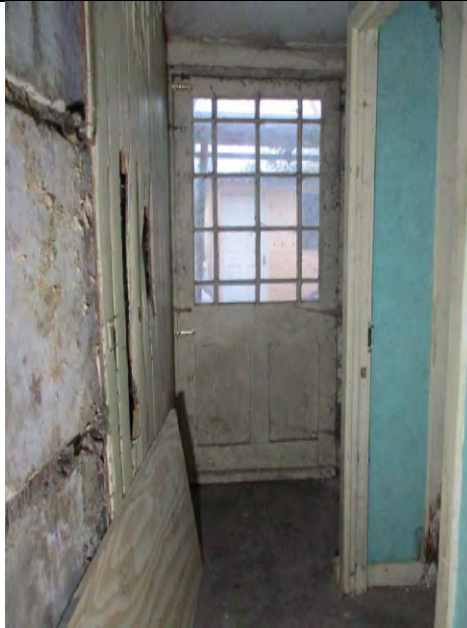
| <b><i>Additional comments</i></b> | Later addition.<br><br>Recorded in Winter 2024. The building has been vacant for around eighteen months and in a dilapidated and deteriorating state for at least a decade and this is reflected in the poor condition of internal fabric including fabric damaged by water ingress. |

Room G4, looking west through back hallway.

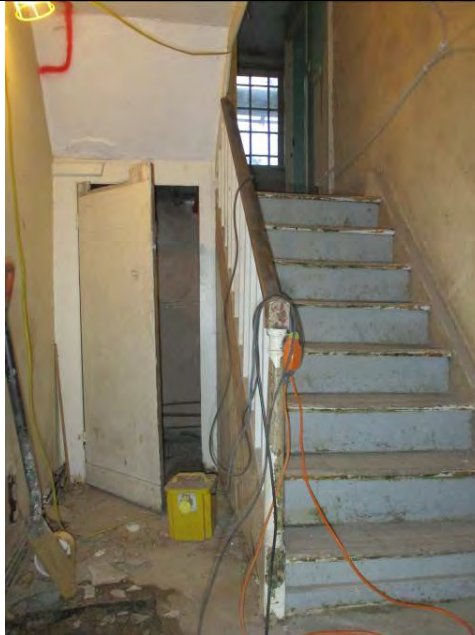
| <b><i>Walls (incl. skirtings) (N/E/SW)</i></b> | LG1 as decorate plaster to brickwork with evidence of gypsum plaster to walls. Skirting missing. LG1a and LG1b as undecorated gypsum plaster. |

Room LG1, looking west towards staircase.

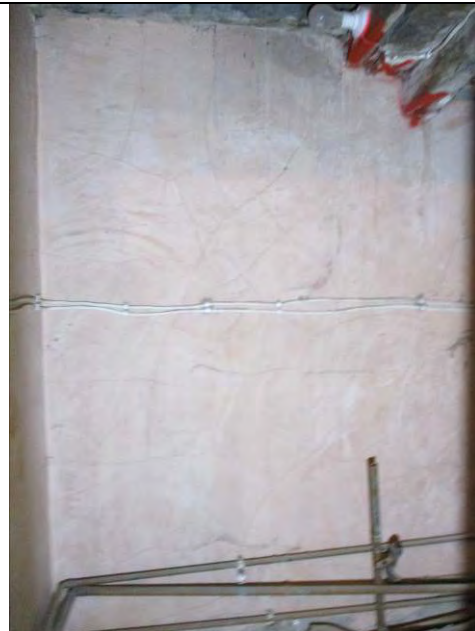
Room LG1a, looking into understairs cupboard.

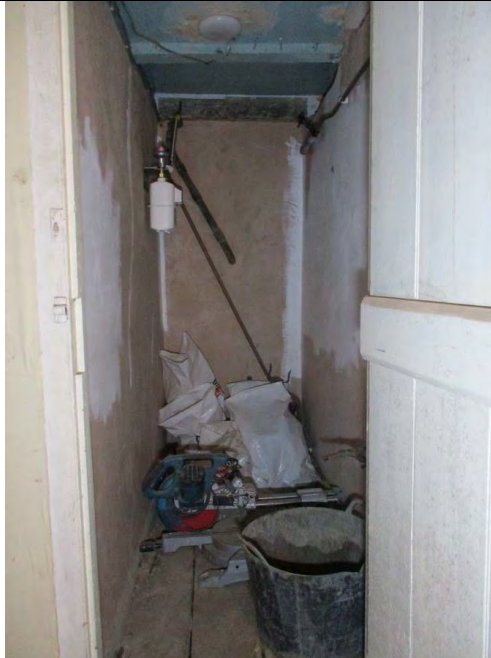
Room LG1b, showing the cupboard with undecorated gypsum plaster wall finishes.

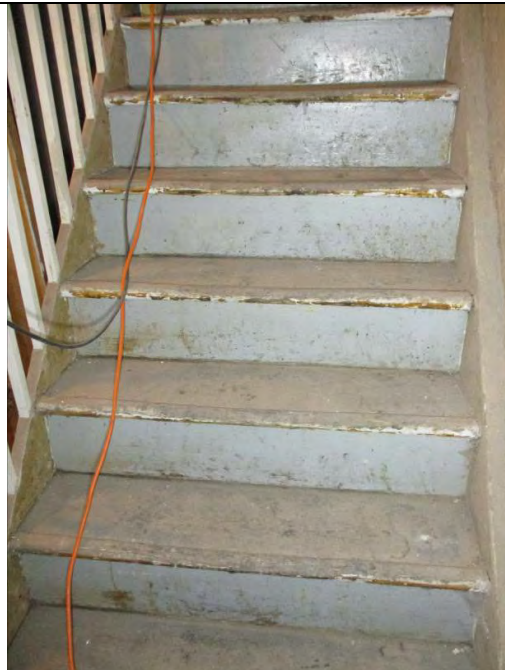
Room LG1, showing staircase (lower flight) between ground floor and lower ground floor.

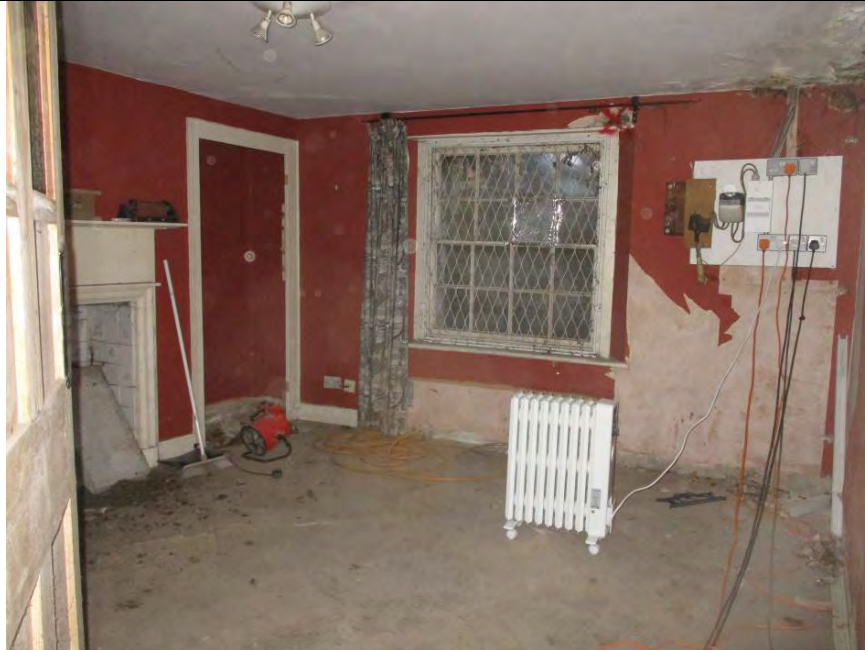
Room LG2, looking east through room.

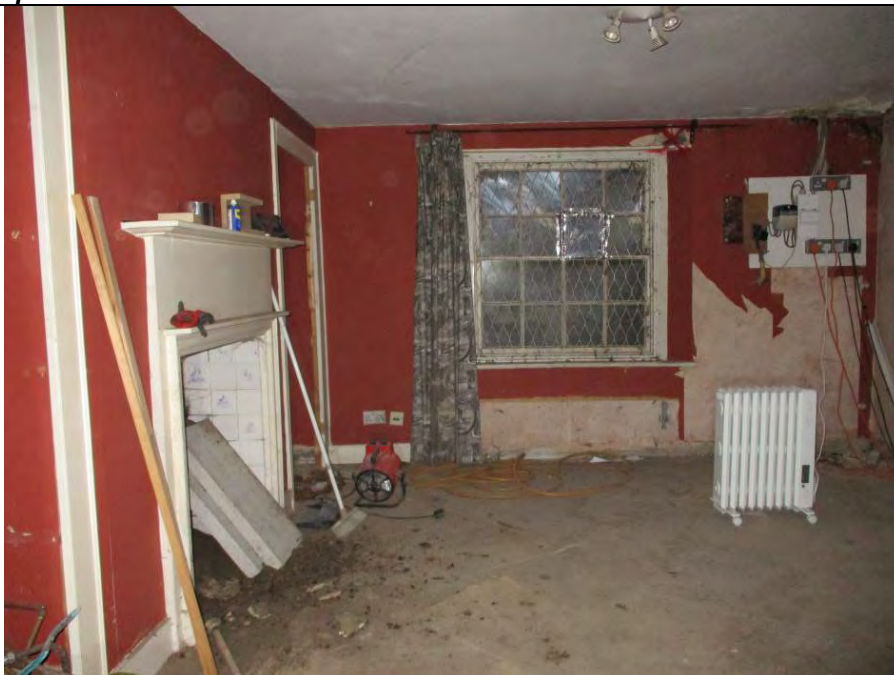
Room G1 looking east through room.

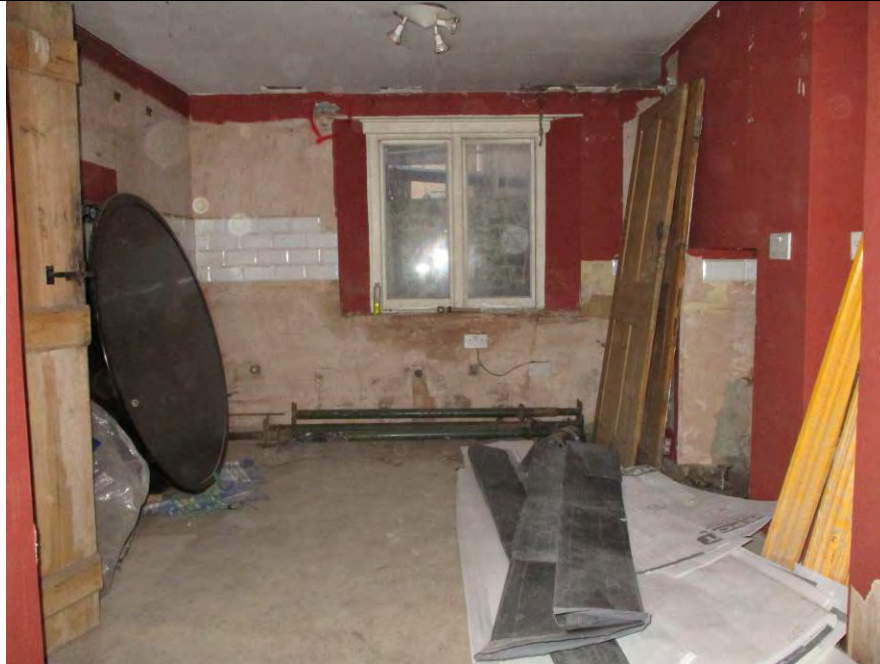
Room LG3, looking west through room.

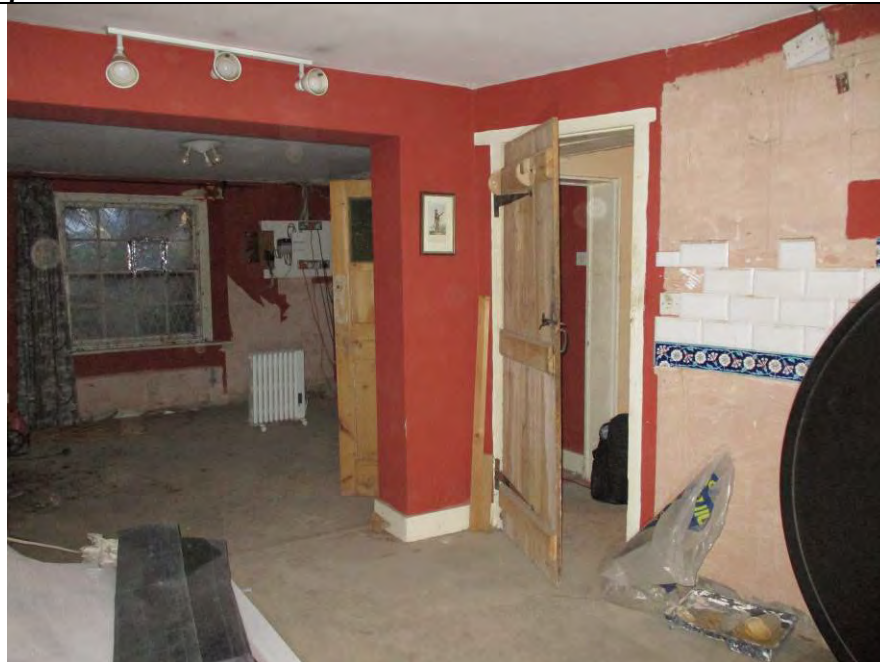
Room LG3, looking southeast through room.
