METHOD STATEMENT  
FOR  
REMEDIAL STRUCTURAL WORKS  
DUE TO DRY ROT

37 NORTH ROAD,  
LONDON  
N6 4BE

17<sup>th</sup> February 2025

PROPOSED MEASURES TO  
ERADICATE DRY ROT IN THE  
PROPERTY

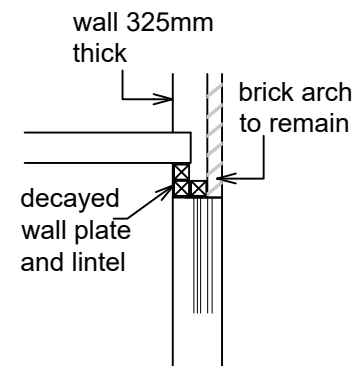
SECTION F - F  
EXISTING

decayed joist cut back to good portion  
and paired with a similar joist, with  
lap equal to  $\frac{1}{3}$  of the length of the joist.  
Joists bolted together using M6 bolts  
at 250mm c/c and staggered.

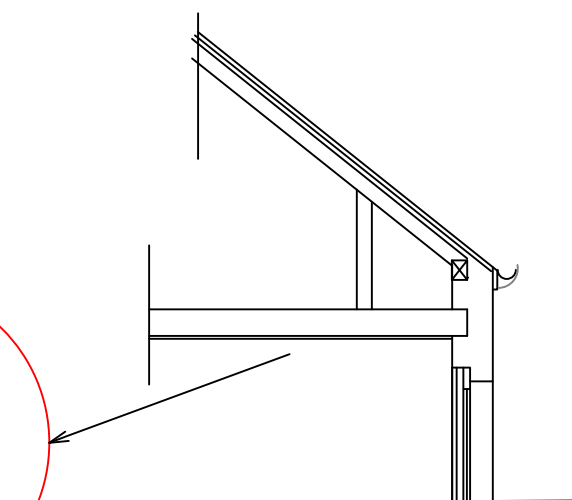
SECTION E - E  
EXISTING

Some of the wall plates under floor joists and under the roof rafters have deteriorated due to dry rot. Only one area of the building to be worked on at any one time.

- a) Temporary support all the joists where the wall plate has deteriorated.
- b) Carefully remove the wall plate without disturbing the surrounding brickwork, one course of brickwork may have to be removed to insert the new wall plate.
- c) Make good the brick course where the new wall plate will be positioned.
- d) Insert the wall plate with DPM wrapped on the three sides touching the brickwork.
- e) Rebuild the brickwork on top of wall plate and rebuild any loose brickwork in the area.
- f) Provide mild steel galvanised straps tying the wall plates to the brick wall below (Section E-E).
