## ADDENDUM TO HERITAGE STATEMENT

### LAND ADJACENT 2 KINGS ROAD, TOTTENHAM

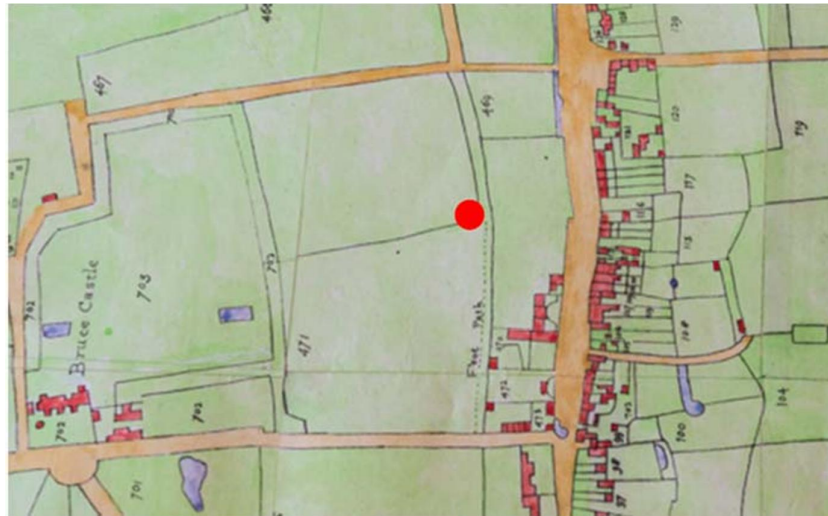
Figure 1. 1798 Wyburd Map (Historic Building Studio Heritage Statement Figure 3).

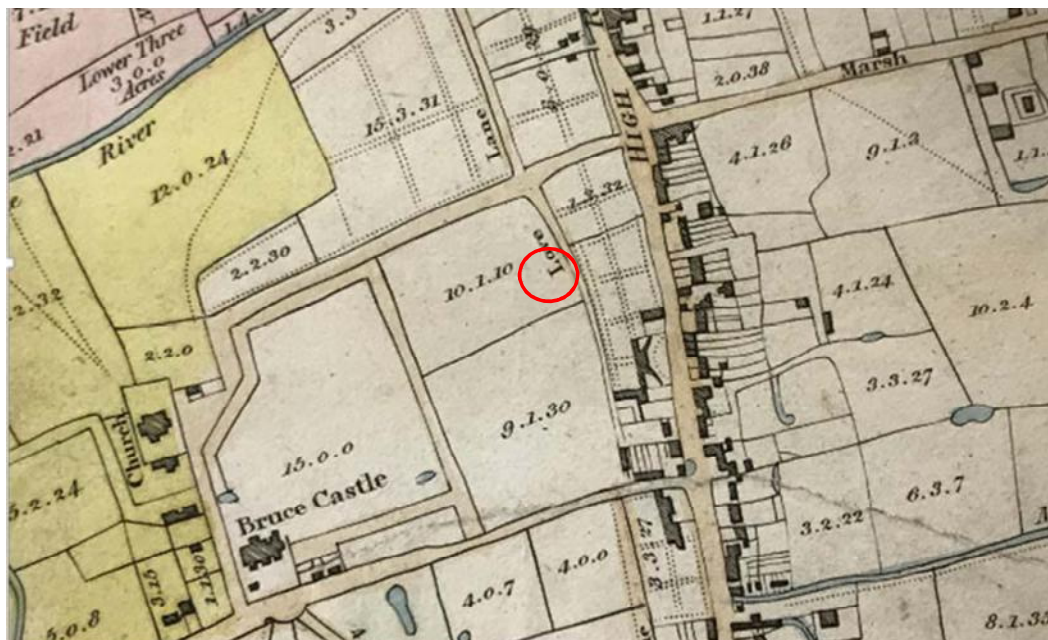
Figure 2. 1798 Jonathon and William Newton survey published in Robinson's History and Antiques of Tottenham 1818. Shows the development of the High Road frontage (Bruce Castle Archive)

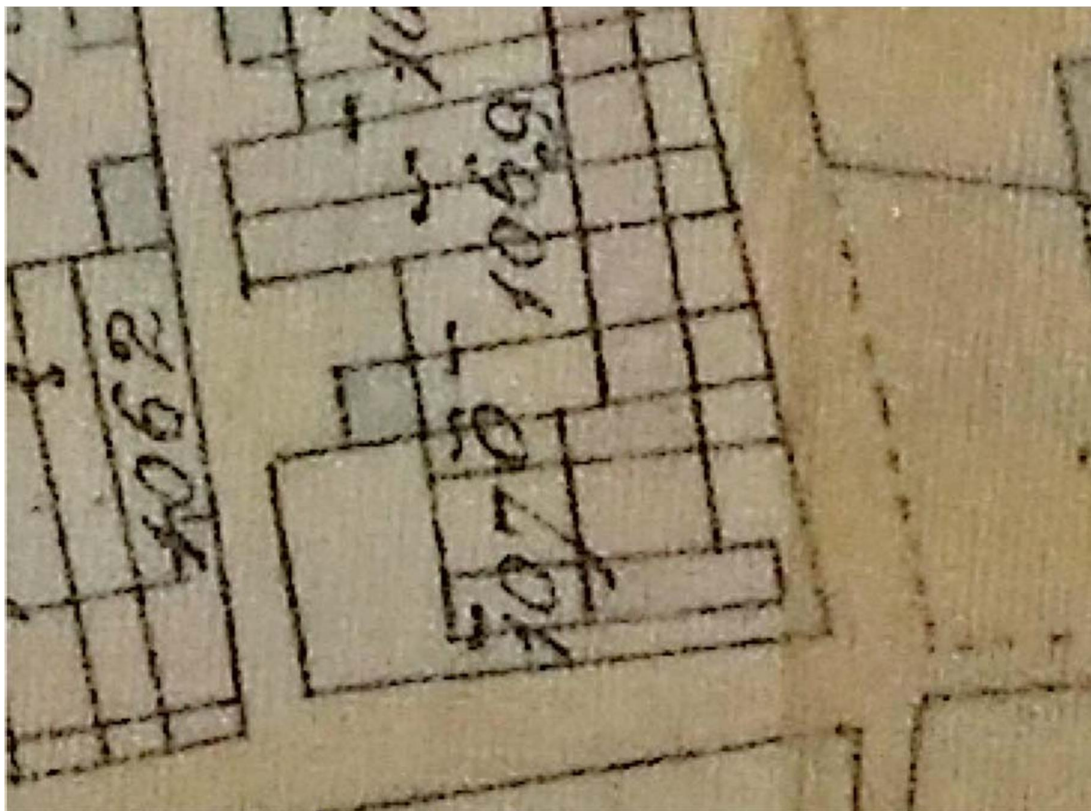
Figure 3. 1844 Tithe Map (Bruce Castle Archive)

- 1.4 The 1844 garden subdivisions are fragmentary but can still be identified. The outer garden wrapped around three properties in the same ownership.

- 1.5 The 1844 map indicates that the initial house was a simple rectangle. The brick of the extension differs (see below) and it is therefore likely that the kitchen and service areas were originally within the basement/lower ground floor, like Georgian townhouses elsewhere in Tottenham.

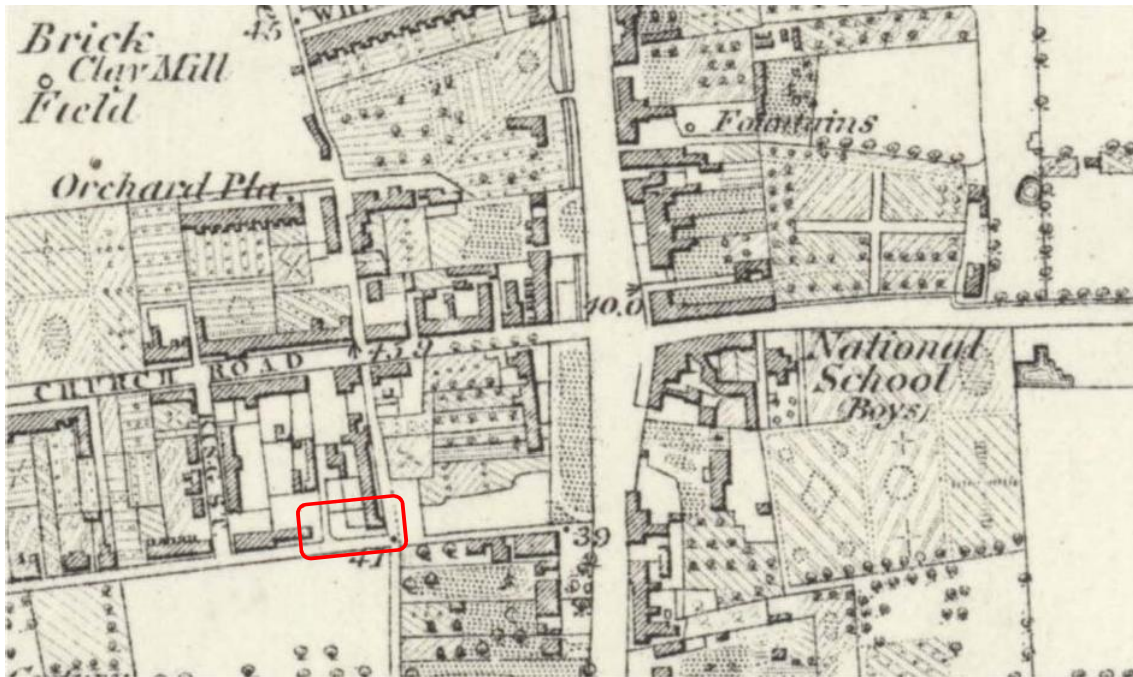
Figure 4. 1873 Ordnance Survey Map. Surveyed 1863 to 1869. 6 inch. Shows context and gardens.

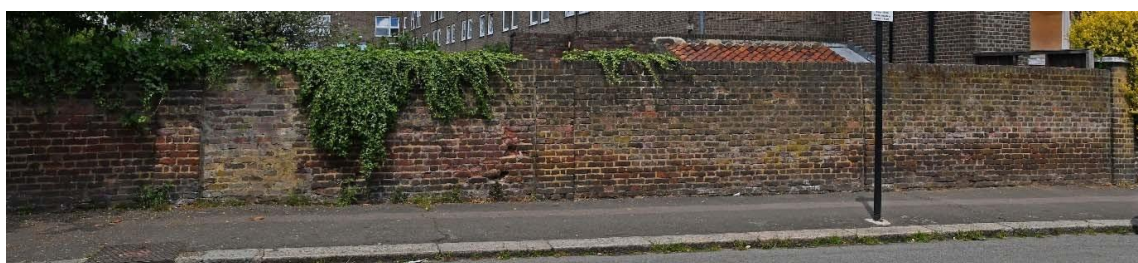
*Figure 13. C19 roadside boundary wall (1). The blocked opening is towards the left.*

- 2.4 The Mid C19 roadside and west boundary wall (1) has Medium historic interest. Its interest derives from being contemporary with the service wing, showing the historic enclosure of properties, and it has a distinctive layout. Loss of interest derives from its alterations, which include that it is repointed with C20 cement pointing and the top is rebuilt. It has Medium architectural and artistic interest as it is a good example of C19 enclosure and is built in flemish bond like the main house. It is of Medium value overall and not of sufficient quality for listing in its own right. For the purposes of this assessment the former unauthorised opening is not taken into account. This is marked pink in Figure 12 and visible as a blocked opening in poor quality brickwork.

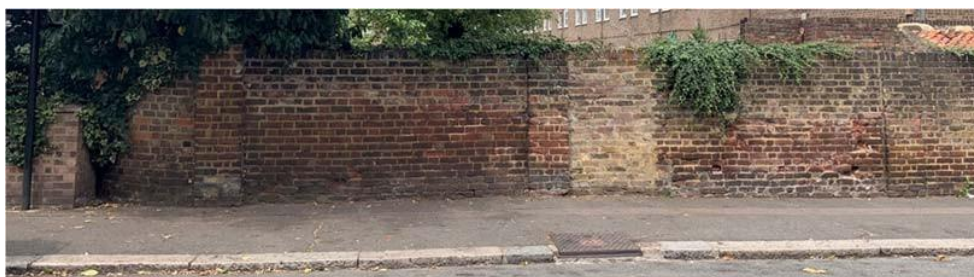
*Figure 14. Western end of C19 roadside boundary wall (1) showing the curved corner.*

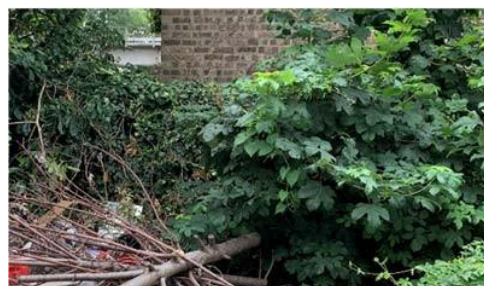
*Figure 15. Typical West boundary (4) to (1)*

- 2.5 The western boundary is hidden by undergrowth and the modern neighbouring wall. Allow for this to be similar in age, survival and significance to the roadside boundary as the visible ends are similar. It is likely to be in poorer condition due to the longstanding plant growth.

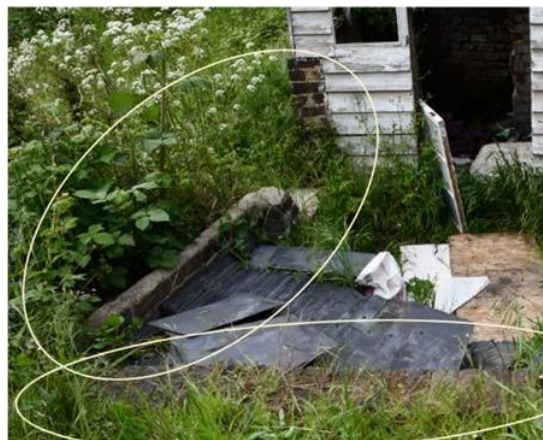
*Figure 16 (right). C19 fragments of boundary wall 2 to 12 courses high (circled).*

- 2.6 The eastern boundary is partly open between (1) and (2) and also has some low level fragments of C19 wall, which are likely to be curtilage listed. The remnants were capped and altered in cement to form a terrace edge and plinth to the C20 shed.

- 2.7 The fragments follow the alignment of the historic boundary of the house but are not shown on OS maps from mid C20. They do not add significantly to historic interest and understanding as they are not continuous and have been substantially altered. The remnants have low historic interest and no architectural or artistic interest, so are of Low / Neutral significance.
- 2.8 The eastern boundary between 2 and 3 follows a mapped C19 boundary line, but visibly dates from late 20/early C21. Internally the face is in flettons in stretcher bond and a hard cement mortar. Position 2 abuts the C20 shed and a C19 and C20 offset brick wall.

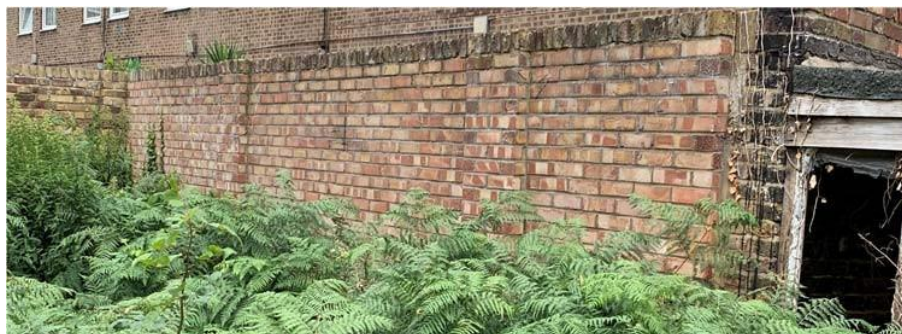
*Figure 17. Late C20/early C21 Eastern boundary from shed to corner.*

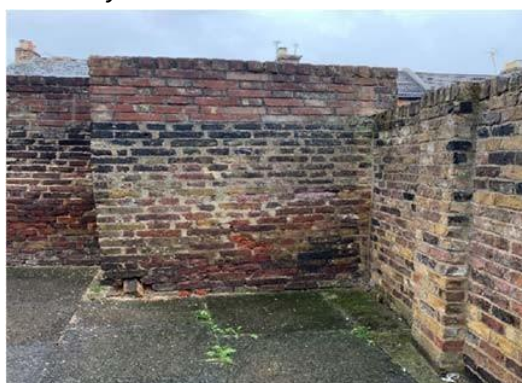
*Figure 18 (right). External face of Late C20/Early C21 Eastern boundary (right).*

*(centre and left) Curtilage listed historic wall forming north boundary of 2 Kings Road. This curtilage listed wall is to be propped and protected as part of a Party Wall Agreement. It comprises 3 phases: The 6 course base is historic incorporating the late C18/early C19 bricks. Above that, the post-war rebuild of the wall can be seen with the original bricks in a cement mortar, and above that, the wall is topped with postwar flettons.*

- 2.9 The external face (seen right) has been rebuilt using secondhand bricks also in stretcher bond. This shows the detail of the abutment with the historic wall (centre) forming the northern boundary of 2 Kings Road.

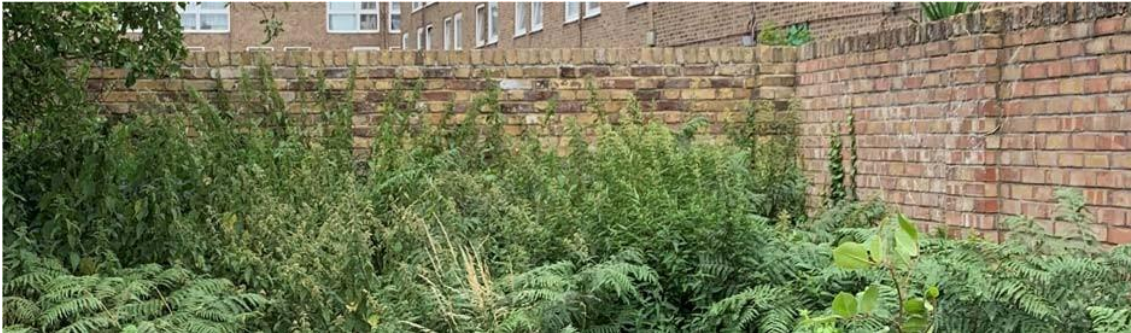
Figure 19. Eastern (right) and Northern (left) boundaries.

- 2.11 The northern boundary between 3 and 4 is also modern on a mapped C19 alignment. It comprises reused / reproduced yellow stock bricks in a cement mortar. It is visibly modern so is of Neutral significance and does not contribute to the setting or understanding of the Listed building.

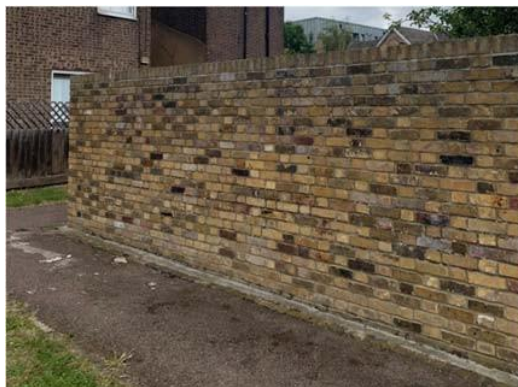
Figure 20 (left). Late C20/earlyC21 Outer face of Northern boundary.

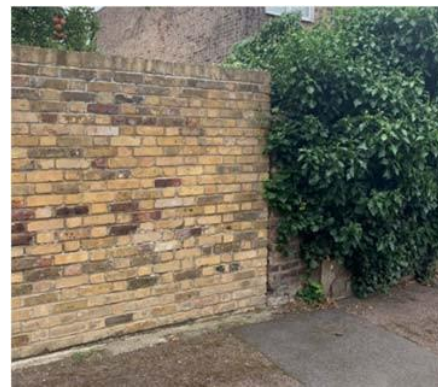
Figure 21 (right). Late C20/earlyC21 Northern boundary with glimpsed curve of the ivy clad overgrown C19 Western boundary.
