# **Arboricultural Method Statement**

High Road West - Plot A

September 2022

**Client Name:** Lendlease  
**Document Reference:** WIE18112-102-R-1-3-1-AMS  
**Project Number:** WIE18112

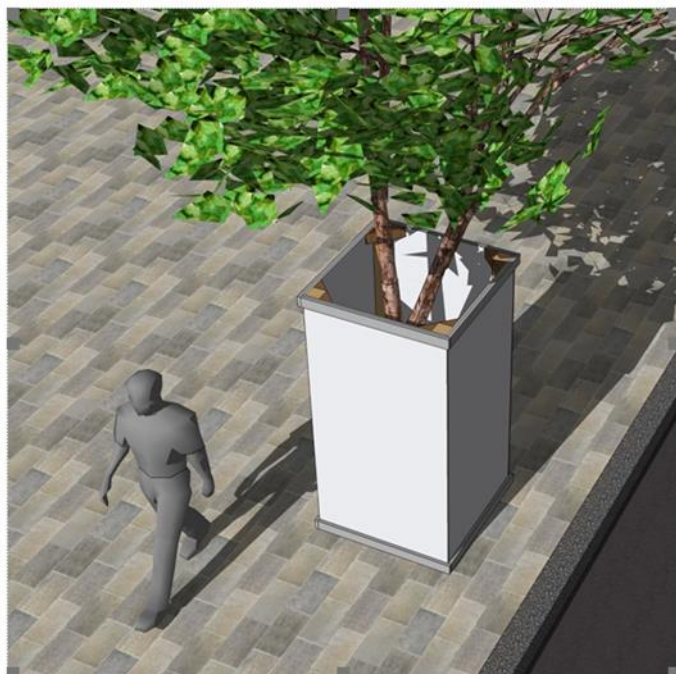
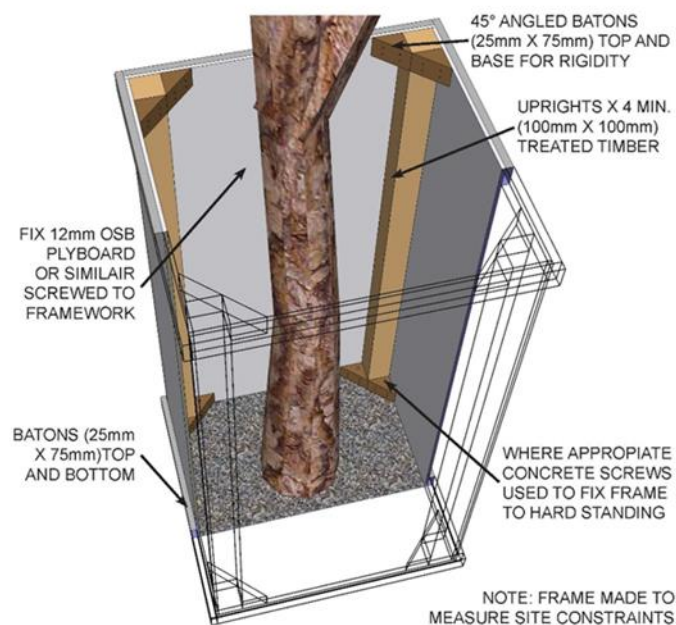
Figure 1 Example Tree Protection Box System

In this instance, as the trees are located in relatively small areas of soft landscaping in otherwise hard surfaced areas, it is proposed that the trees will be protected by ‘Tree Protection Boxes’, positioned to protect the unsurfaced ground where it is within the RPAs of the retained trees. An example of this type of tree protection system is shown in **Figure 1**.

#### TREE PROTECTION BOX FRAME SPECIFICATION

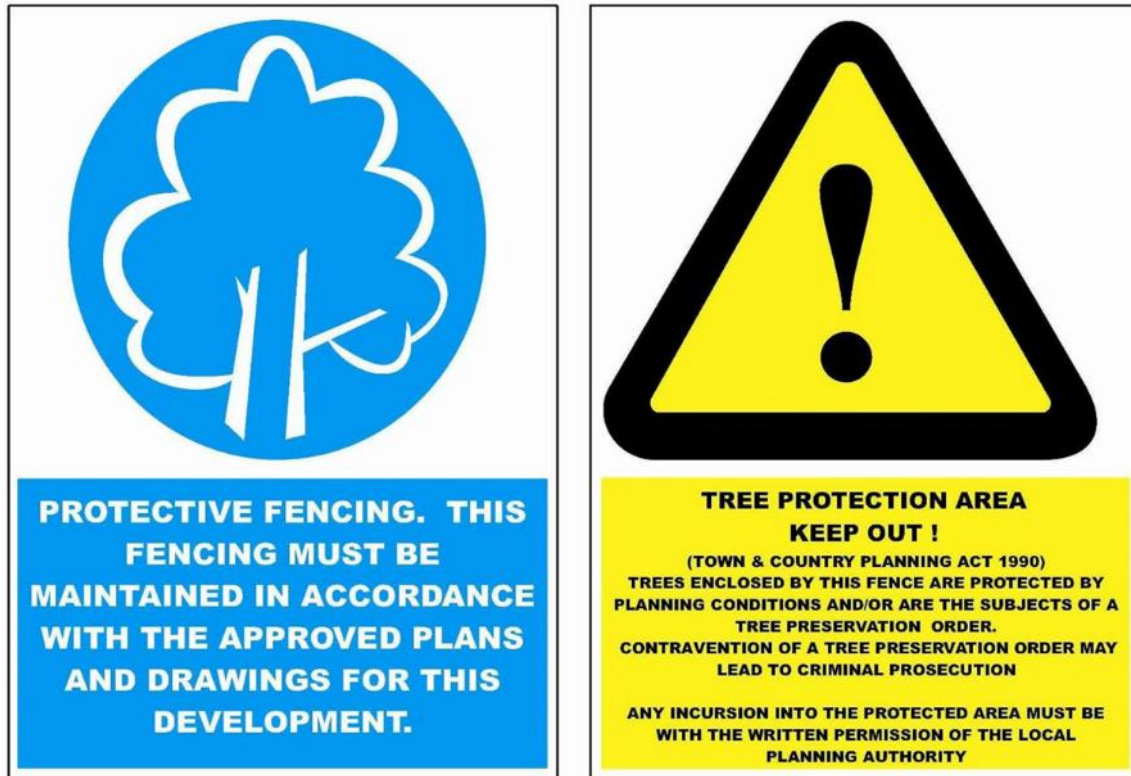
Figure 2 Example Tree Protection Barrier Sign

All weather notices will be secured to the Tree Protection Boxes, examples of which are contained in **Figure 2**.
