# **DAYLIGHT, SUNLIGHT & OVERSHADOWING OF NEIGHBOURING PROPERTIES**

30-36 Clarendon Road, London N8 0DJ

Produced by XCO<sub>2</sub> for Paul Simon Magic Homes

October 2022

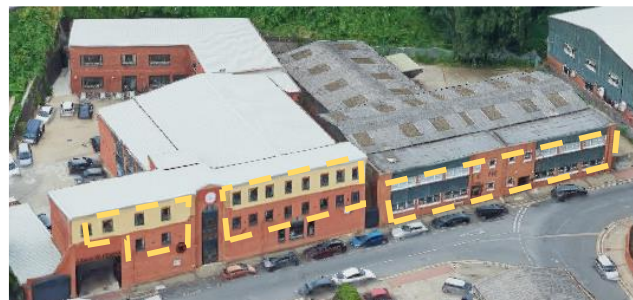
Figure 4: 19-27 Clarendon Road

These two buildings are located to the west of the proposed development. Figure 4 shows the assessed windows.

The results show that from a total of 43 windows facing the proposed site 7 windows achieved VSCs over 27%. From the remaining 36 windows one window achieved relative VSCs of at least 0.8 of the existing value and 7 windows achieved relative VSCs only marginally below 0.8 of the existing value. The remaining 28 windows belong to non-residential spaces where artificial lighting is expected and the requirement for daylight levels is not like that of residential developments.

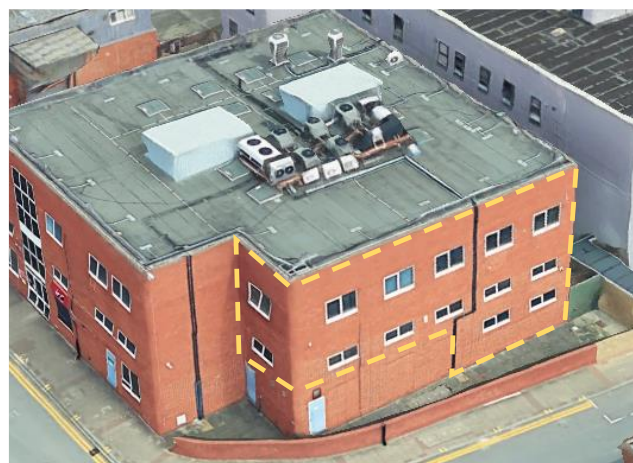
Figure 5: 50A Clarendon Road

This building is located to the north of the proposed development. Figure 5 shows the assessed windows.

A total of 14 windows facing the proposed site were assessed from this building. These windows belong to non-residential spaces where artificial lighting is expected and the requirement for daylight levels is not like that of residential developments.

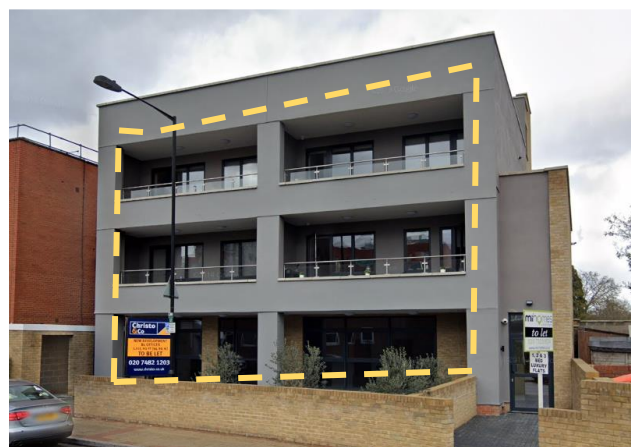
Figure 6: Katerina House Apartment Building

This building is located to the north of the proposed development. Figure 6 shows the assessed windows.

All 11 windows assessed from this building were found to not be meeting the BRE criteria as they are located beneath a recessed balcony which limits the daylight received.

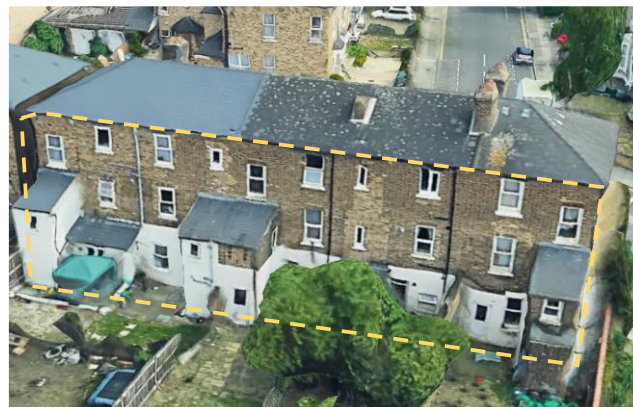
Figure 8: 23,25,27,27A,29,31,31C Hornsey Park Road

These buildings are located to the northeast of the proposed development. Figure 8 shows the assessed windows.

The remaining 5 windows achieved VSCs higher than 20% or slightly below 80% of their former value, which is considered to be a good amount of daylight in a city environment. Therefore, the proposed development is not considered to have any significant daylight impact on these properties.

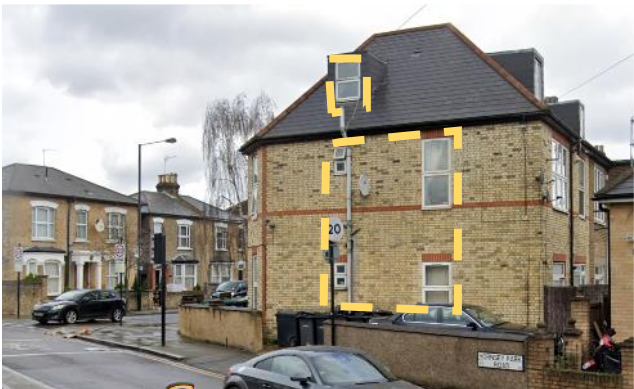
Figure 9: 2 The Avenue

This building is located to the east of the proposed development. Figure 9 shows the assessed windows.

The results show that all 5 windows assessed achieved VSCs higher than 27%, therefore the proposed development is not considered to have any significant daylight impact on 2 The Avenue.

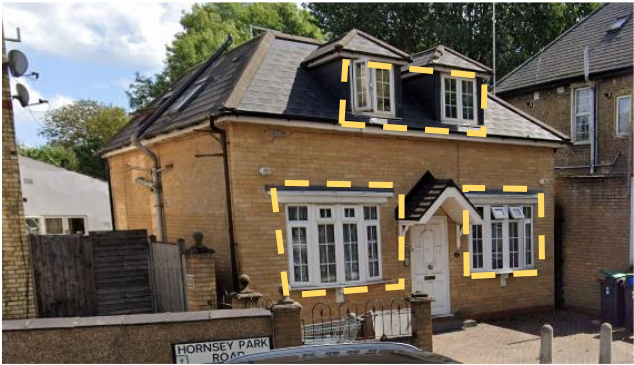
Figure 10: 8 Hornsey Park Road

This building is located to the east of the proposed development. Figure 10 shows the assessed windows.

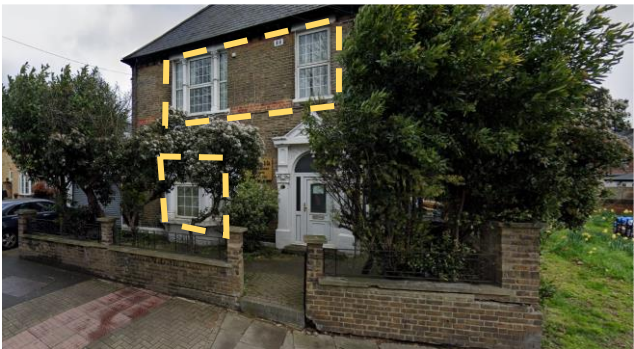
Figure 11: 10 Hornsey Park Road

This building is located to the east of the proposed development. Figure 11 shows the assessed windows.

A total of 3 windows were assessed from this building. All 3 assessed windows achieved VCSs over 27%, therefore the proposed development is not considered to have any significant daylight impact on 10 Hornsey Road.

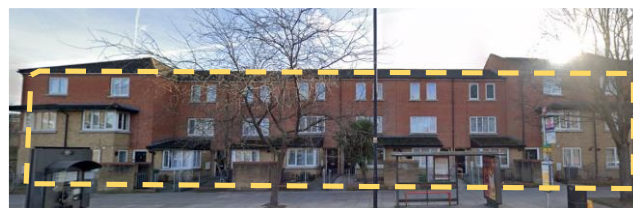
Figure 12: 141-159 Turnpike Lane

This building is located to the south of the proposed development. Figure 12 shows the assessed windows. Figure 13 shows the 25-degree line test carried out.

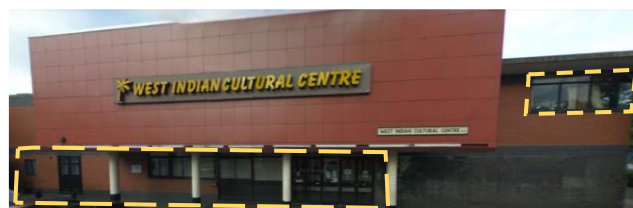
Figure 14: West India Cultural Centre

This building is located to the southeast of the proposed development. Figure 14 shows the assessed windows.

A total of 10 windows were assessed from this building. The results show that from a total of 10 windows 7 windows achieved VSCs over 27% and 3 windows achieved relative VSCs of at least 0.8 of the existing value, therefore the proposed development is not considered to have any significant daylight impact on West India Cultural Centre. The table below summarises the findings.

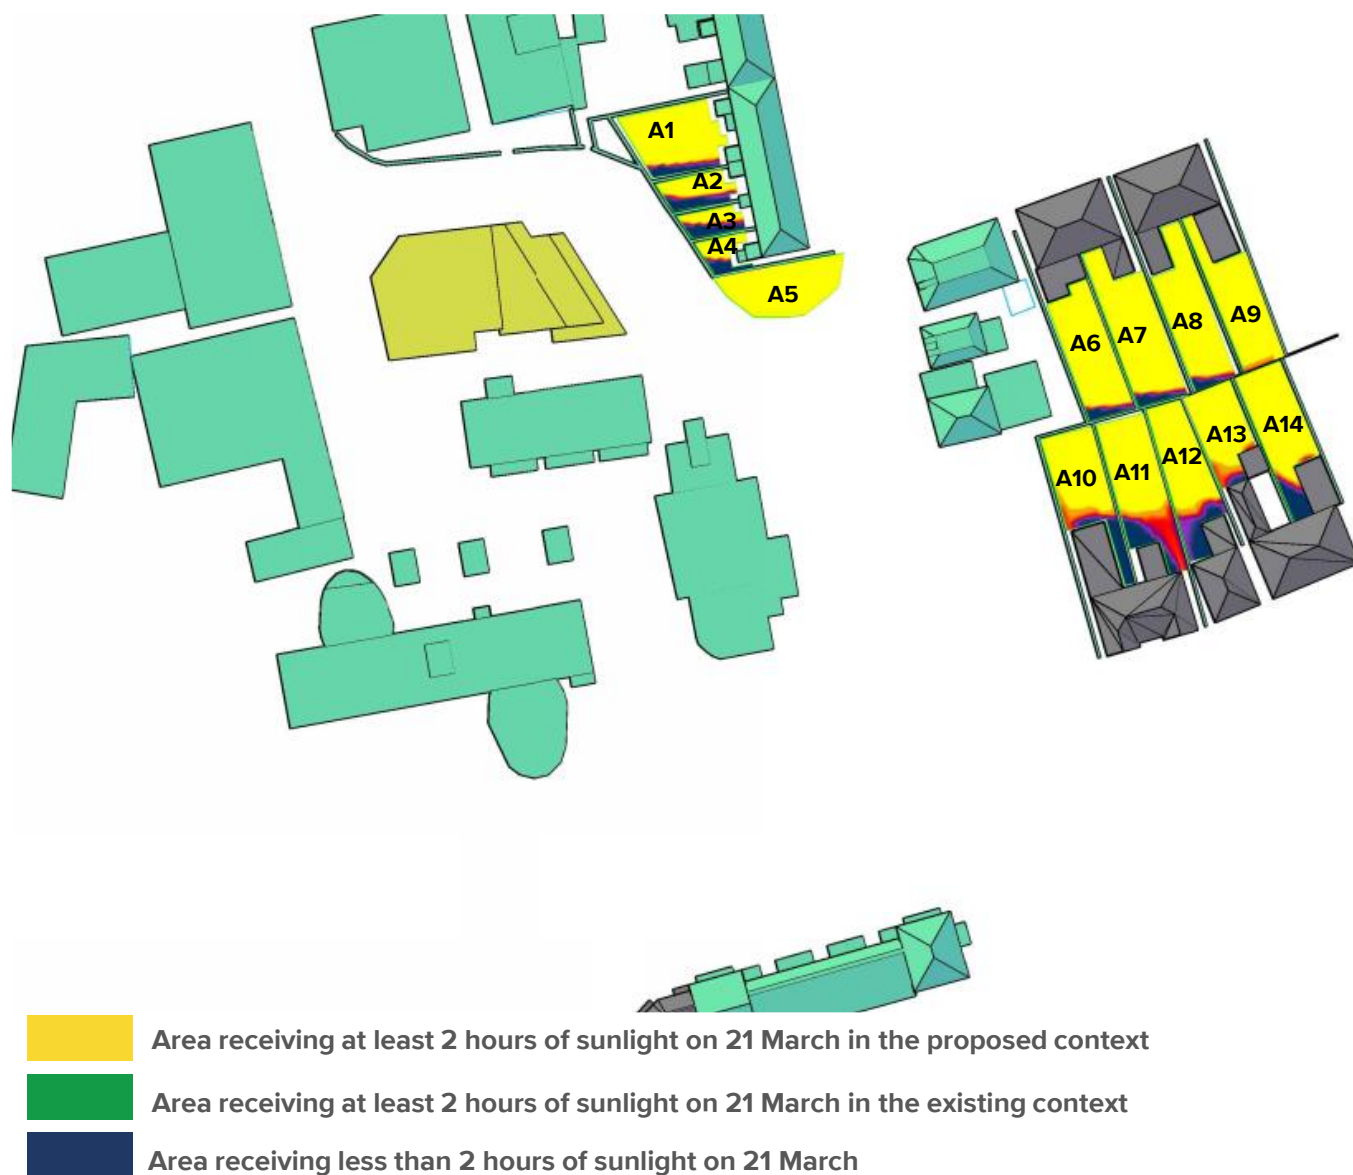
Figure 17: Overshadowing results for the amenity spaces surrounding the proposed site. Contours under proposed lit area (yellow) and existing lit area (green) overlap in most spaces indicating minimal/no reduction in the sunlight received between proposed and existing scenarios

The results show that all but one of the analysed areas will receive more than two hours of sunlight on 21 March under proposed conditions over 50% of their

areas, meeting the BRE requirements for overshadowing. Where this is not achieved (A3), the area achieving 2 hours of sun on 21 March is higher than 0.8 times its former value.

The results show that all but one of the analysed areas will receive more than two hours of sunlight on 21 March under proposed conditions over 50% of their areas, meeting the BRE requirements for overshadowing. Where this is not achieved (A3), the area achieving 2 hours of sun on 21 March is higher than 0.8 times its former value.
