### Report on the Garden Beech Tree and Damage to 135 Dukes Avenue London N10 2QD

Carried out by  
Robin Howorth MRICS, MICFor  
Chartered Arboriculturist

Report date: 13<sup>th</sup> October 2022

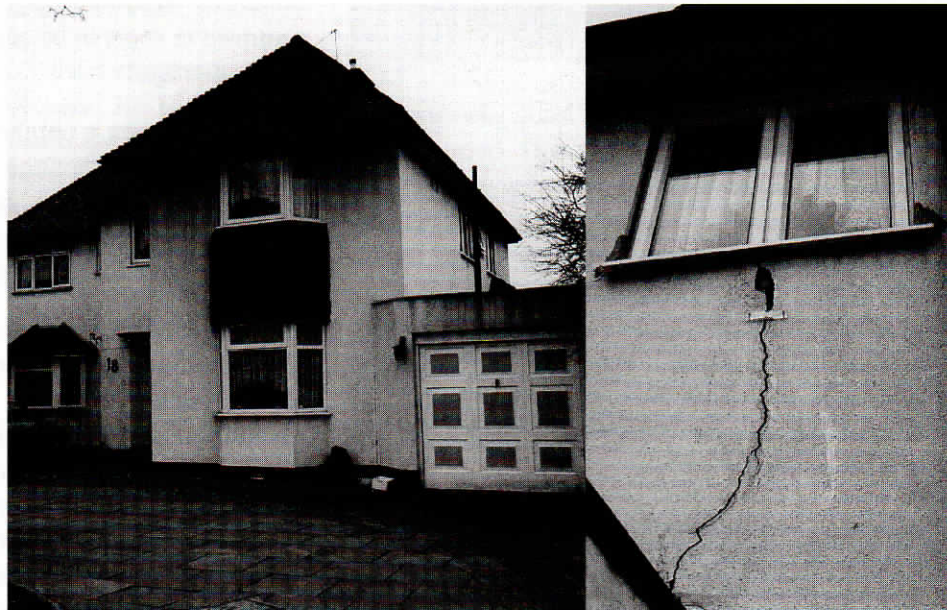
Building with structural cracking

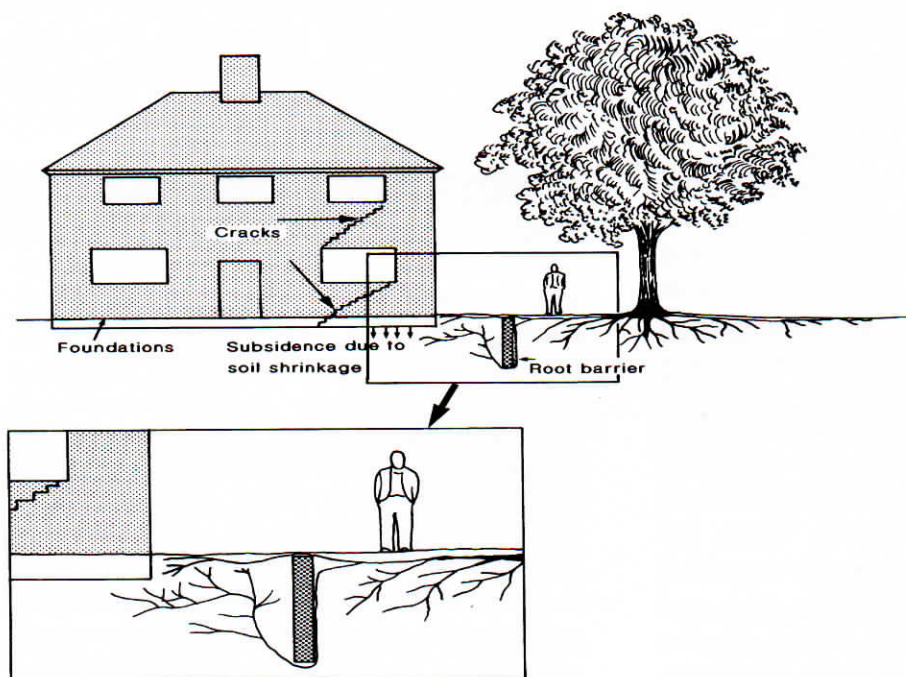
Root growth around a barrier

- be impenetrable to tree roots. The limited investigations undertaken on some materials used as barriers are not extensive enough to permit comprehensive advice to be given on their appropriateness. The claims of the manufacturers should be regarded with caution as some materials are marketed on the basis of a theoretical rather than experimental appraisal of their effectiveness. Nevertheless, some of the properties that should be looked for in a barrier material are discussed below.

In some situations it may be important that the barrier material does not prevent water movement

through the soil (for example, if there is an underground spring). However, permeable materials may only briefly delay the passage of roots (see Appendix) and it may be better to design the barrier so that water movement is deflected rather than stopped..
