BROADWATER FARM ESTATE  
TANGMERE MURAL RELOCATION  
FEASIBILITY STUDY  
HARINGEY COUNCIL  
November 2022

PROJECT NAME: Broadwater Farm – Tangmere Mural Relocation  
PROJECT NUMBER: 5013178  
PROJECT REF: 5013178-RDG-XX-XX-DOC-S-9900

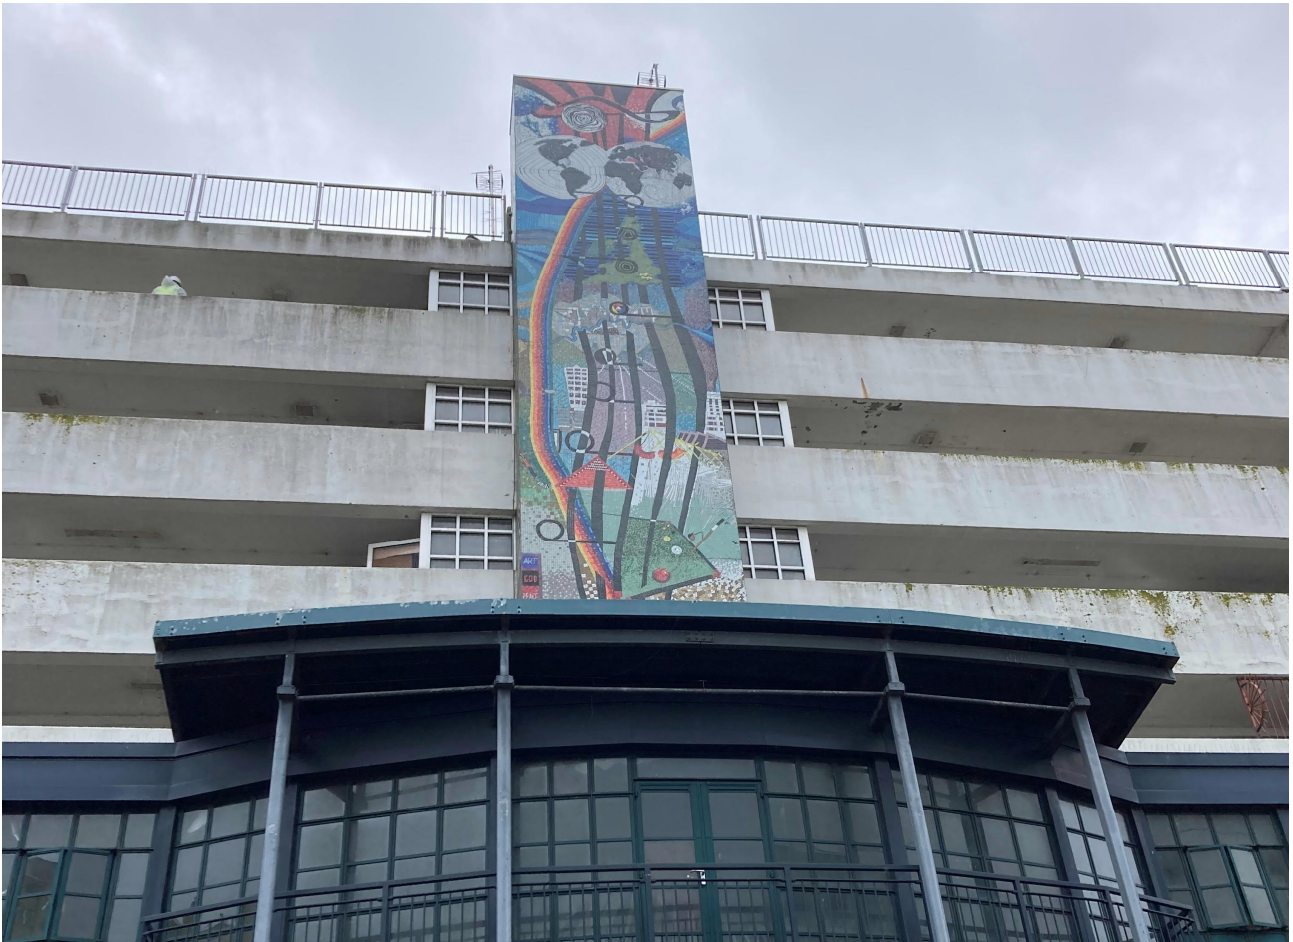
Figure 1 – Tangmere North Elevation Mural

On the North elevation of the block is an existing mosaic mural which is hoped to be retained and relocated so as not to be lost during the demolition.

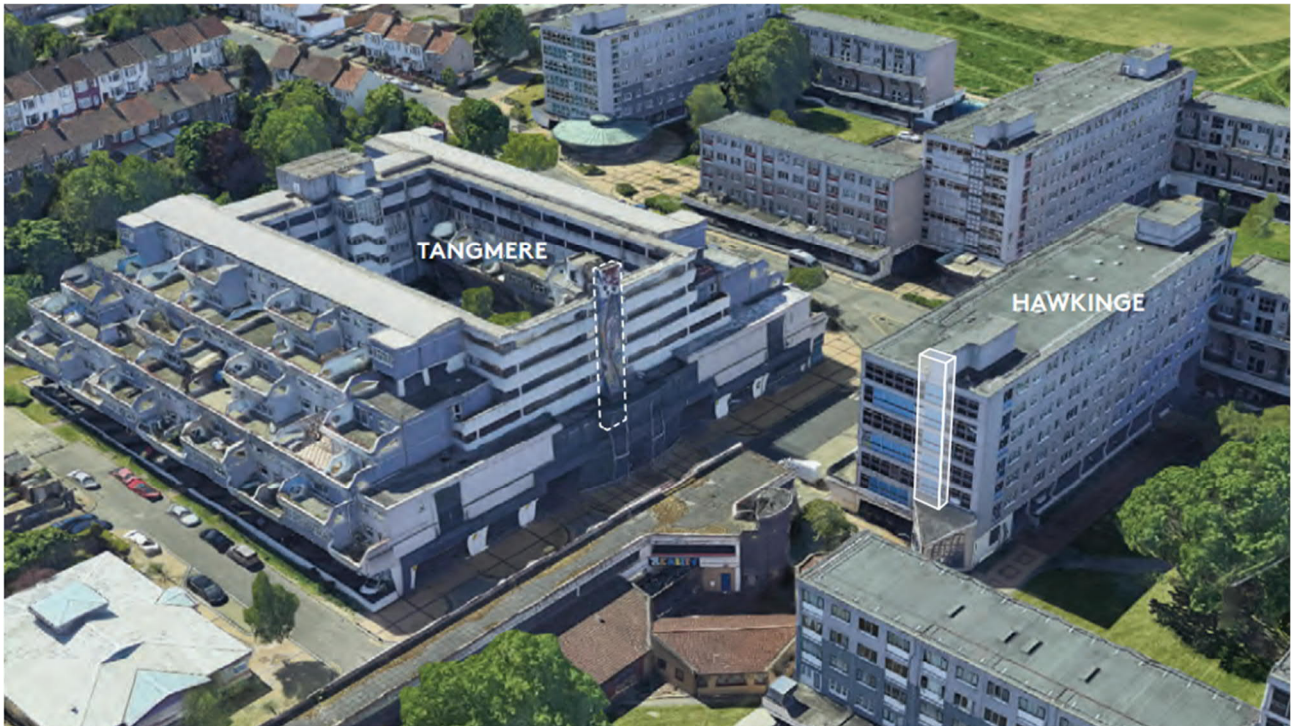
Figure 3 – Proposed location for mural relocation

It is proposed to relocate the mural from Tangmere to the east elevation of the adjacent Hawkinge building, see Figure 3.

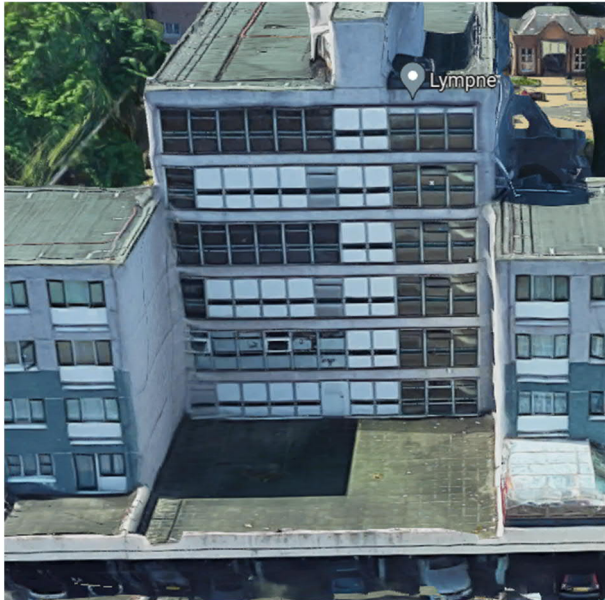
Figure 8 – End elevations of the Lypne and Rochford 6-storey blocks

- East elevation of the six-storey Lypne block
- West elevation of the six-storey Rochford block

In these locations the supporting steelwork could be supported of the existing concrete deck, negating the need for a bridging structure over entrance lobbies.
