## Townsend Yard : Method Statement

A document written to Discharge Condition 3 of Planning Approval HGY/2021/3273 granted 01/09/2022 for works abutting flank wall and garden wall of No 36a Highgate High Street (The Asset) in association with demolition of garages in line with planning consent ref: HGY/2020/1326.

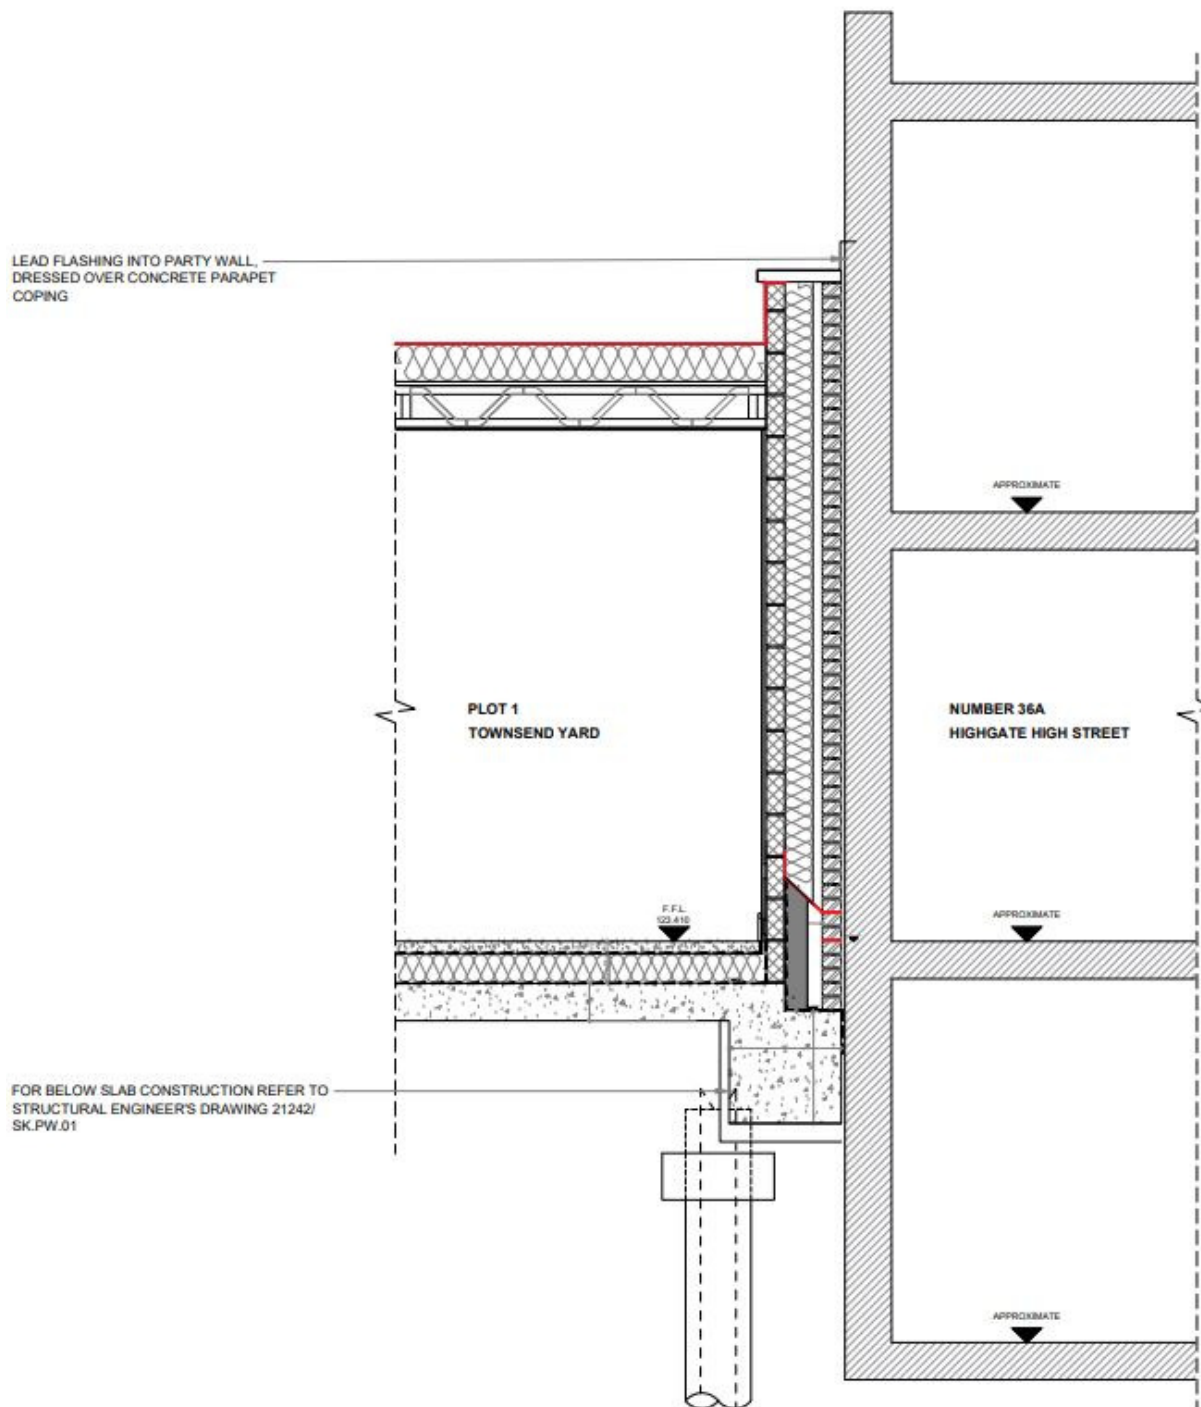
*Above: Party Wall drawing. Notional construction of No. 36a indicated to the right.*

Proposed construction has been designed to stand away from the existing wall of 36 Highgate High Street so that the piling rig can operate at a safe distance. The depth of the gap between the properties will depend on how vertically plumb the wall is found to be. Existing drainage will be extended from No.36 into the wall construction zone. When the new wall is built the junction will be flashed over with sections of Code 6 lead to standard details set down by the Lead Sheet Association. The flashing shall be secured by lead wedges into a prepared brick joint in the wall of No. 36a and fixed by lead clips. The joint will be filled with the approved mix of lime mortar sufficient for the site exposure.

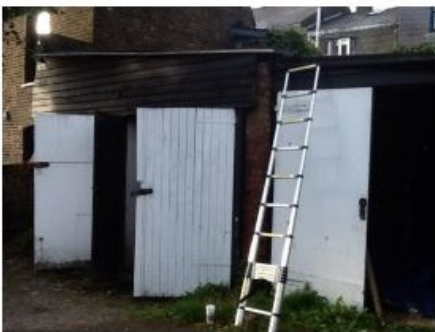
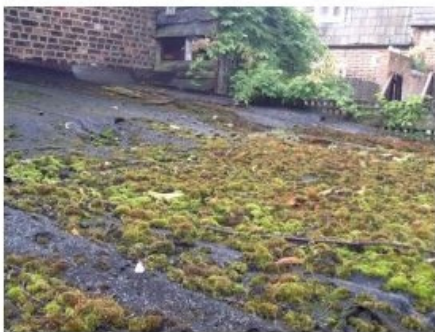
| Sample reference: SF01/Garage blocks N6 5JT | | | |
|---|---|---|---|
| Comments: | No asbestos detected<br>Non-asbestos roof sheeting to 3 No. garages | | |
| Close up of sample area | | General area of sample | |

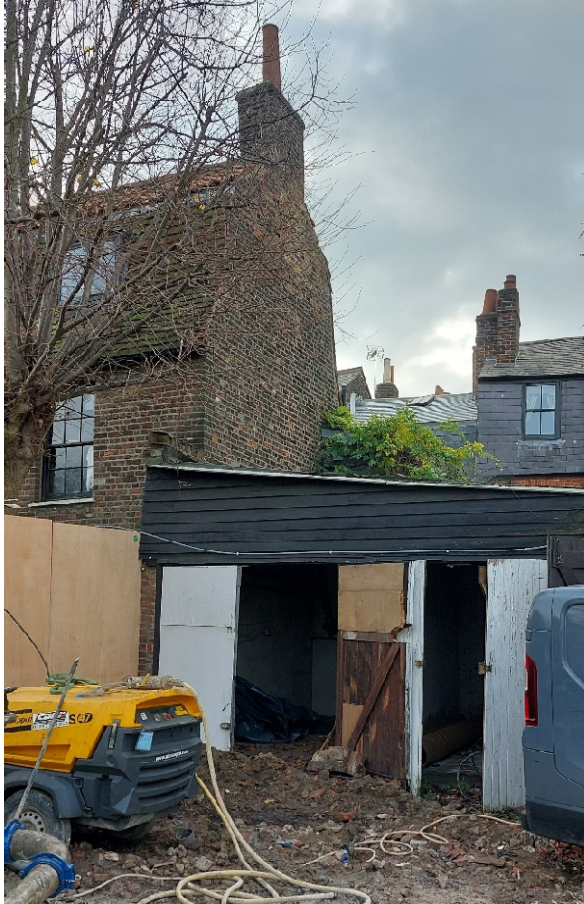
No. 36a to left, garages centre & right

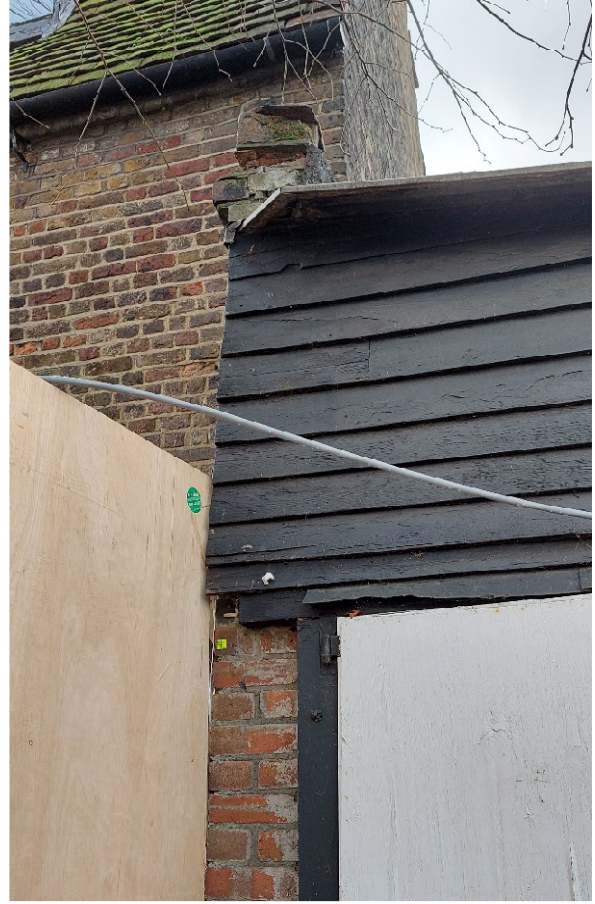
Loose Parapet at top of garage.

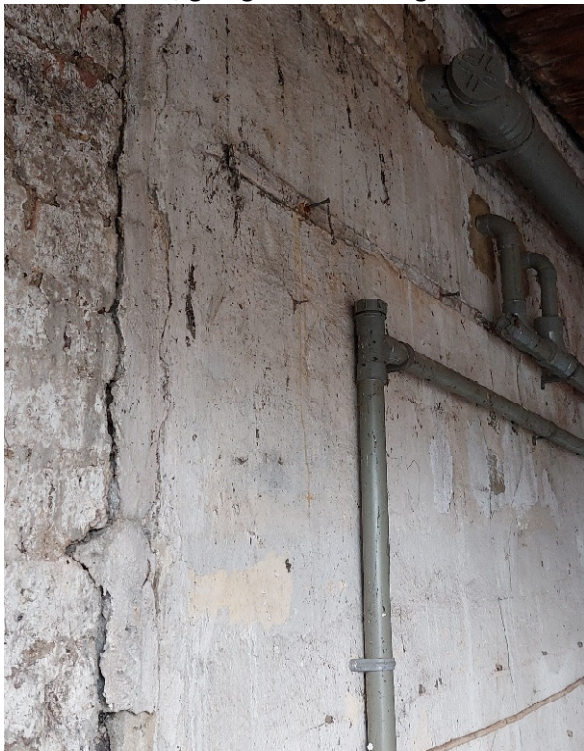
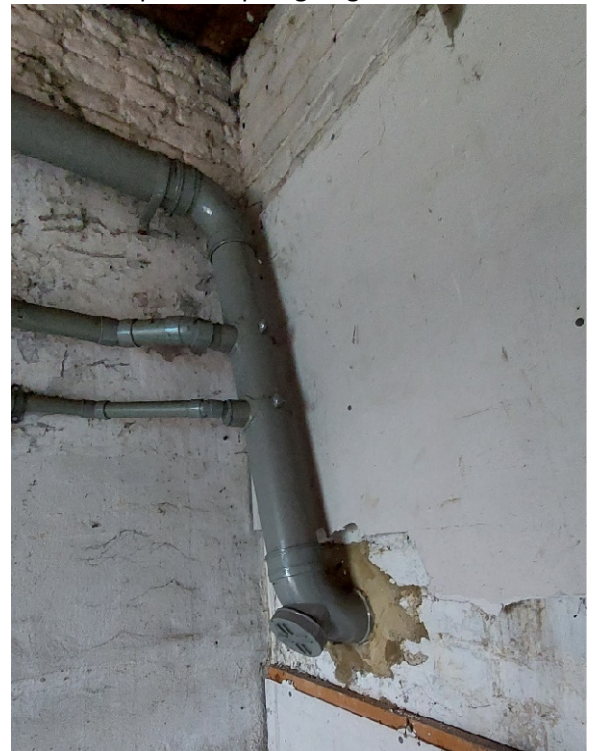
Above: Drainage from No.36a Highgate High Street, crosses the wall and leaves by No. 40

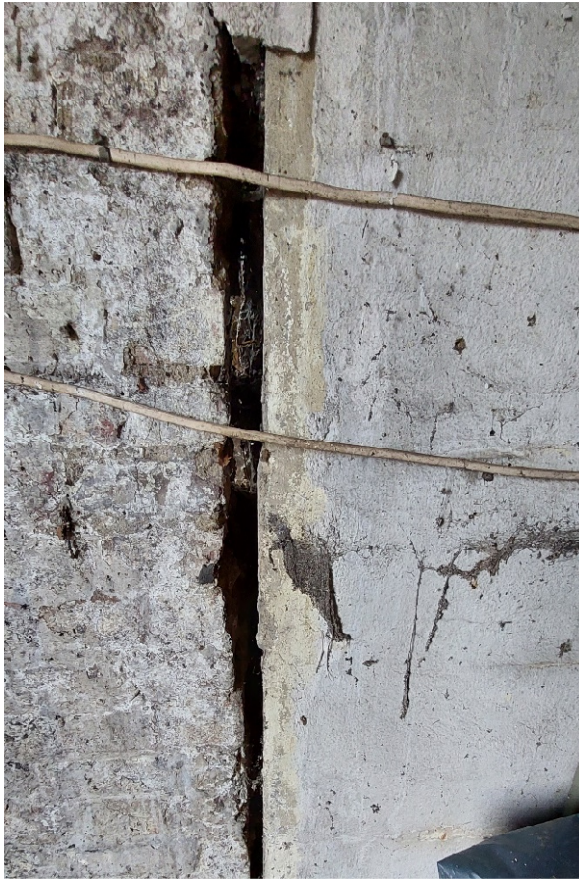
Gap between nib-wall and wall of the Asset

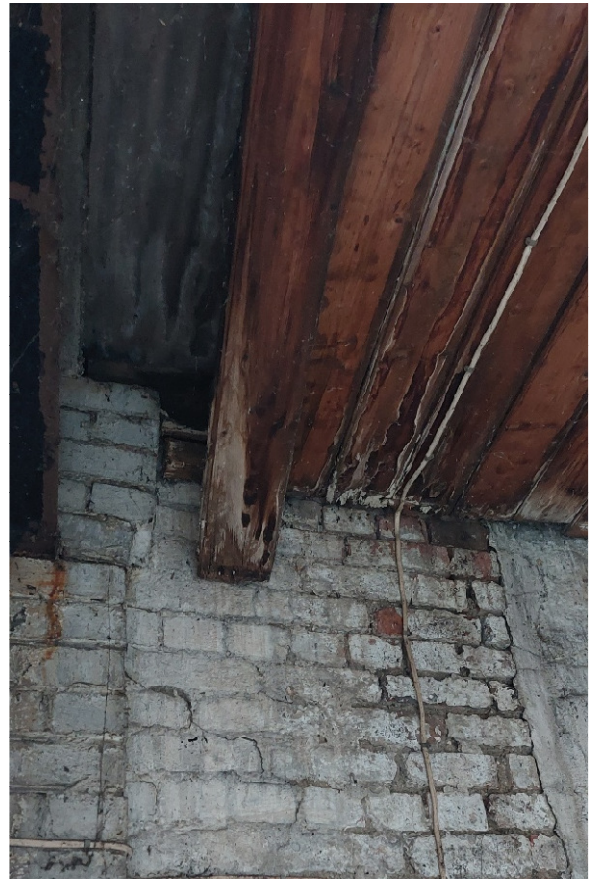
Same area with view upwards of ceiling boards

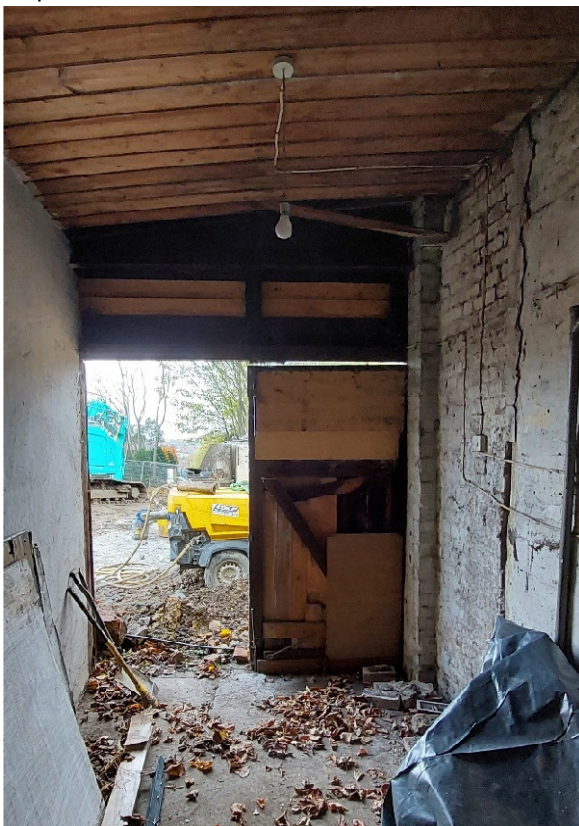
End wall- garage door

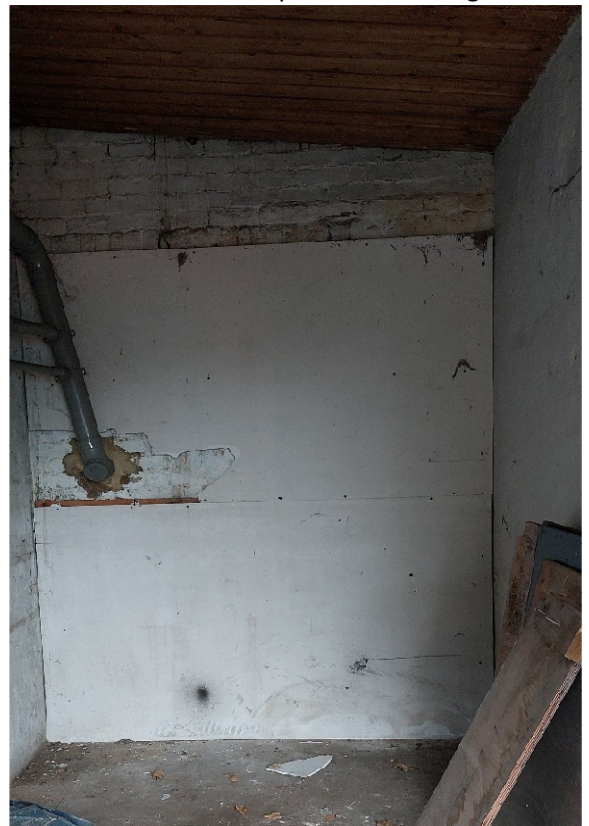
End wall- garden wall with No. 40

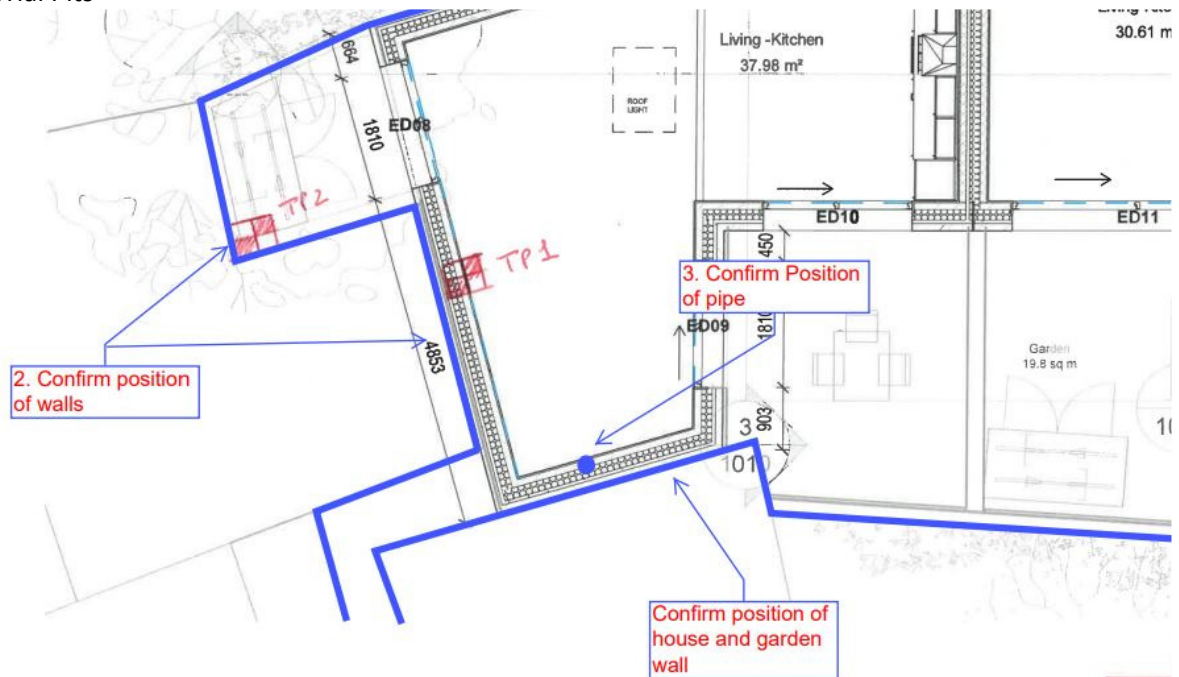
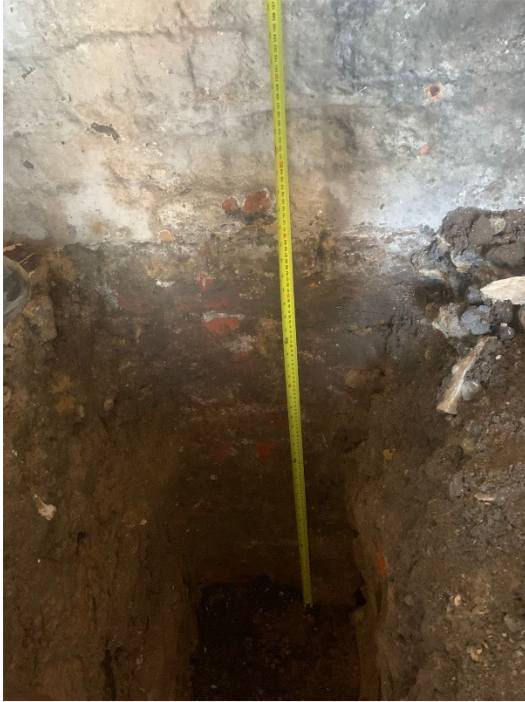
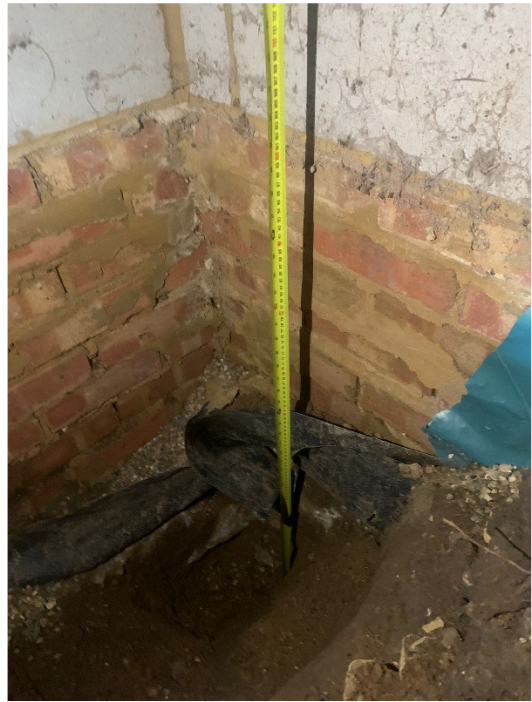
Pits 1 and 2 prepared for information at the above locations.

1. TP1 – brick spreader course on ash, 1100mm down.
2. TP2 – 200mm thick concrete footing, top of concrete 600mm down.

A small trial pit should be dug against 36a Highgate High Street in the small space outside the garage wall. This will indicate the depth of any unexpected adjacent footings although the wall of No 36a Highgate High Street is expected to go down for a full storey height and the structural engineer will be asked to advise on the depth of slab removal required along the property interface. A CAT scanner is to be used before breaking out any slabs and foundations. Breaking out should be carried out in strips taking particular care not to affect any neighbouring properties during the works. This to be completed by an operative suitably competent to undertake this. Alongside the wall of the Listed building the break-out will commence at the nib wall end so that it will be clear how deep the fill is likely to be. There will be water suppression to all dust-raising work. Note any areas where the retained existing services pass into the concrete slab, the immediate covering of concrete will be retained until there is confirmation from the project architect of how these will be safeguarded. The dismantled material should be kept clear of the Listed building wall and
