## Basement Impact Assessment

26 Sheldon Avenue

Report Ref: B2538/22/BIA/1

December 2022

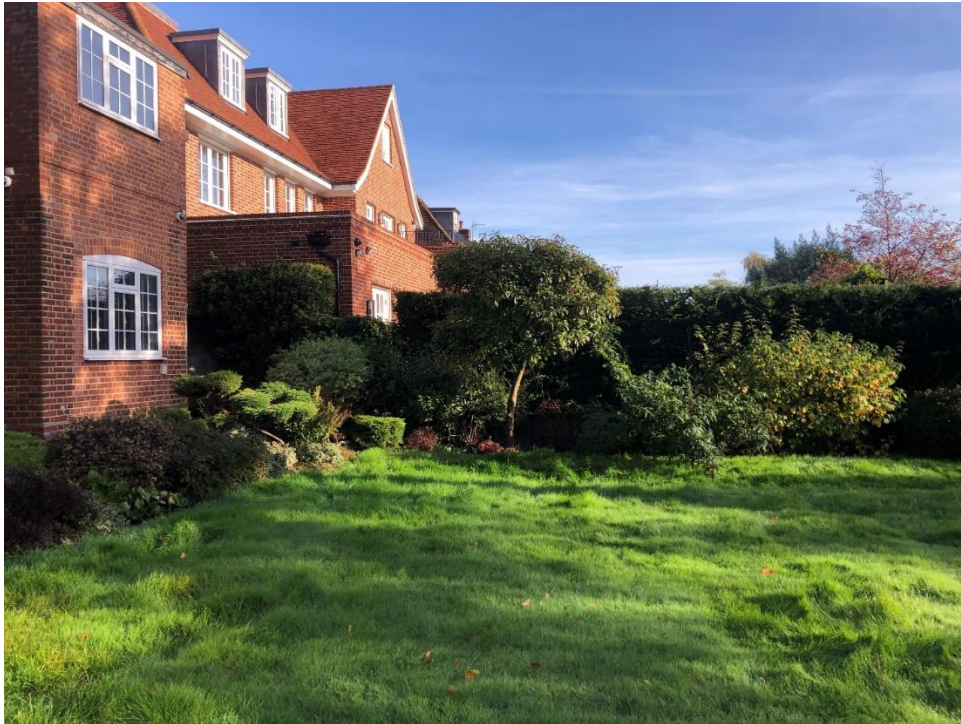
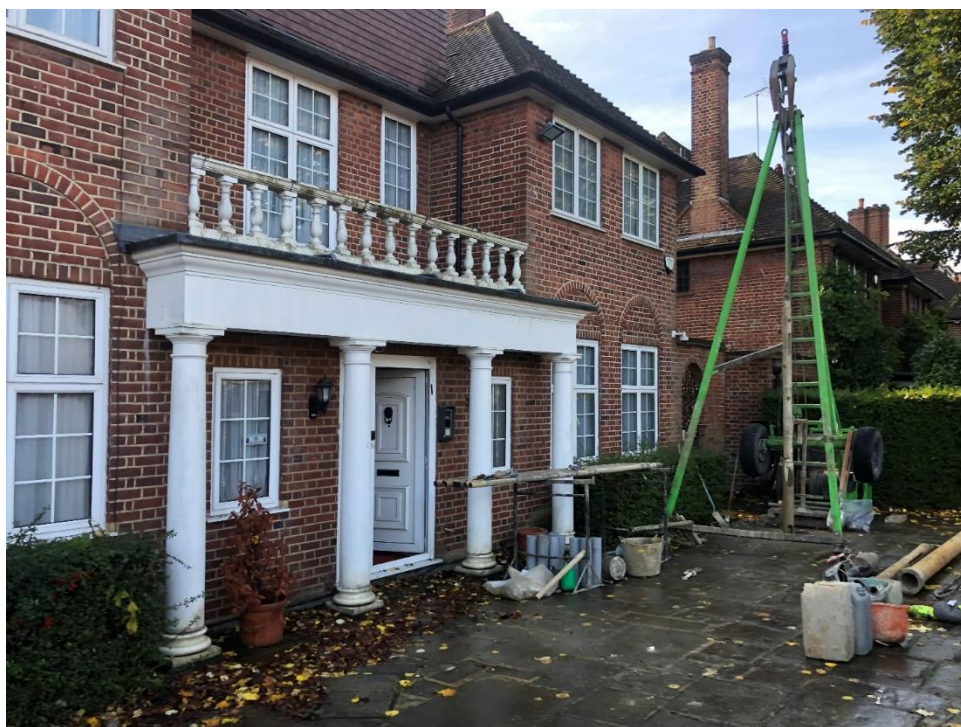
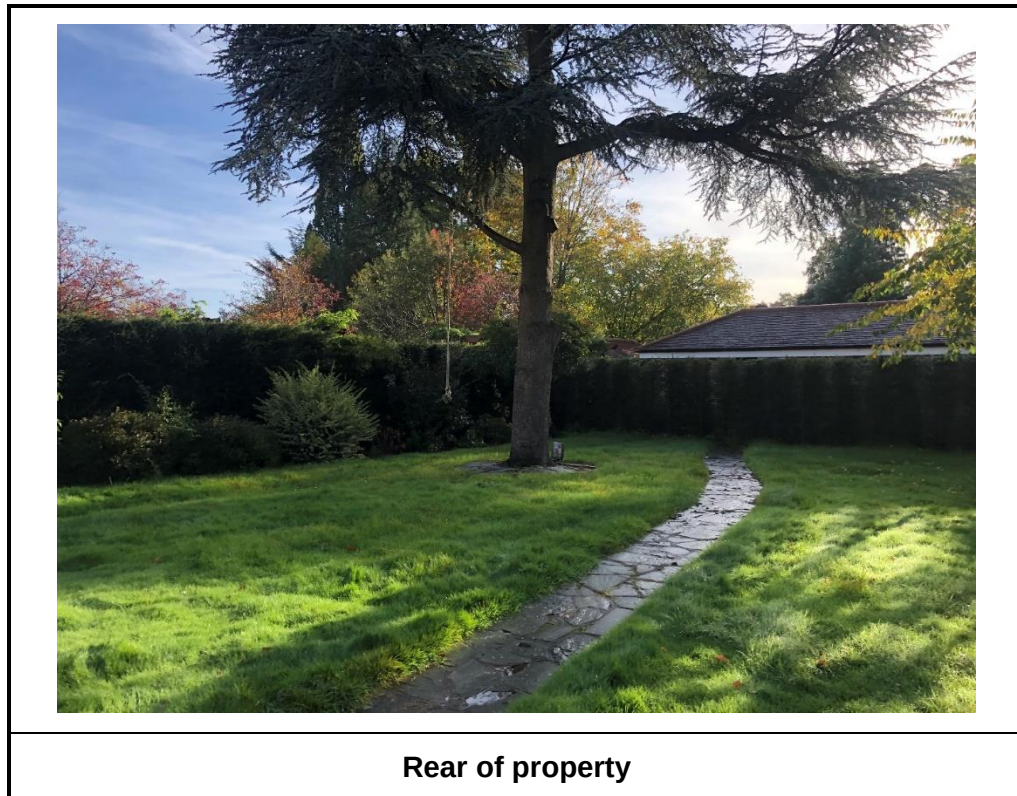
**Figure 2 – General Site Photographs**

**Rear of property**

**Front of property including CP01**

General site photographs are presented in Figure 2 overleaf.
