6.1 Civic Centre

6.1.1 Repair and restoration of the civic centre

CIVIC  
CENTRE

Haringey Civic Centre

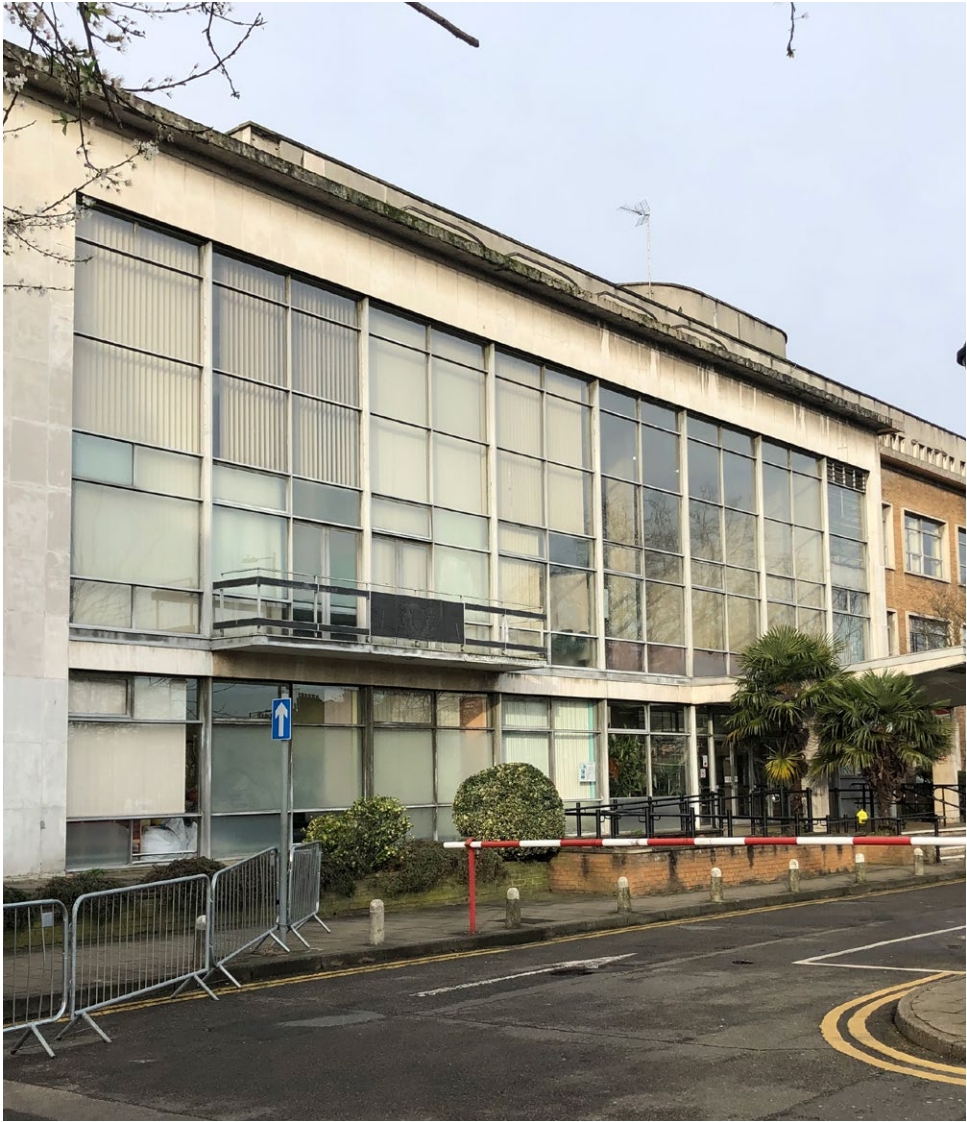
Type 01  
Aluminium Curtain Walling System

- Council Chamber and Entrance Lobby**  
**West Elevation Ground and first Floor**  
**West (Committee) Wing**
- Generally Single glazed
  - Inconsistent top-hung opening lights,
  - Internally solar control film in places - in some locations this is degrading/peeling
  - External privacy film in various locations
  - Secondary Steelwork in back-boxes of mullions with larger profiles
  - Several panels/bays have been replaced on west elevation ground floor
  - Double doors have been replaced in north and south elevations
  - Sealant/beading has degraded and contains asbestos

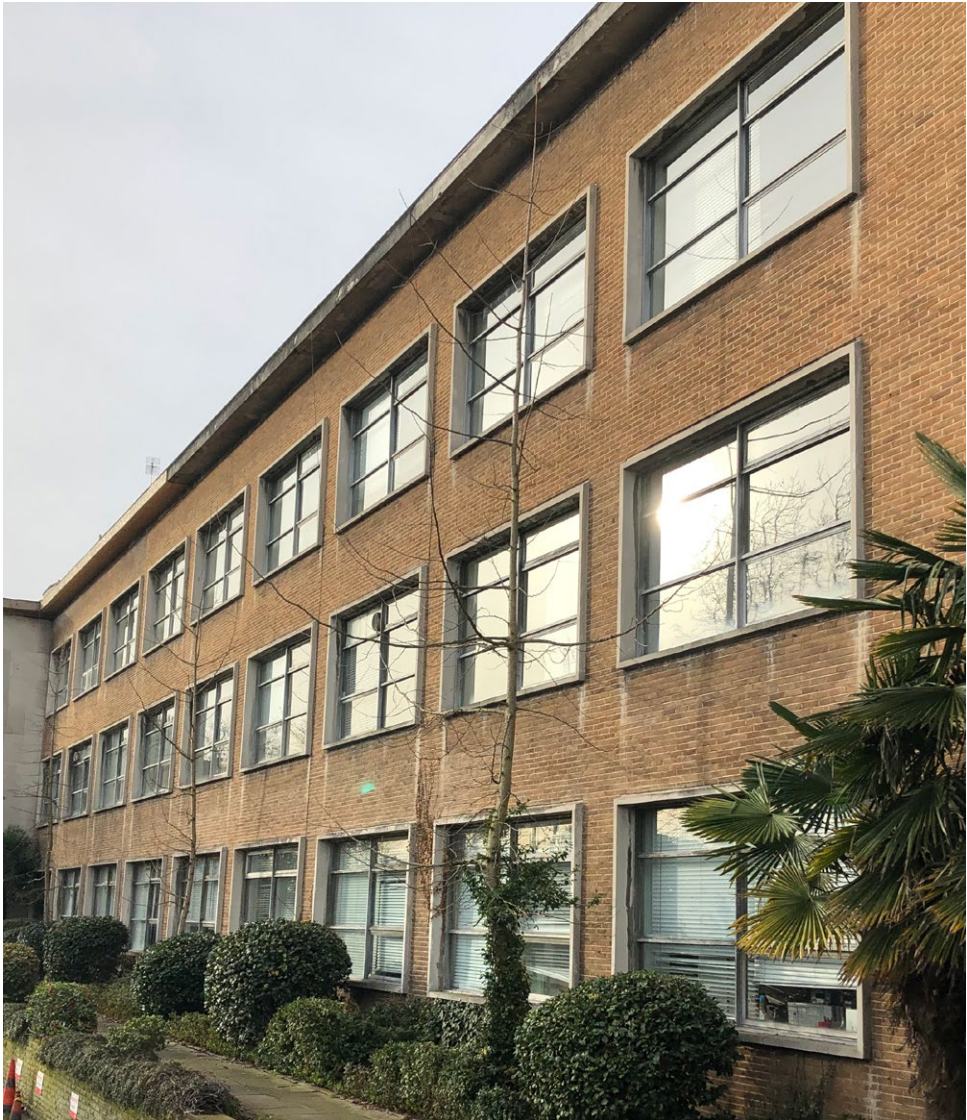
Aluminium Punch Windows - GF-L02

Ground floor to Second Floor  
East (Front) & West (Courtyard) elevations

- Aluminium stick system
- Generally Single glazed
- Inconsistent positioning of top-hung opening lights,
- Internally solar control film in places - in some locations this is degrading/peeling
- Sealant/beading has degraded and contains asbestos

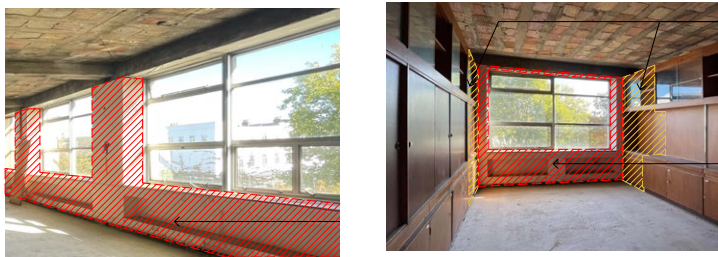
North Wing - East Elevation

Proposed demolition of internal finishes

Existing condition: brickwork on concrete substrate (minimal cavity) with uninsulated plastered lining.

Proposal: the uninsulated plastered lining is to be removed and replaced with an insulated plasterboard lining.

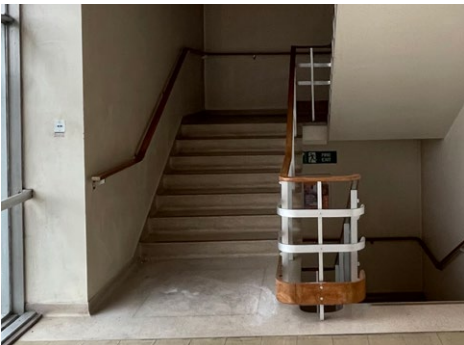
Left: Council chamber. Right: North stairwell

Existing condition: cavity wall with brickwork inner and out leaf, plastered internally.

Proposal: The existing terrazzo stair butts up against the wall making an insulated internal lining impossible. The preferred option to limit heat loss is to remove existing plaster and replace with an insulating plaster. This will not achieve the target 0.3 W/m2/K but will reduce heat loss. As this is a transitory area, the council may wish to set the thermostat level lower than elsewhere in the building to further reduce heat loss.
