Interior Design

North Wing Workspace

Original Design

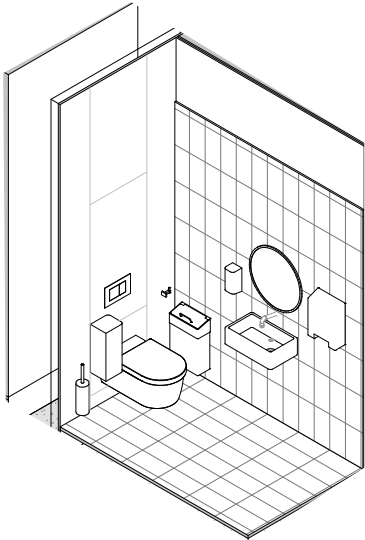
Axo of typical Toilet cubicle

The material finishes of the toilets will create a warm environment through a simple design, mainly using porcelain tile and IPS systems at the back for easy access. The selection of finishes will take into consideration BS8300 recommendations for accessible design.

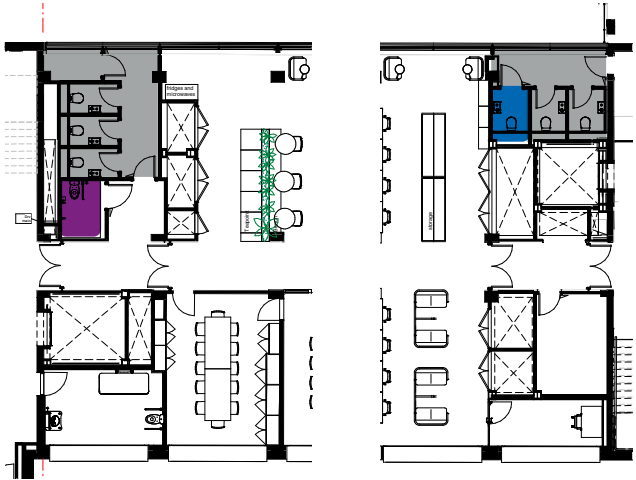
North Wing typical Toilet Blocks

The existing toilets no longer meet the council's needs and aren't in good condition. The proposal seeks to reconfigure the toilet areas to provide high-quality facilities that meet current standards and regulations and the council's ambitions on accessibility and gender equality. The design creates individual, self-contained unisex toilets, ambulant and accessible toilets
