No 12 Wood Lane Highgate.

## Revised Statement of Significance & Heritage

JME Conservation Ltd.

September 2022

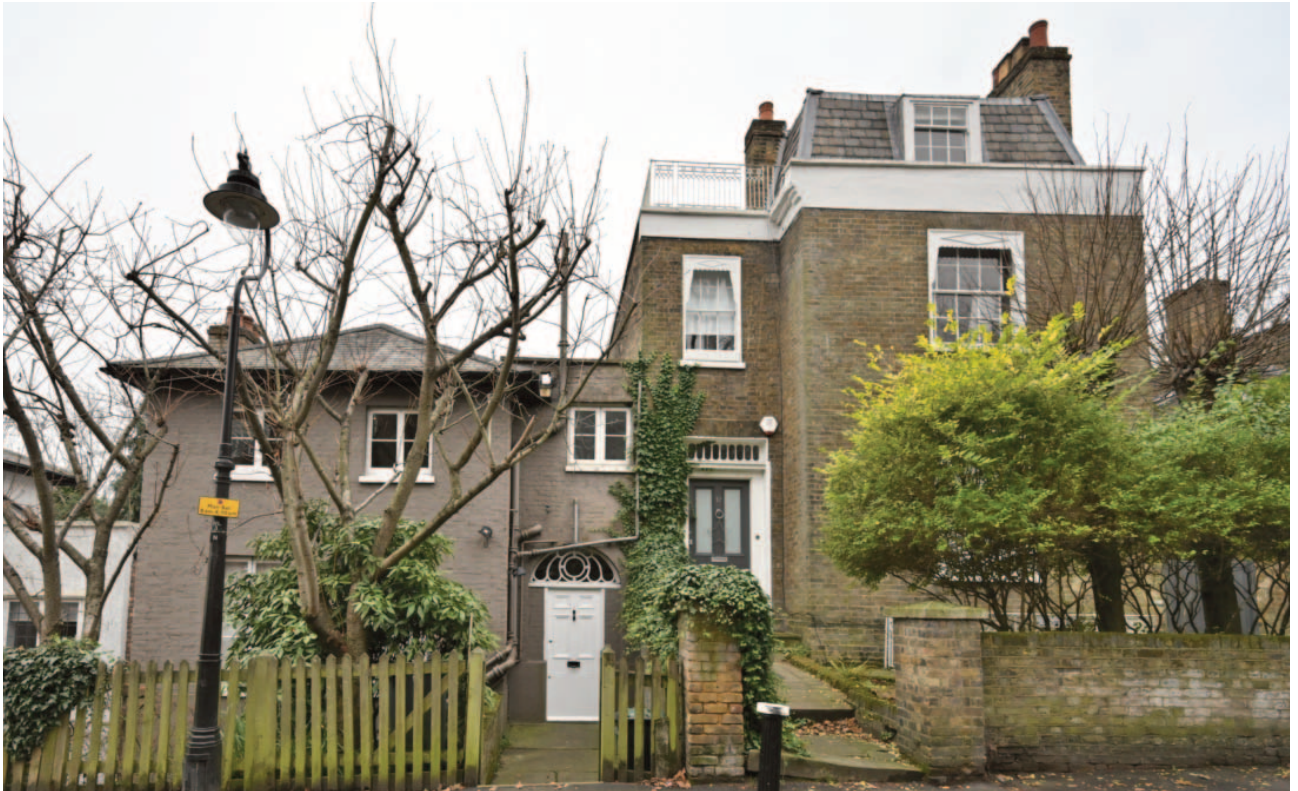
Fig 3. No 12 with its later mansard roof with 14 Wood Lane, on the left. The mansard roof and sloping ground emphasizes the difference in scale between the two properties which are of similar age.

The steeply pitched hipped mansard roof to the principal range incorporates a central dormer with a three over six paned sash window. This is a later alteration to provide an additional usable attic floor, that would have replaced the earlier low pitched hipped slate roof found on the neighbouring properties. In its present form it has a rendered parapet with concrete copings to the front elevation, with the render carried across the upper courses of the side wing.

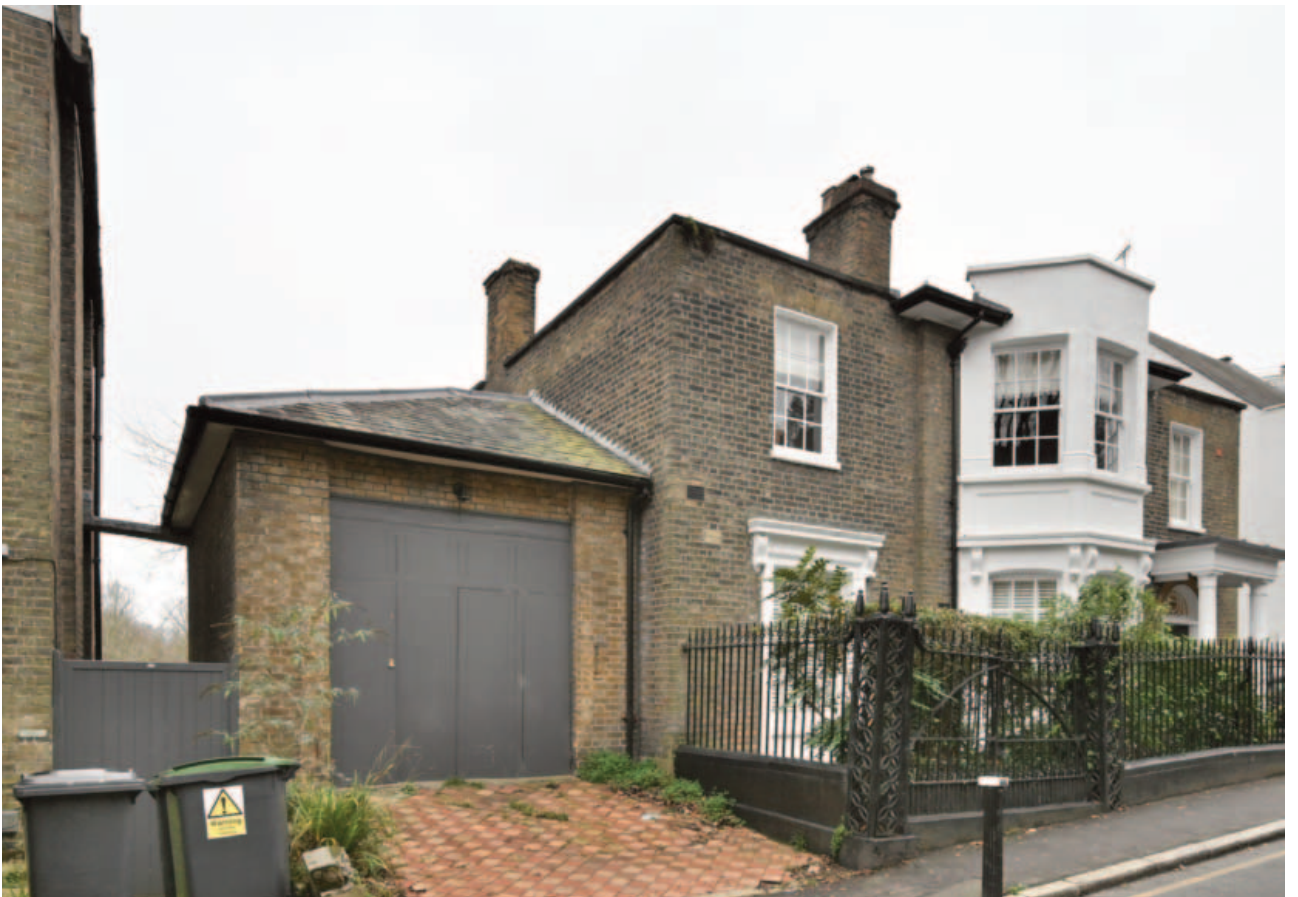
Fig 4. The two storey outbuilding reads as single storey from the street where it relates to No 10 because of the service passage that separates it from No 12 which is just visible on the left.

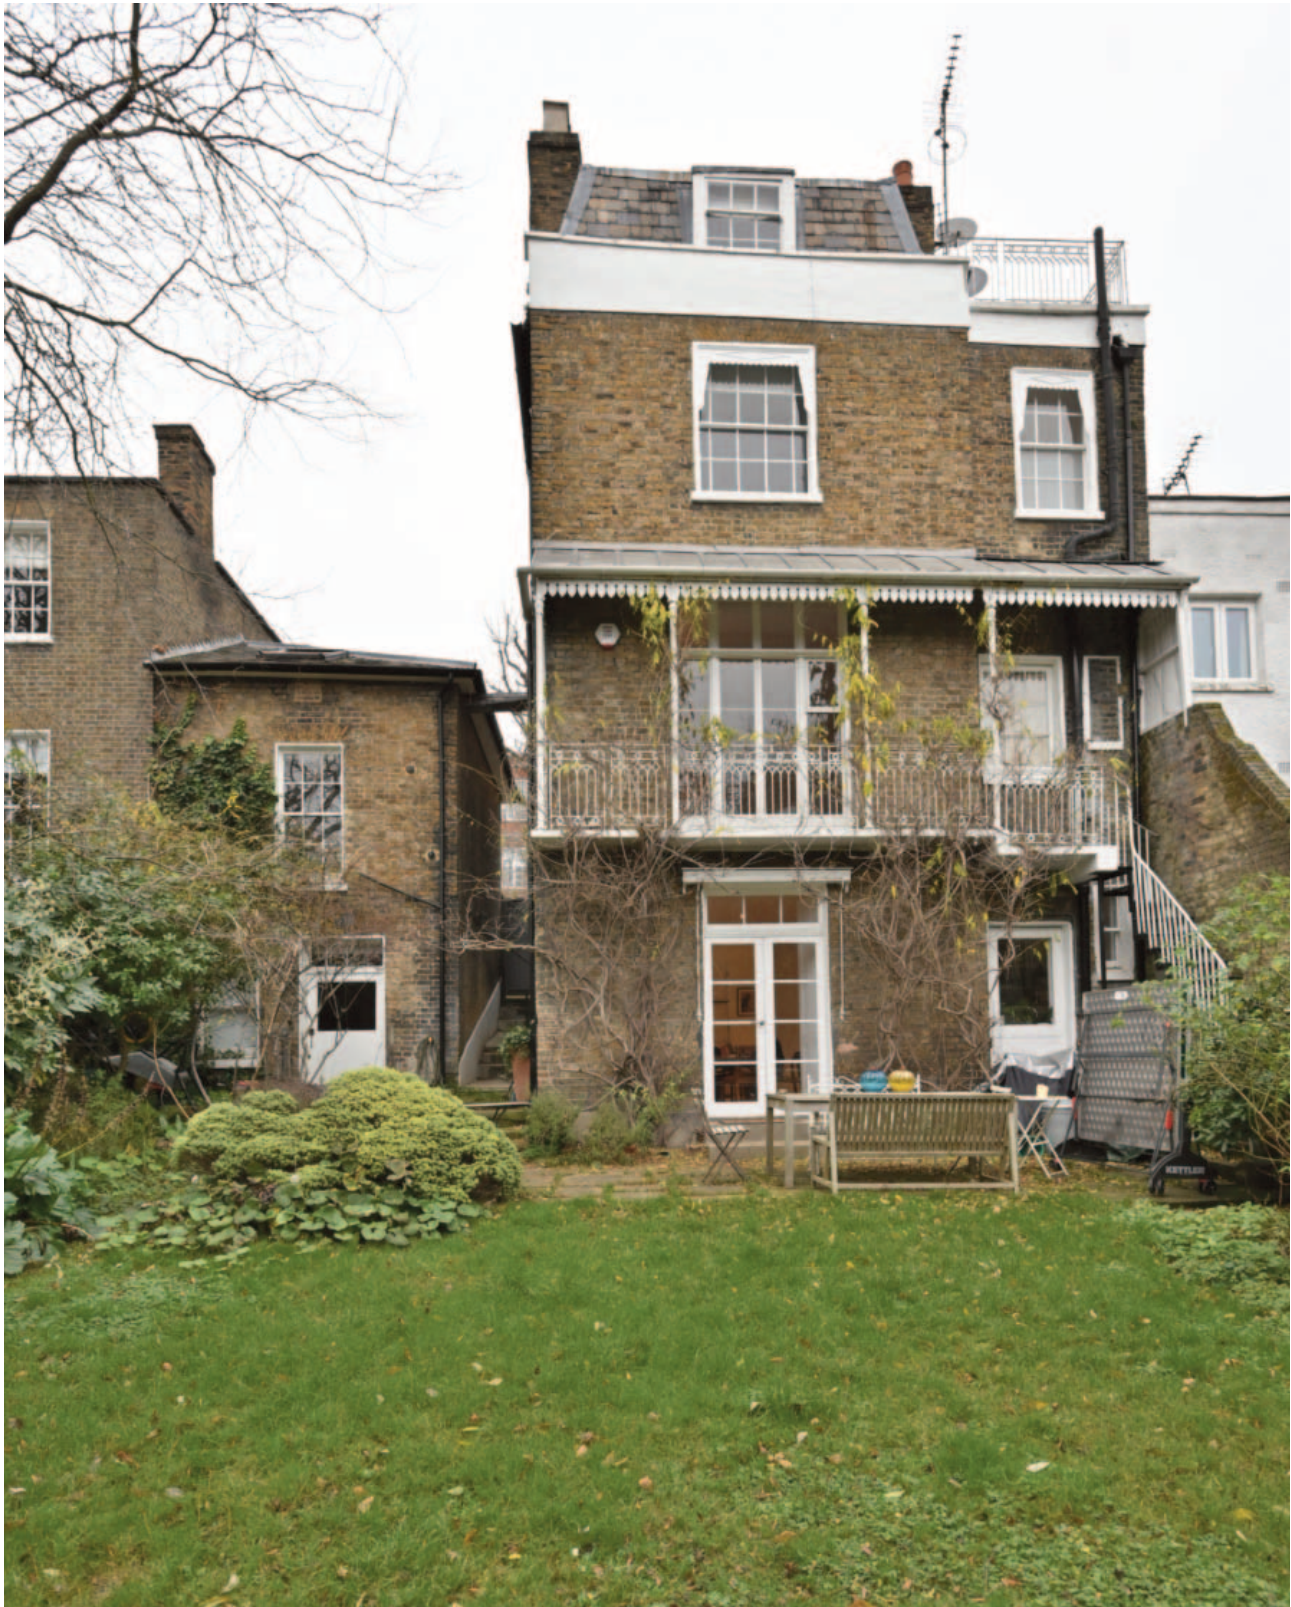
Fig 5. The rear elevation of No 12 with on the left the two storey rear elevation of the adjacent outbuilding separated by the narrow stepped path. Just visible in the distance are the flats on the north side of the lane.

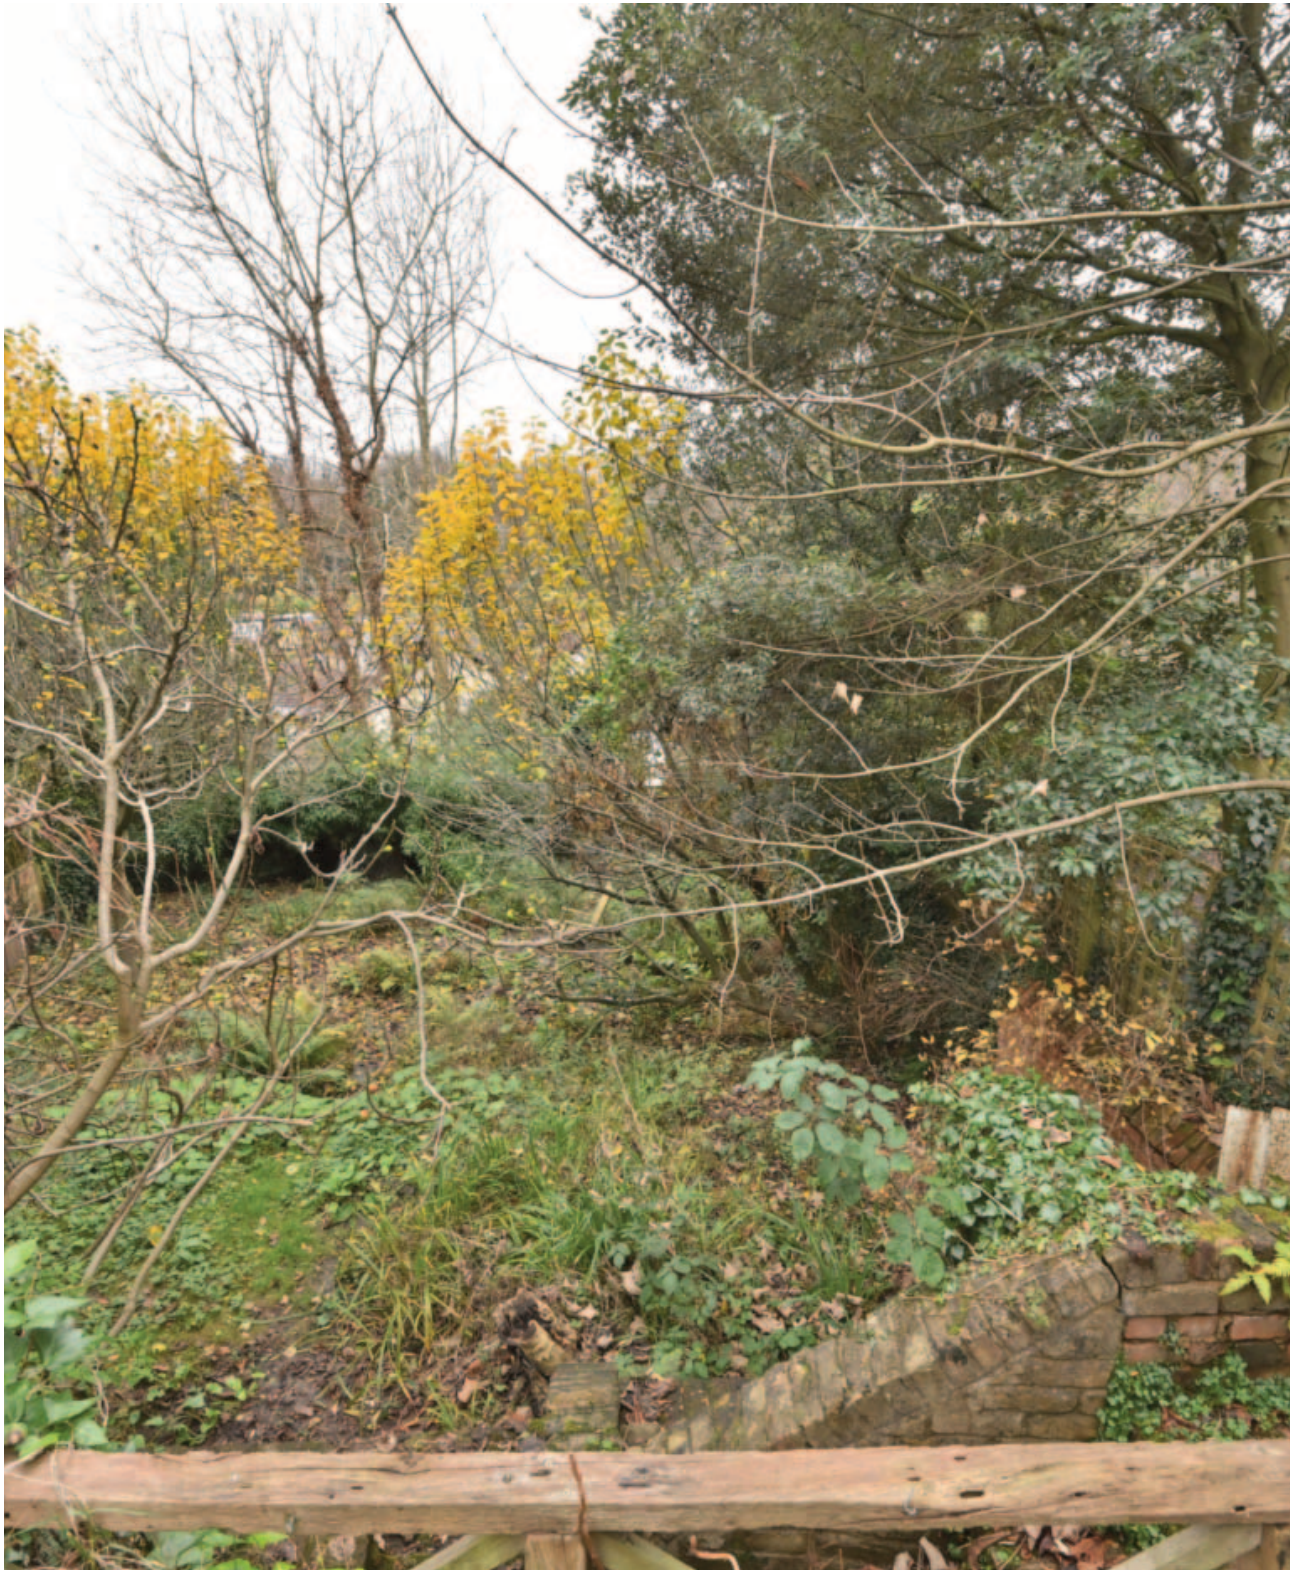
Fig.6. The lower garden terrace with mature shrubs and a small woodland pond. Visible through the trees are the roofs of the houses in Priory Close. The brick steps in the foreground are of mid 20th century date and both the steps and the adjacent boundary wall are of a mix of gault and red brick.

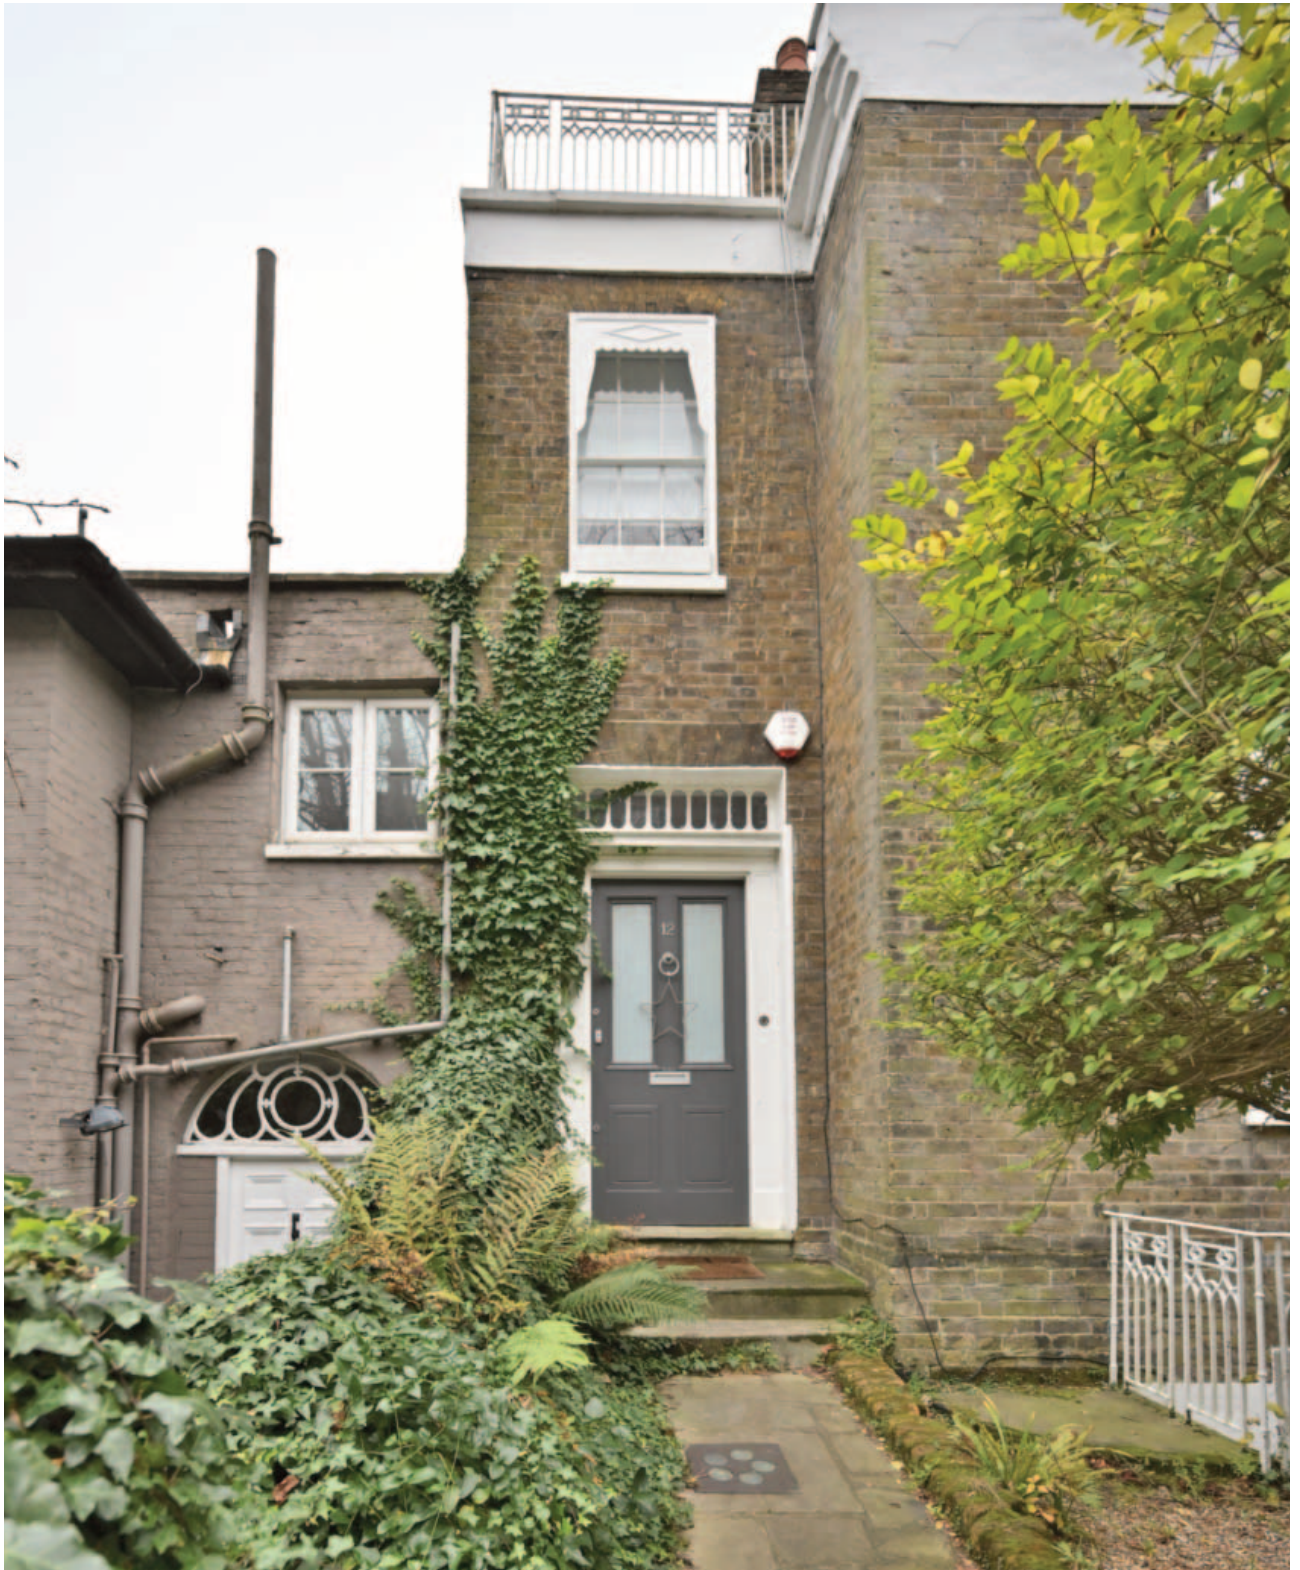
Fig. 8. The front door is located within the recessed side range. The flat roof to this range has 20th century railings matching those round the front lightwell. Its rendered eave cornice is also of 20th century date.

The side wing is set back behind the main range and has a similar but narrower sash of six over six panes, above the front door. Two stone steps rise to the traditionally-detailed front door which is four panelled, the upper panels being glazed with flush beaded panels below, and set within a simple timber doorcase with full height panels to each side, and a narrow simply detailed fanlight above. All the front facing windows have early-mid 19th century external blind boxes. The front facing windows have early-mid 19th century external blind boxes.

The recessed side wing has a lower flat roof enclosed by a metal balustrade which matches the detail to the front basement lightwell but would have been contemporary with the later mansard roof and the heavy rendered eave would have been added at the same time. The west elevation of the principal range has a pair of wide (four shaft) stacks rising against the mansard roof, that would have been raised in height when the roof was changed.

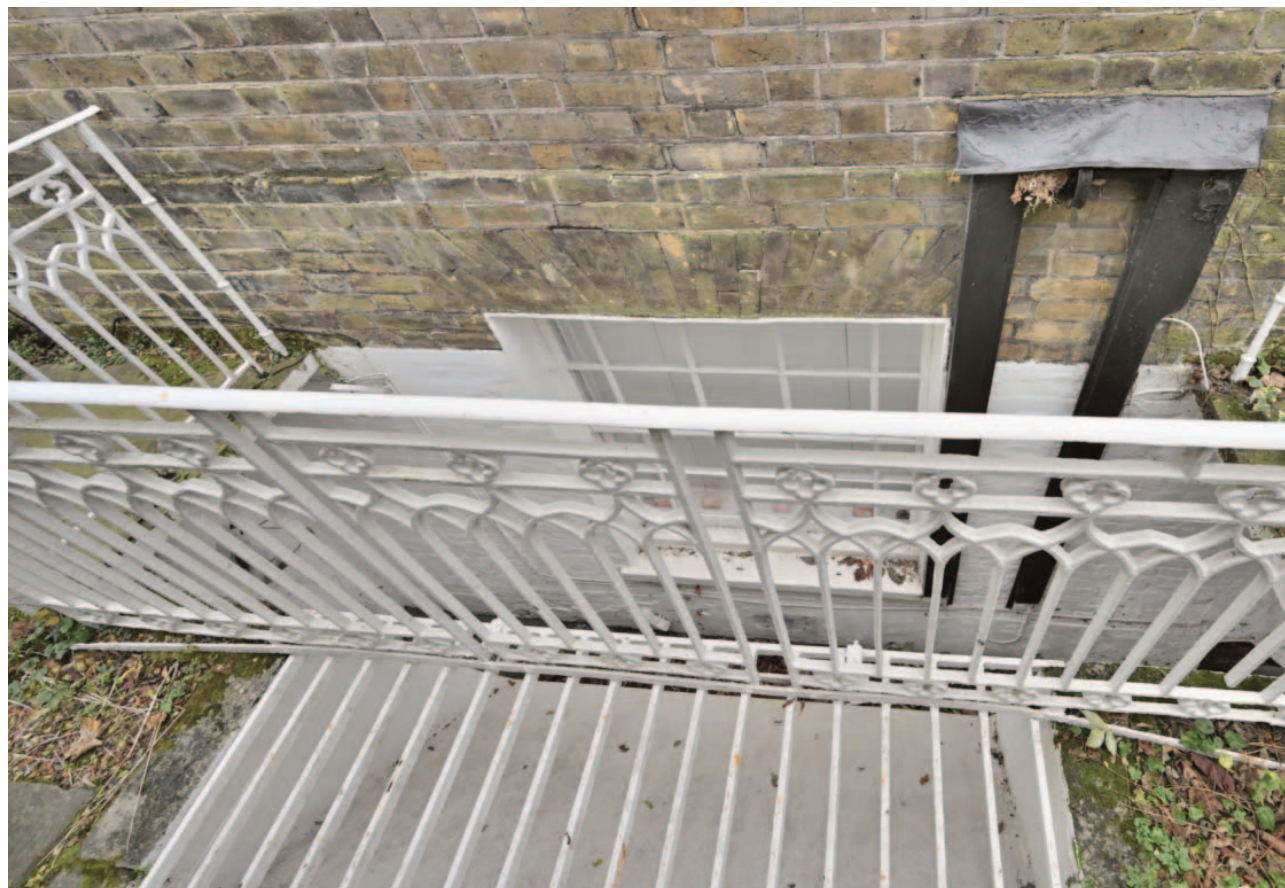
Fig. 9. The front basement window with its narrower outer panes detailed to resemble margin lights. On the right are the remains of a 19th century service hoist on the right. The historic railings round the lightwell, (including an opening gate panel with a pivot) have been reset beneath a later D section handrail.

There is a matching but slightly narrower basement sash window also with narrower panes to either side reading as margin lights, which is set behind a small lightwell enclosed by an original early 19th century cast iron metal balustrade. This is detailed with horizontal rails to the top and bottom incorporating panels with quatrefoils, and balusters linked to form *Gothick* heads rising to the upper quatrefoils. The slightly taller panels to the front incorporate quatrefoils below.

The awkward curved metal strap below the front panels, the pivot detail showing that one panel was used as a gate, and the later D-shaped handrail fixing the panels together all indicate that these have been reset. The rare survival of a 19th century service hoist - albeit without the swinging hoist arm - would have required an access gate through the railings to allow goods to be lowered into the front area, provides additional confirmation that these historic railings have been altered.

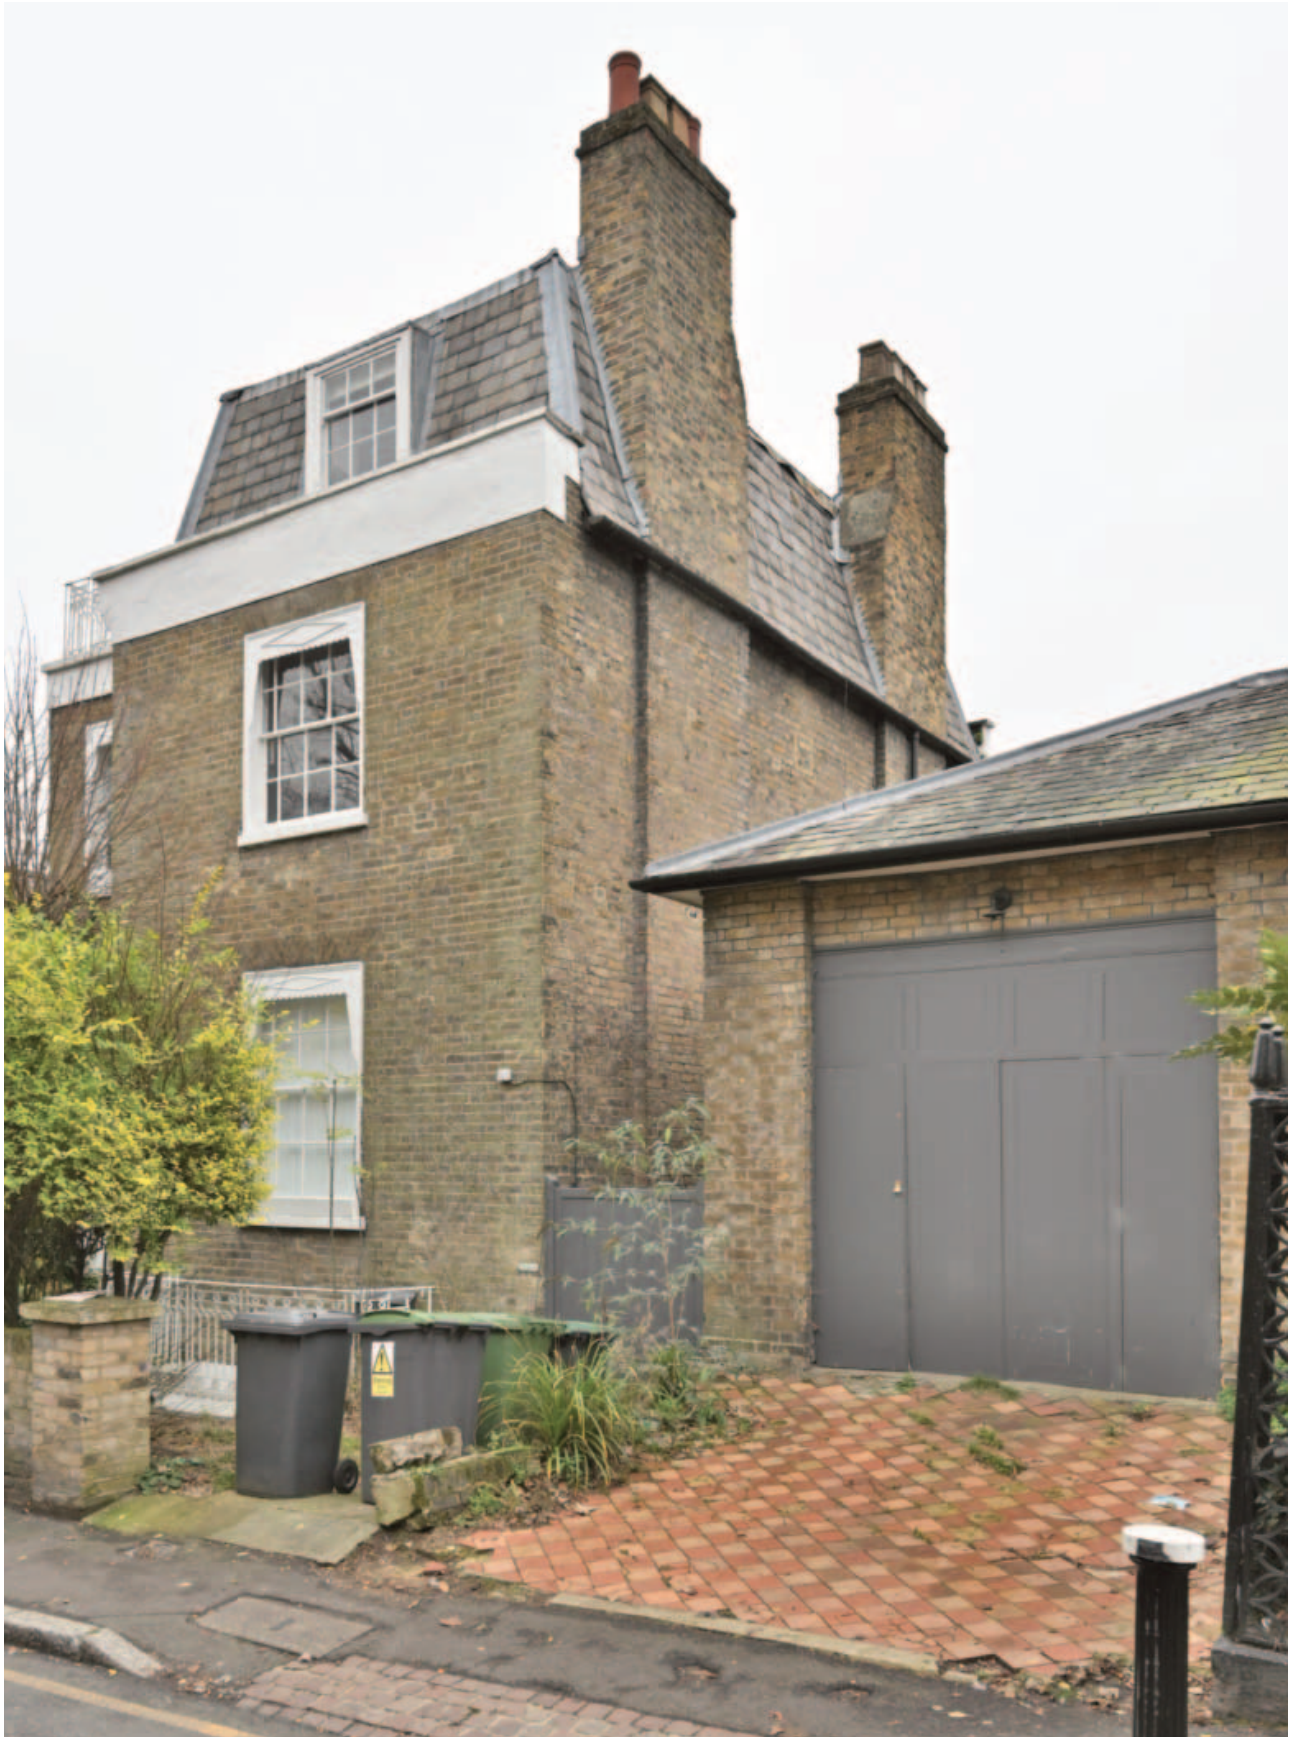
Fig 10. The west elevation of the main house with its two external stacks. Separated by a narrow path to the rear garden and tradesman's entrance is the two storey former coach house and workshop. The building reads as a single storey hipped roofed extension to the adjacent No 10.

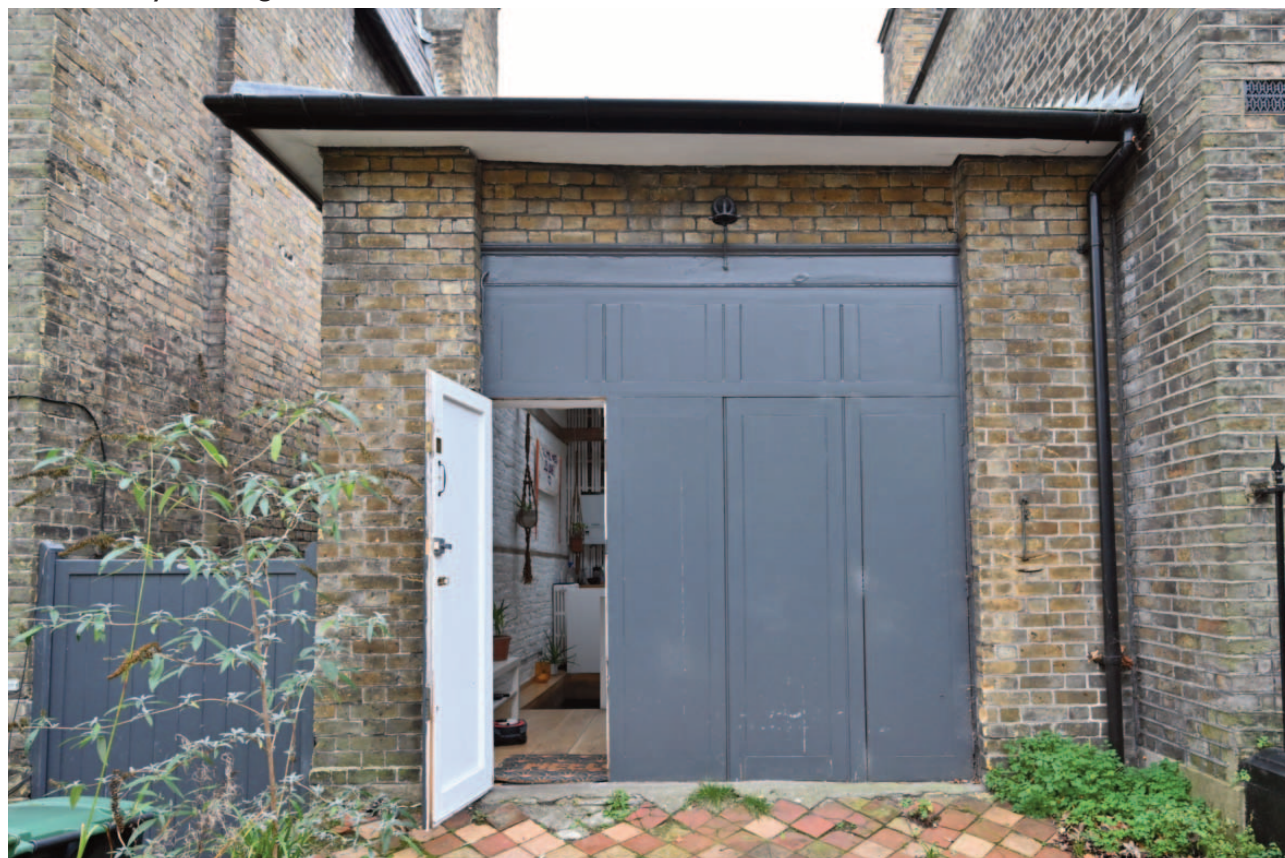
Fig. 11. The opening now reads as a four panelled folding door, but only the left hand door now opens and inside, the building has been converted to provide ancillary living accommodation on both floors.

To the right (west) of the house, the front elevation of the outbuilding is detailed with two c.900mm columns of brickwork that form pilasters to each side of a recessed central panel above the historic door opening. The brickwork is separated by a painted rendered panel (concealing a lintol) from the timber panelled screen detailed to read as tall folding flush panelled doors with four fixed identically detailed panels above a timber transom. The doors have been altered to provide one opening door to the left and three matching fixed panelled doors to the right. Above is a hipped slated roof with a wide projecting eave with a plastered soffit. In front of this elevation is a sloping ramp laid with modern clay rectangular tiles.

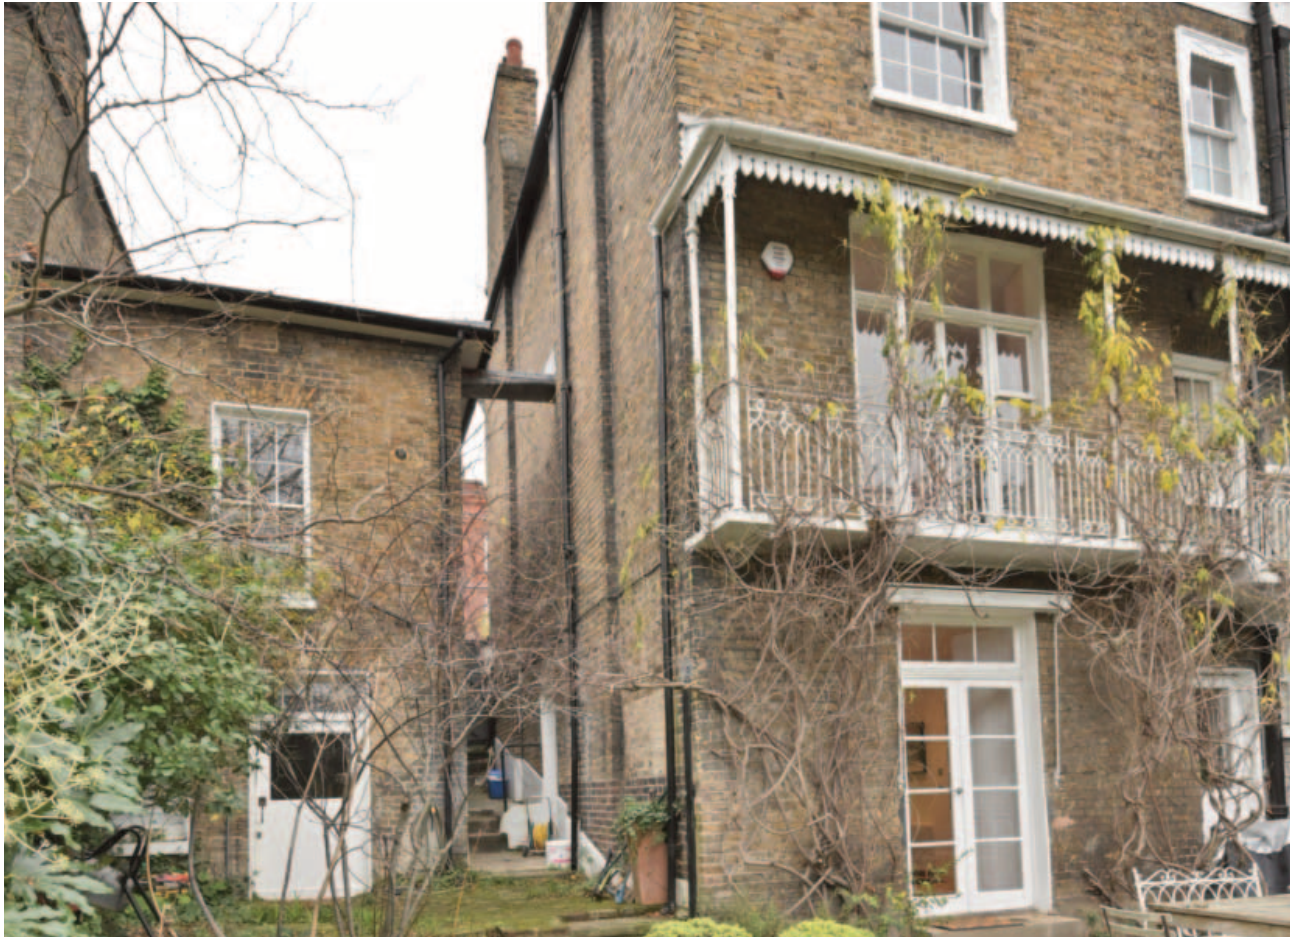
Fig. 12. The rear elevations of the outbuilding and main house separated by the sloping stepped path to the garden and tradesman's entrance. Just visible beyond is one of several blocks of 20th century brick flats.

A modern framed and vertically boarded gate separates the outbuilding from the main house and this opens onto an irregular flight of concrete steps that leads down to the raised terrace with herring bone brickwork at the rear of the outbuilding. A slightly lower paved terrace extends round the rear of the main house. A tall side door almost centrally positioned on the side elevation of the main house opens onto the stepped passageway. The arch above the opening has been rebuilt and the existing door is a later replacement and its slender proportions suggest that the path may have been lowered slightly - perhaps when the base of the wall was rendered as part of damp-proofing works.

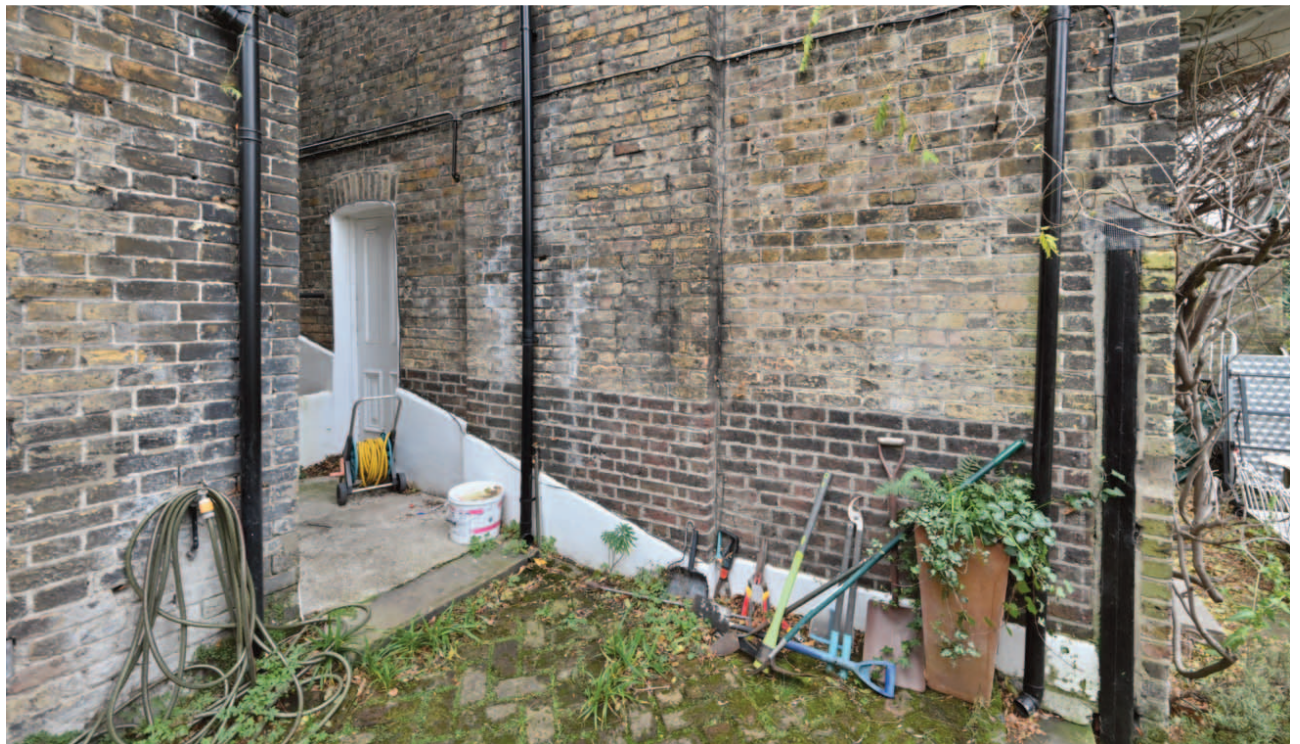
Fig. 13. The former tradesman's entrance with a low wall that extends partly across the steps on the left. This was presumably to prevent water running off the steps into the house. Note the change in brickwork at the base of the wall, and the later cement plinth presumably added as part of damp proofing works.

This tradesman's entrance door is currently blocked internally, but historically would have opened into a passage running between the two lower ground floor service rooms which would have been a kitchen overlooking the garden and a basement pantry or larder at the front. To each side of the door are wide full height shallow brick columns marking the positions of the two external stacks that rise above eave level as a pair of tall four shaft chimney stacks. To the right of the door the lower c.1m of brickwork (including the base of the right hand stack) appears to have been rebuilt in red bricks. A later cement rendered "plinth" on either side of the stepped path conceals the base of both elevations. The stacks would have been raised when the taller mansard roof was introduced.

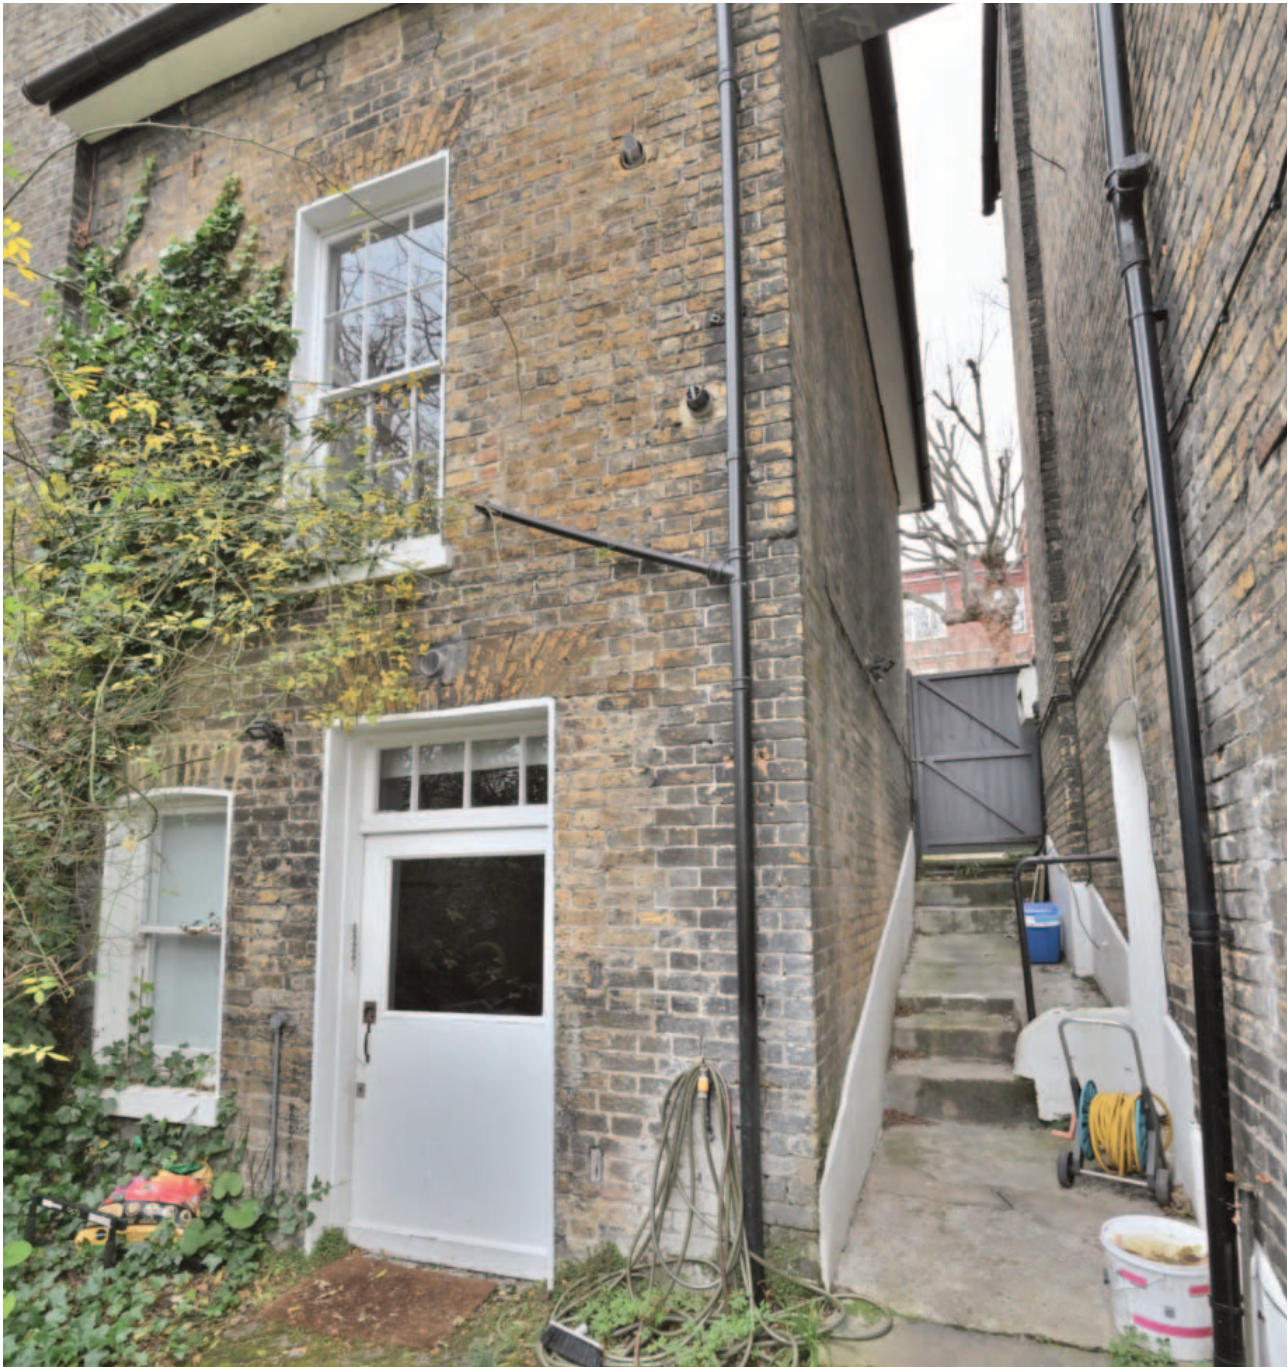
Fig. 14. The tall former stable door and later window (with the arched brick head) at ground floor level. The low wall adjacent to the side door of the main house was presumably to keep out rainwater from the path.

The rear elevation of the outbuilding has an off-centre doorway at ground floor level below a central six over six pane sash window at first floor level both within historic openings detailed with a flat brick arch. A large pane inserted sash window at ground floor level has a modern shallow arch of brick headers and a heavy painted cill; the adjacent door is also a modern replacement. It is likely that this lower floor was built as a stable for the coach house above and the window was added later.

The passage would have originally been a sloping path in order to provide access to the stable, but it would not have been an ideal even for small horses, and it is likely that the stable and coach house use had ceased by the time Highgate station opened in 1867 providing more convenient local travel.

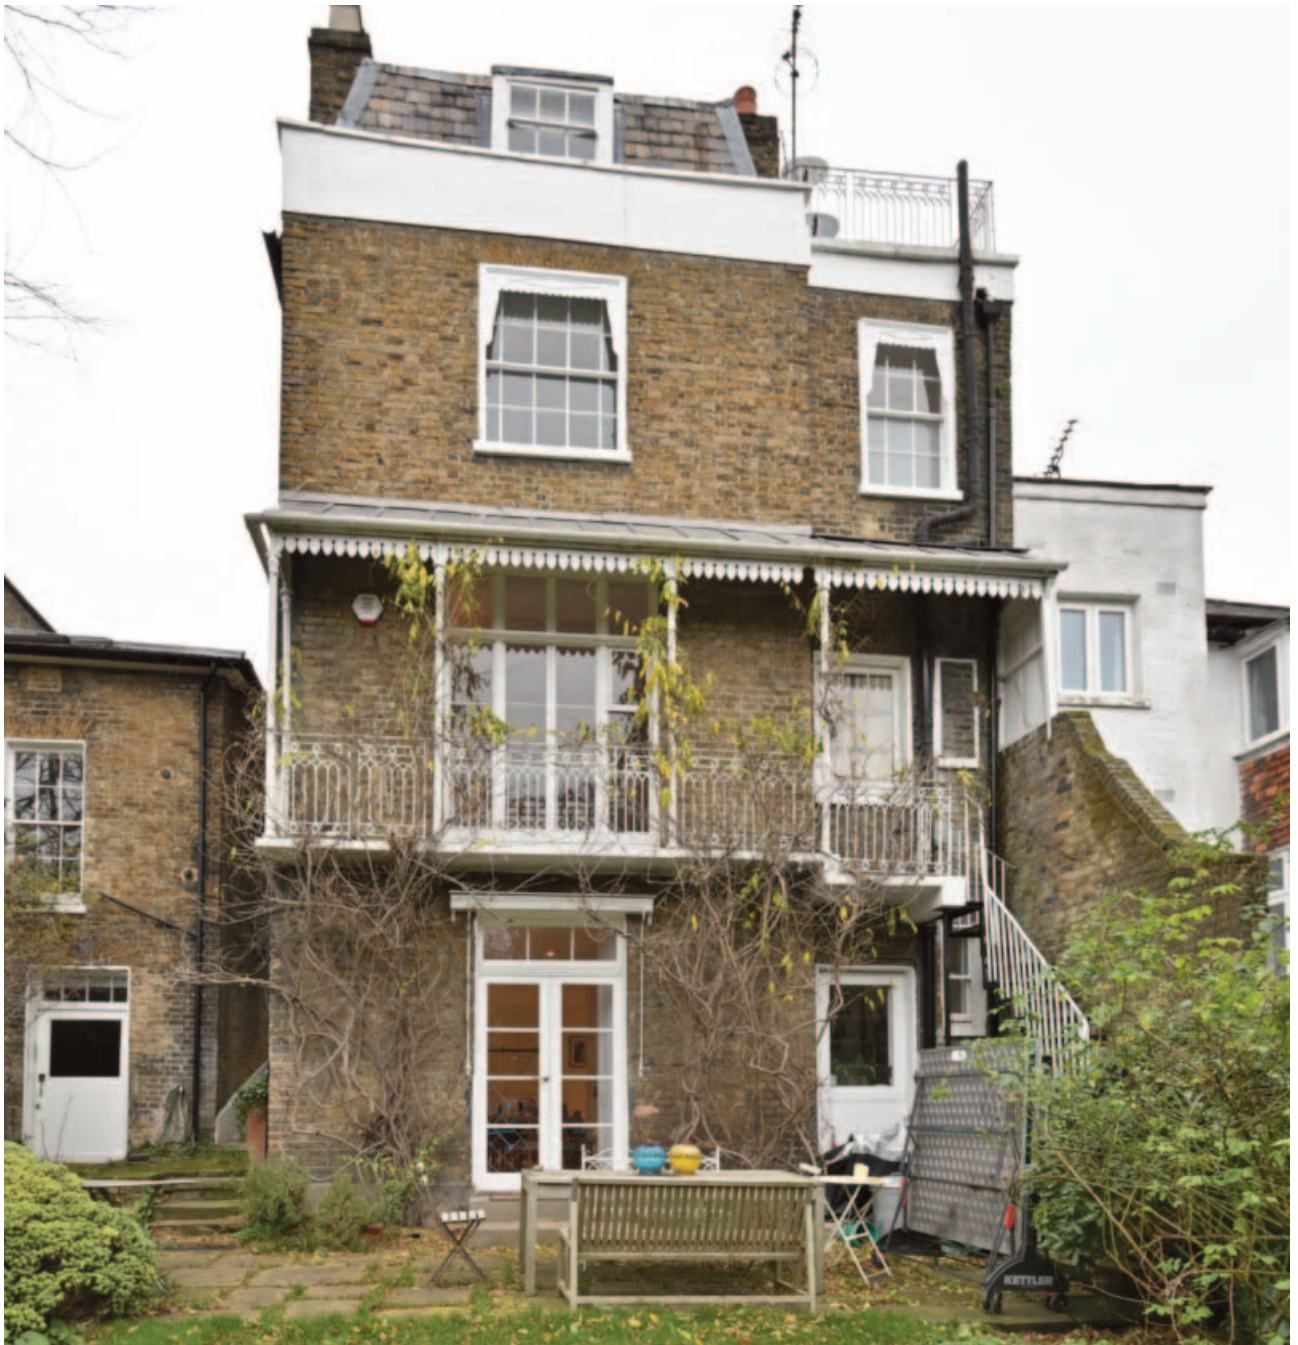
Fig. 15. The rear of the main house with inserted French doors replacing a sash window to the semi-basement floor and the partly rebuilt verandah with its cast concrete deck and replacement staircase and roof.

It is likely that the lower terrace along the rear of the main house was lowered by c.0.4m, (presumably as part of damp proofing measures) and that the newly exposed brickwork was cement rendered, continuing the rendered plinth detail along the gable wall. Two concrete steps lead up to a pair of centrally positioned French doors in the rear elevation. These French doors, which open into the former lower ground floor service room, are assumed to have replaced a sash window. They are fully glazed with four panes to each door, with a three-paned transom light above; and a traditionally-detailed awning above the opening cuts across its flat brick arch.
