No 12 Wood Lane Highgate.

## Revised Statement of Significance & Heritage

JME Conservation Ltd.

September 2022

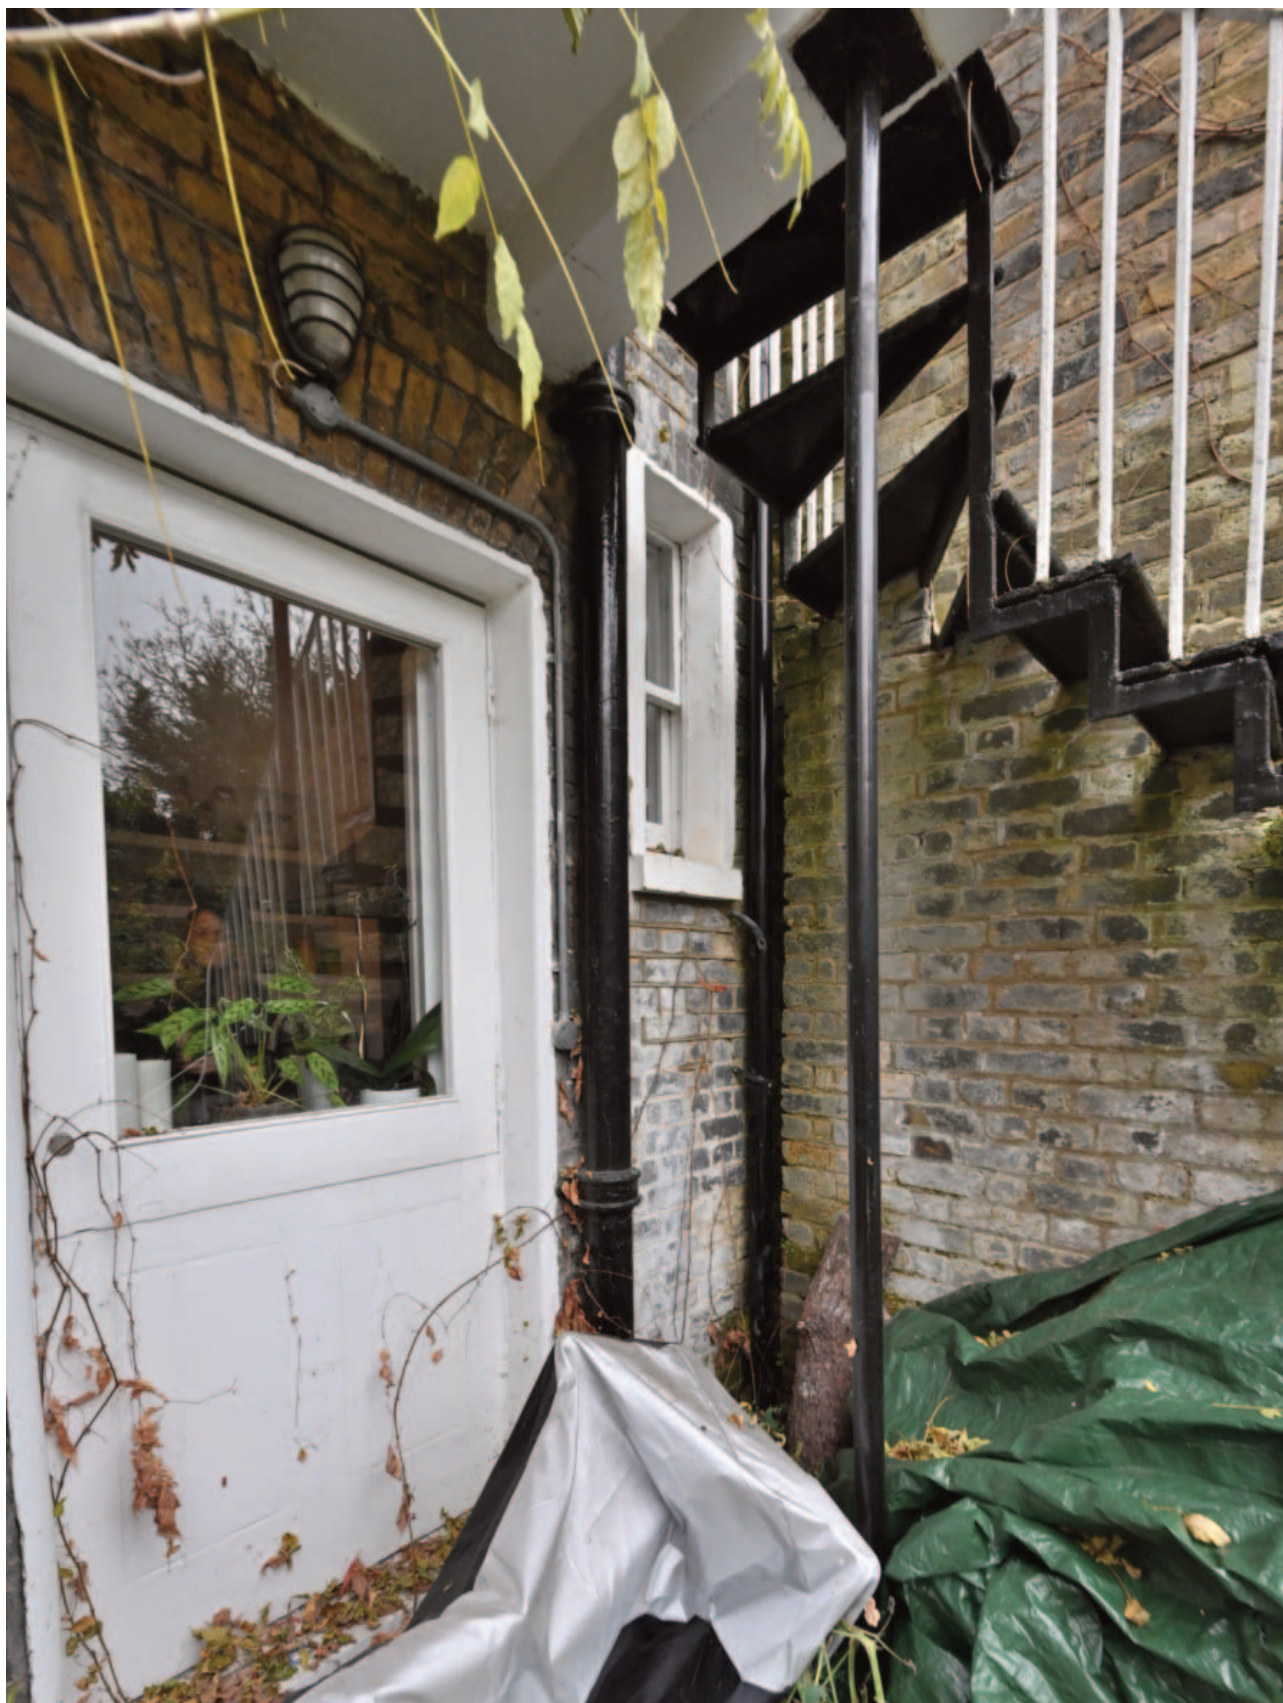
Fig. 16. The historic flush panelled door is inserted into an deepened former window (originally matching the window above), probably as part of the 1947 flat conversion because it has a slender wooden door-frame. It has subsequently been fixed shut and replaced above the lock rail by a modern side hung casement. In the foreground is a modern steel post supporting the replacement concrete balcony floor.

To the right of the principal range is the recessed side wing which contains a blocked flush panelled door which has been replaced above the lock rail by a modern side hung casement. To the right is a small historic window with a flat arched head which is mirrored but blocked in at first floor level. An external staircase rises against the garden boundary wall to a first floor level balcony that extends across the full width of the rear elevation. Both the staircase and balcony have been extensively repaired in the mid 20th century, as has the adjacent section of gault brick boundary wall.

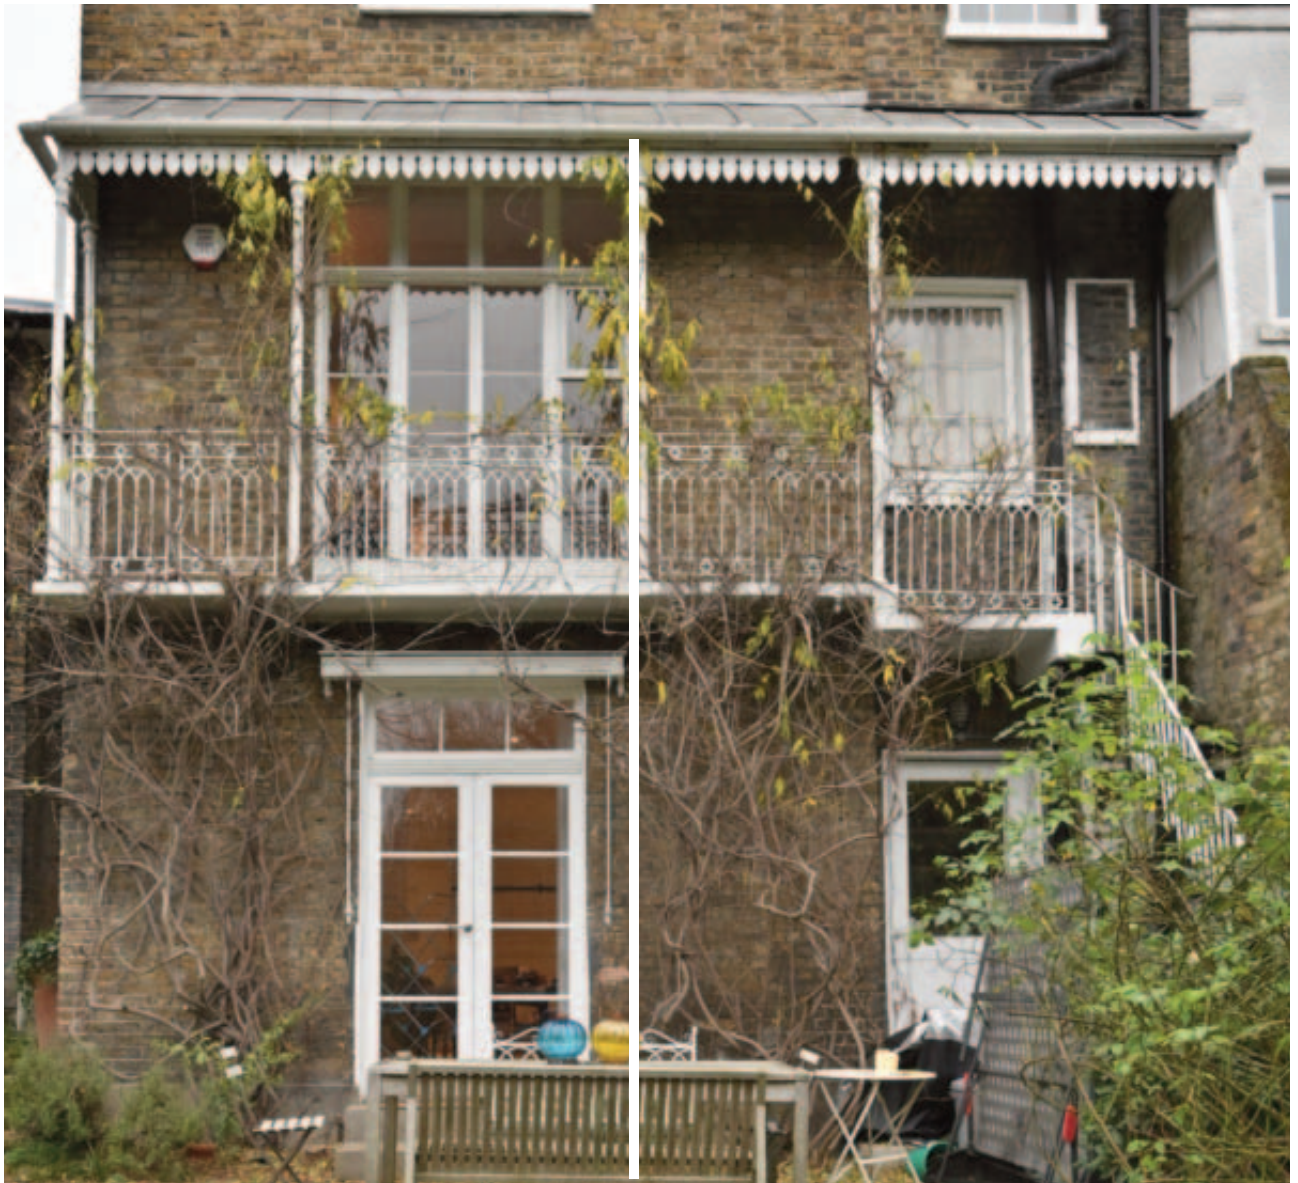
Fig. 17. The balcony retains its historic balustrade and decorative fluted cast iron posts and fretwork. The roof and deck are modern as is the additional corner post support adjacent to the stairs. Above the stair are the remains of a timber casement attached to the wall in front of a blocked window (which retains its flat brick arched head) matching the surviving window at semi-basement level below.

The balcony was largely rebuilt during the repairs and it has a cast concrete deck that steps down in front of the side range and a modern roof structure. The structure is supported on replacement metal brackets, and a clearly-modern metal post adjacent to the (replaced) staircase. The balustrade appears to be historic and is formed using cast iron panels set between slim fluted cast iron posts with floral capitals, embellished by simply moulded timber fretwork between the capitals and at the eave to the canopy. These details appear to be reused from the original early 19th century structure, although they are still available from specialist foundries and joiners.

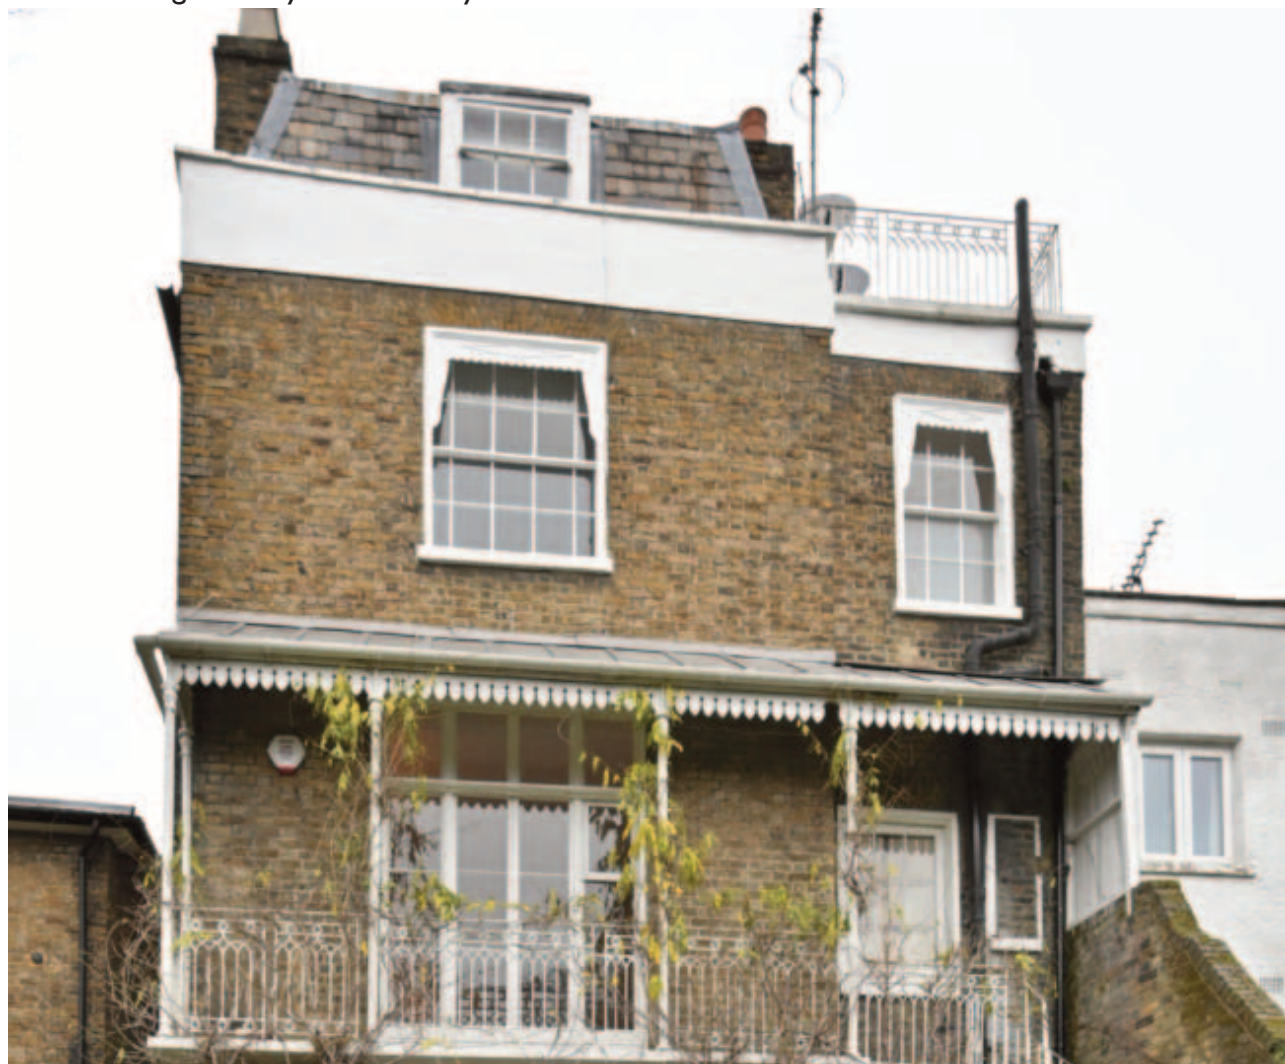
Fig. 18. The first floor windows retain their original external blind boxes and sashes. The attic windows are modern, and rendered has been partly rebuilt and the wrought iron balcony has been reset.

At second floor level on this elevation, (first floor level internally) the window openings to both the principal range and side wing are centrally positioned on their respective elevations, and contain an eight over eight paned and a narrower six paned sash window respectively. Whilst the glass in these windows is modern, they match the first floor windows on the front elevation, and both windows retain their original early 19th century external blind boxes.

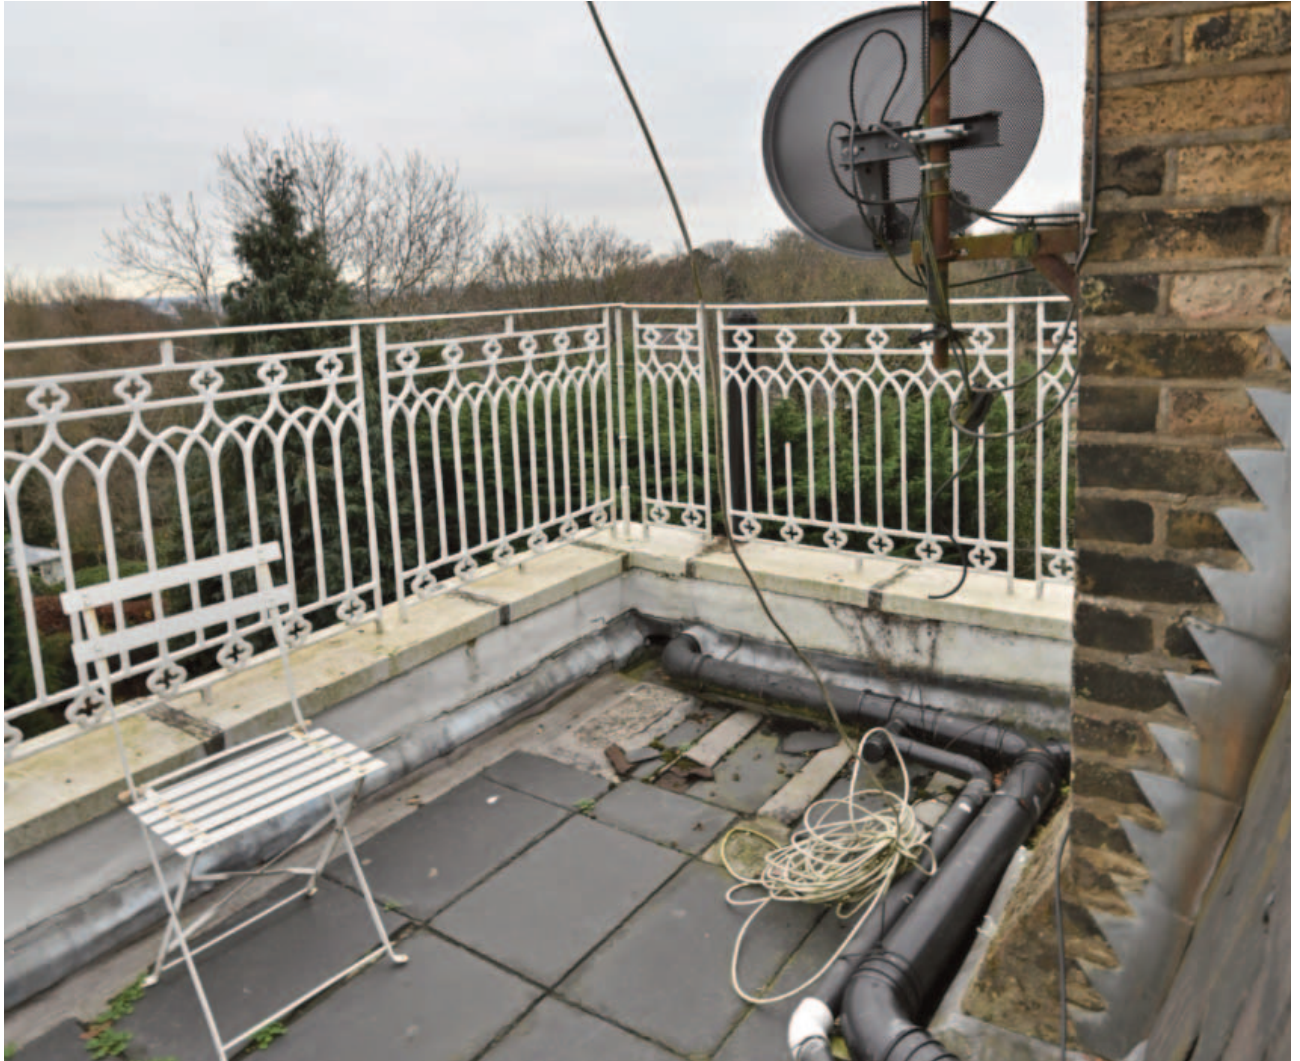
Fig. 19. The parapet to the flat roof of the east wing has been partly rebuilt in the later 20th century and the railings reset. The D-section handrail is a later alteration although the panels appear historic ones.

As with the front elevation, a band of cement rich render has been applied to the rear parapets to both the principal range and the side wing, and they have concrete copings. The centrally positioned attic dormer window to the central range has a three over six paned sash window matching that on the front elevation; whilst the side and rear elevations of the flat roof of the side wing have the same matching railings to those on the front elevation. All have been reset beneath a later D-section handrail and the parapet has a painted artificial(?) stone parapet coping.

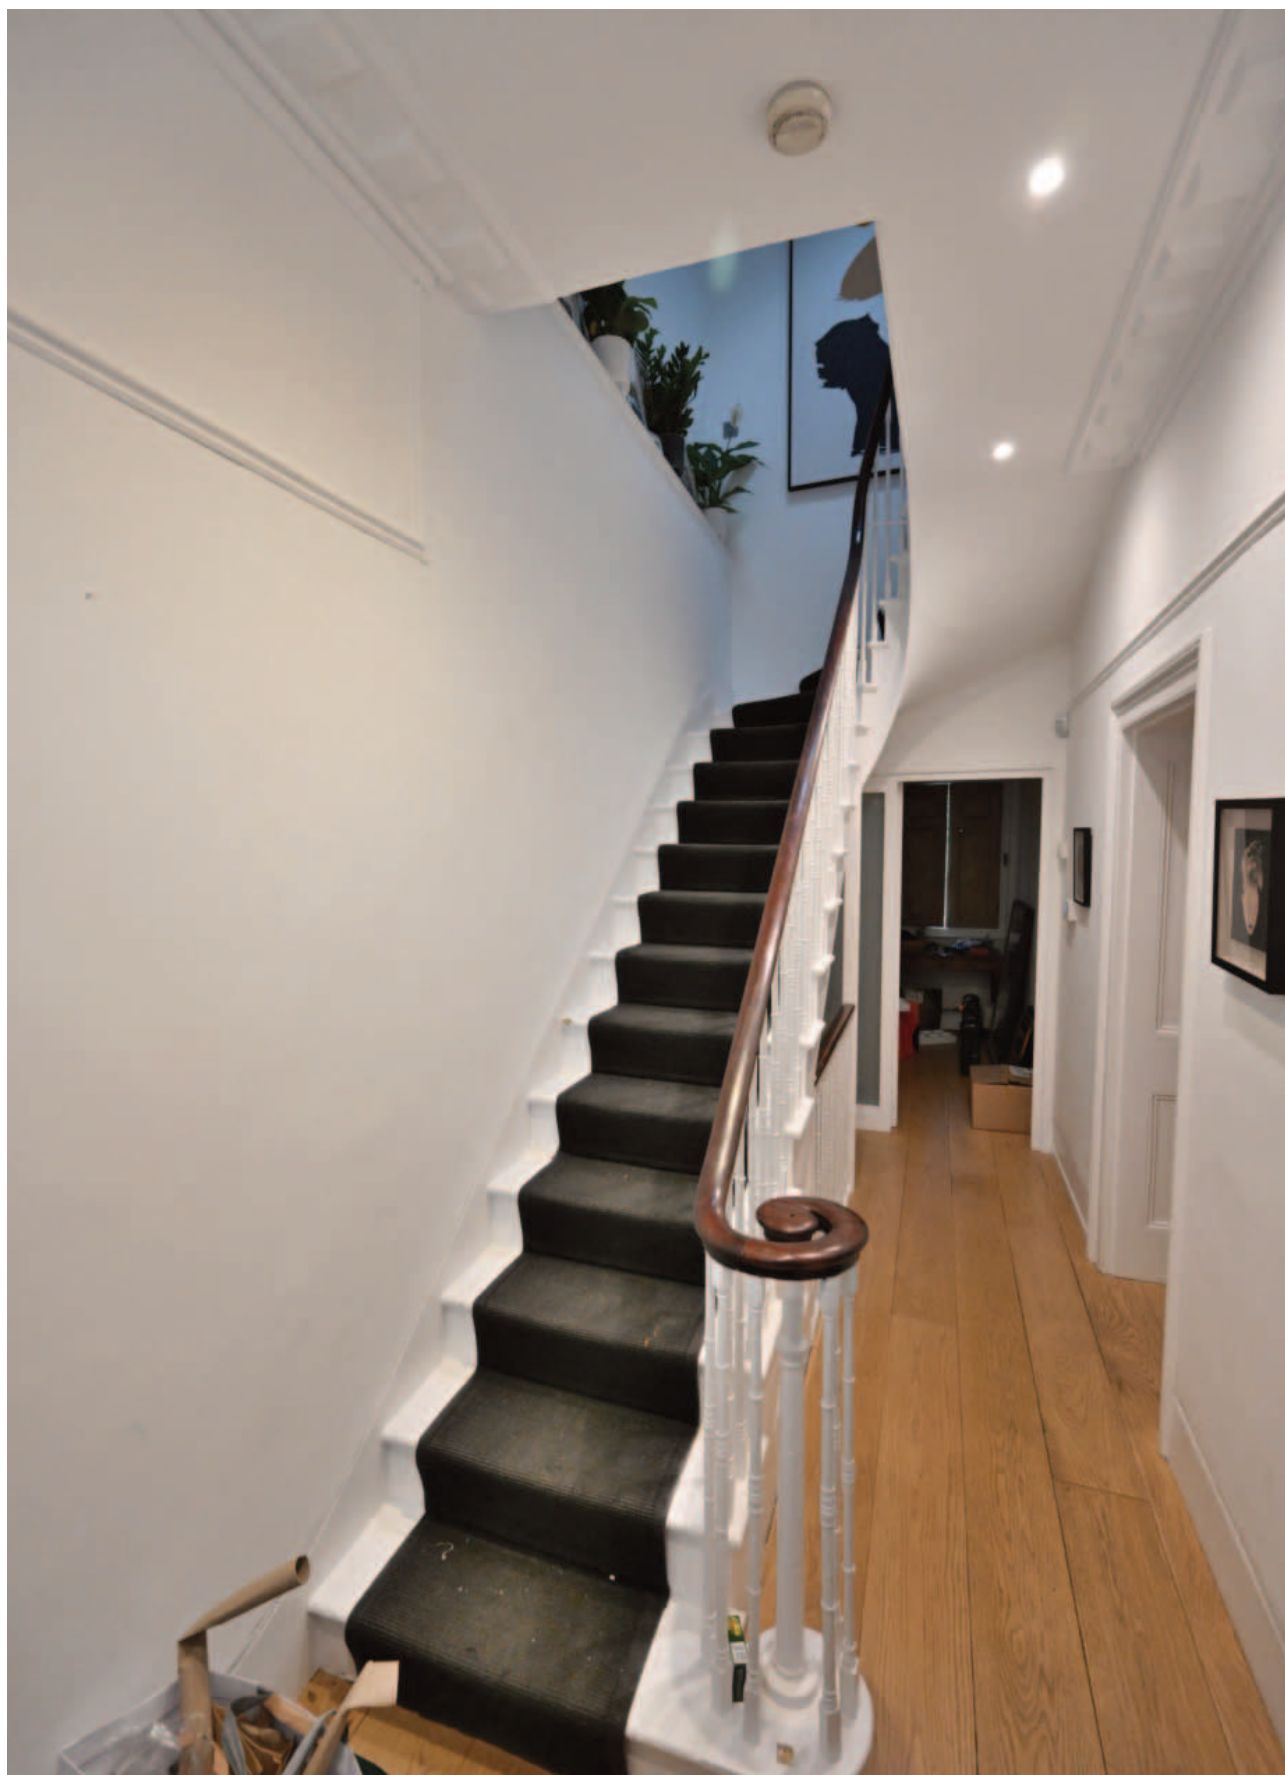
Fig. 20. The entrance hall with its dentilled cornice and elegant staircase. On the right is the door into the principal reception room with its fine architrave and panelled lining. The floor has modern overboarding.

The hall has a heavily overpainted dentilled cornice set between reeded mouldings, with the addition of a later moulded picture rail. It has a flush double-beaded skirting although some sections have been renewed in a triple bead, and the historic boards have been overlain by a later 20th century wide over-boarded finish, which has been carried across all the ground floor rooms. To either side of the front door are boxing and a small cupboard for services and a recess marks the position of the now-blocked door into the north room.

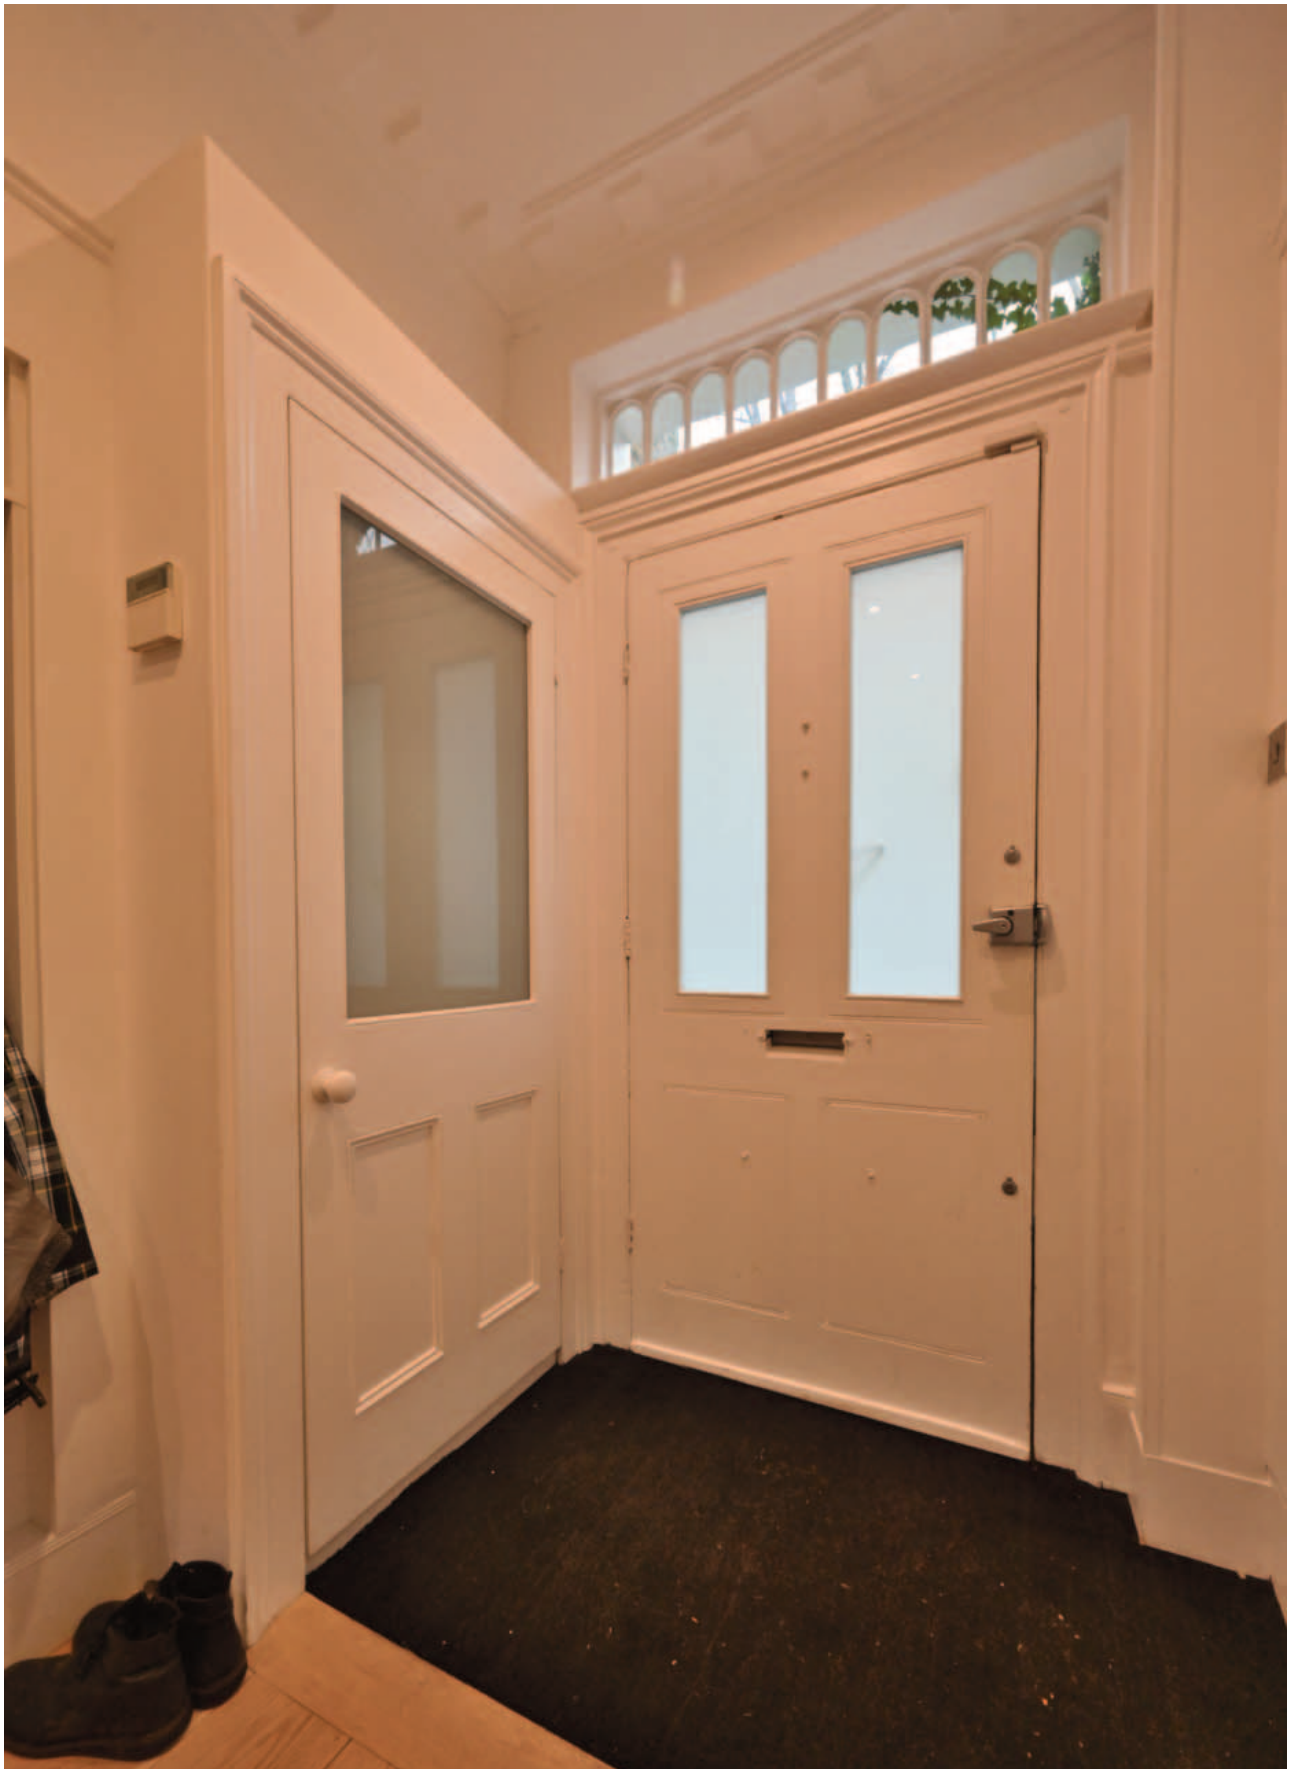
Fig. 21. Immediately adjacent to the front door is a modern cupboard containing services - perhaps reusing the architrave & door from the adjacent blocked doorway into the front room, which is now an open recess.

Within the entrance hall the unsightly meter cupboard will be removed following creation of the new plant room within the basement of the outbuilding, and a new jib door will be introduced to the adjacent recessed opening to form a small cupboard. The crude modern newel at the head of the basement stair will be replaced by a carefully detailed newel replicating the historic form, and the glazed partition between the basement stair and rear room will be replaced by a solid partition incorporating a pocket sliding door. The small room will be reinstated as a cloakroom and W.C. The existing double doors between the north and south principal rooms will be re-hung to open into the south room and fixed open.

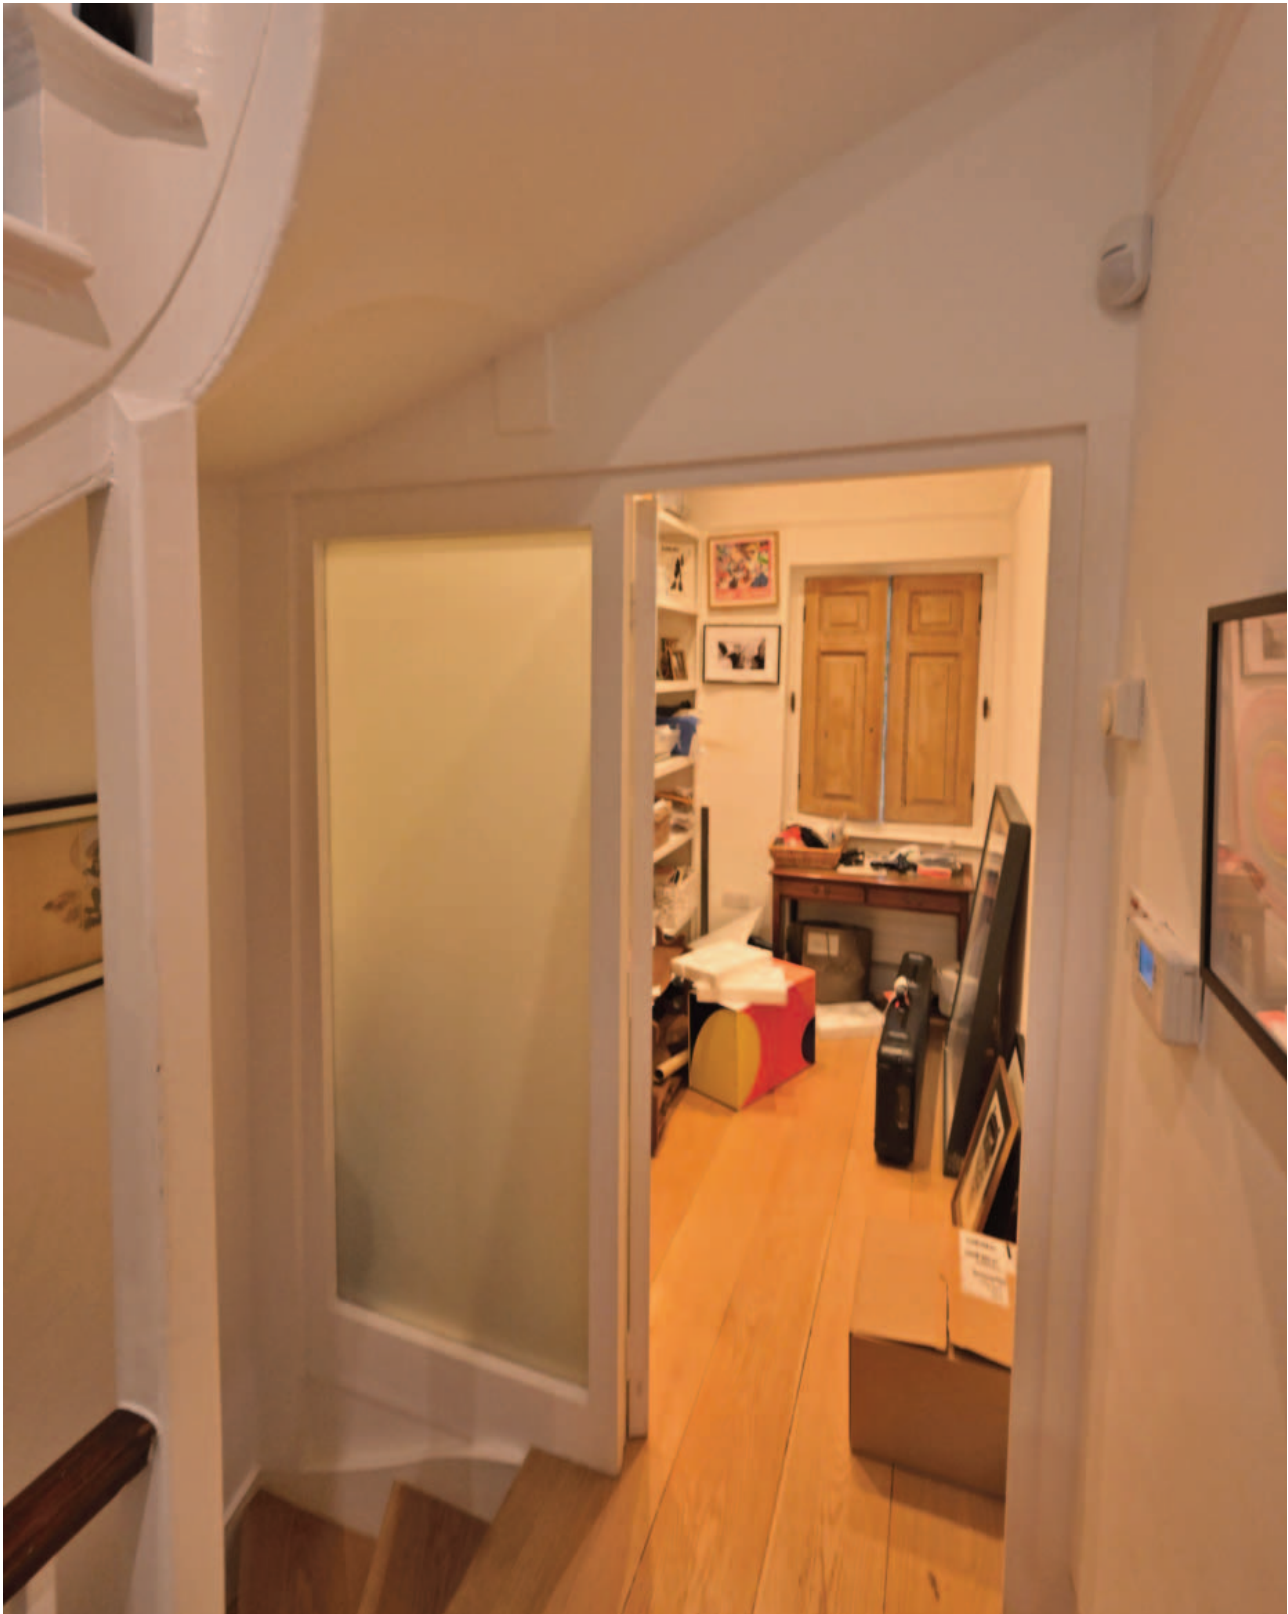
Fig. 22 The former historic W.C. and cloakroom at the south end of the east wing. The glass partition and door replaced a wall and door when the basement staircase was opened up. Only the shutters are historic.

At the south end of the hall, the doorway into an early inside W.C. and adjacent cloakroom has been replaced by a modern opaque glazed partition and door. The original W.C. window has been blocked and the partition removed so that the only remaining historic detailing is a pair of reset historic shutters in front of the later 20th century 9-paned casement. There was a similar W.C. in the basement.

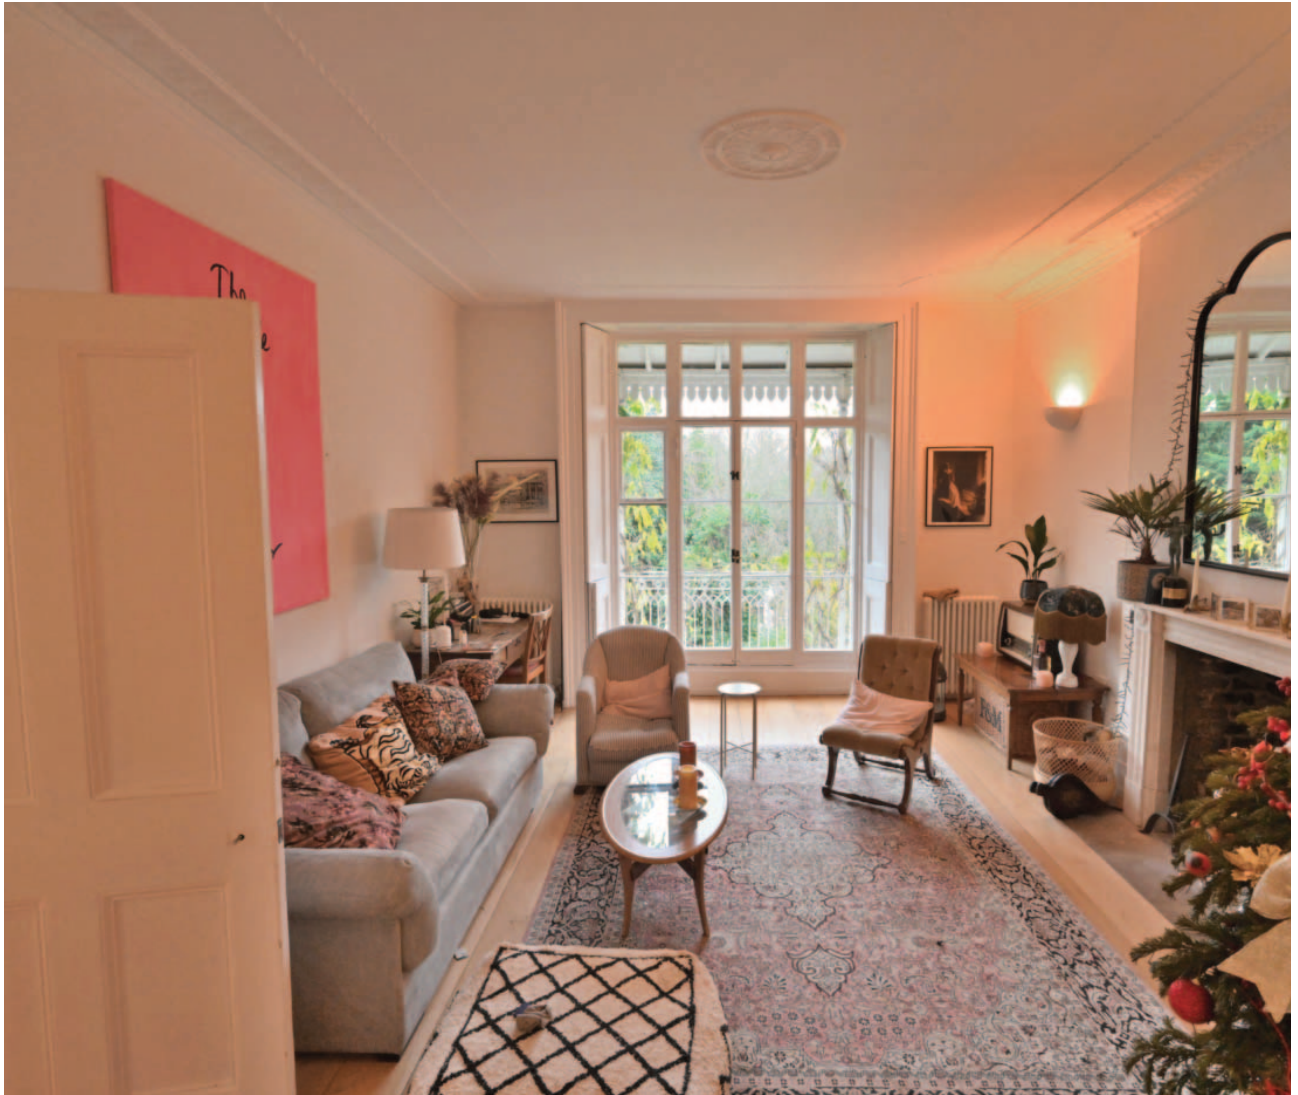
Figs. 23. The principal ground floor reception room with its restrained ceiling rose and foliate and beaded cornice. The inner band of elongated bellflowers on the ceiling bed is a later introduction. The marble fireplace and hearth appear to be original but reset on the modern overboarded floor.

The ceiling retains its historic but heavily overpainted moulded plaster cornice, detailed with a wide band of enriched plasterwork with foliate decoration, which is set between moulded beads, including a deeper roll with egg and dart egg and dart decoration to the lower bands. There is a later moulded strip of elongated bellflowers applied to the ceiling bed which is inset from the cornice; and an apparently original and typically small-scale early 19th century central ceiling rose detailed with a circle of narrow oak leaves surrounded by a ring of reeds and floral bosses.

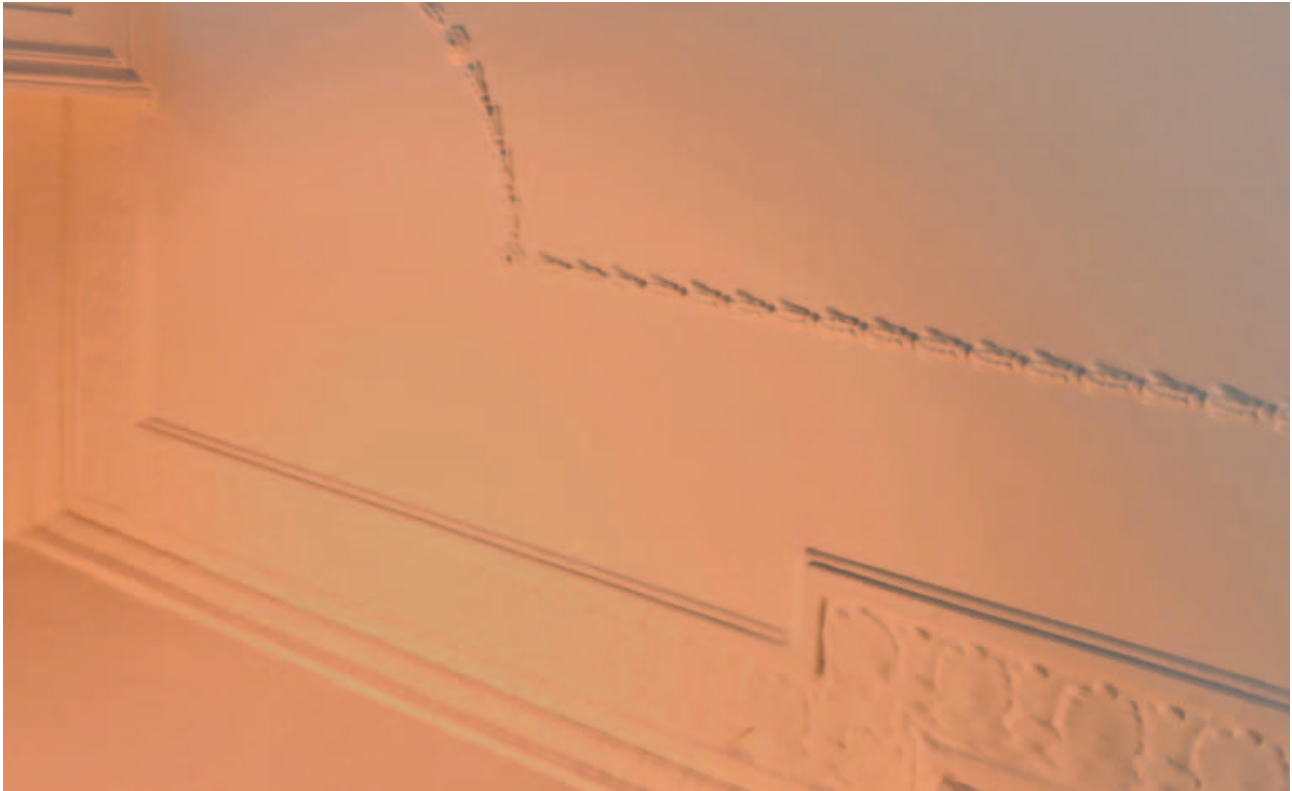
Fig. 24. Detail of the heavily overpainted ceiling cornice, with the later foliate addition on the ceiling bed.

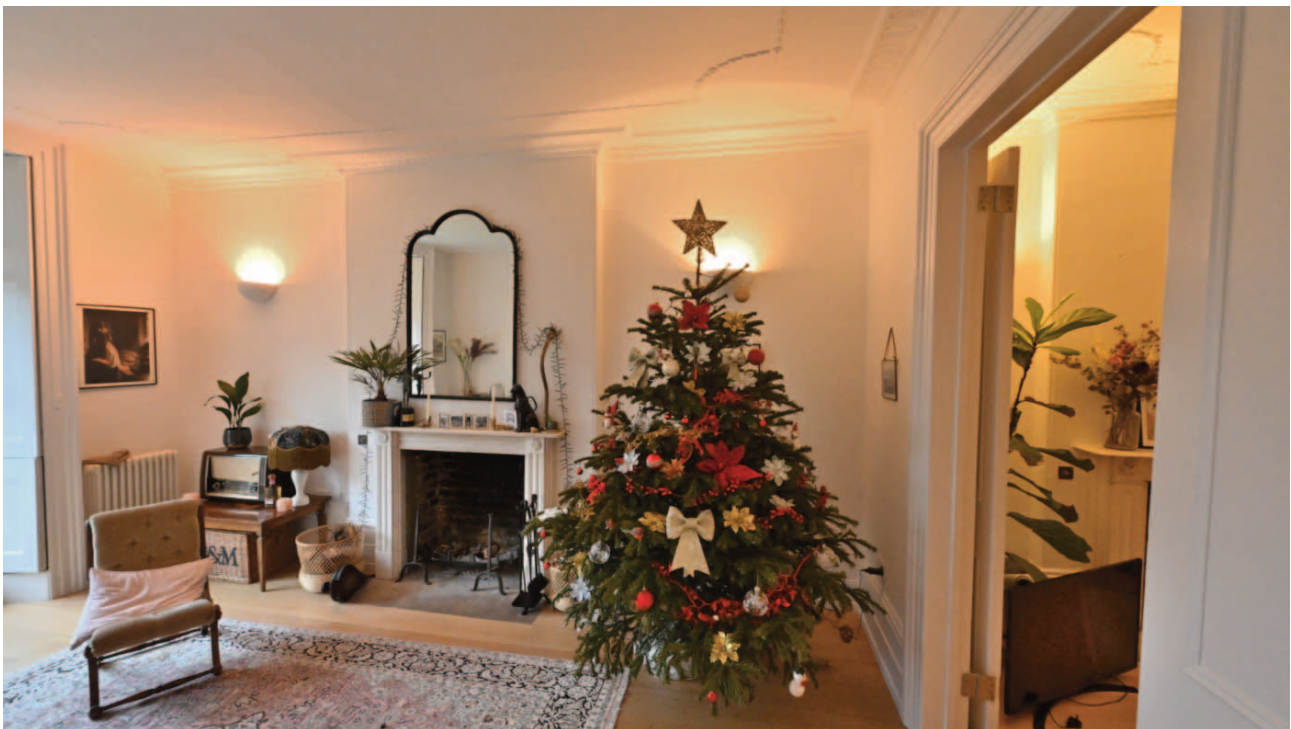
Fig. 25. The reset marble fire surround and hearth with the similar fireplace and cornice just visible on the right in the smaller front room.

The room has deep (c.300mm) skirtings detailed with rolls, triple beads and a stepped profile. A low step round all the skirtings in these two principal rooms may be a later introduction contemporary with the introduction of the modern floor finishes. The chimney is centrally positioned against the east wall, and has a well detailed early 19th century marble fire surround with reeding to the jambs and frieze, and floral corner roundels. The insert is missing and both the surround and hearth have been reset, presumably in association with the introduction of new floor finishes.

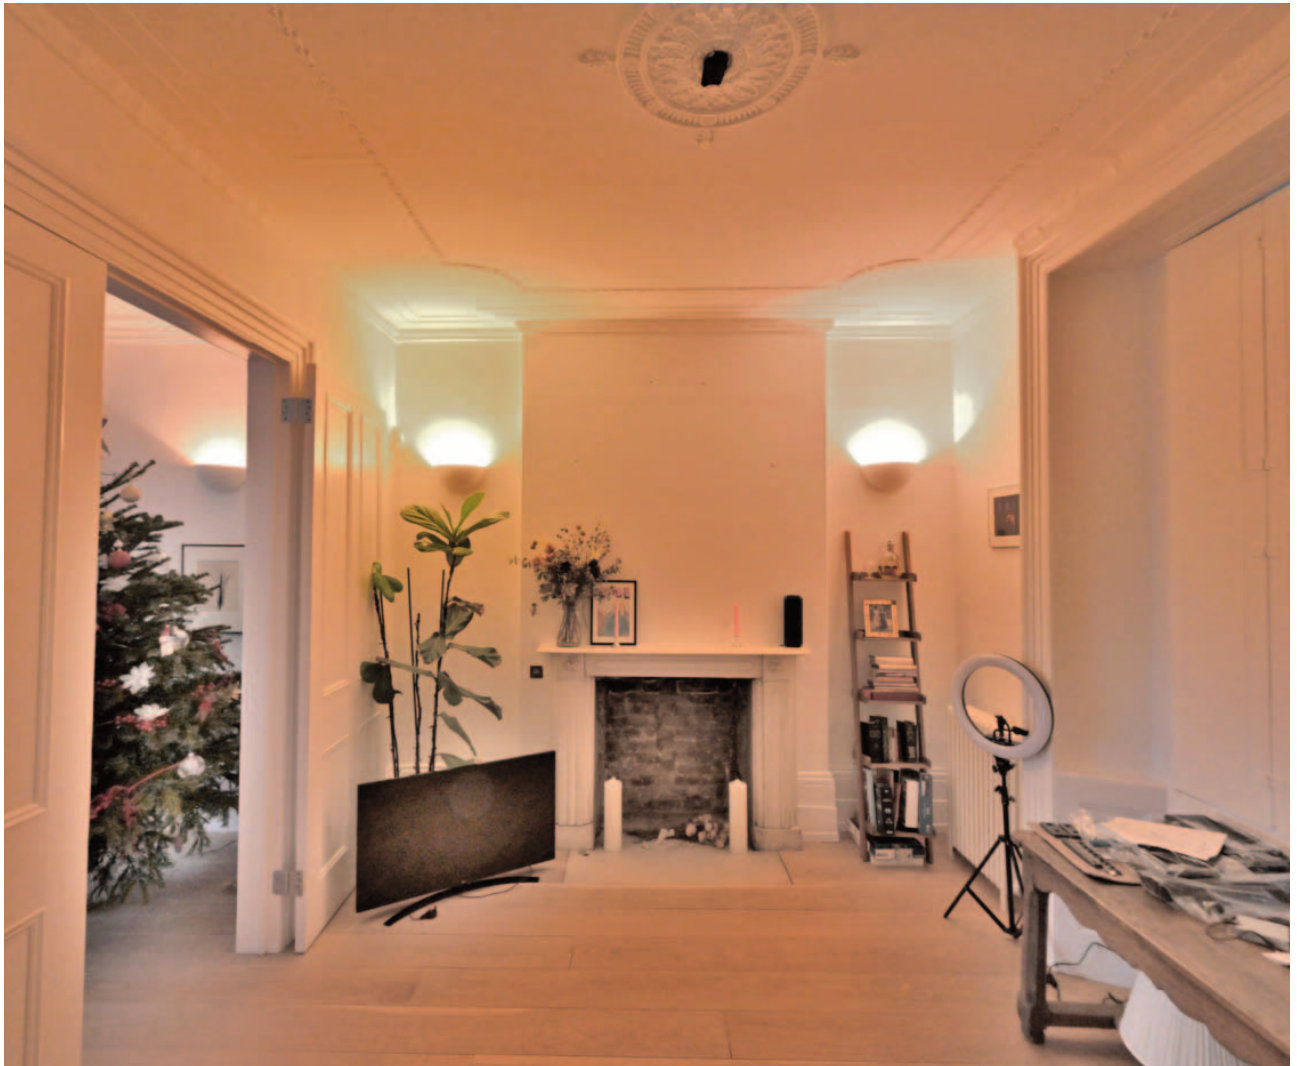
Fig. 26. The front room with its similar detailing including the deep stepped skirting, marble fire surround, ceiling rose and heavily overpainted cornice.

The front room also has a heavily-overpainted cornice comprising two bands of moulded plasterwork which matches those in the south room, with a pair of later stepped flat bands added to the ceiling bed. Additionally, it has another foliate band added to the ceiling plane inset from the widened cornice, and a central ceiling rose which is similar to the one in the adjacent room, but has four stylised honeysuckle leaves round the outside.

The window to this room is set within its historic full height architrave, and retains its historic shutters and linings and the sashes retain their historic proportions with narrower margins lights, but all the glass is modern. This room has similarly detailed deep section skirtings to those in the rear room and a straight joint marks the position of the now sealed-up door opening from the entrance hall. It also has a good quality but reset early 19th century marble fire surround but it has a single flute moulding to the jambs and frieze and floral corner bosses. The marble hearth has been replaced and as with the front room, the insert is missing.

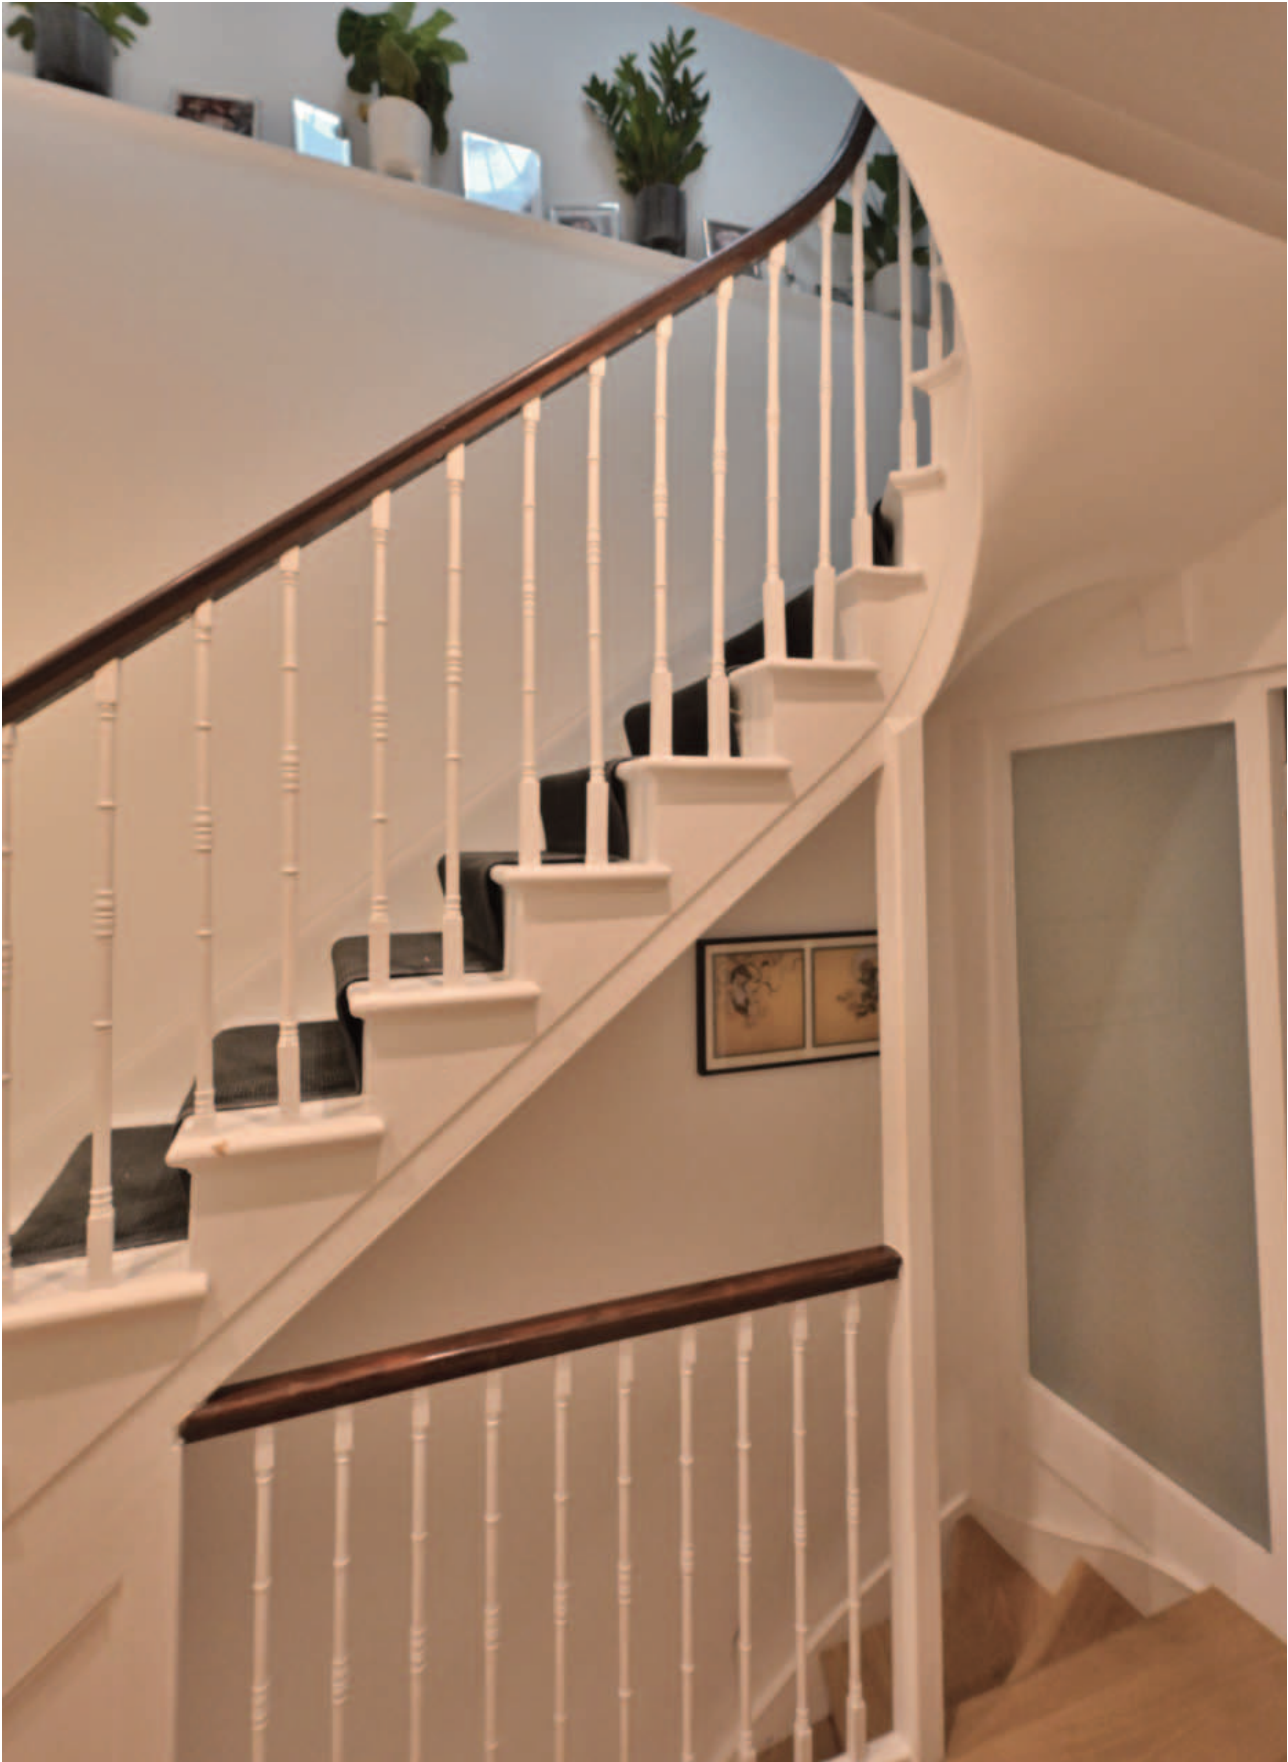
Fig. 27. The basement stair has been opened up and a section of balustrade a glazed panel and a crude rectangular newel post replaces the boarded enclosure that would have separated off the basement rooms.

A small section of surviving panelling below the stair with similar detailing to the historic doors indicates that historically the basement stair was enclosed. Most of the panelling has been removed and replaced by a new section of hand rail with matching slender that terminates in a substantial and crudely detailed square section “newel” post that rises to the underside of the curved staircase.
