No 12 Wood Lane Highgate.

## Revised Statement of Significance & Heritage

JME Conservation Ltd.

September 2022

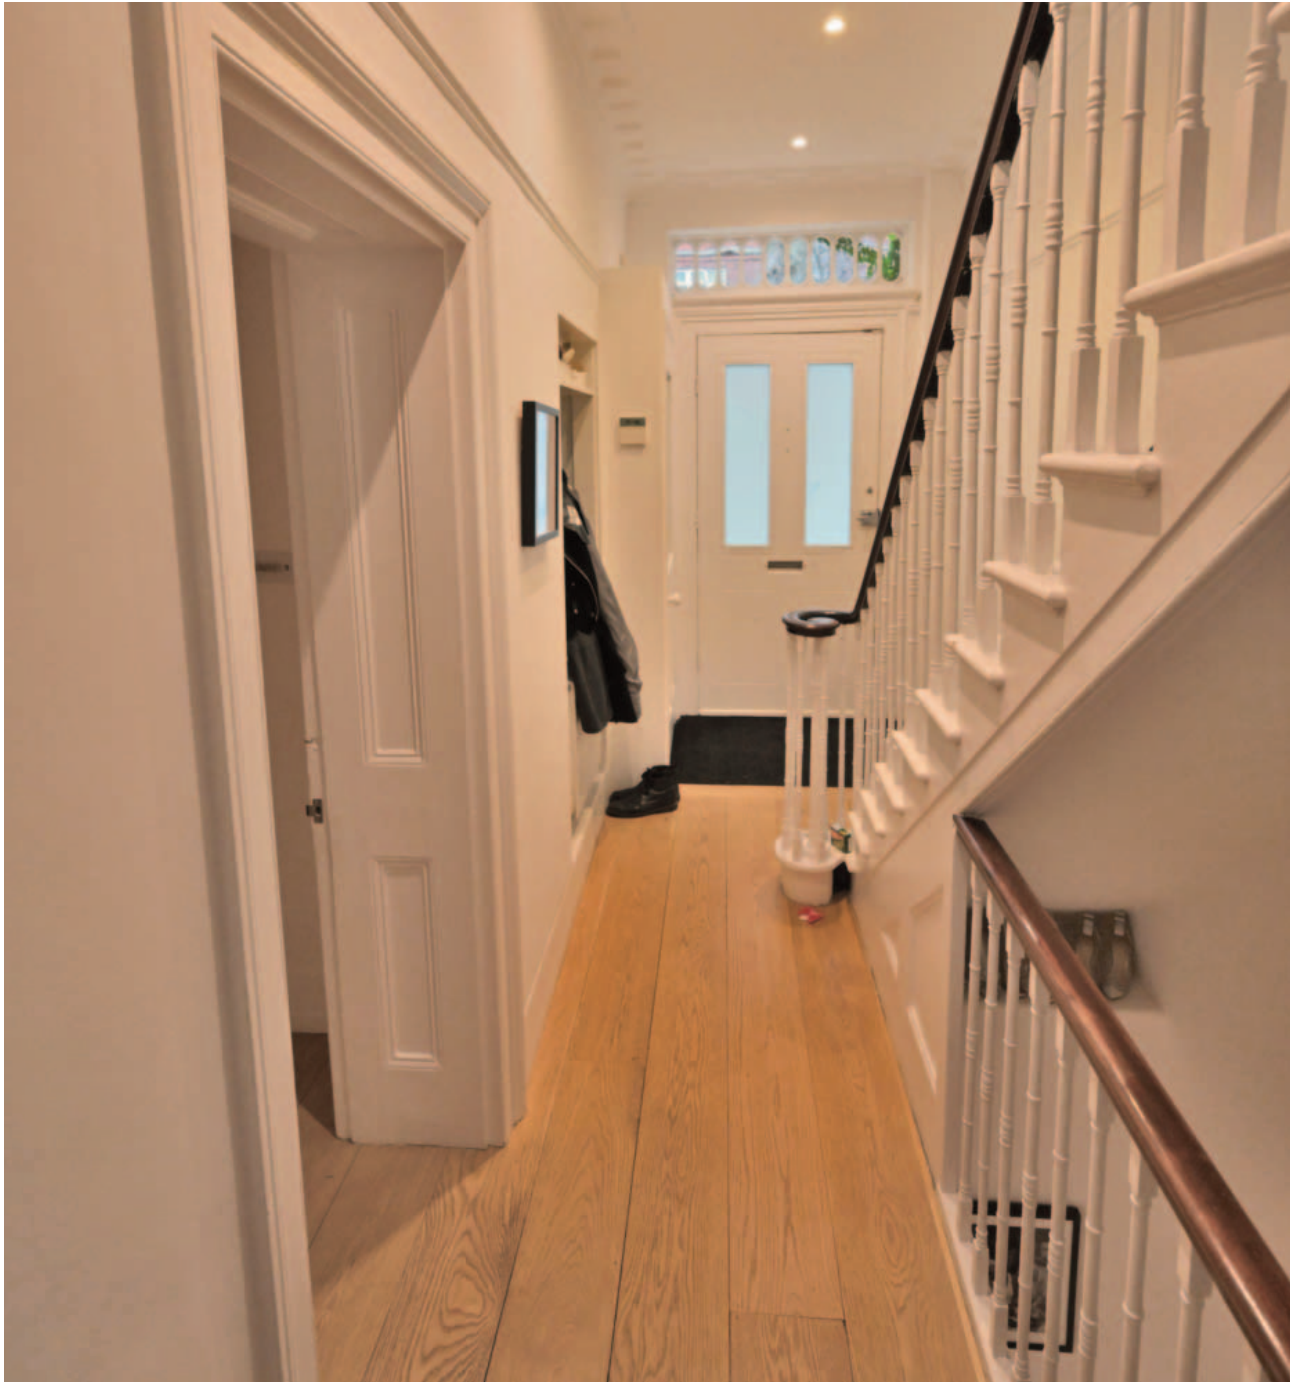
Fig. 28. The open basement stair with its modern balustrade replacing the original panelled infill, only a small area of which remains. Note the blocked doorway and inserted service cupboard by the front door

A small section of surviving panelling below the stair with similar detailing to the historic doors indicates that historically the basement stair was enclosed. Most of the panelling has been removed and replaced by a new section of hand rail with matching slender that terminates in a substantial and crudely detailed square section “newel” post that rises to the underside of the curved staircase.

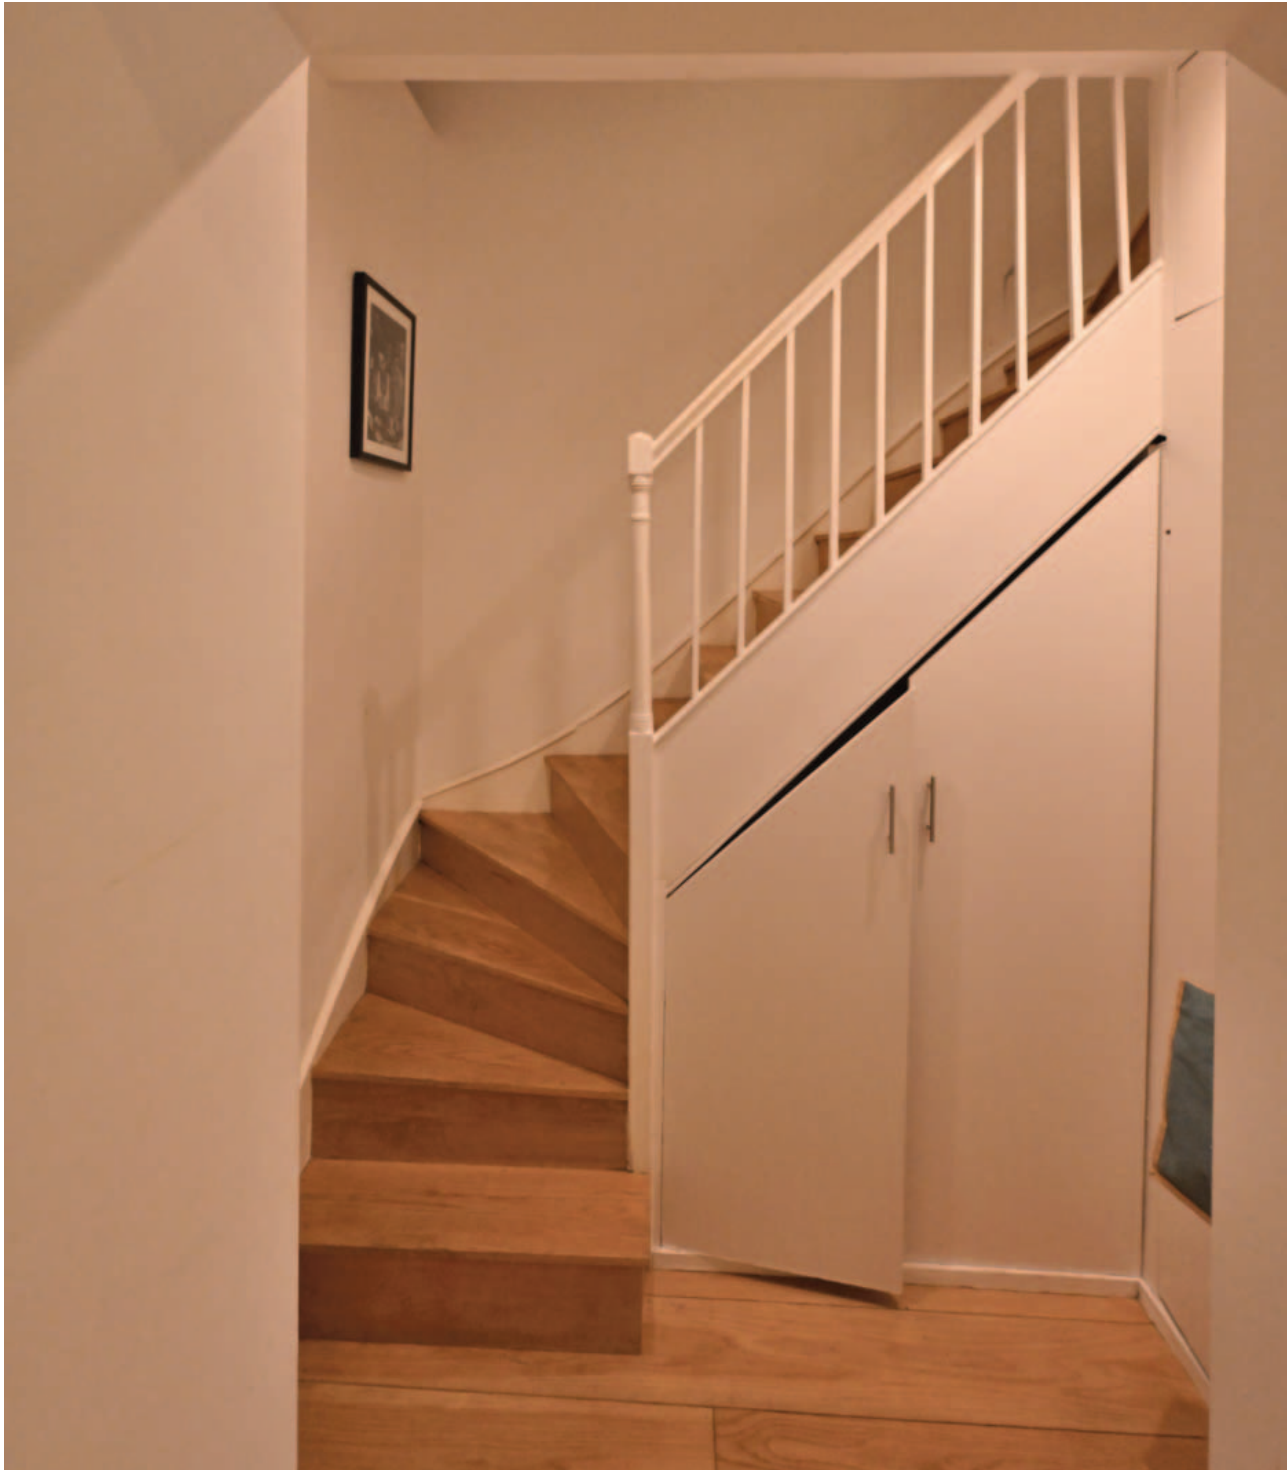
Fig. 29. The modified basement stair - note how the lower winders crash into the skirting and project beyond the newel post. The straight flight may be historic but the underside is concealed by modern finishes.

The basement staircase has clearly been extensively altered, although without opening up modern finishes it is unclear how much historic fabric survives. Whilst the handrail and the basement newel post are historic, all the treads and risers have been overboarded or replaced with the same boarded finish used on the ground floor. In addition the lower winder steps have been extended beyond the historic newel post into the basement hallway. Whilst the skirting along the straight section of stair appears to be historic it seems to have been replaced although to the same detail where it turns to run along the lower winder steps – presumably when the bottom steps were altered.

The opening up works confirmed that the historic upper section of the staircase survives beneath the modern oak cladding as does part of the lower section of the staircase. This lower section had been extensively altered and damaged to such an extent that its repair is not considered to be realistic. The revised proposals are now to retain all the surviving historic parts of the staircase but to overboard the historic risers and treads with antique Baltic pine. In addition to retention of the surviving historic fabric the method statement has been amended to make clear that no new routing into the historic strings, or alterations to the historic section of newel post, is proposed.

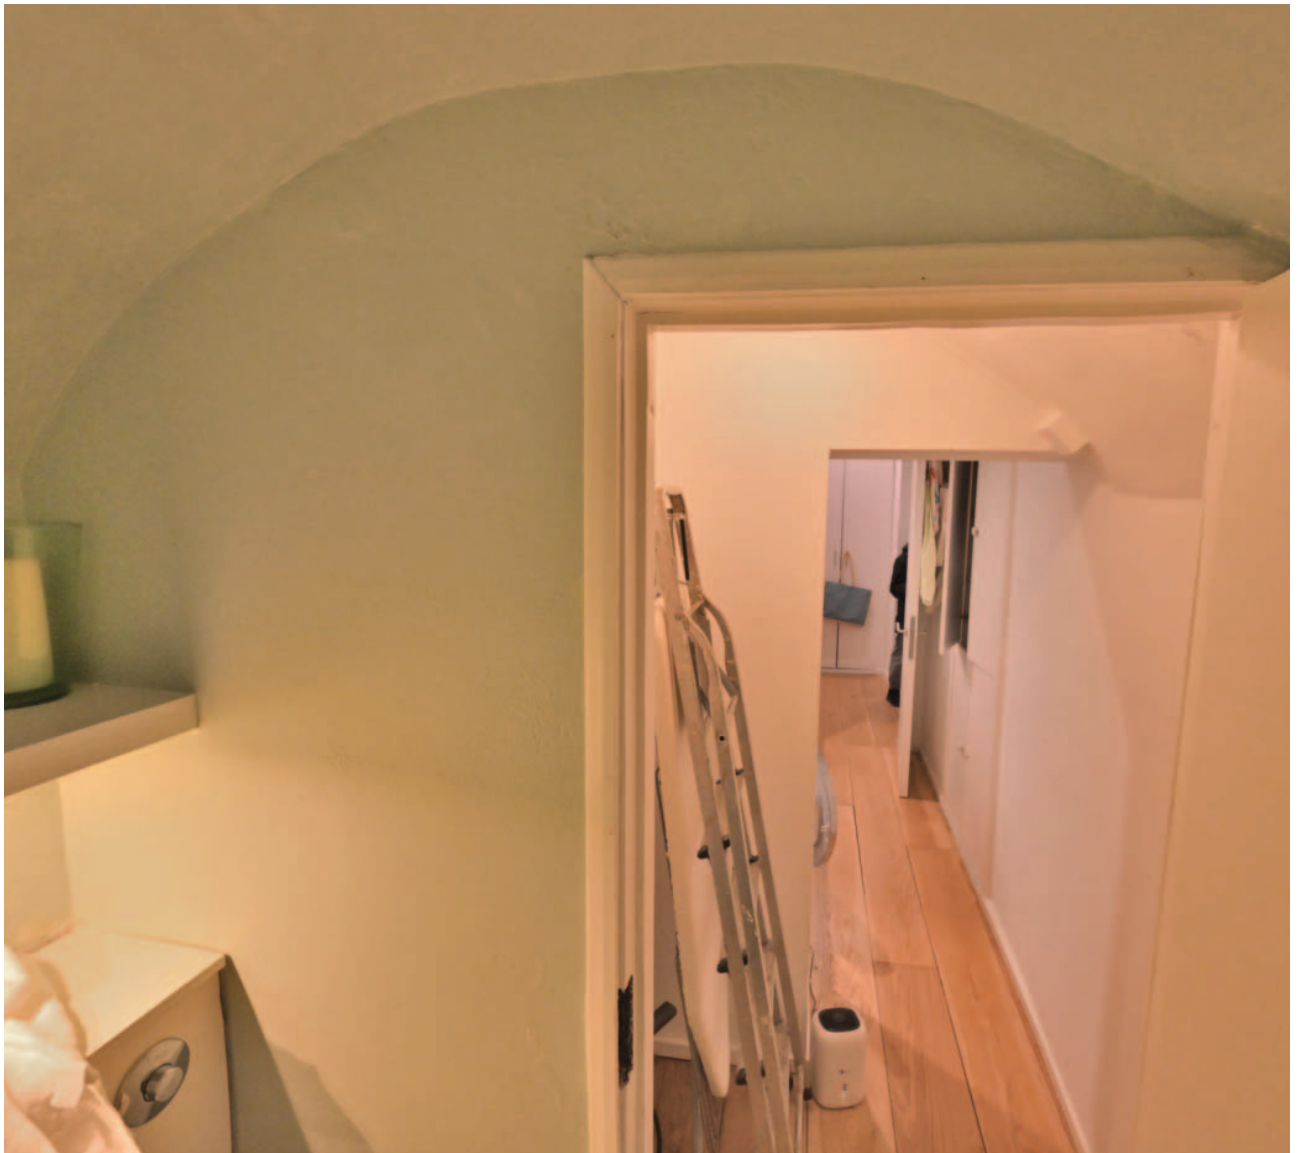
Fig. 30. The external vault below the front pavement is now a W.C. and utility area adjacent to the front basement room. A blocked door into this utility room is now a cupboard (visible on the right).

At the end of this room is a historic doorway into the front vault beneath the path to the front door and historically this would have had a door into the front open area with its outside hoist. This vaulted space has been sub-divided to form a W.C. and cupboard and the external door infilled.

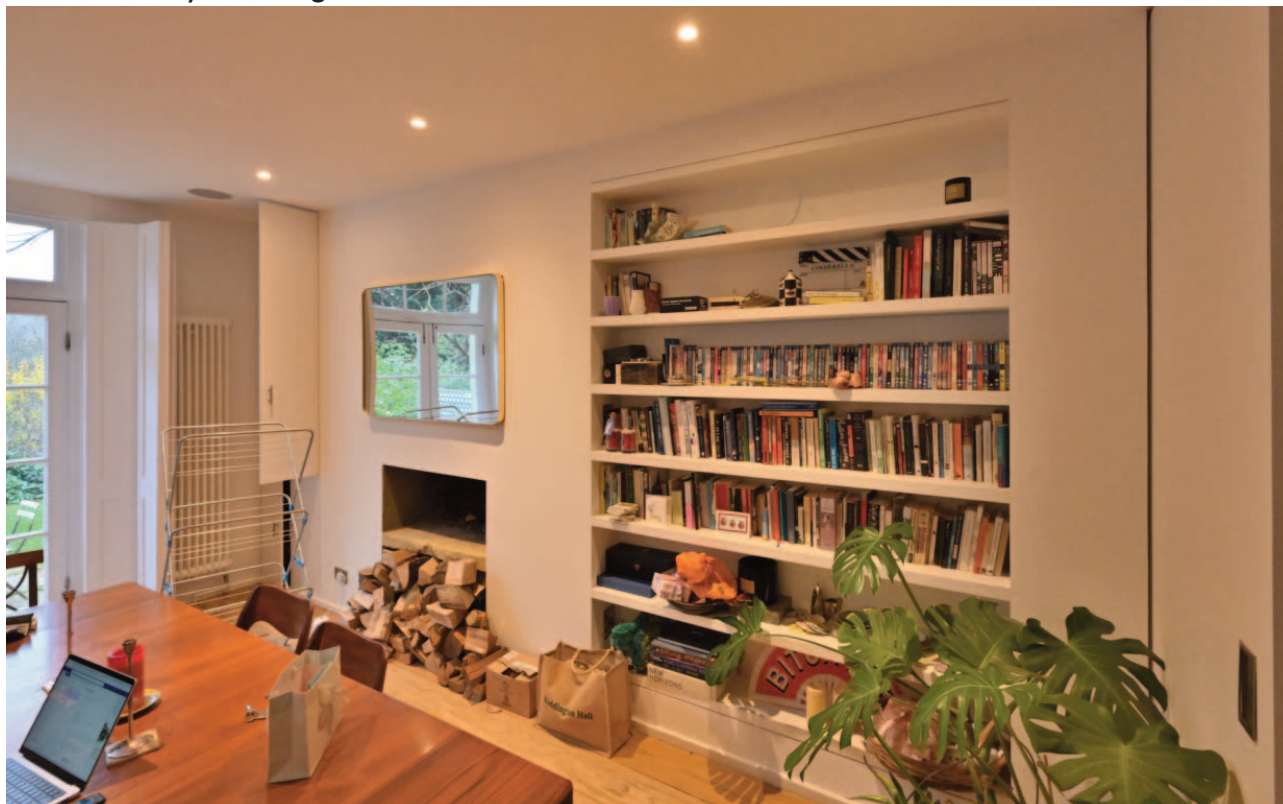
Fig. 31. The principal semi-basement rooms have been opened up to form a single space with tall flush doors replacing the service passage from the side tradesmans entrance that originally separated the front (pantry) and rear (kitchen). This opening up formed part of the 2005 consent which also saw the kitchen fireplace replaced; the bookshelves indicate the location of the blocked former tradesmans entrance and the service passage.

The current rear semi-basement dining room would have been the historic kitchen although the substantial kitchen fireplace has been replaced by a small centrally positioned modern fireplace opening which has concrete linings to each side with a centrally positioned stone flag forming a shelf. A cupboard with flush doors has been formed to the left side of the chimney breast with bookshelves to the right. Apart from the external frame to the French doors and the transom lights, all the joinery is 20th century, including the shutters to each side.

The modern full height sliding doors on the line of the removed service corridor partition will be removed along with a section of the modern brick walls supporting the steelwork introduced in 2005. This will provide a wider opening between the front and rear basement rooms, however a downstand will be introduced within the opening to reinstate the visual evidence for the historic separation of the two basement rooms. Within the front room, the dry lining on the west wall will be removed together with the modern flush cupboards to each side of the chimney breast, and these will be replaced with traditionally-detailed cupboards. The fireplace will be reinstated, with an appropriately detailed simple fire surround.

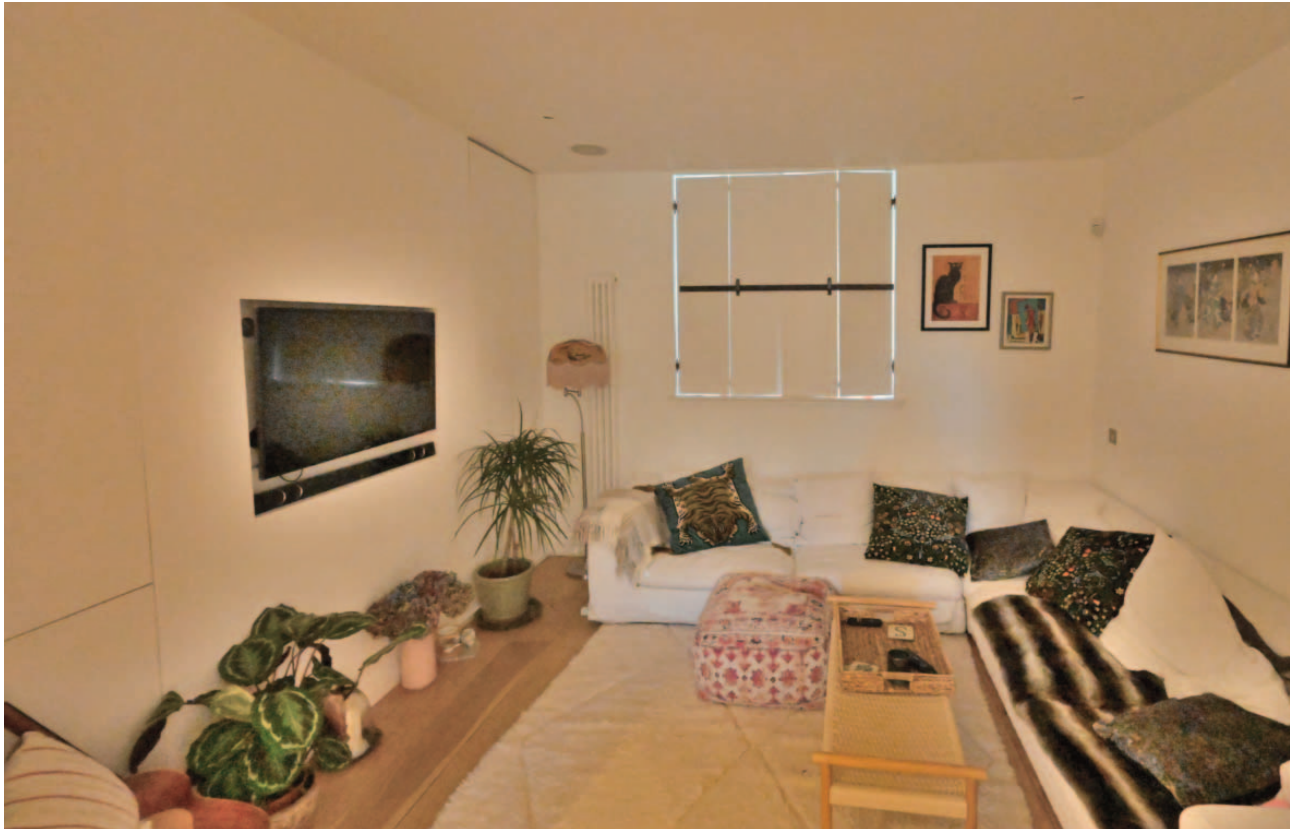
Fig. 32. The front basement room has a modern ceiling, wall and floor finishes and a television set into the former chimney breast. The door into the service passage on the right has been infilled.

Full height flush doors separate the front and rear basement spaces and the small front room retains its historic shutters (although the associated ironmongery is modern). The fireplace has been infilled, and a television has been recessed into the projecting stack and flush finished modern cupboards fill the recesses to either side.

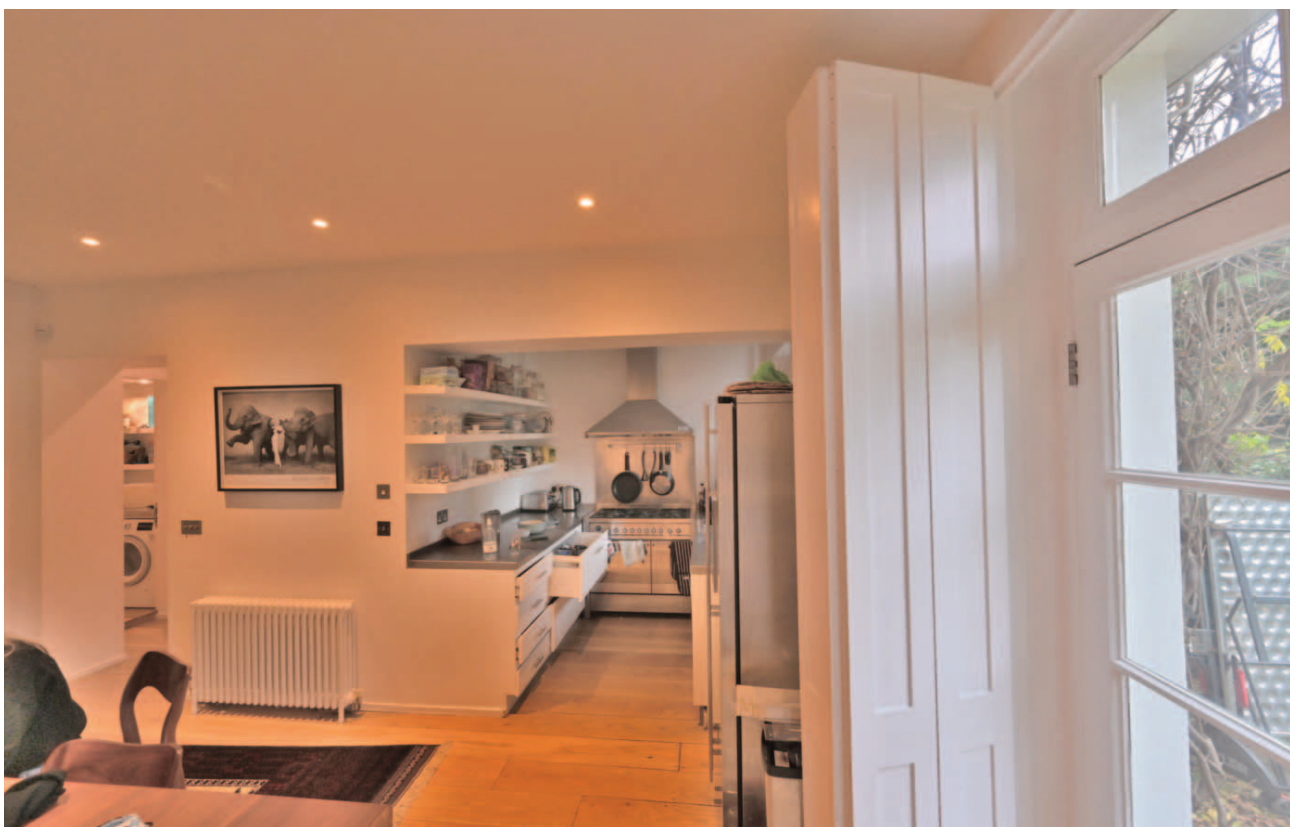
Fig. 33. The original W.C. and cloakroom in the east range is now incorporated into the main semi-basement and its door from the stair hall has been blocked. The French door replaced a historic kitchen window.

A downstand has been retained above the wide modern opening between the rear dining area and the adjacent modern kitchen in the small east room. This has modern kitchen fittings to either side of a kitchen range against the east gable wall. Its small window tucked against the boundary wall is mirrored by a blocked window in the identical room at ground floor level above. Both these rooms were historically partitioned to provide a narrow W.C. lit by the narrow window and an adjacent cloakroom with a washbasin lit by a larger window. This historic arrangement marked a very early introduction of internal W.C.s and it gives these narrow window openings particular significance.

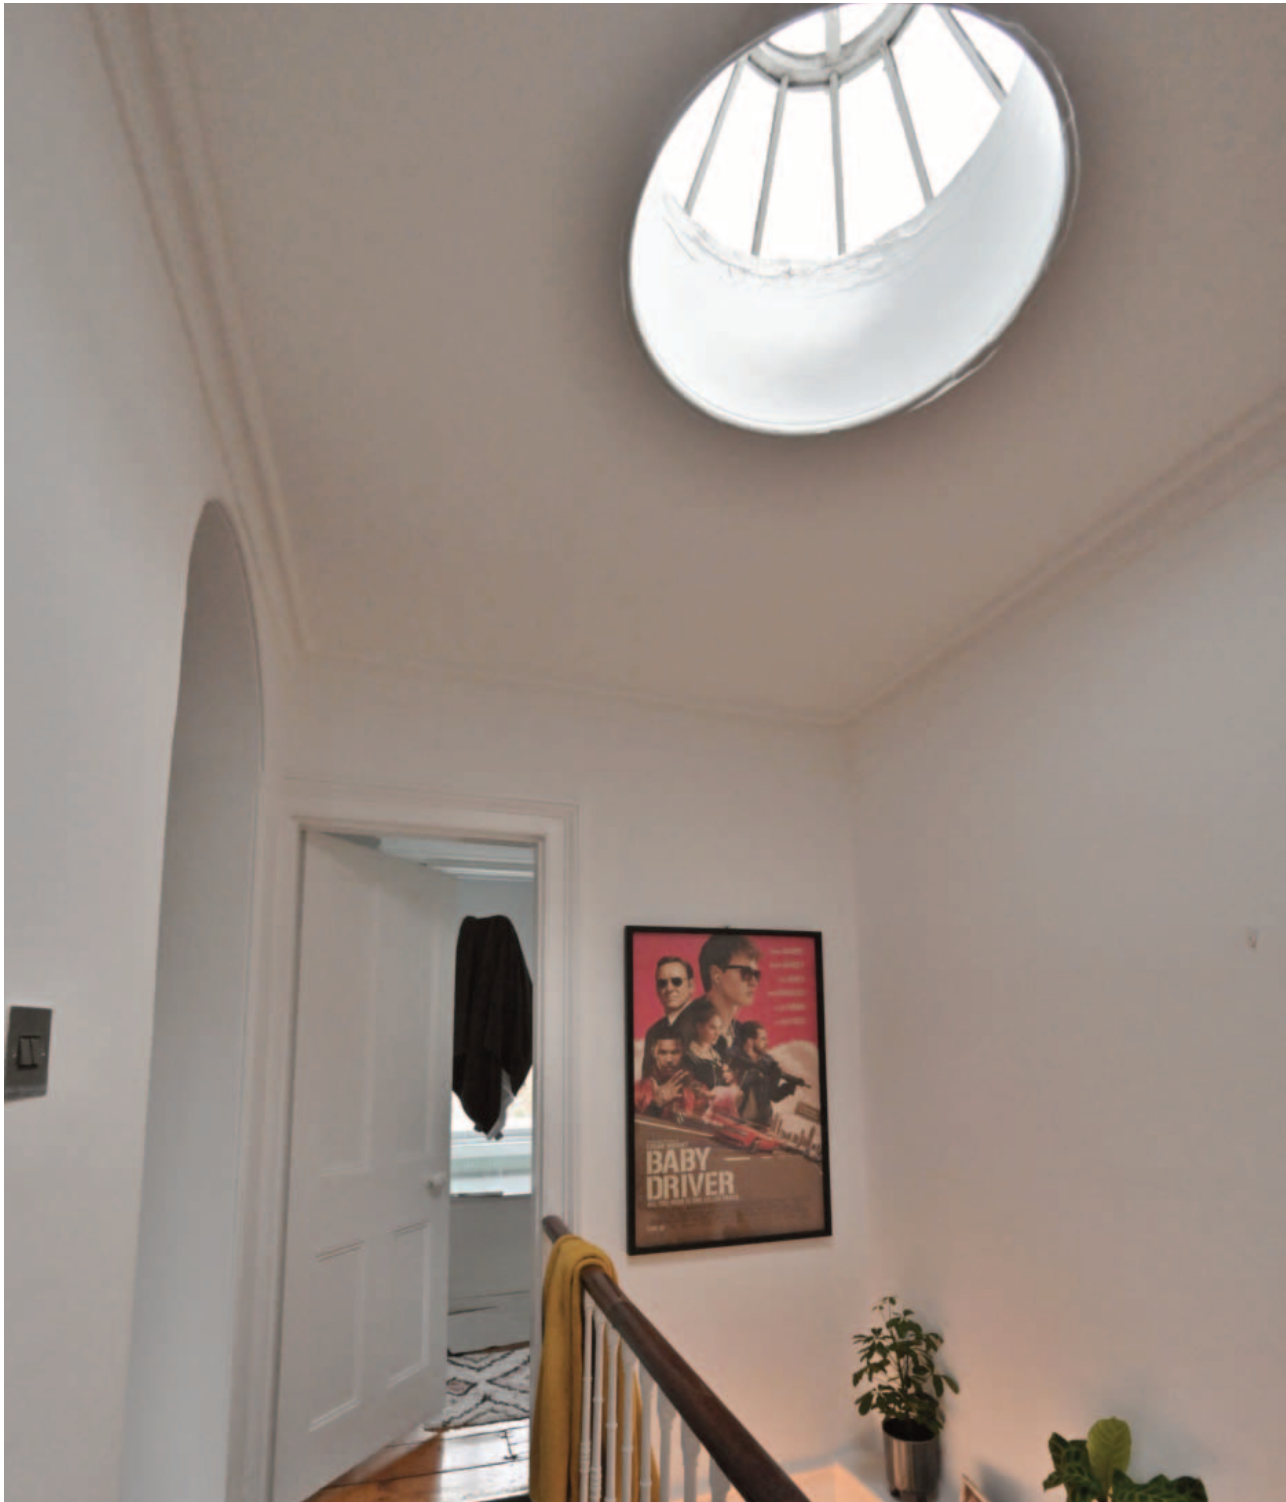
Fig. 34. The first floor landing with its simple cornice is lit by a historic skylight in the flat roof of the east wing. A small bathroom occupies the front room and the architrave and door match the detailing elsewhere.

The upper flight of the staircase, with its elegantly detailed handrail, slender balusters and double beaded skirting, is lit from above by a small simply detailed 19th century glazed lantern above a simple oval beaded opening in the ceiling. At first floor level a door opens into a bathroom above the entrance hall, and a 20th century tall arched opening leads to an inner landing with doors opening into the front and rear rooms within the principal range (with a slightly wider lobby extending into the south room), as well as a steep staircase that rises between these two rooms to attic level.

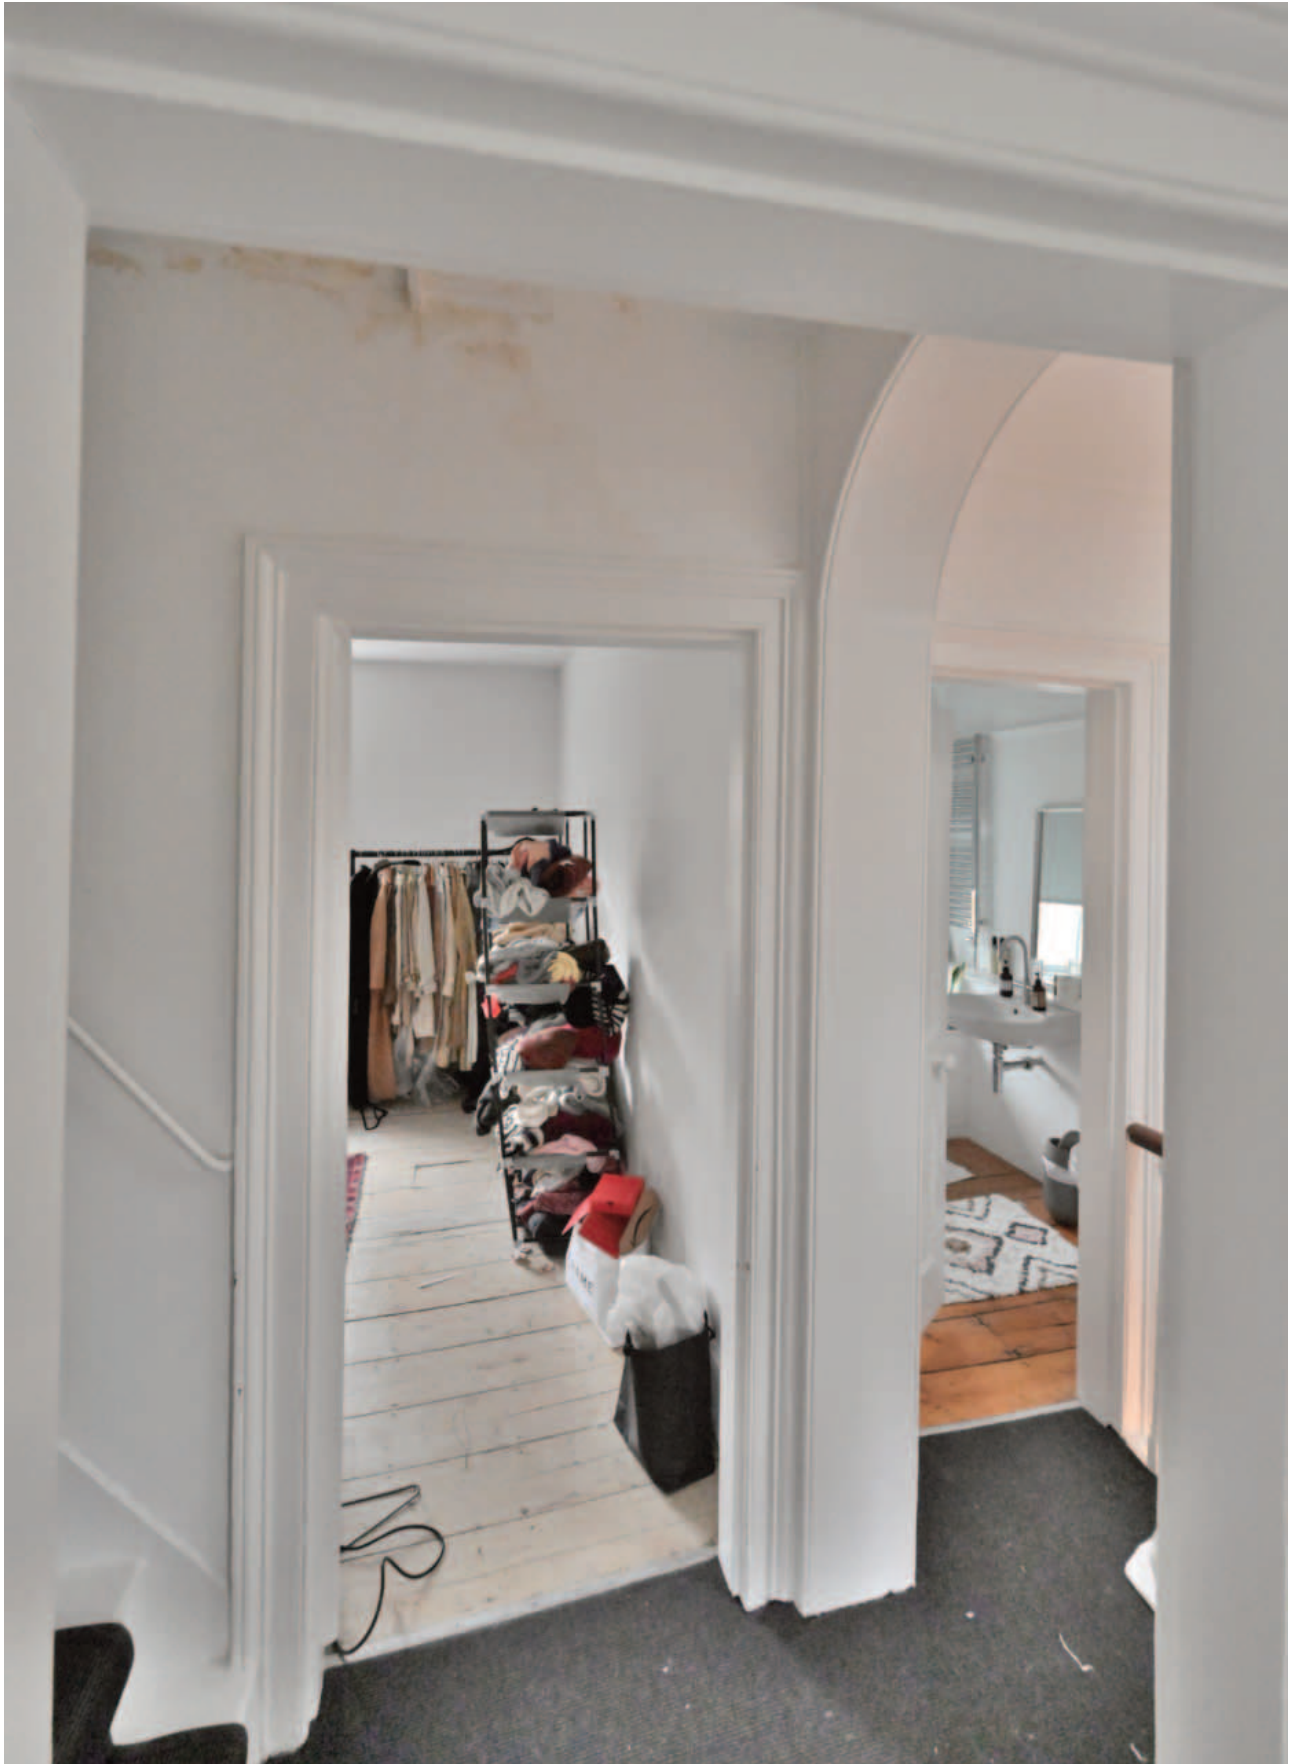
Fig. 35. Detail of the small lobby at the foot of the attic stairs with the arched opening from the stair hall. The architraves and doors share the same detailing although the cornicing is simpler at this level.

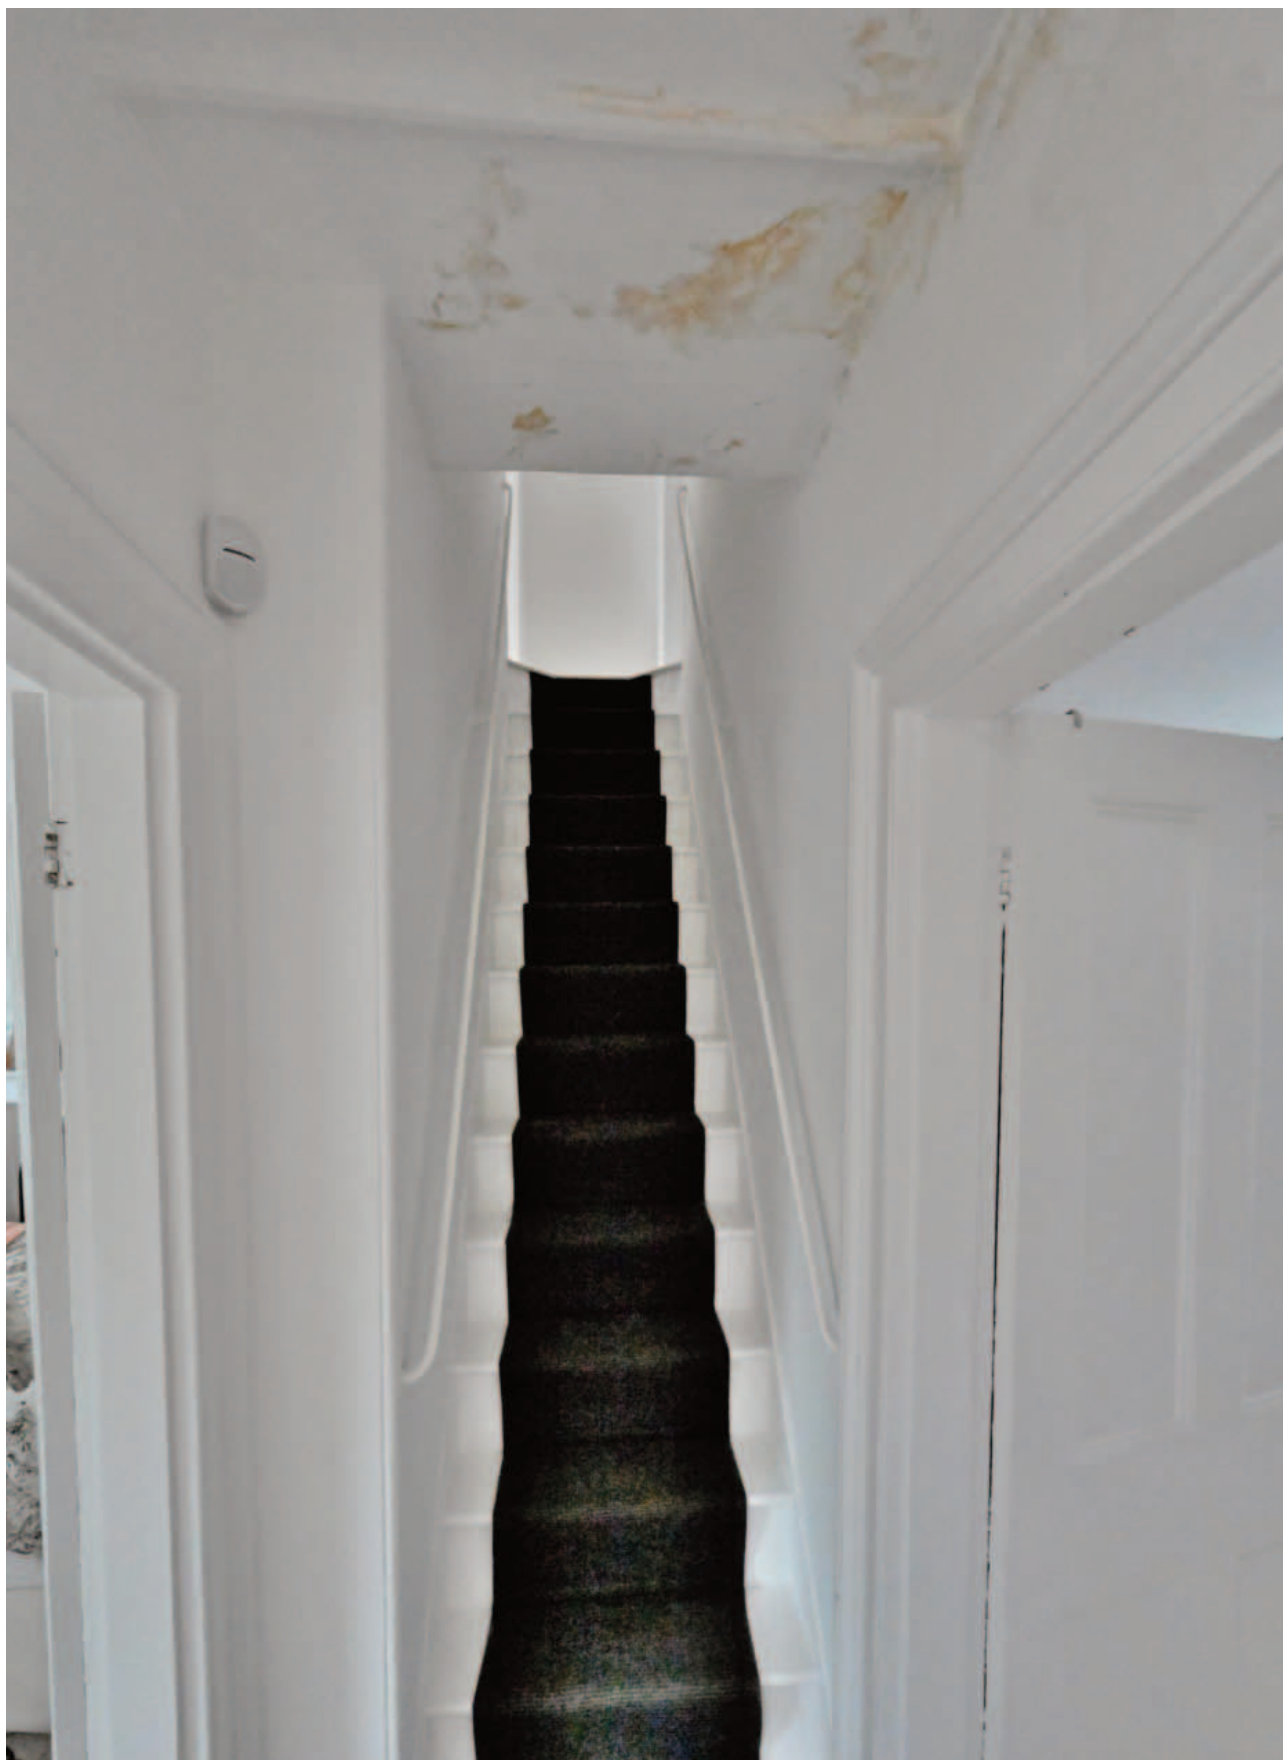
Fig. 38. The small lobby at the foot of the narrow attic stairs opens into the principal bedroom on the south (rear) whilst a similarly detailed door opposite opens into the smaller front room.

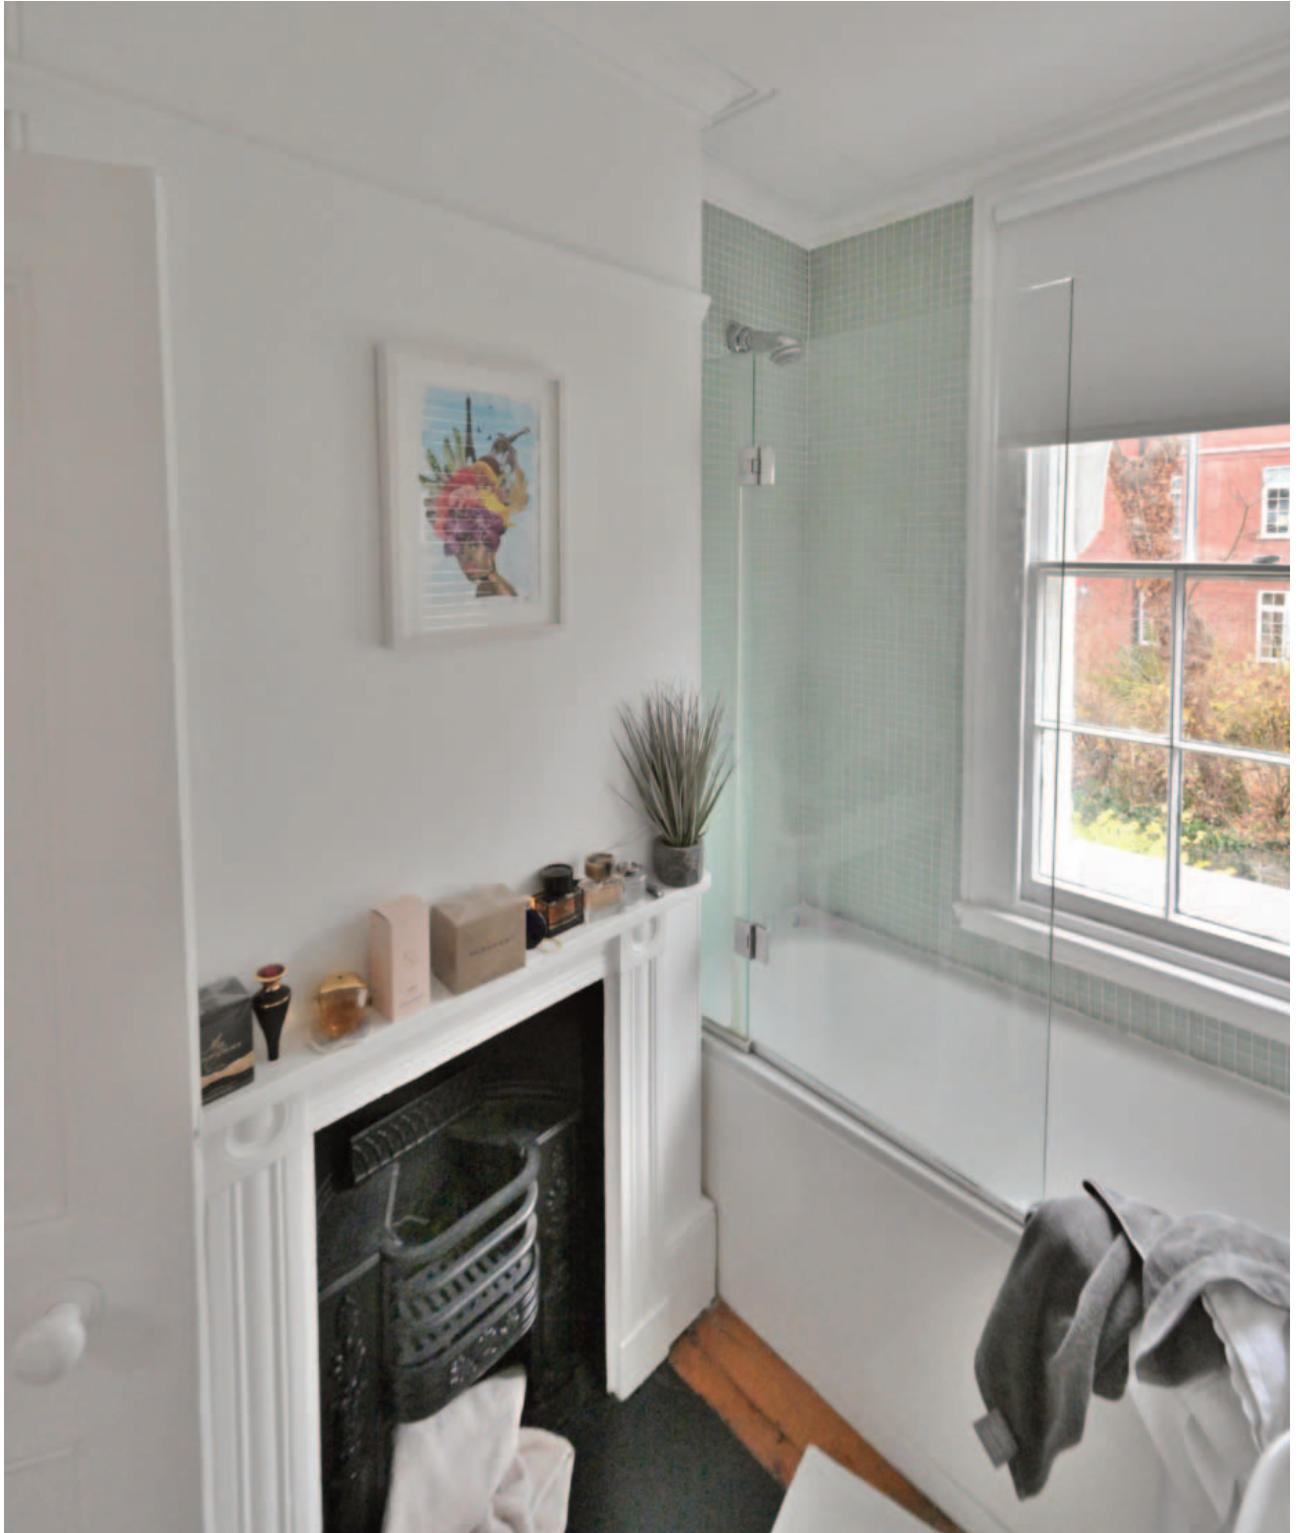
Fig. 37. The small front bathroom opening off the staircase has a small mid 19th century hob grate suggesting that it was originally a dressing room or small bedroom.

The first floor doors and architraves all match the detail of the historic door on the ground floor hall. Whilst the stair landing is carpeted the other floors retain exposed historic floorboards and skirtings and both the stair landing and front bathroom retain their original simply detailed cornices. The bathroom has a small centrally positioned fireplace on the east wall, with a mid-19th century hob grate, and a later but well detailed timber surround with reeds to the jambs and frieze and roundels in the corners. This rests on the original hearth.

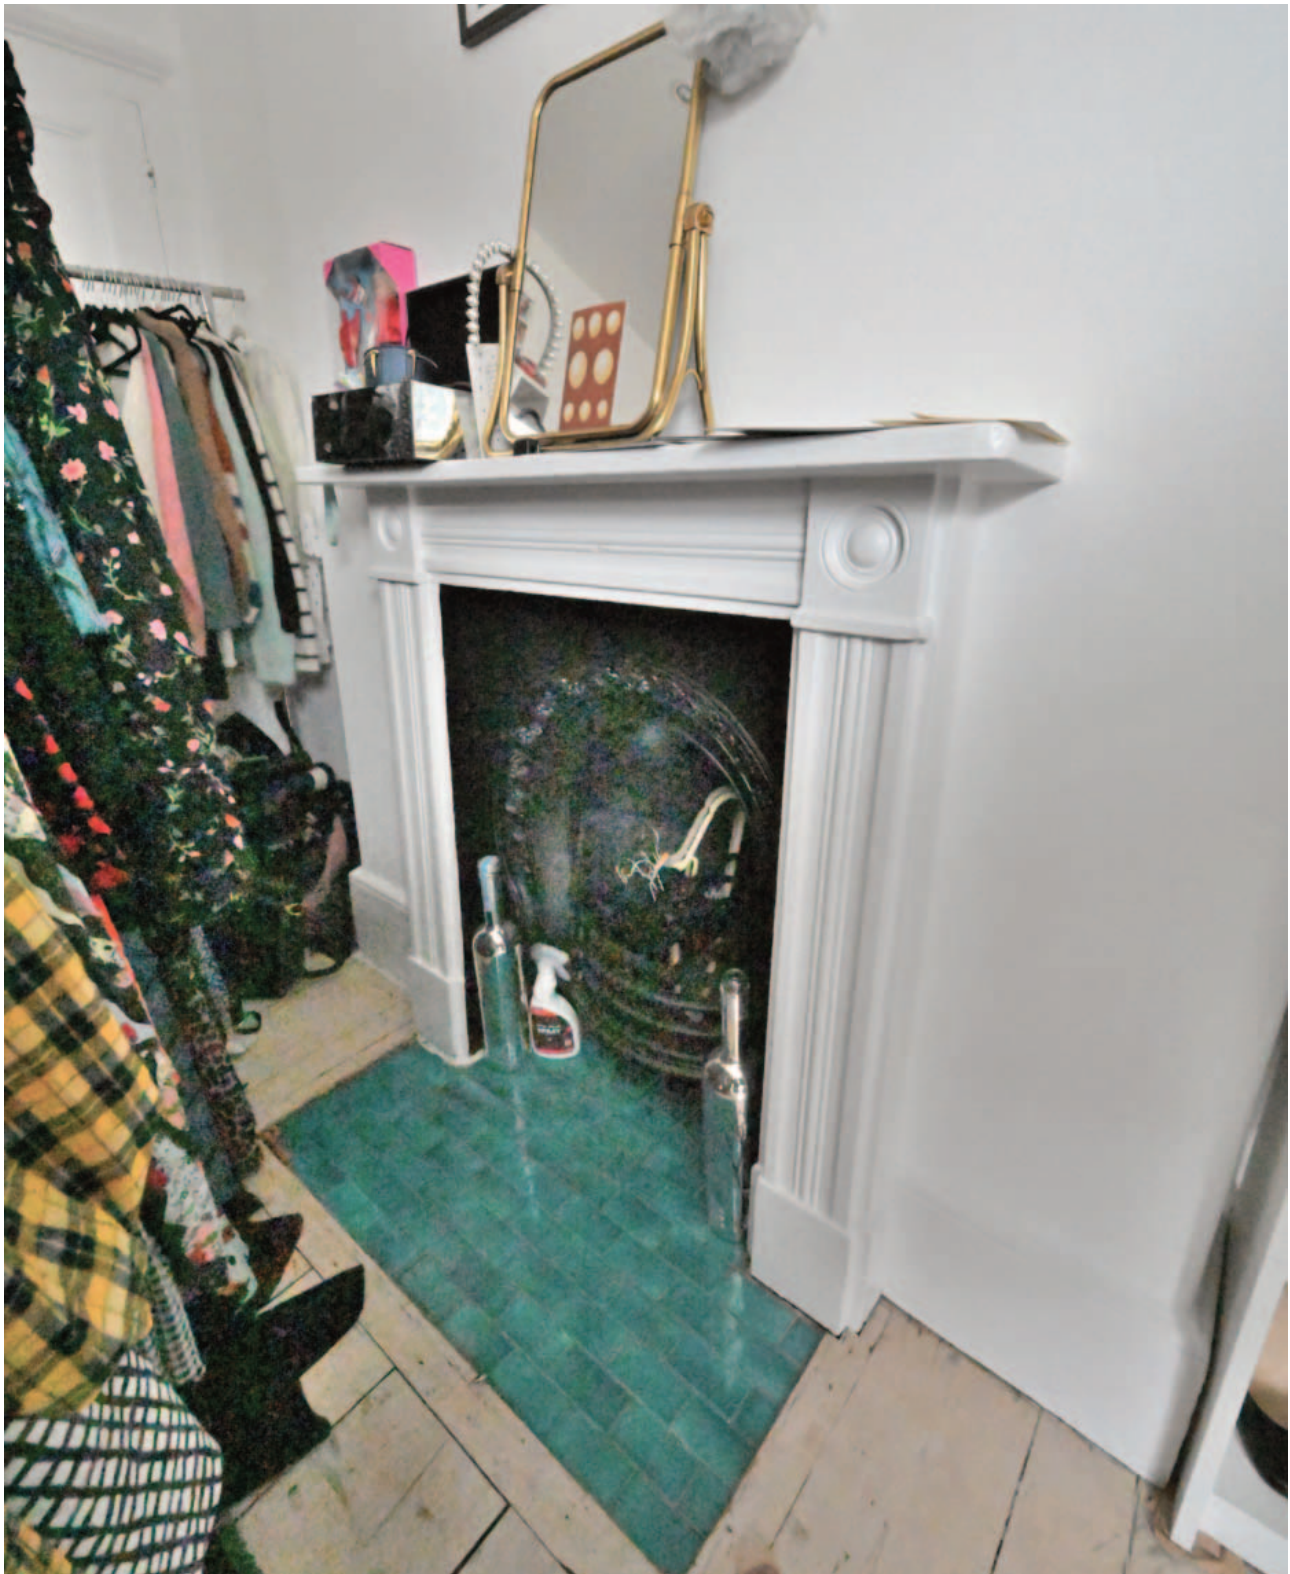
Fig. 38 The front bedroom in the main range with its mid 19th century detailing and later surround. Just visible behind is the door into the passage behind the attic stairs to the rear bedroom.

The cornice no longer survives in the small north-facing bedroom, however it has a mid 19th century cast iron register grate with a decorative half round surround, and what appears to be 19th century tiling in the hearth. The painted surround is modern matching the one in the bathroom. A four panelled door in the south east corner of the room opens into a cupboard beneath the attic staircase, with a matching door at the other end that opens into the principal south bedroom.

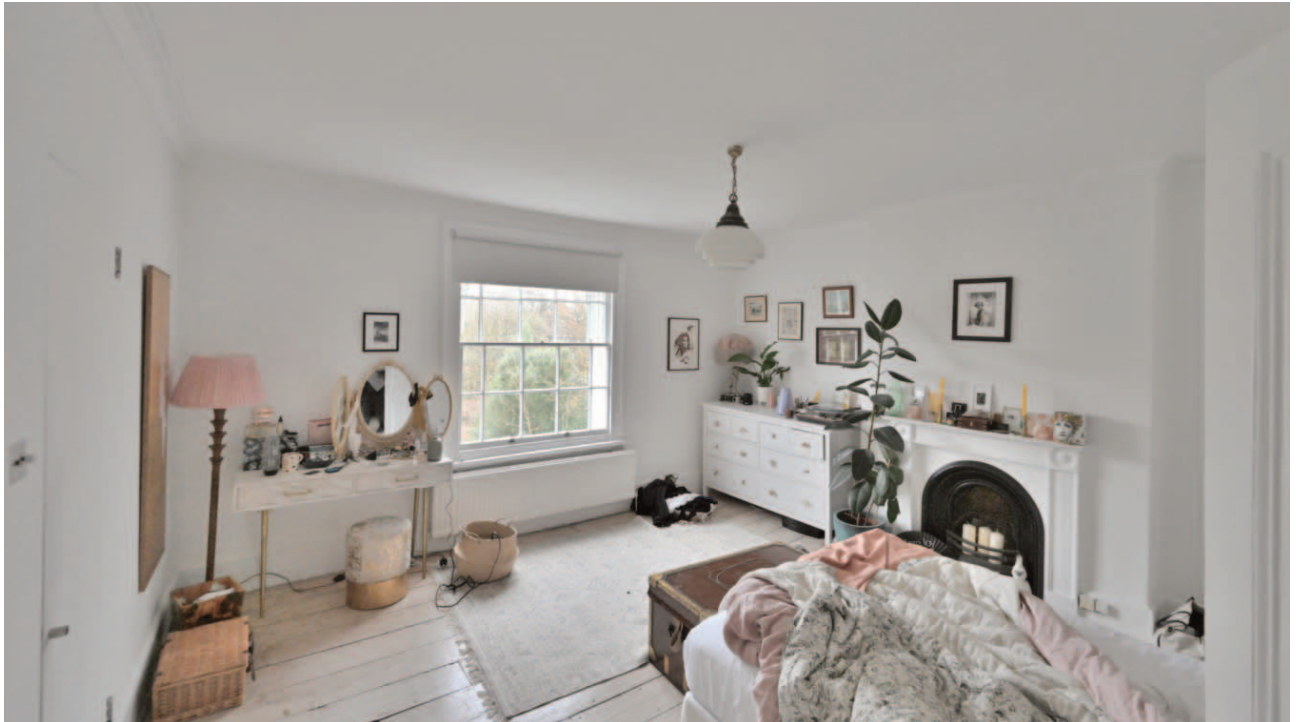
Fig. 39. The principal south facing bedroom has a simple cornice and mid 19th century fireplace with a modern timber surround. Just visible on the left is a modern jib door to an en-suite bathroom.

The principal south facing bedroom has a small entrance lobby formed within the room and the room itself is plainly detailed with a simple reeded cornice and a more simply detailed fireplace to that within the adjacent front bedroom. It has a mid-19th century register grate with ovolo mouldings to each side of the jambs and original hearth with a simple modern timber fire surround with framed roundels and a simply moulded mantel shelf and its historic stone hearth.
