No 12 Wood Lane Highgate.

## Revised Statement of Significance & Heritage

JME Conservation Ltd.

September 2022

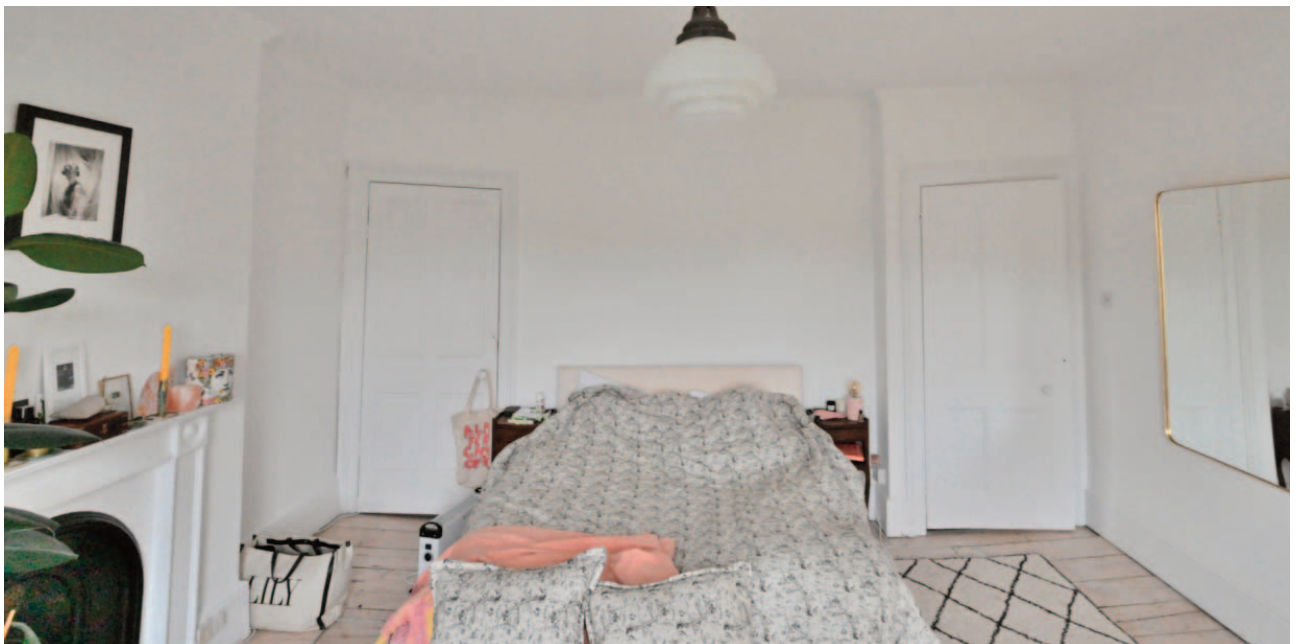
Fig. 40. The entrance door on the right is inset to provide a small lobby within the landing, whilst the left hand door connects to the front bedroom via a passage behind the attic stair.

A jib door to the left of the entrance connects with an en-suite bathroom formed within the small south-facing room in the east wing. No historic features survive in this bathroom, apart from the window, although this has been altered and the window glass and bottom sash have been replaced.

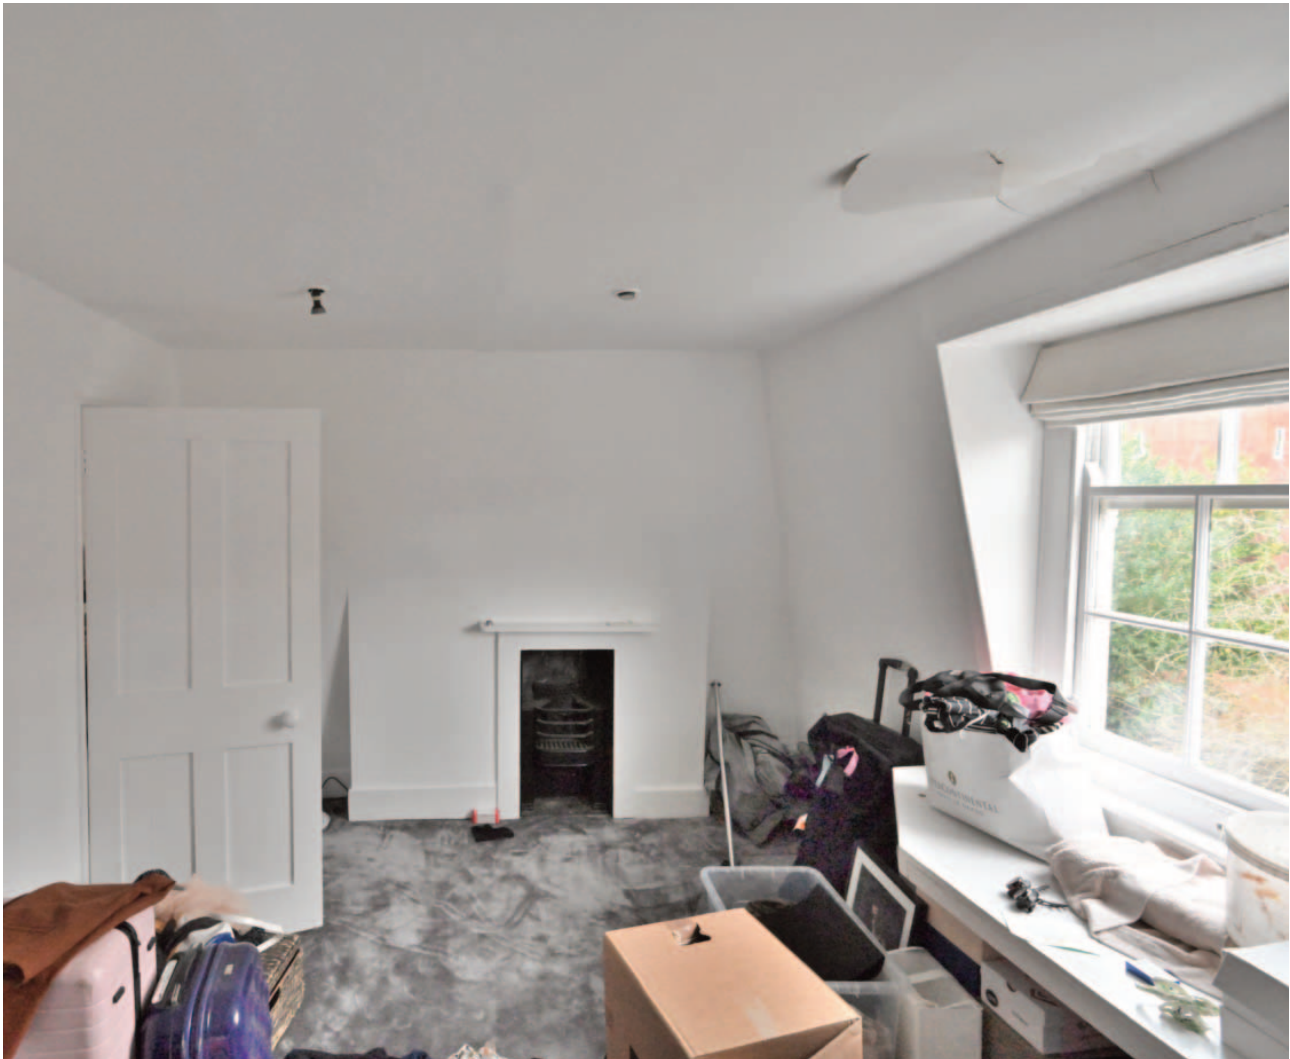
Fig. 41. The attic front bedroom with its steeply sloping walls and a small historic fireplace which appears to be *in-situ*. It is suggested that these attic rooms with their four panelled doors are of later 19th century date

The slightly shallower pitched upper section of the roof structure is concealed beneath the horizontal plaster ceilings and in the small north-facing room, the walls are all plastered, and finished with simple boarded skirtings to all the walls. This room has a small mid 19th century hob grate with an undecorated timber surround and a black tiled hearth which is largely concealed beneath a carpet.

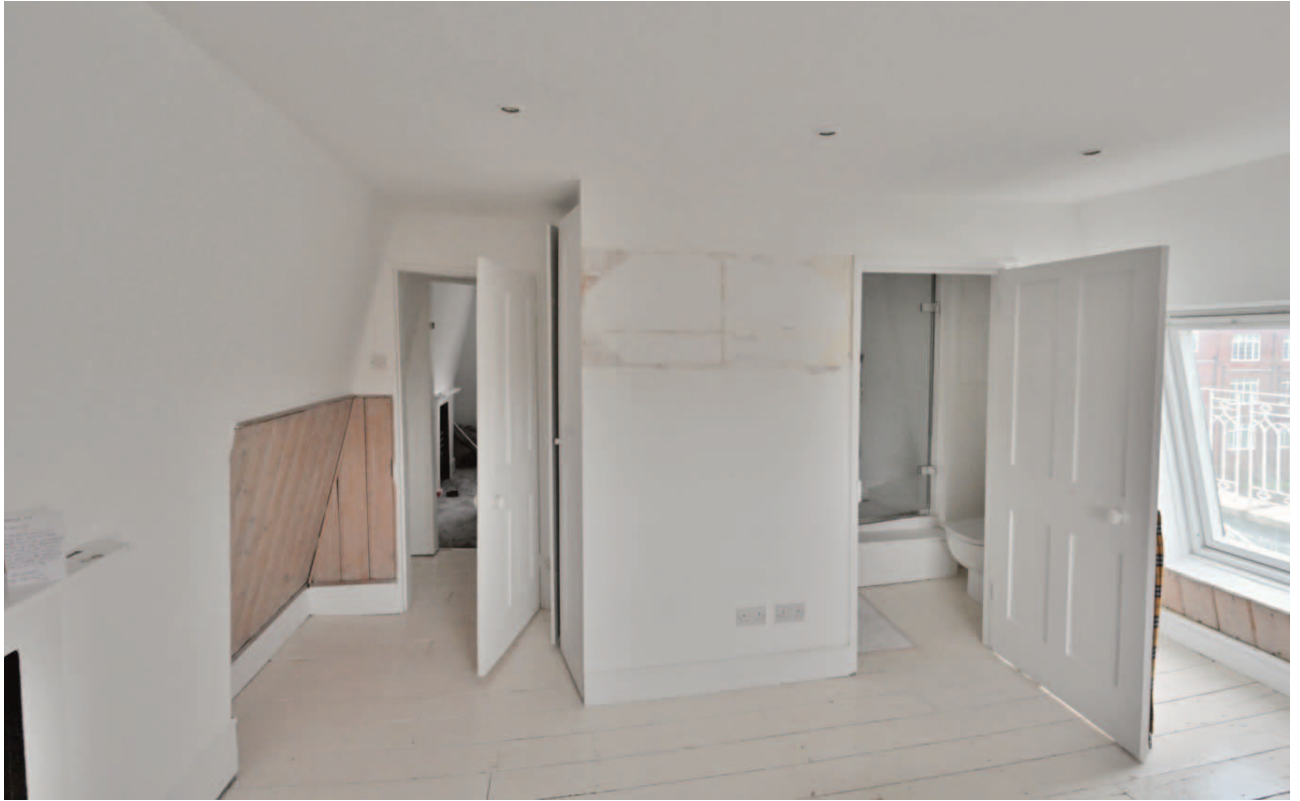
Fig. 42. The modern bathroom enclosure formed within the south attic bedroom with the modern poor quality rooflight providing access to the adjacent flat roof. It is assumed this replaced a historic window.

The skirtings have a double beaded detail and the fireplace has a slightly more elaborate mid 19th century hob grate than in the north room, although it has a matching timber surround. The hearth has a 20th century tiled finish and a large poor quality 20th century rooflight provides access onto the flat roof above the east wing allowing it to be used as a roof terrace. It is assumed that the sections of metal balustrade were introduced round the east roof when the mansard roof was added.

Within the larger south bedroom the existing modern stud partition forming the en-suite will be repositioned to form a slightly wider shared shower room and access lobby, and a new door will be created to provide access into the front bedroom. As part of these works, it is proposed to carefully lift the floorboards at this level, introduce inter-joist sound insulation and relay the boards. Additionally, the existing poor quality rooflight opening through the later mansard roof onto the balcony will be repositioned slightly, and replaced with a new flush-fitting Velux access window onto the roof terrace.

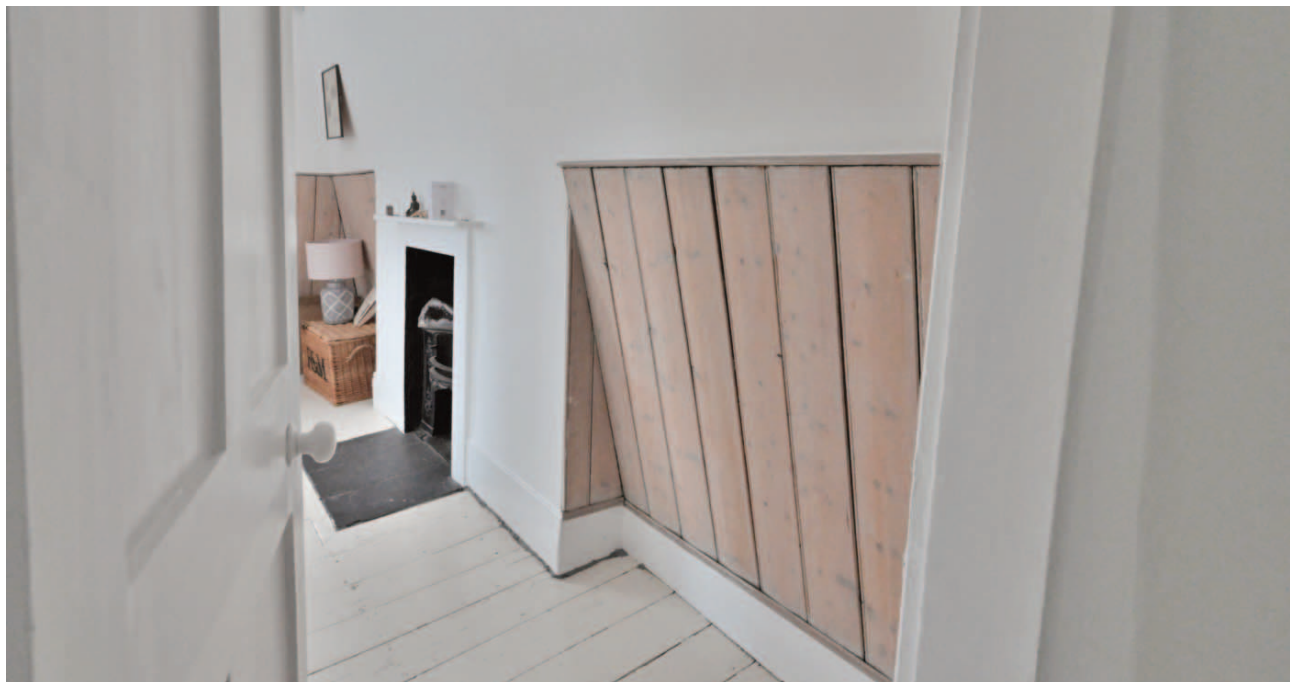
Fig. 43. Detail of the timber boarding below dado level within the south room. The fireplace retains its original hob-grate, mantelsheaf and hearth.

In the slightly larger south room partitions have been introduced to form a bathroom adjacent to the stair landing and this has a shower tucked in behind the staircase in what would presumably have been a cupboard. Whilst the upper part of the walls of this room are plastered, the lower section of the sloping walls are lined with vertical boarding with a simple bead to the boards and this lining is carried round into the reveals of the dormer window.

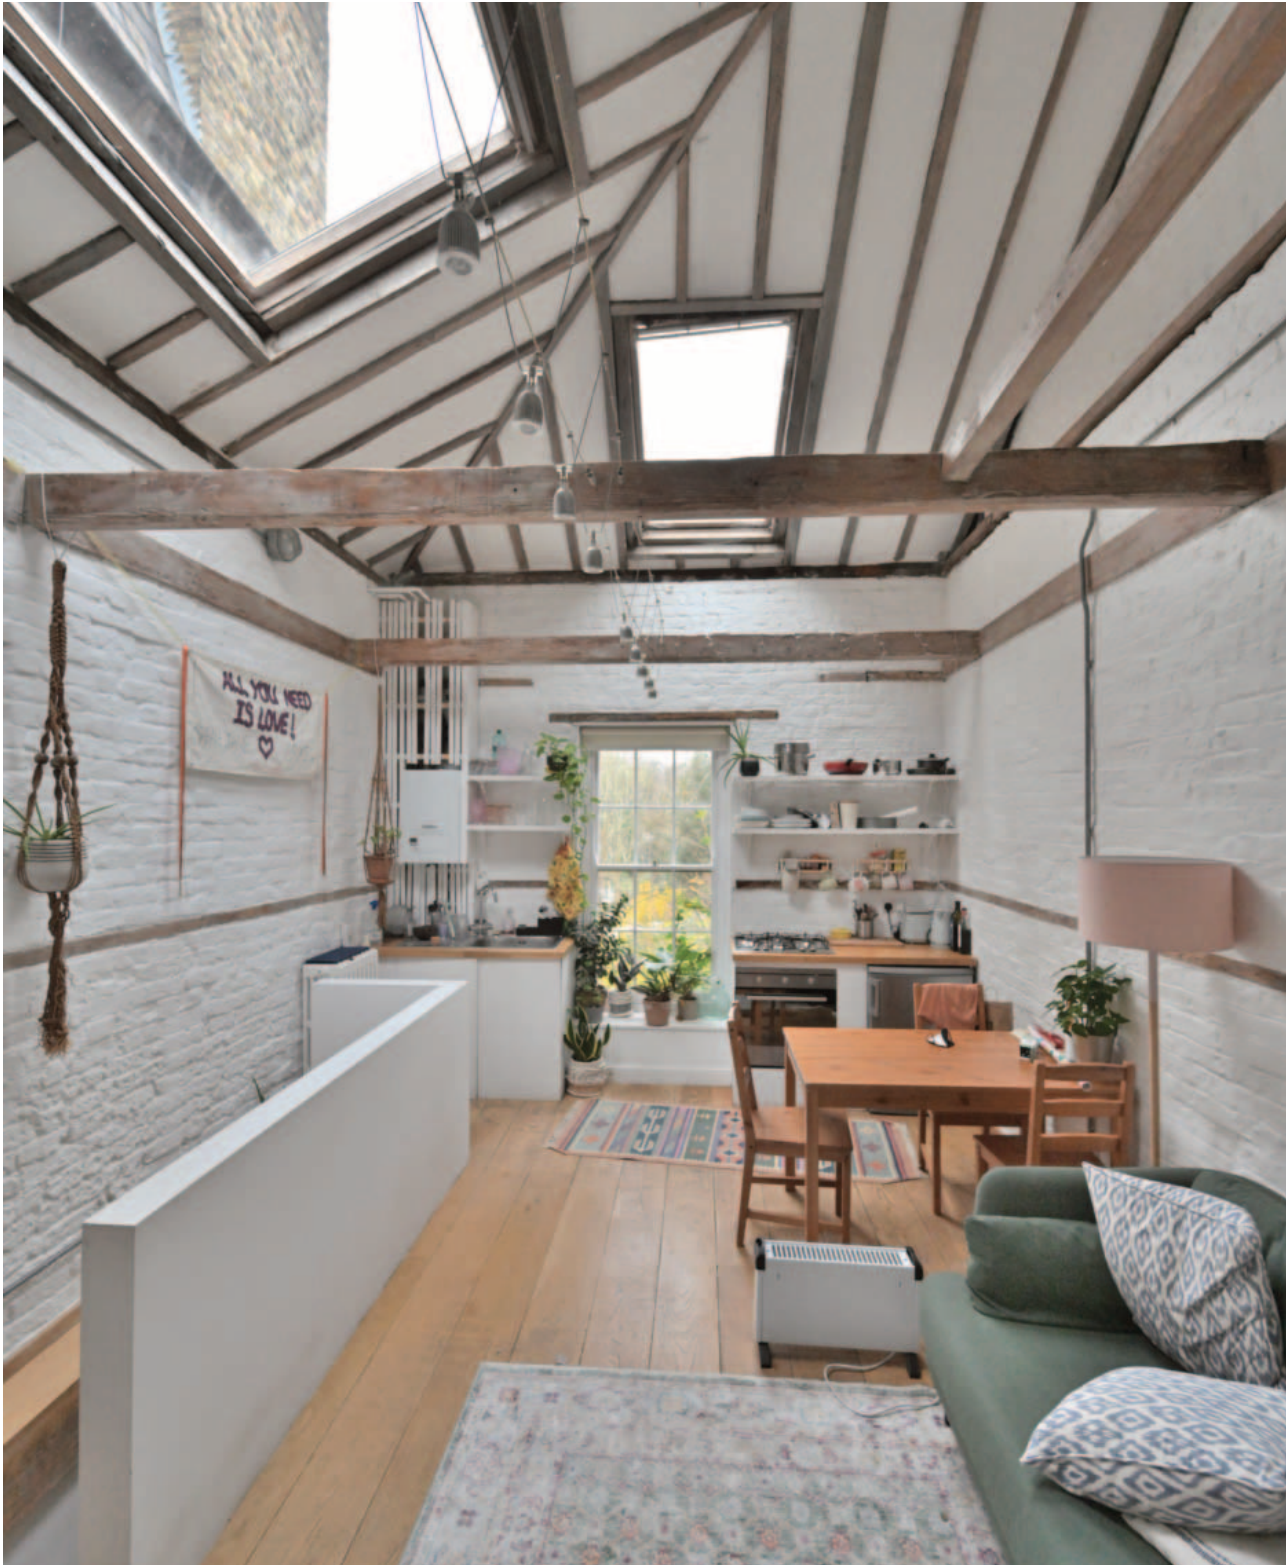
Fig. 44. The upper floor residential conversion within the outbuilding. A lath and plaster ceiling would have concealed the roof structure whilst the tall window in the rear wall may have held a hoist door.

The principal entrance into this annexe is from the door set within the fixed timber screen on the front elevation which reads as one of a series of panelled doors. At this upper level, the hipped roof structure is fully exposed, albeit cut by the introduction of large rooflights on its west and south roof slopes; it is detailed with common rafters rising to members forming the ridges and valleys to the hipped roof structure, with no purlins or collars. There are rows of timber trimmers set into the walls and three deep ceiling beams set c.700mm below wall plate level run east-west across the structure and historically supported the now-missing lath and plaster ceiling. In the northeast corner trimmers extend between the north ceiling beam and the walls to support steps or a ladder, indicating that the roof void was used historically for storage.

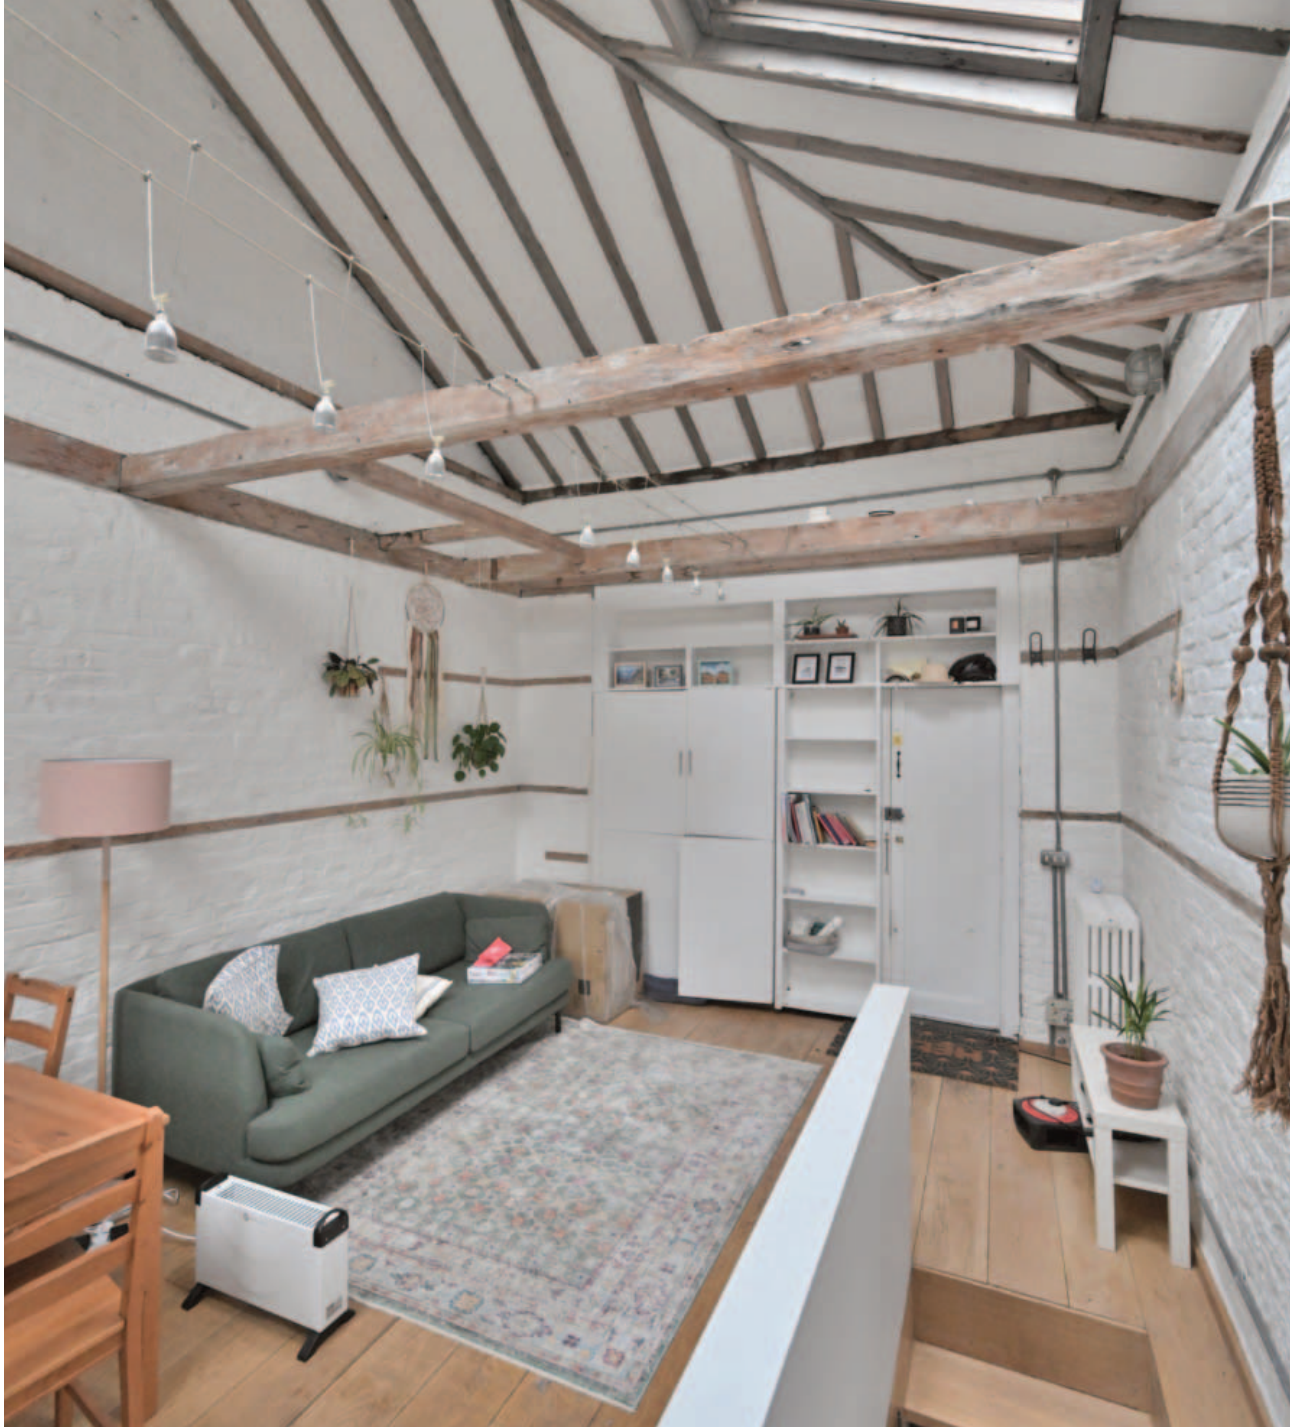
Fig. 45. The front of the upper floor showing cupboards built on the inside of the historic door opening from the lane. The ceiling structure suggests there was originally ladder access up to storage within the roof.

As part of the residential conversion, a storage unit has been attached to the inner face of the fixed timber screen that forms the front wall, and at the opposite end of the space shelves and kitchen fittings are set to each side of the centrally-positioned south facing sash window. The floor structure appears historic although curiously both the joists and boards run from front to back rather than the joists spanning from side to side which would be usual. It is assumed that the floor has been overboarded in the 20th century and a set of modern stairs has been introduced along the east wall leading down to the lower ground floor level.

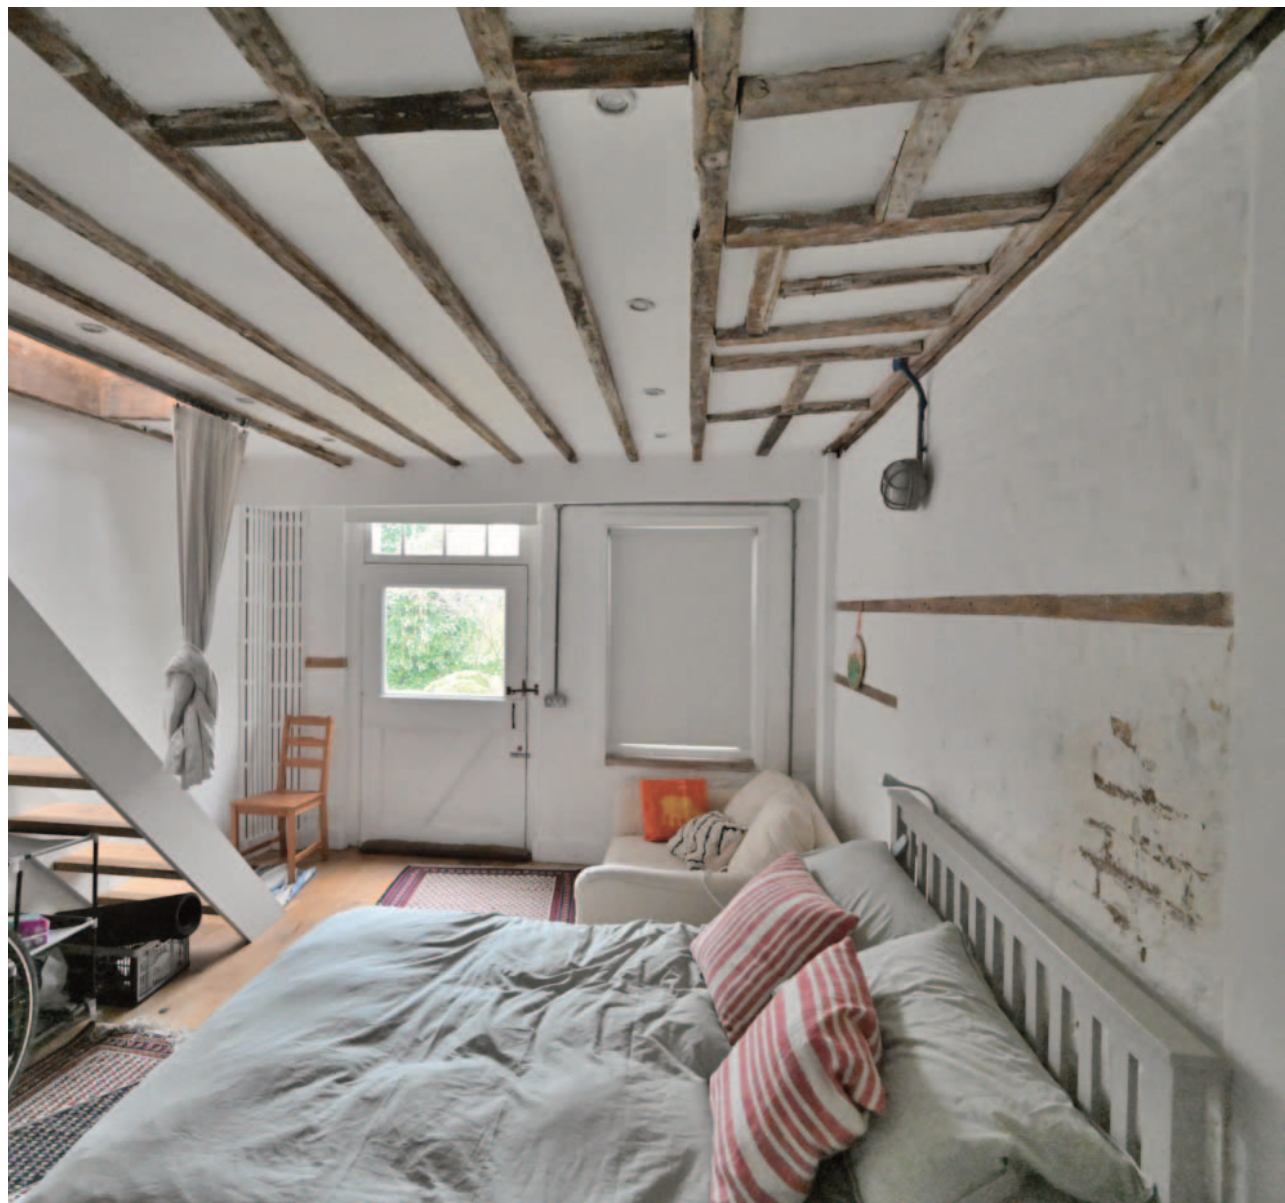
Fig. 46. The basement room - originally a stable it was converted to a workshop by the addition of a hearth to the left and a window to the right of the door. The stairs are modern and not in their historic position.

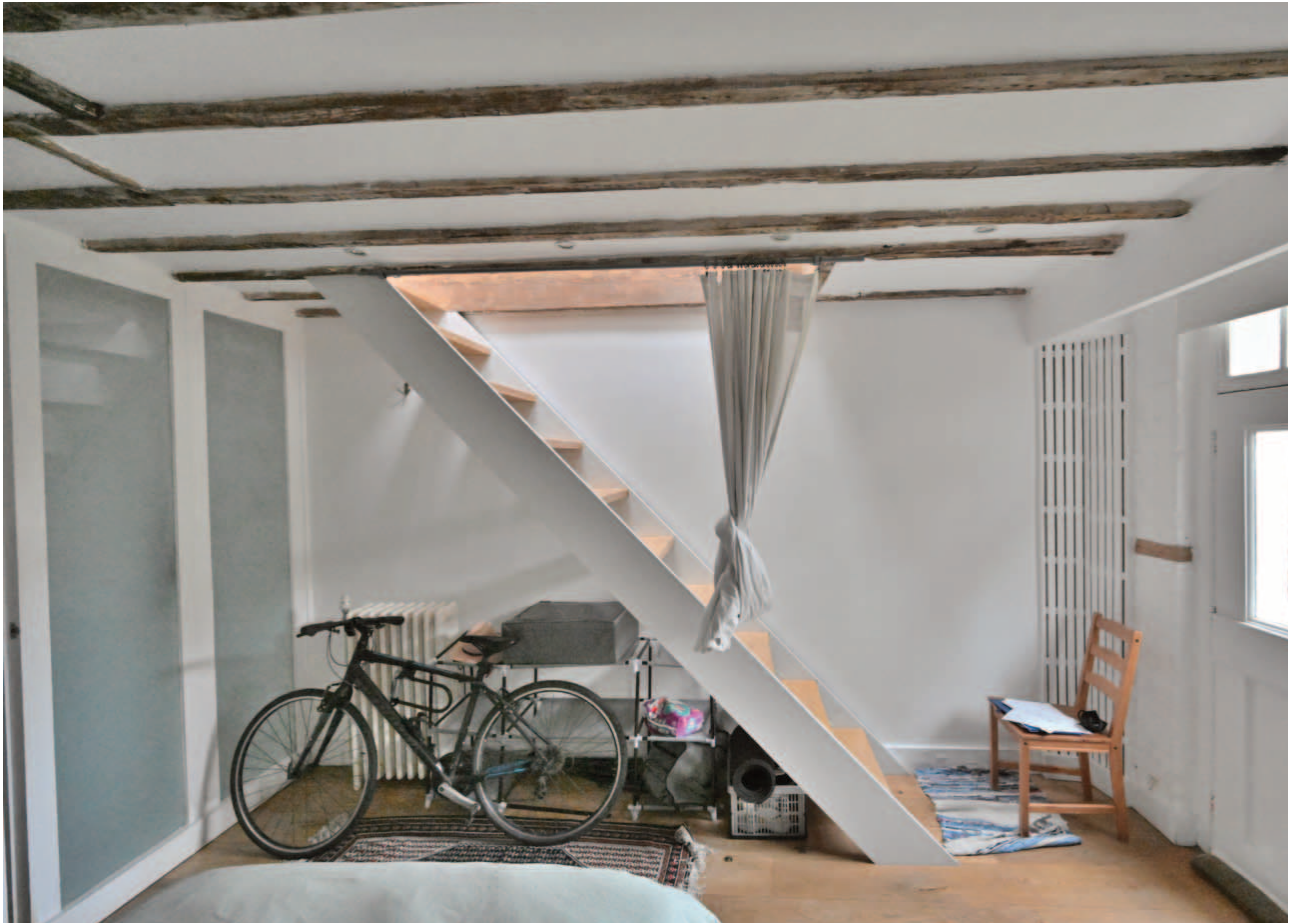
Fig. 47. Historic plans show a fireplace was located in the corner by the rear door until the 2008 conversion. The modern partition conceals a bathroom enclosure and the stairs and floor are modern.

A triangular section of masonry (?) built into the timber floor in the southeast corner of the building may be associated with a small fireplace on the ground floor which was removed as part of a 2005 permission. This part of the upper floor is partially concealed behind a deep timber board running parallel to the south wall, which was presumably added to support decayed joist bearings. The awkward relationship between the fireplace and the access door from the garden indicates that this fireplace was a later introduction after its original use as a stable had been abandoned.

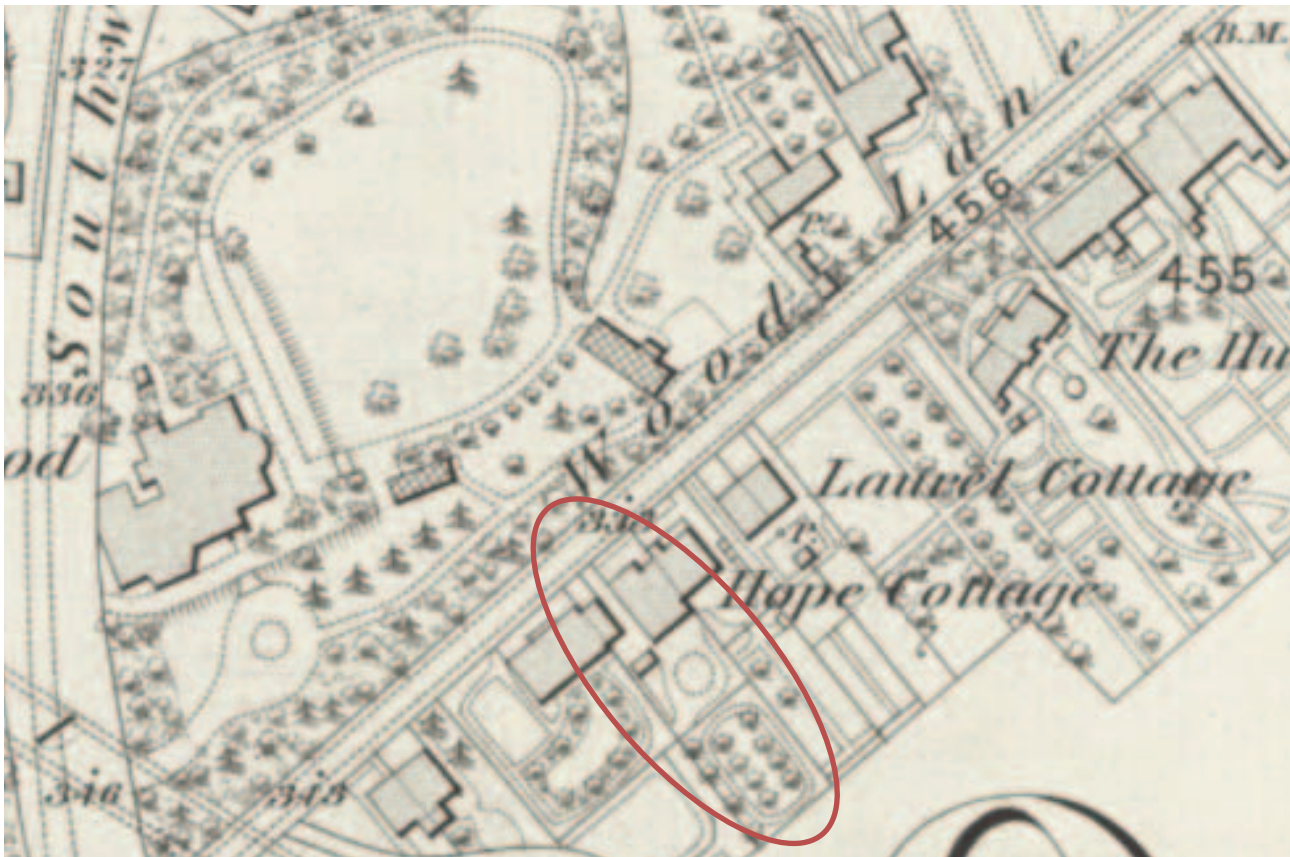
Fig. 50. The 1st edition large scale Ordnance Survey map of 1863 (published 1870) shows the site accurately for the first time. The rear garden is divided into two levels and there is an additional small outbuilding that still survived although shown as derelict in 1936.

It was not until the first edition large scale Ordnance Survey map surveyed in 1863 that the site was accurately recorded for the first time, and at this date there was an additional outbuilding in the garden. Unfortunately no other documentary history for the property appears to be held in either the Haringey or the London Metropolitan archives.
