## **Object**

The development proposed is incompatible with the preservation and long-term health of the trees alongside.

## **Summary**

The many deficiencies in the development design proposals and methodology mean the standard for discharge of conditions has not been met, and the proposed development should not be permitted.

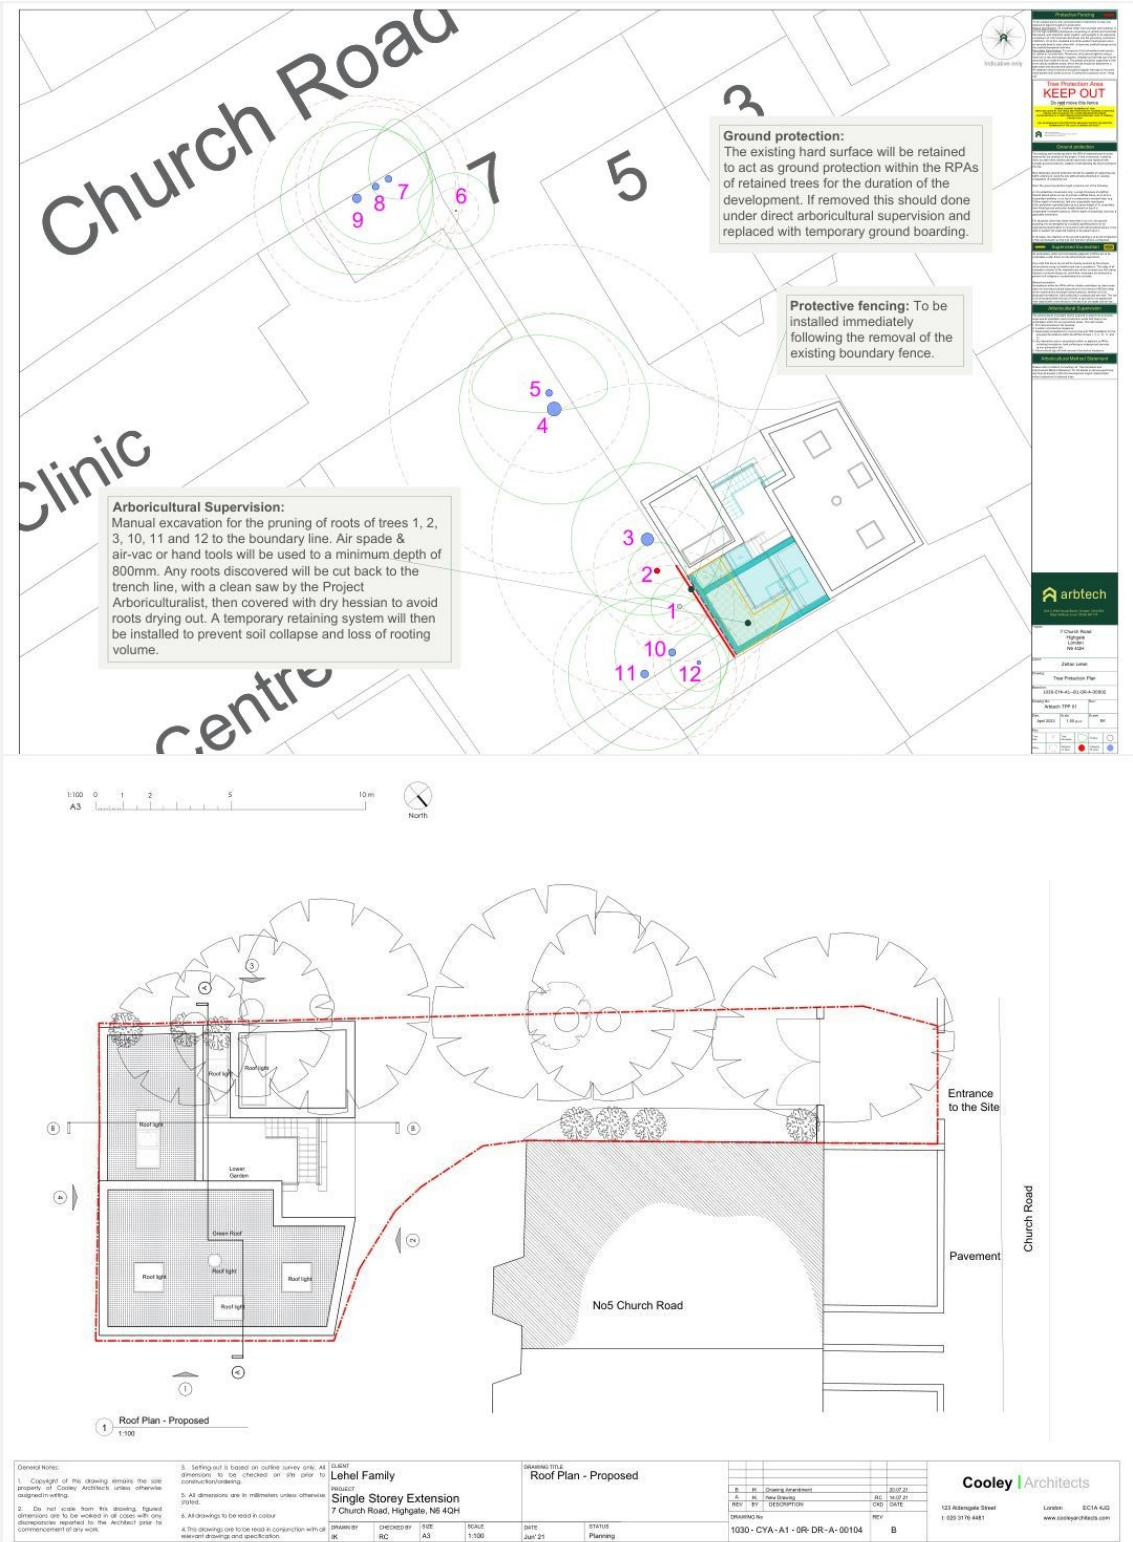
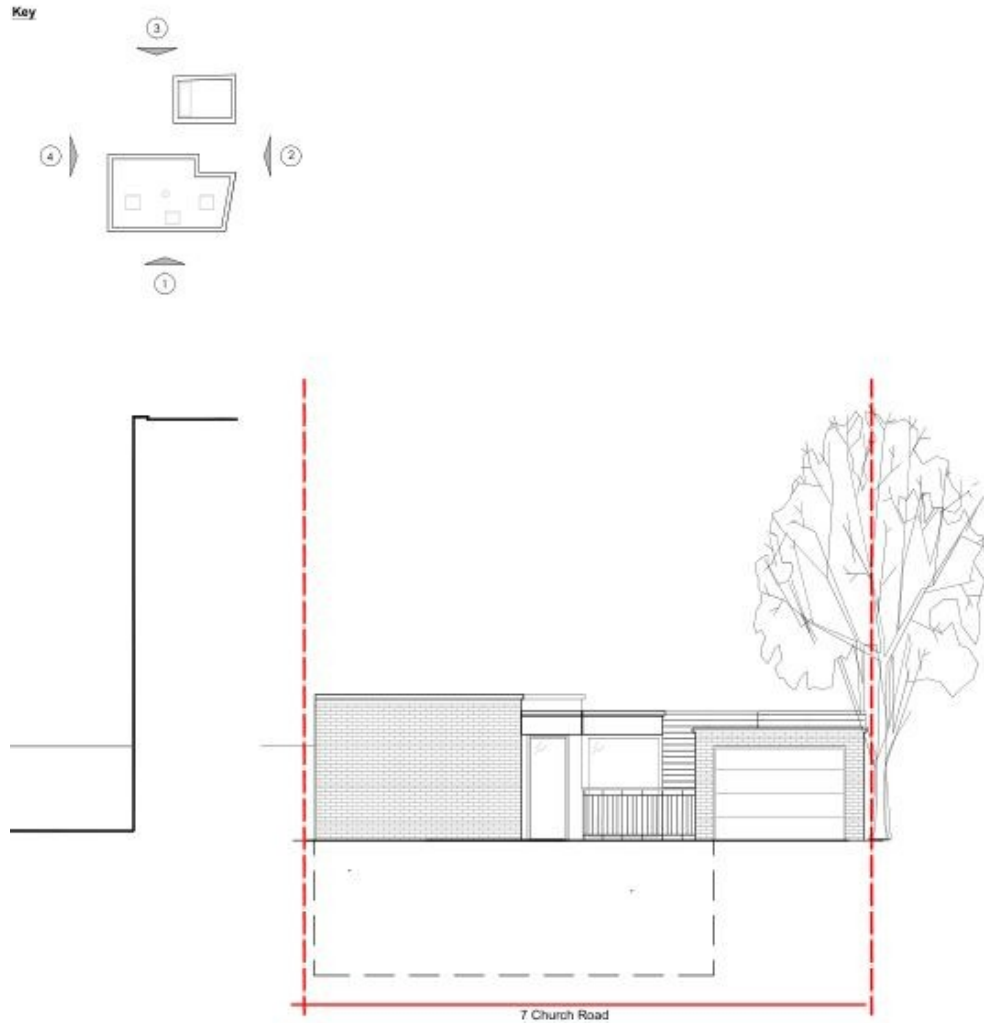
Conflicts between drawings

There are differences in the locations of trees 1, 2 and 3 shown in the drawings below. Given that the RPAs of trees 1 and 2 have radii of 1.5 m and 1.7 m, differences of 1 to 2 m in trunk locations mean large differences in impact. The close locations of the nearest trees are reinforced by the drawing of the trees alongside the garage.
