6 Architecture

6.1 Civic Centre

6.1.1 Repair and restoration of the civic centre

6.1.1.1 Curtain Walling and Windows

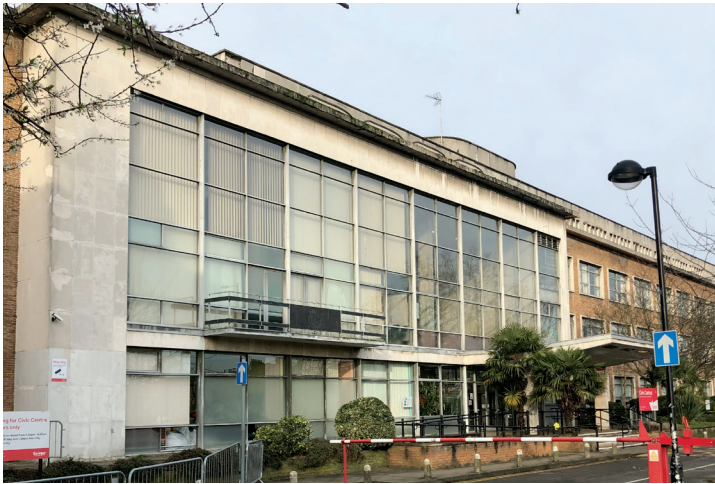
Extracts from section 5.5 on page 12 of Facade Systems Condition Survey

Windows & Curtain Walling Generally - Ground Floor to Second Floor

- Overall, these window systems are in poor condition and appear to have reached the end of service life.
- The framing is generally in poor condition: externally the painting or coating applied at some point to the aluminium mullions and transoms is degraded and patchy in places.

- The sealant between the frame and glass is brittle and patchy.
- A solar coating was present internally on most of the glazing inspected, marked as 'SOLAR SHIELD BS 6206/B FILM', which could be evidence of a perceived discomfort with the original glazing specification. The majority of this film applied was in good condition, but in many locations was starting to peel at the edges.

- A few panels on the West elevation curtain walling had an additional film applied externally with a 'blue' appearance, possibly a privacy filter, which appears to be in bad condition.

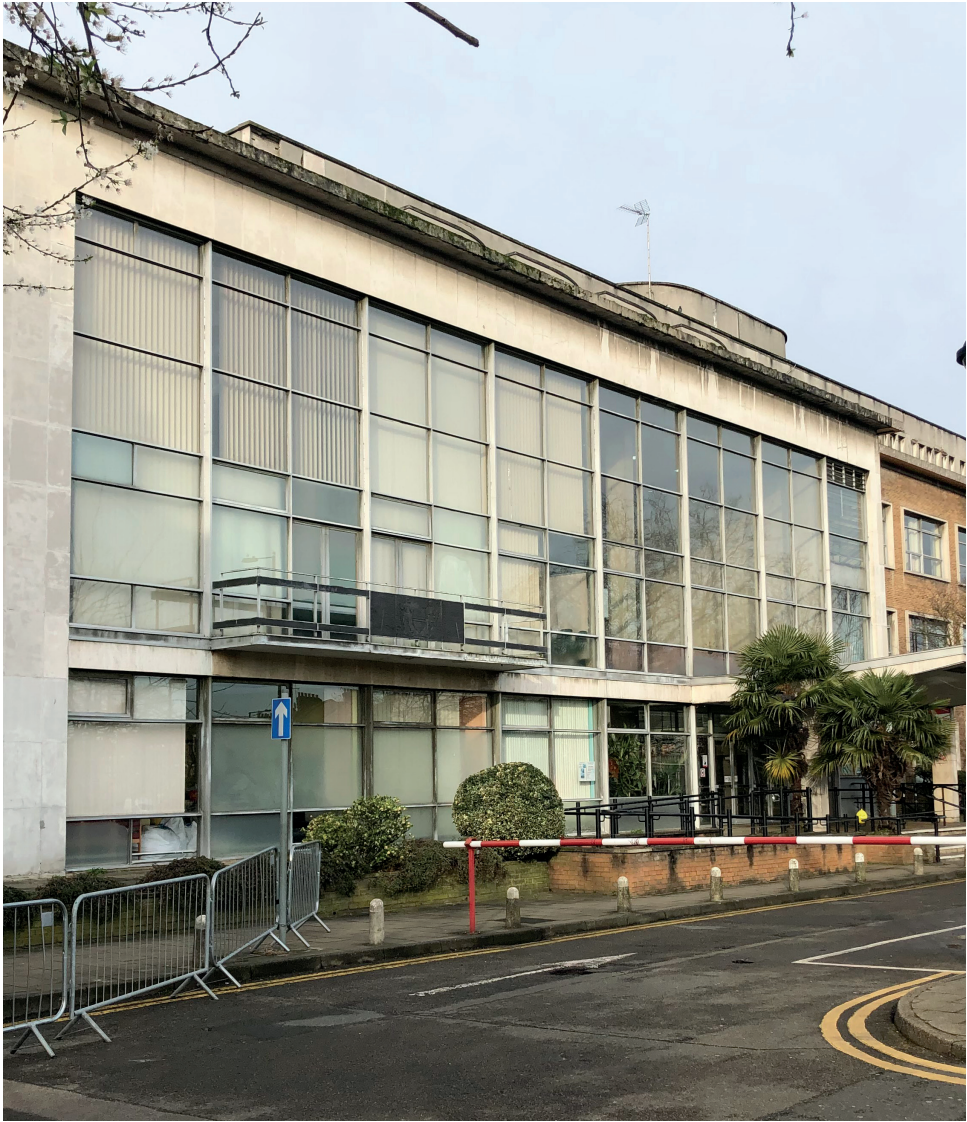
Type 01  
Aluminium Curtain Walling System

- Council Chamber and Entrance Lobby**  
**West Elevation Ground and first Floor**  
**West (Committee) Wing**
- Generally Single glazed
  - Inconsistent top-hung opening lights,
  - Internally solar control film in places - in some locations this is degrading/peeling
  - External privacy film in various locations
  - Secondary Steelwork in back-boxes of mullions with larger profiles
  - Several panels/bays have been replaced on west elevation ground floor
  - Double doors have been replaced in north and south elevations
  - Sealant/beading has degraded and contains asbestos
