Haringey Civic Centre

Repair and restoration of the civic centre

Existing pre-cast cladding / proposed GRC replacement

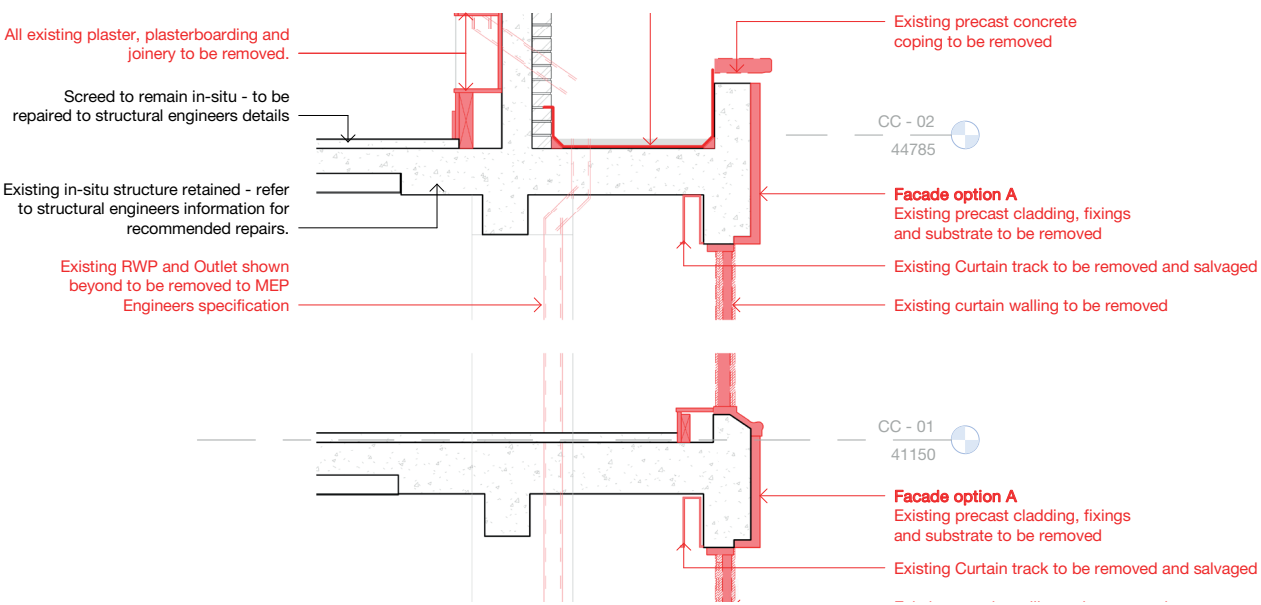
Section through West Elevation - Proposed demolition

As there is only a very small cavity behind the panels (10-20mm), it will be impossible to access fixings to carry out any repair or maintenance without removing panels. Removal of the panels would inevitably lead to further damage.

Full replacement of the pre-cast panels is recommended for the following reasons:

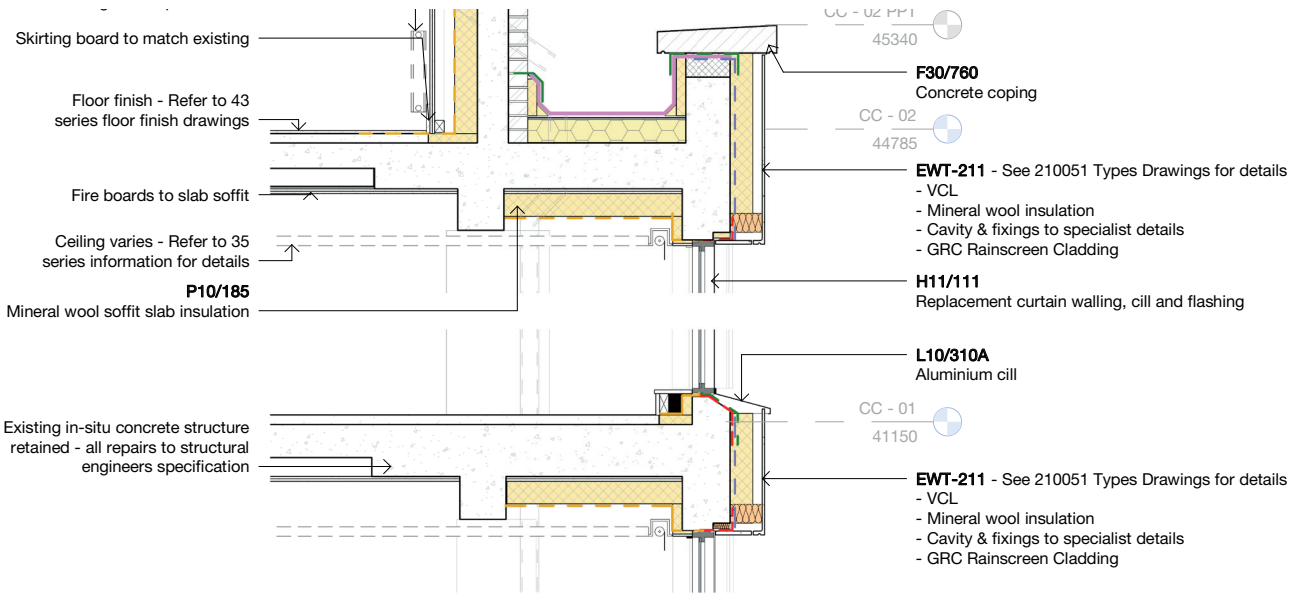
Section through West Elevation - Proposal

It is proposed to replace the pre-cast panels with insulated GRC (glass reinforced concrete). GRC is a lightweight product available in a colour and texture to match the existing pre-cast. Because it can be made in thinner panels than pre-cast, it provides an opportunity to insulate the building. The detail right illustrates the proposal to replicate the appearance of the existing pre-cast but integrate 100mm of mineral wool insulation. This will create a thicker overall build-up than the existing (approx 60mm thicker), but will not significantly change the appearance of the building. This will achieve the target U-value of 0.3W/m2/K

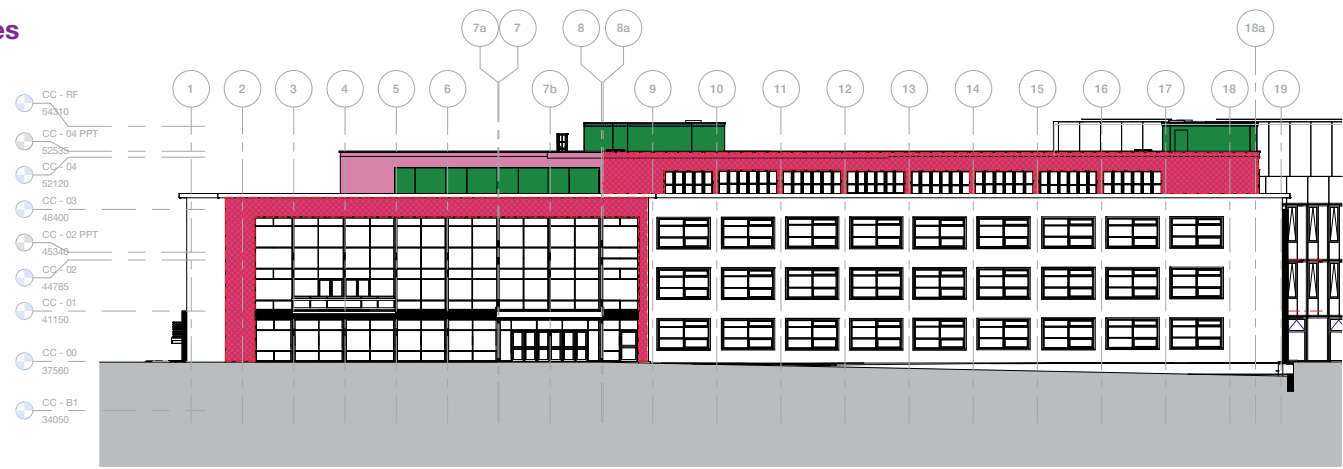
GRC Wall Types

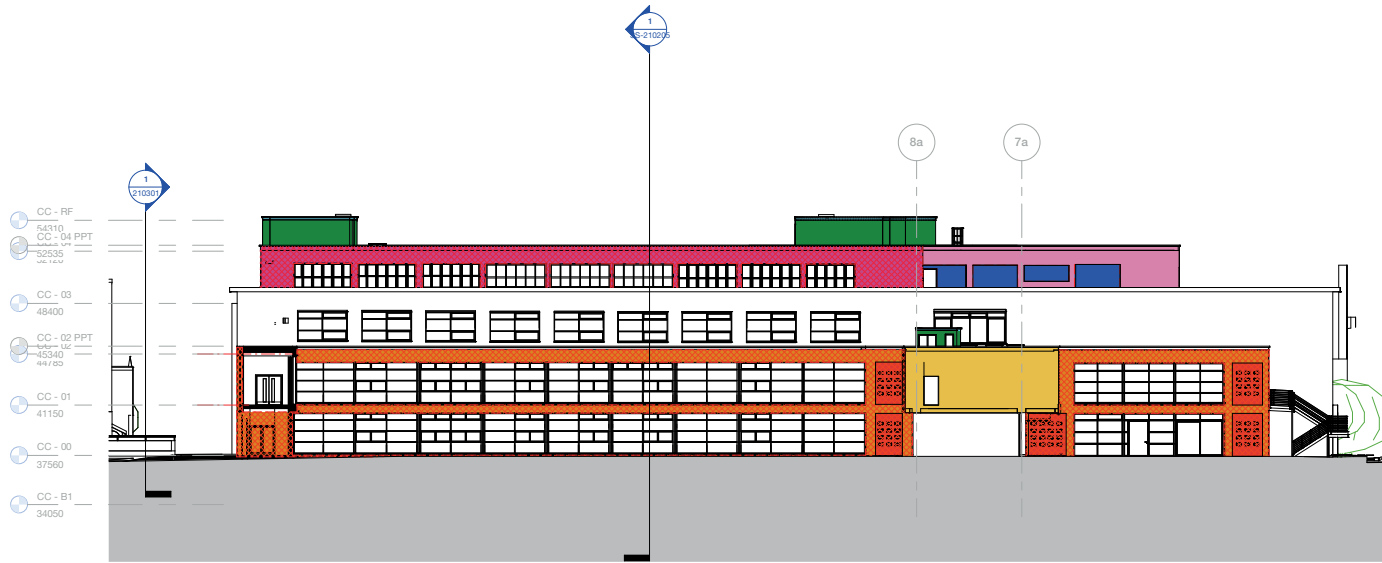
External Concrete & Render Wall Types - East Elevation  
1 : 200

The extent of the pre-cast / GRC areas is highlighted on the elevations overleaf - different colours represent different substrates - all will adopt the same basic approach for the new cladding.

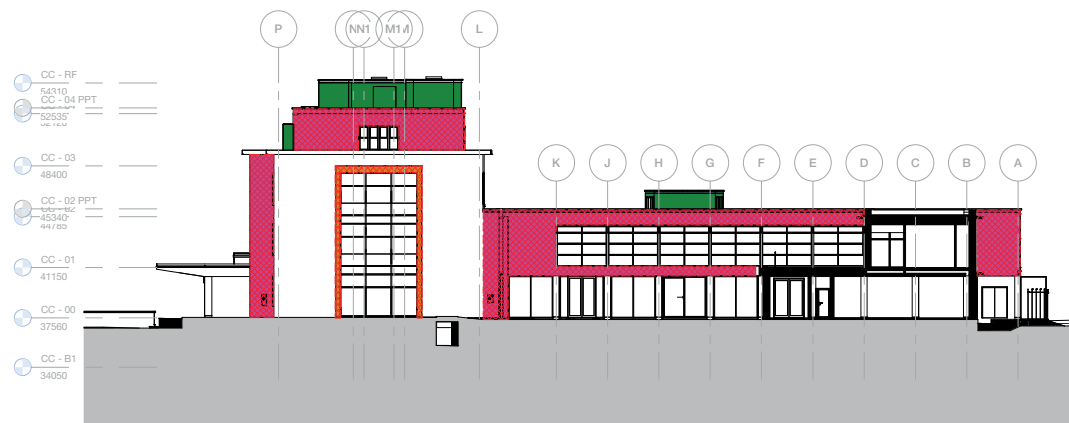
External Concrete & Render Wall Types - West Elevation  
1 : 200

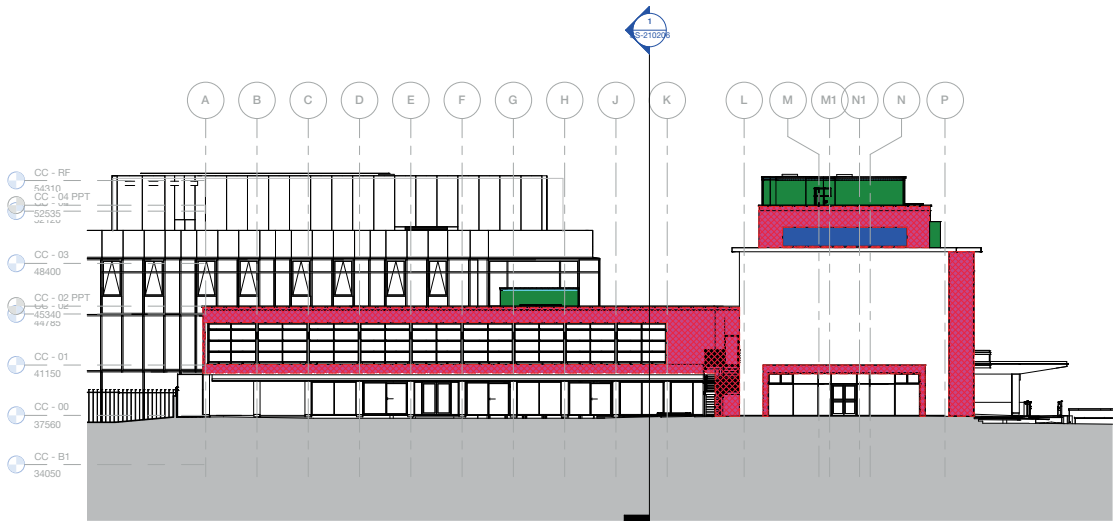
External Concrete & Render Wall Types - North Elevation  
1 : 200

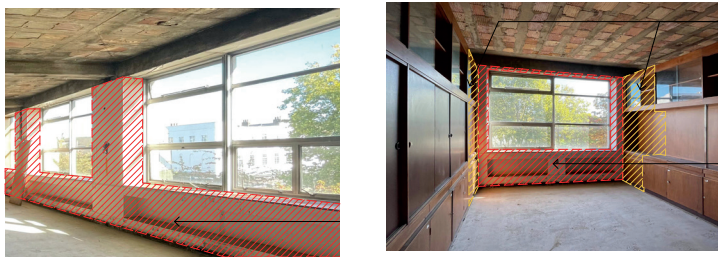
External Concrete & Render Wall Types - South Elevation  
1 : 200

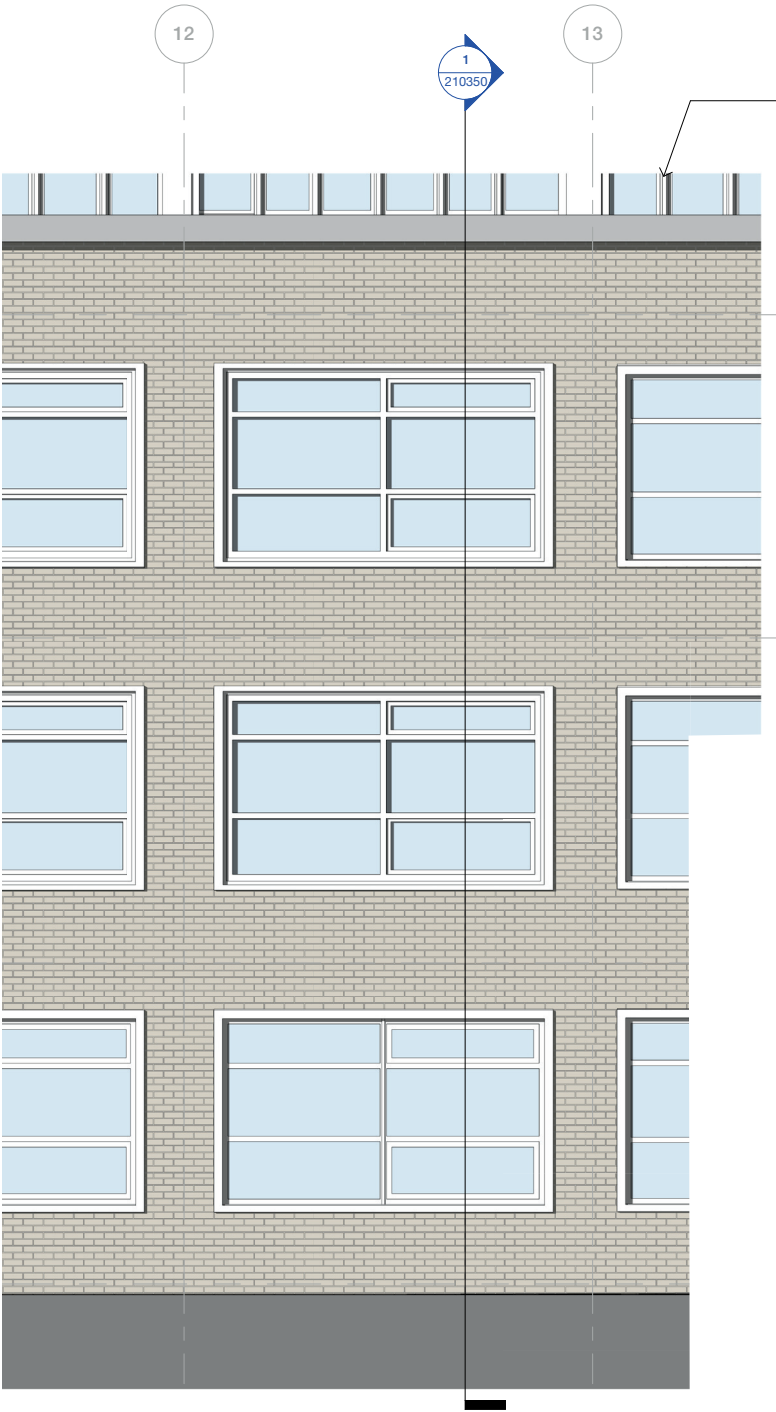
Proposed demolition of internal finishes

The extent of the brickwork areas is illustrated in the diagrams overleaf. The different colour coding represents conditions / wall types as described below.

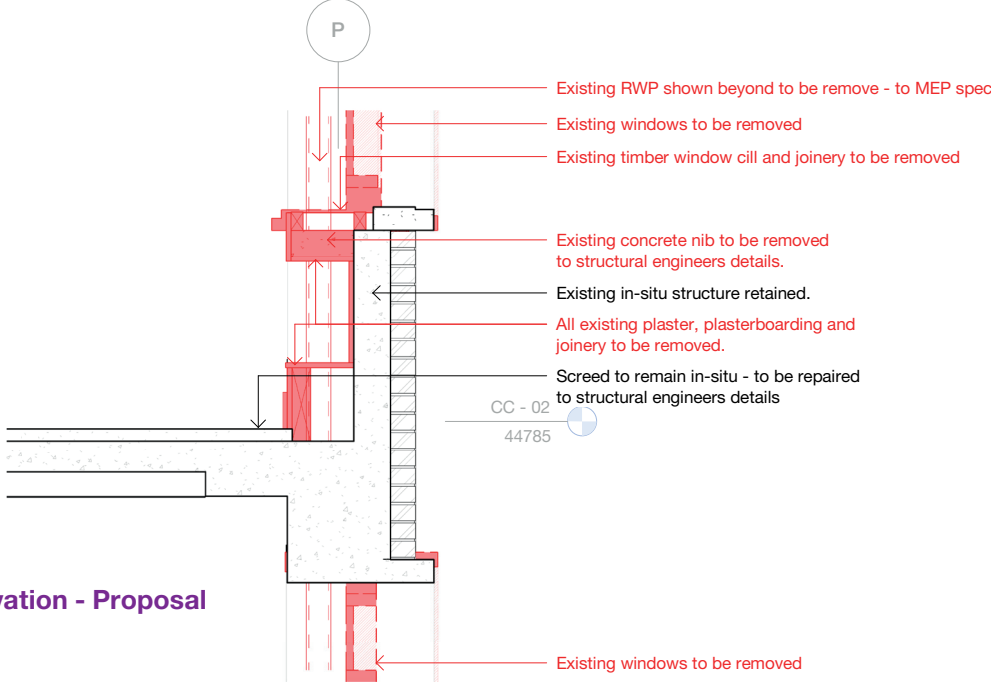
Section through East Elevation - Proposed demolition

Existing condition: brickwork on concrete substrate (minimal cavity) with uninsulated plastered lining.

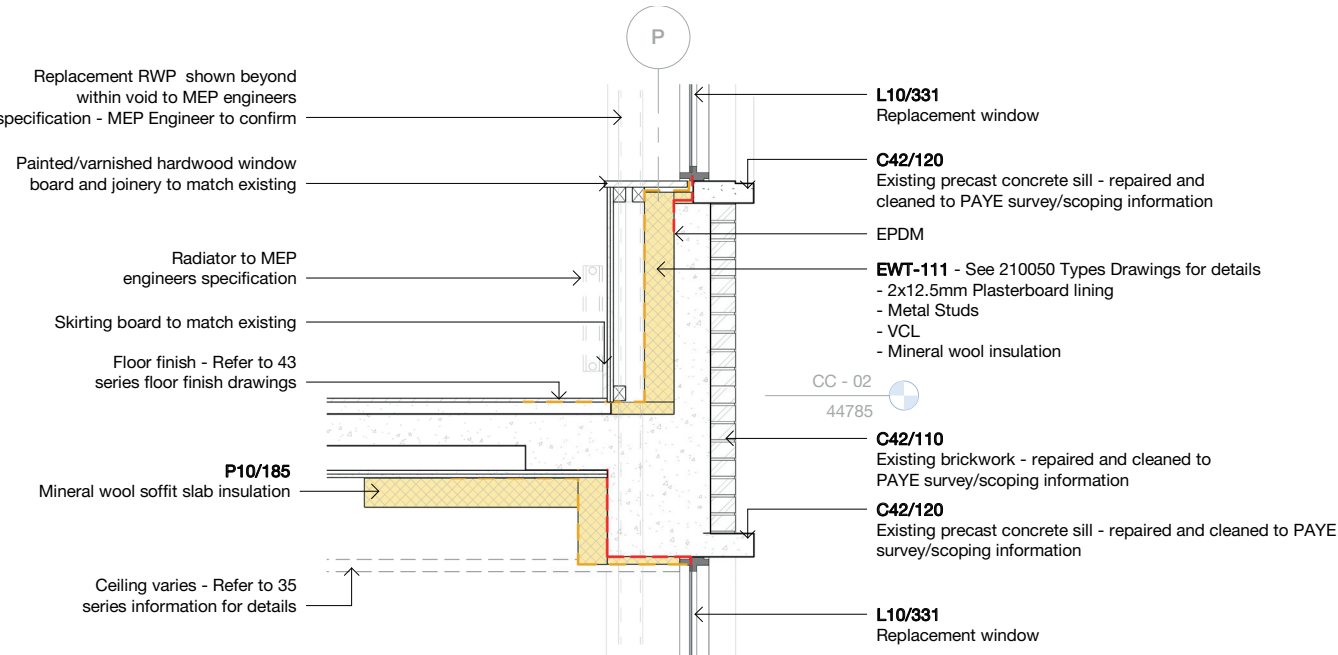
Section through East Elevation - Proposal

Proposal: the uninsulated plastered lining is to be removed and replaced with an insulated plasterboard lining.

Air tightness and vapour permeability and condensation risks will be considered and addressed through the use of vapour barriers and air tightness membranes. These details will be developed at the next stage.
