Interior Design

North Wing Workspace

WCs

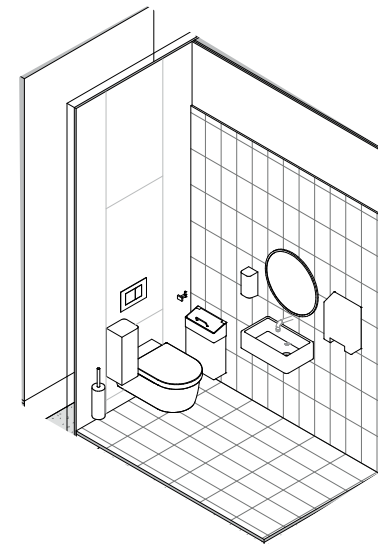
Axo of typical Toilet cubicle

New, integrated plumbing fixtures and sanitary appliances with IPS panels.

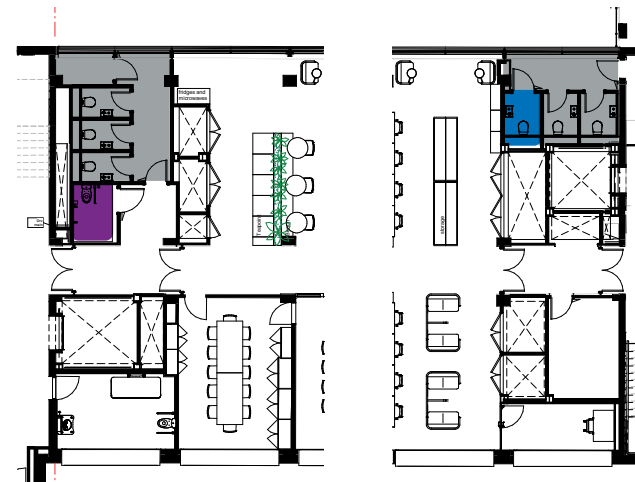
North Wing typical Toilet Blocks

The proposal looked to re-use the existing risers to toilets while reconfiguring the toilet space with new sanitary appliances and finishes. The proposal is to use tiled floors and walls in keeping with the previous design and reflect the design principles/era of the building in the design.

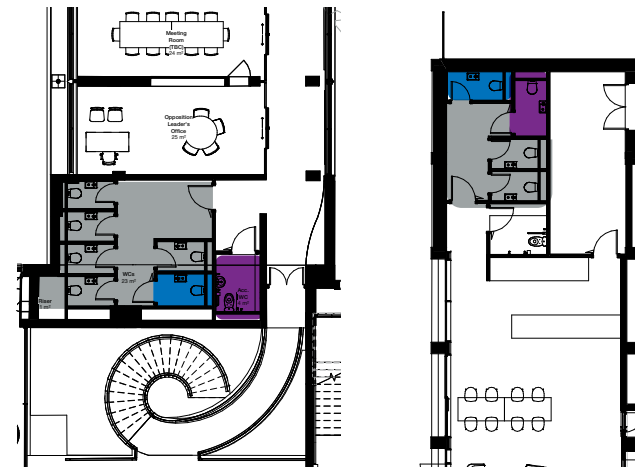
West Wing Toilet Block

Welcome Space Toilet Block

- Toilets blocks
- Accessible toilet
- Ambulant toilet

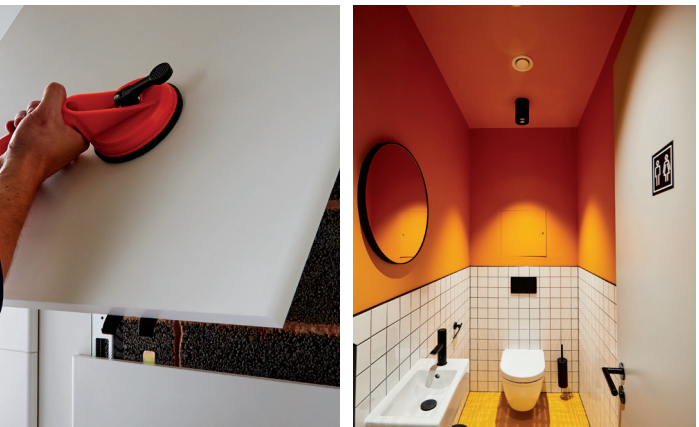
Integrated IPS Panels

Forge Working by Hawkins\Brown

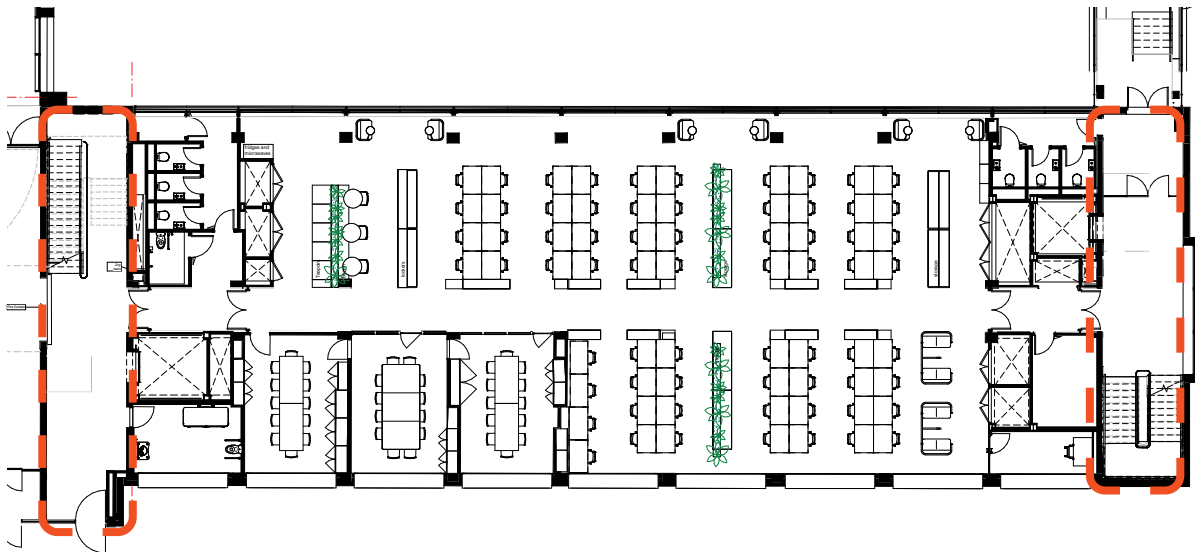
North Wing typical staircores

- Terrazzo steps to be repaired and made good;
- Plaster Soffits to be repaired and made good;
- Plasterboard ceilings in lobbies are to be reinstated;
- Repair of balustrades and railings (resistance and fixings to be tested before repair;
- Strip out redundant signage;
- Repair plaster where necessary
- Plaster to external walls is to be removed and replaced with insulated lining.
