# Detailed Unexploded Ordnance (UXO) Risk Assessment

| Project Name | Land at Kerswell Close |
| Site Address | Kerswell Close site, Haringey, N15 3JH |
| Report Reference | DA5223c-00 |

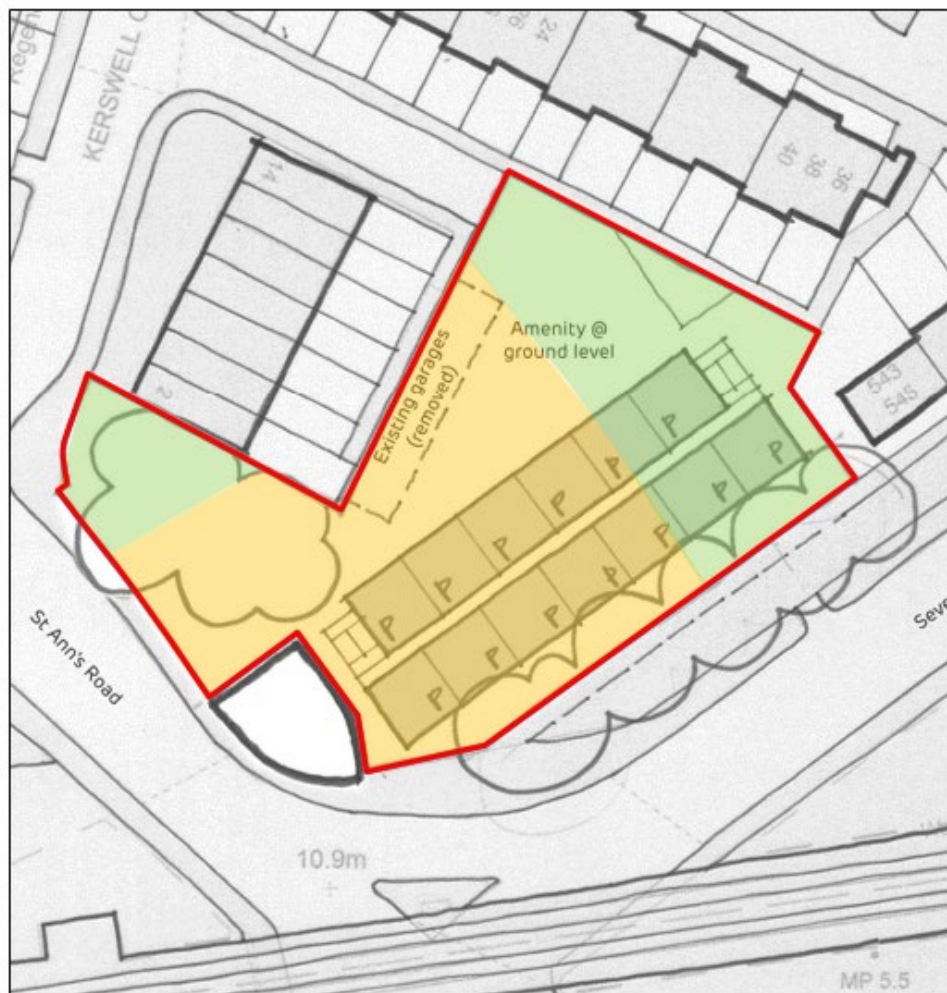
**UXO Risk Map and Recommended Risk Mitigation Measures**

| Risk Zone | Activity | Recommended Risk Mitigation Measure |
| Low | All Works | <ul style="list-style-type: none"> <li>UXO Risk Management Plan</li> <li>Site Specific UXO Awareness Briefings to all personnel conducting intrusive works.</li> </ul> |
| Medium | Open Excavations<br>(trial pits, service pits, bulk excavations, strip foundations etc.) | <ul style="list-style-type: none"> <li>UXO Specialist On-site Support</li> </ul> |
| | Boreholes and Piled Foundations | <ul style="list-style-type: none"> <li>Intrusive Magnetometer Survey of all borehole and pile locations/clusters down to maximum bomb penetration depth.</li> </ul> |

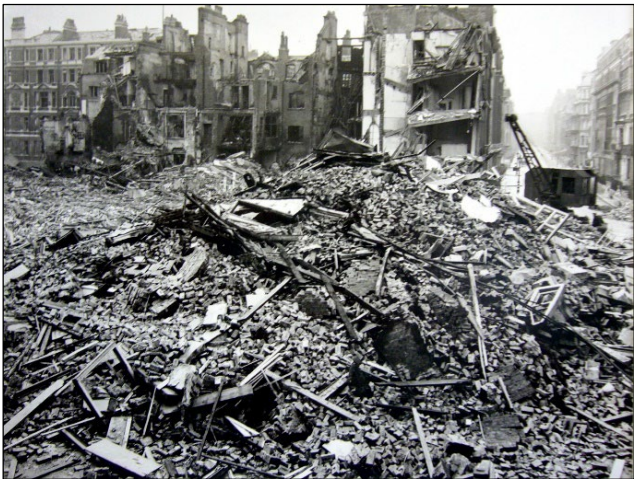
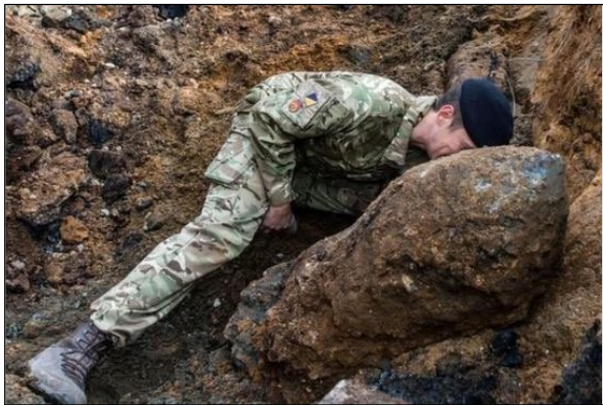
**Top:** J-curve Effect - Due to angle of entry, unexploded bombs would often end their trajectory at a lateral offset from point of entry, often ending up beneath adjacent extant structures/sites.

The photograph **above** shows a 250kg unexploded bomb found in Bermondsey in 2015, pointing upwards, demonstrating 'J-curve'.

One of the most common scenarios for UXO going unnoticed was when a UXB fell into a 'bomb site' (such as the area shown **Top Left**), the entry hole of the bomb obscured by any debris and rubble present. Note that the entry hole of a 50kg UXB could be as little as 20cm in diameter (**Left**).

J-curve is the term used to describe the characteristic curve commonly followed by an air delivered bomb dropped from height after it penetrates the ground. Typically, as the bomb is slowed by its passage through underlying soils, its trajectory curves towards the surface. Many UXBs are found with their nose cone pointing upwards as a result of this effect. More importantly, however, is the resulting horizontal offset from the point of entry. This is typically a distance of about one third of the bomb's penetration depth, but can be higher in certain conditions (see **Annex E**).

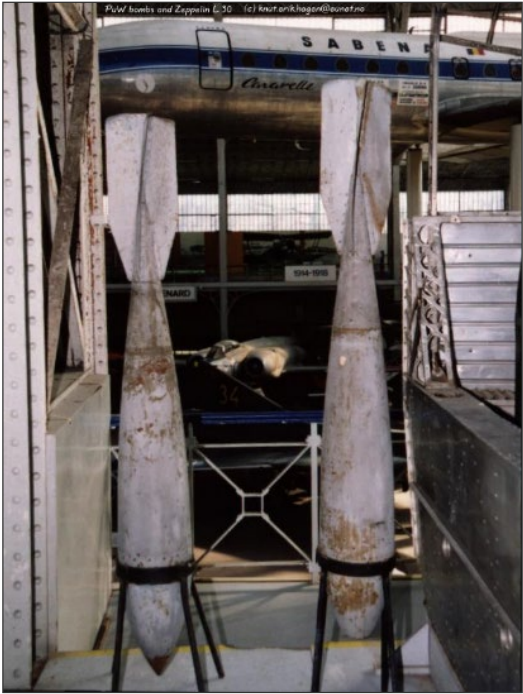
Examples of 50 and 100kg German WWI bombs

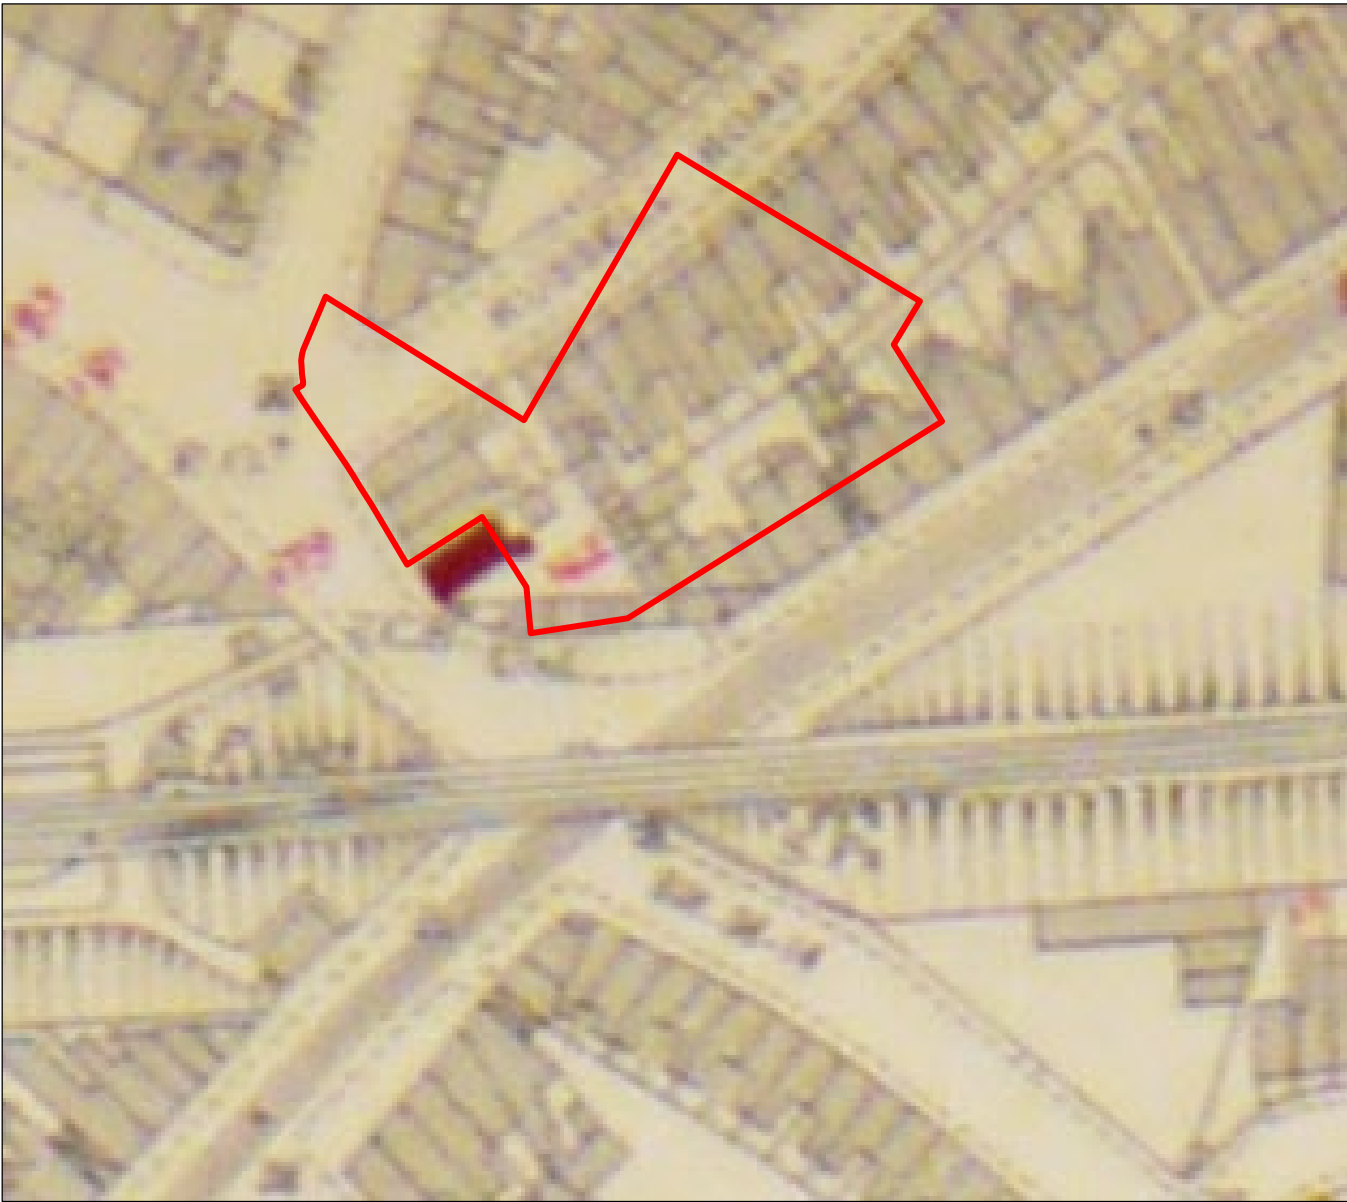
Category 1 - "Total damage, building to be demolished."

Category 2 - "Some repairs possible, but could become Cat 1."

Category 3 - "Border line areas, uncertain whether repairs possible, might have to be demolished."

| 11.9. | Middlesex County Council War Damage Map ..... | 13 |

| List of Report Annexes | |
|---|---|
| Annex P | Middlesex County Council Bomb Damage Map |

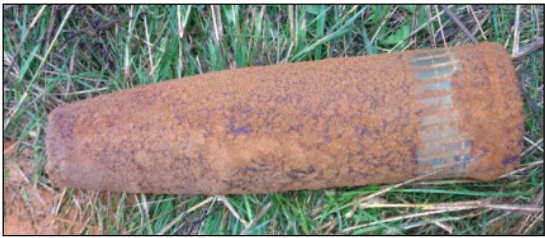
| 3.7 Inch QF Anti-Aircraft Projectile | | | <br> |

| 3.7 Inch QF Anti-Aircraft Projectile | | | <br> |
|---|---|---|---|
| Projectile Weight | 28lb (12.6 kg) | | |
| Explosive Weight | 2.52lbs | | |
| Use | The 3.7in AA Mks 1-3 were the standard Heavy Anti-Aircraft guns of the British Army and were commonly used on the Home Front. | | |
| Ceiling | 30,000ft to 59,000ft | | |

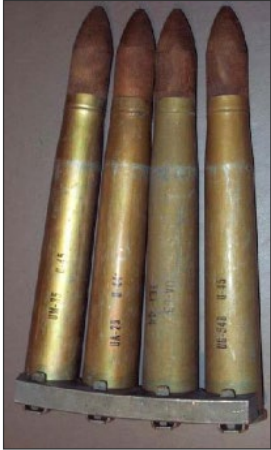
| 40mm Bofors Projectile | | | | |

| 40mm Bofors Projectile | | | | |
|---|---|---|---|---|
| Projectile Weight | 196lb (0.86kg) | | | |
| Explosive Weight | 300g (0.6lb) | | | |
| Remarks | Light quick fire high explosive anti-aircraft projectile. Each projectile fitted with small tracer element. If no target hit, shell would explode when tracer burnt out. Designed to engage aircraft flying below 2,000ft. | | | |

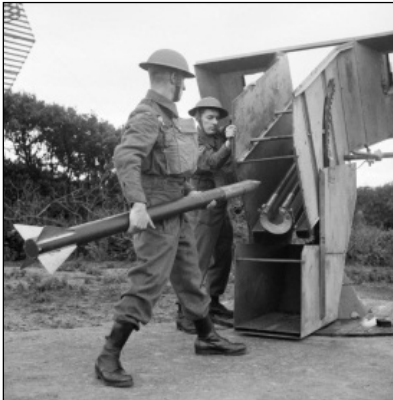
Figure 185—3-in. U.P. Anti-aircraft Rocket Components

| 3in Unrotated Projectile (UP) Anti-Aircraft Rocket ("Z" Battery) | |
|---|---|
| Dimensions of projectile | 236 x 83mm (9.29 x 3.25in) |
| Remarks | As a short range rocket-firing anti-aircraft weapon developed for the Royal Navy. It was used extensively by British ships during the early days of World War II. The UP was also used in ground-based single and 128-round launchers known as Z Batteries. Shell consists of a steel cylinder reduced in diameter at the base and threaded externally to screw into the shell ring of the rocket motor. |
