# Highways Condition Survey Woodridings Court, London N227RX 4 February 2026

REPORT 01

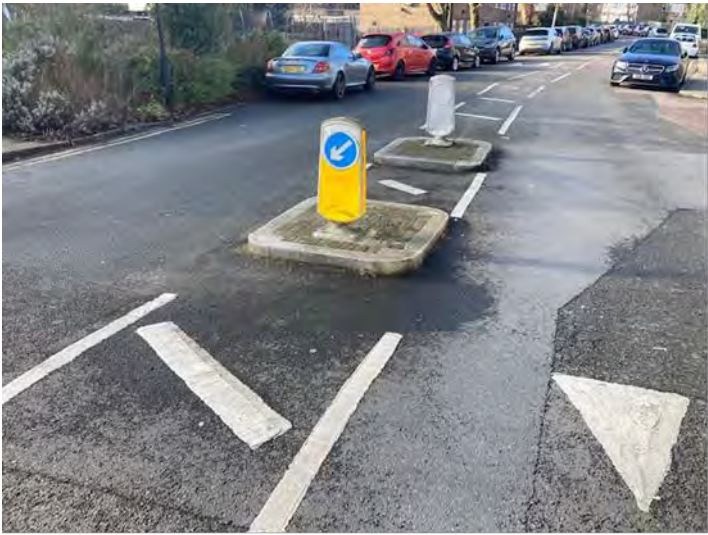
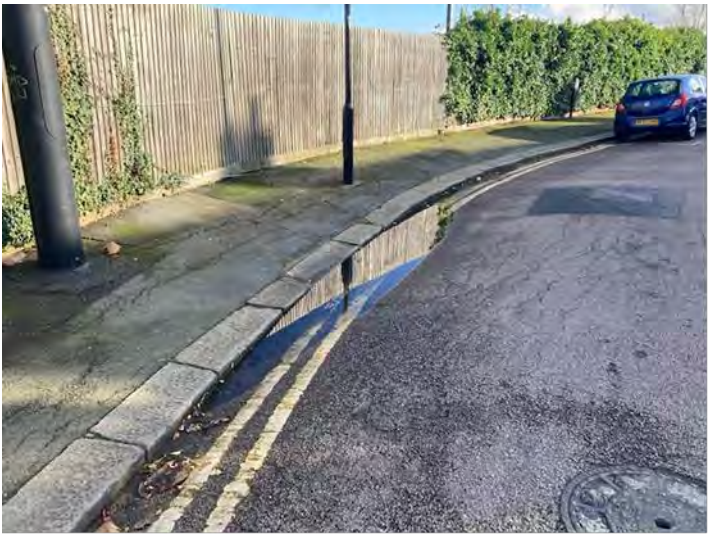
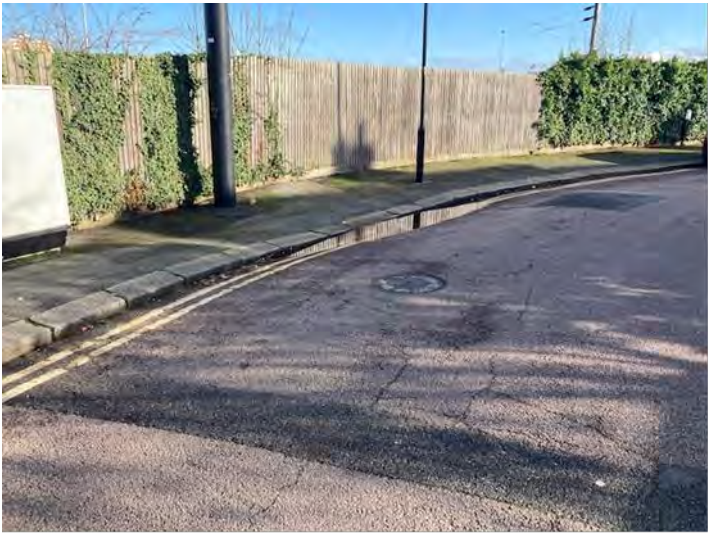
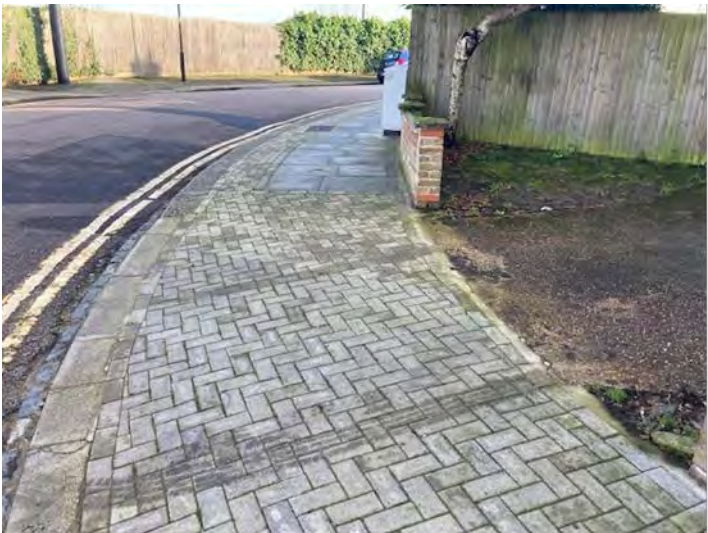
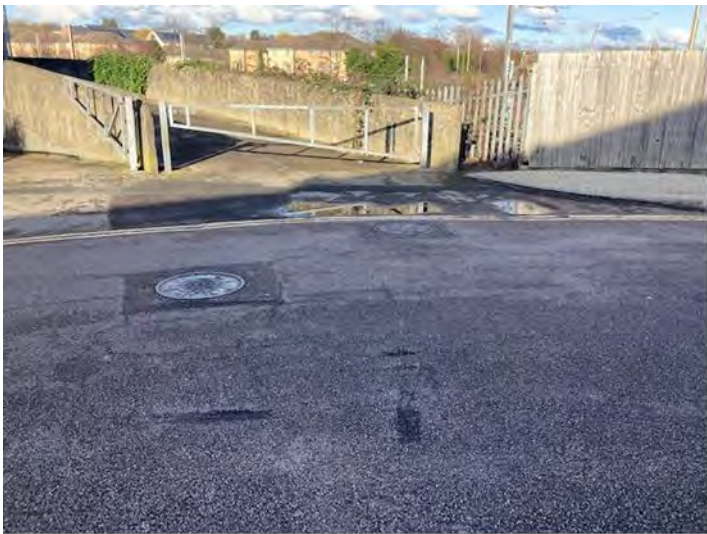
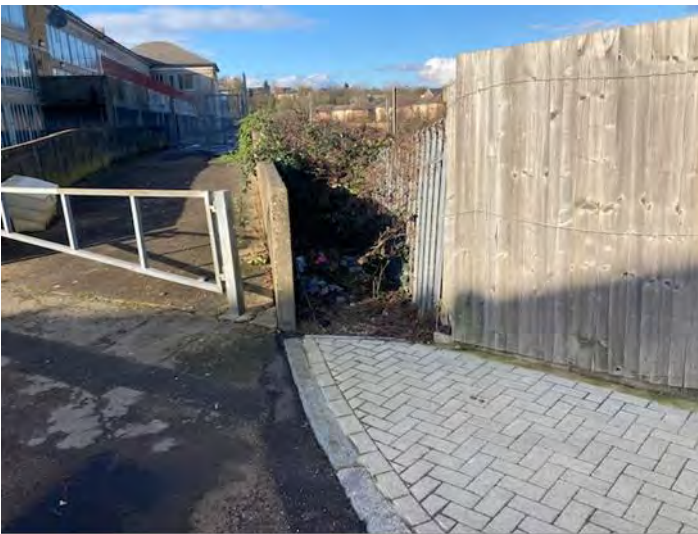
- The condition of the paving along Crescent Road around the entrance is poor and there are a large percentage of cracked and broken paving slabs and kerb stones, this is evident by the photos in the survey. The tarmac road surface has several repairs and crack . As we progressed along Crescent Road, approximately 90m, the paving changes and has been renewed, although ponding was evident in several places.
- Dagmar Road paving was generally in good condition having been renewed, the entrance around the railway sidings is tarmac and there are several areas where ponding has occurred , with the tarmac to the road surface with several cracks and in a poor state. The kerbs in this area, near the entrance to the sidings on the curve have been dislodged and sunken into the road.
