Job/Project Name:  
51A HILLSIDE ROAD, N15 6LU

Drawing Title:  
EXISTING & PROPOSED FRONT SECTION

| Drawing No:<br>L1020406-02 | Revision:<br>OR |

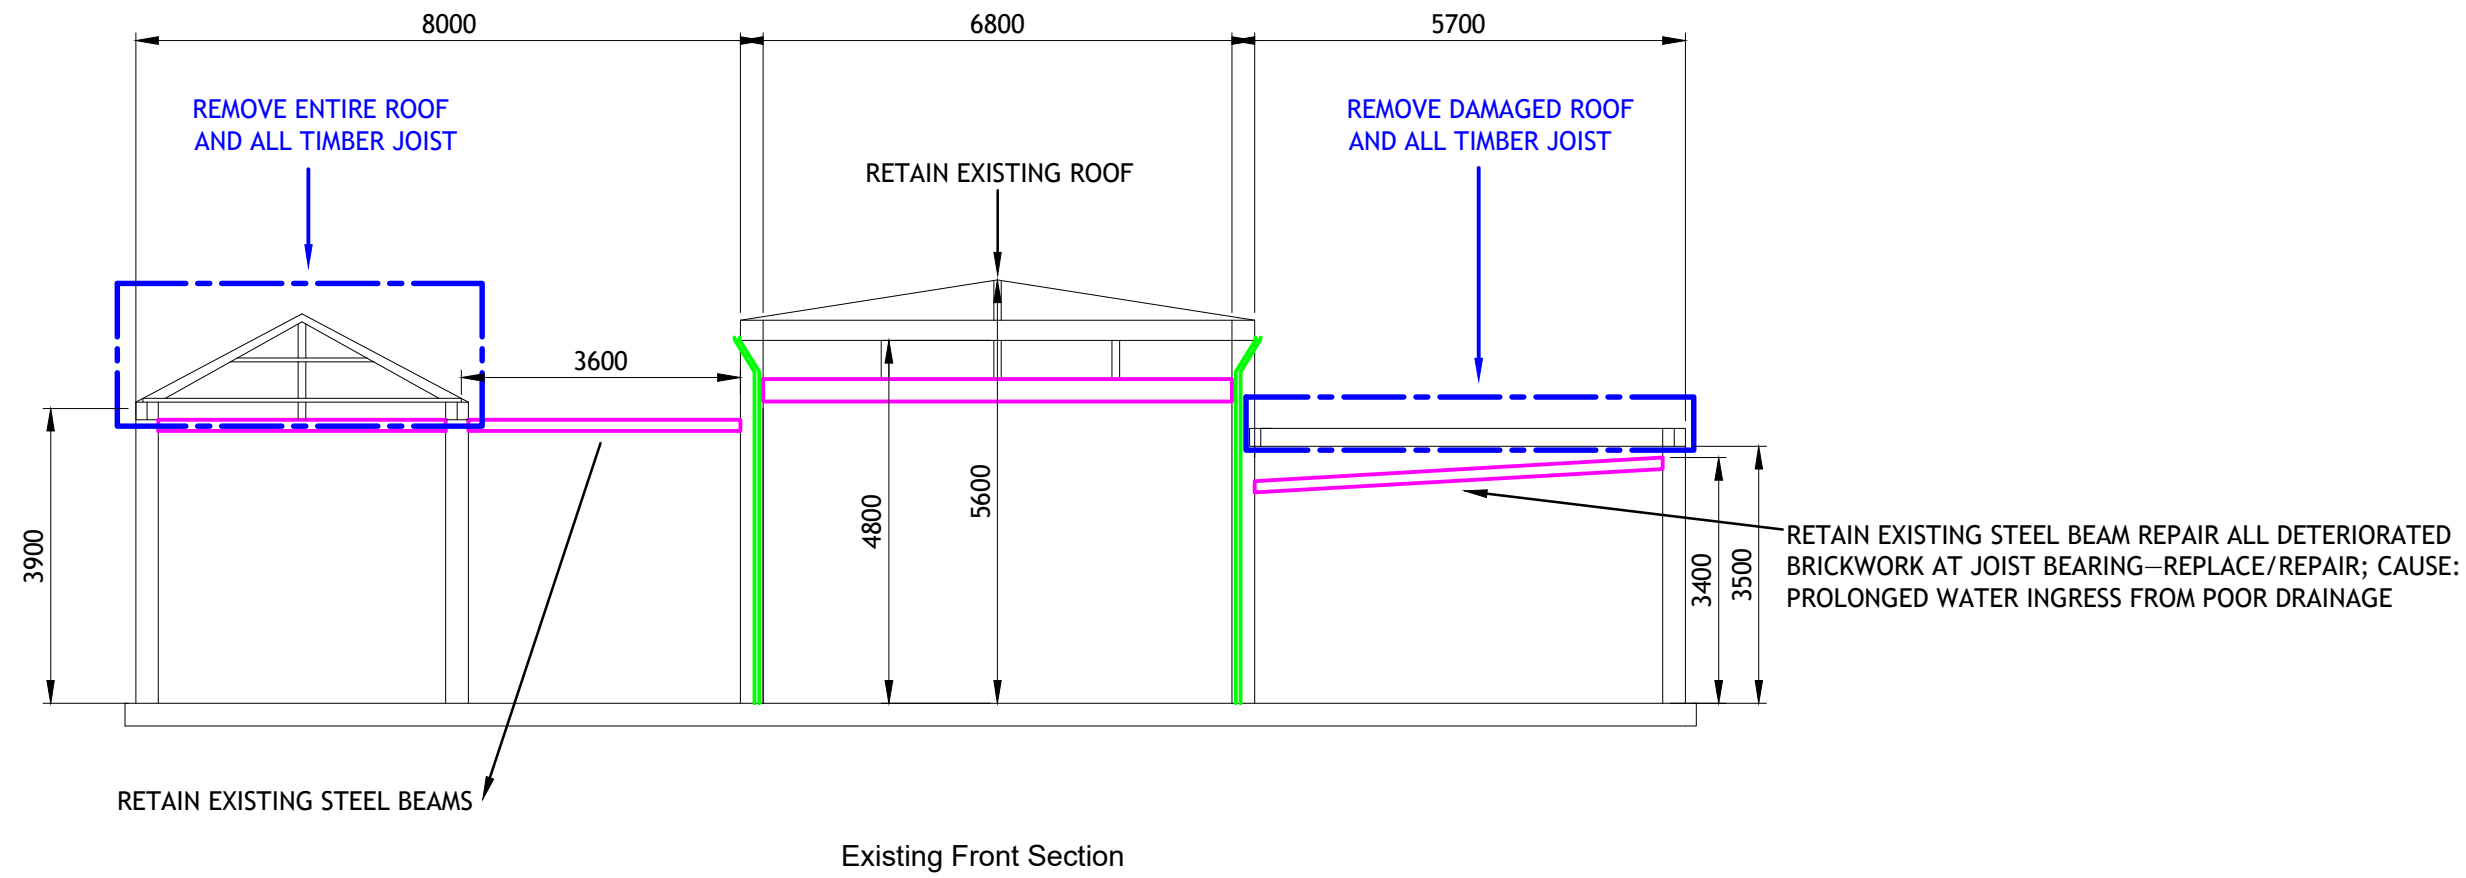
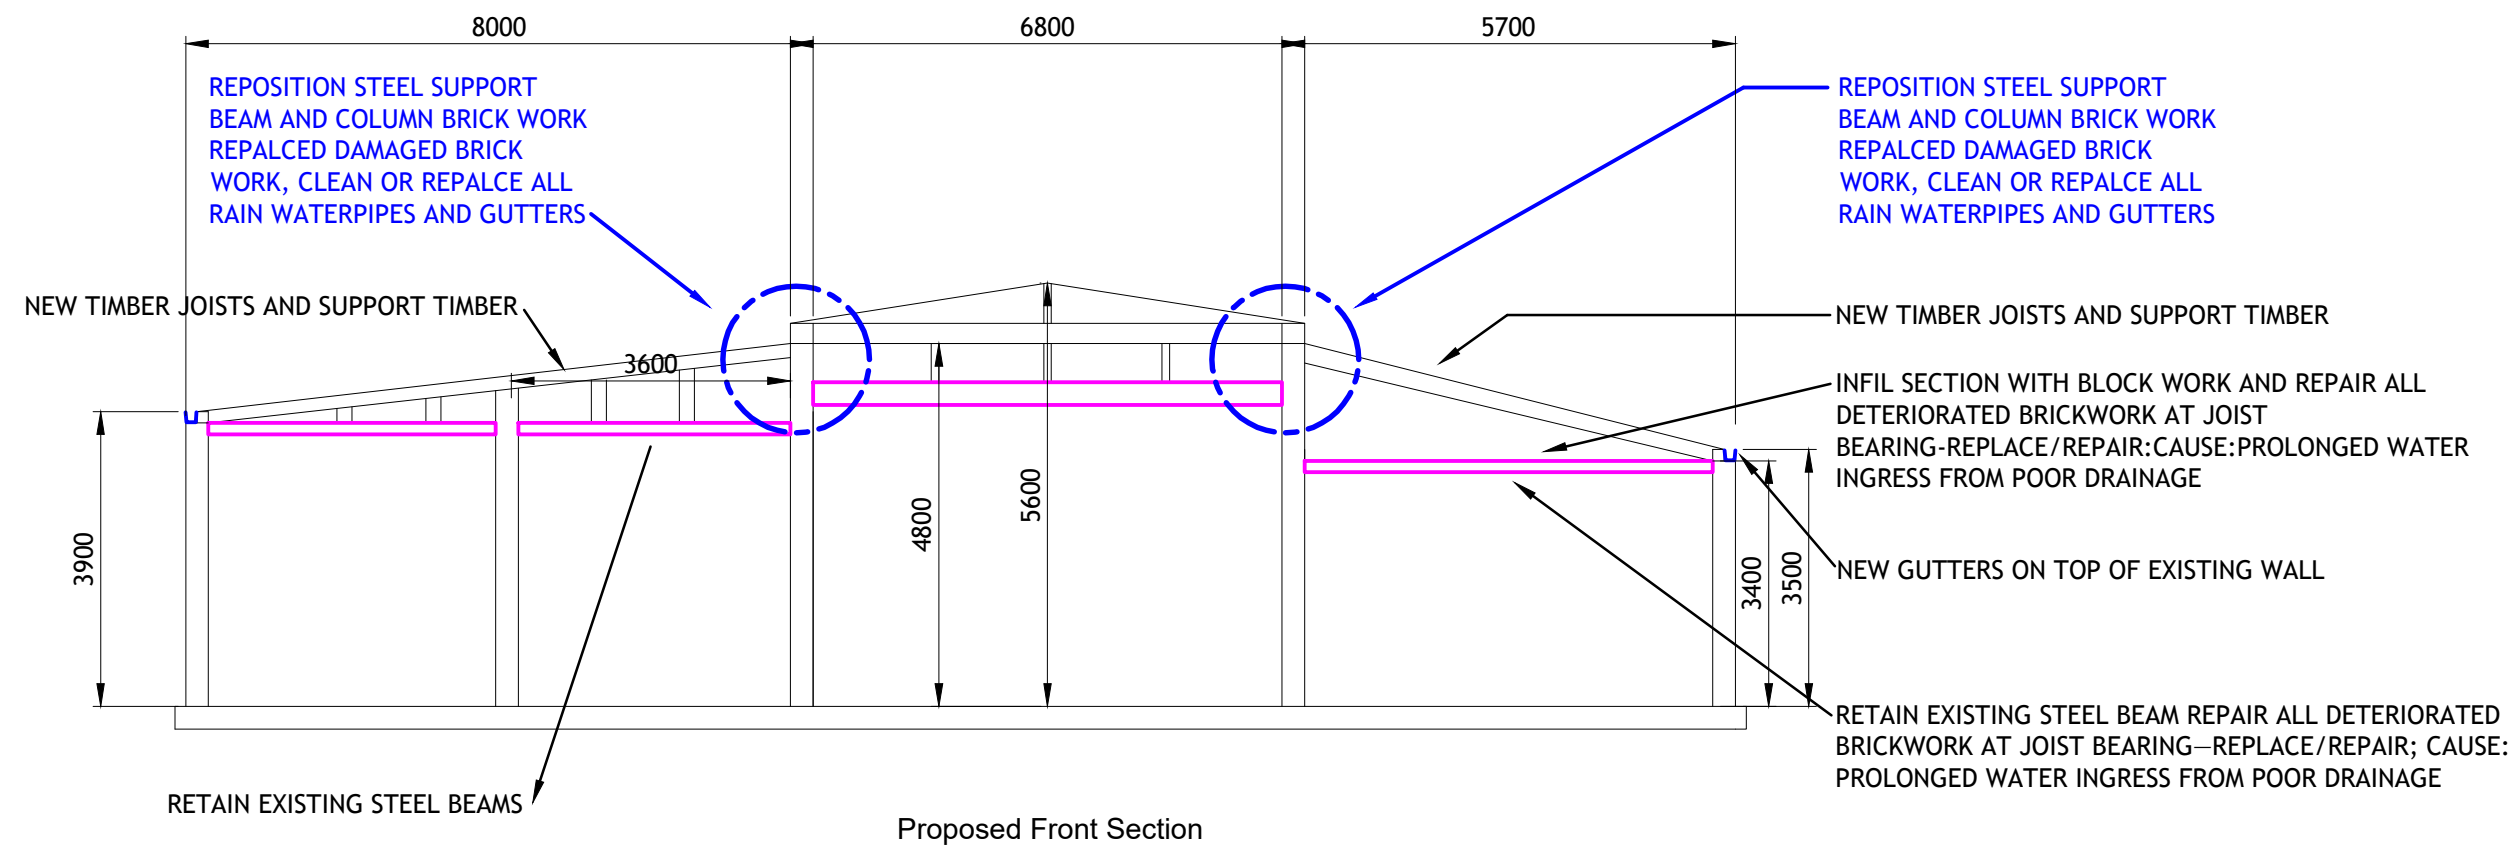
1. ALL STEEL HORIZONTAL BEAMS TO BE RETAINED.
2. WHERE ROOF IS DAMAGED ON EAST AND WEST SIDES ALL ROOF FABRIC REMOVED, ALL TIMBER JOISTS REMOVED AND REPLACED.
3. FLAT ROOF CHANGED TO A MONO PITCHED ROOF WITH 1:4.4 GRADIENT 12.9 DEGREE TO AVOID STAGNANT WATER AND INGRESS TO NEW RAIN WATER CHANNELS.
4. REPLACE 1-2 COURSES OF BRICK WORK TO TOP OF PARTY WALL, REMOVE WATER DAMAGED BRICKS, REPLACE BRICK WITH NEW AND ANY SUPPORTING BRACKETRY FOR JOIST AND RAIN WATER GUTTERING.
