# SIR FREDERICK MESSER ESTATE

## NMA SECTION 96 APPLICATION

This document provides a description of the design changes proposed for Sir Frederick Messer Estate development.

These proposed changes to planning permission HGY/2024/3315 mainly respond to structural requirements, UKPN requirements, and fire safety compliance. They have also been proposed with the intention to improve the scheme compliance with Building Regulations and to reduce design hazard risks.

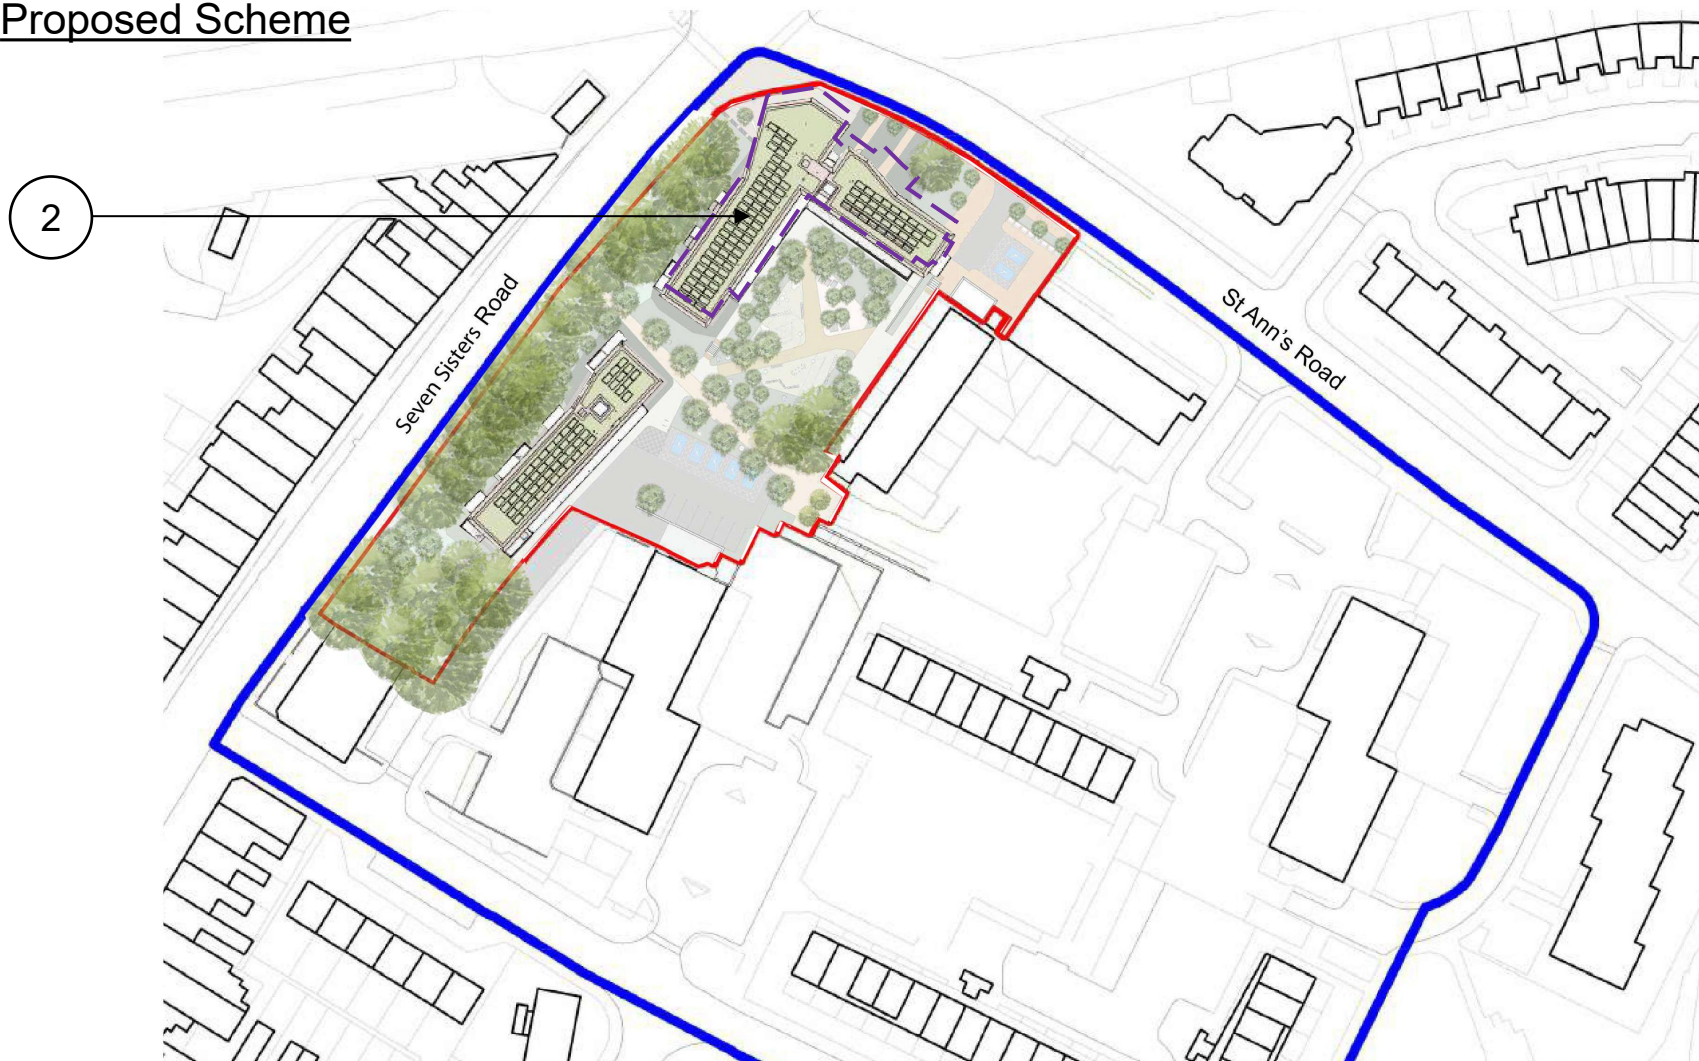
### Proposed Scheme

2. Block 1 relocated and moved 2 metres towards Block 2 (dashed purple line indicates previous building location).

| ITEM NO. | ITEM | PLANNING PROPOSAL - POTENTIAL ISSUE | PROPOSED CHANGE - MITIGATION PROPOSAL |
|---|---|---|---|
| 2 | Block 1 site location. | Block 1 site proposed location – too close to existing underground services / structures and not possible to build within an area around it of 3 metres. | Block 1 relocated and moved 2 metres towards Block 2 to avoid clashes between building foundations and existing underground services / structures.<br>Daylight / sunlight assessment revised based on this move and confirmed that no adverse impact to Block 2 or existing neighbouring buildings have been created.<br>Arboricultural impact report addendum included to confirm no impact on trees to be retained (as per planning approved). |

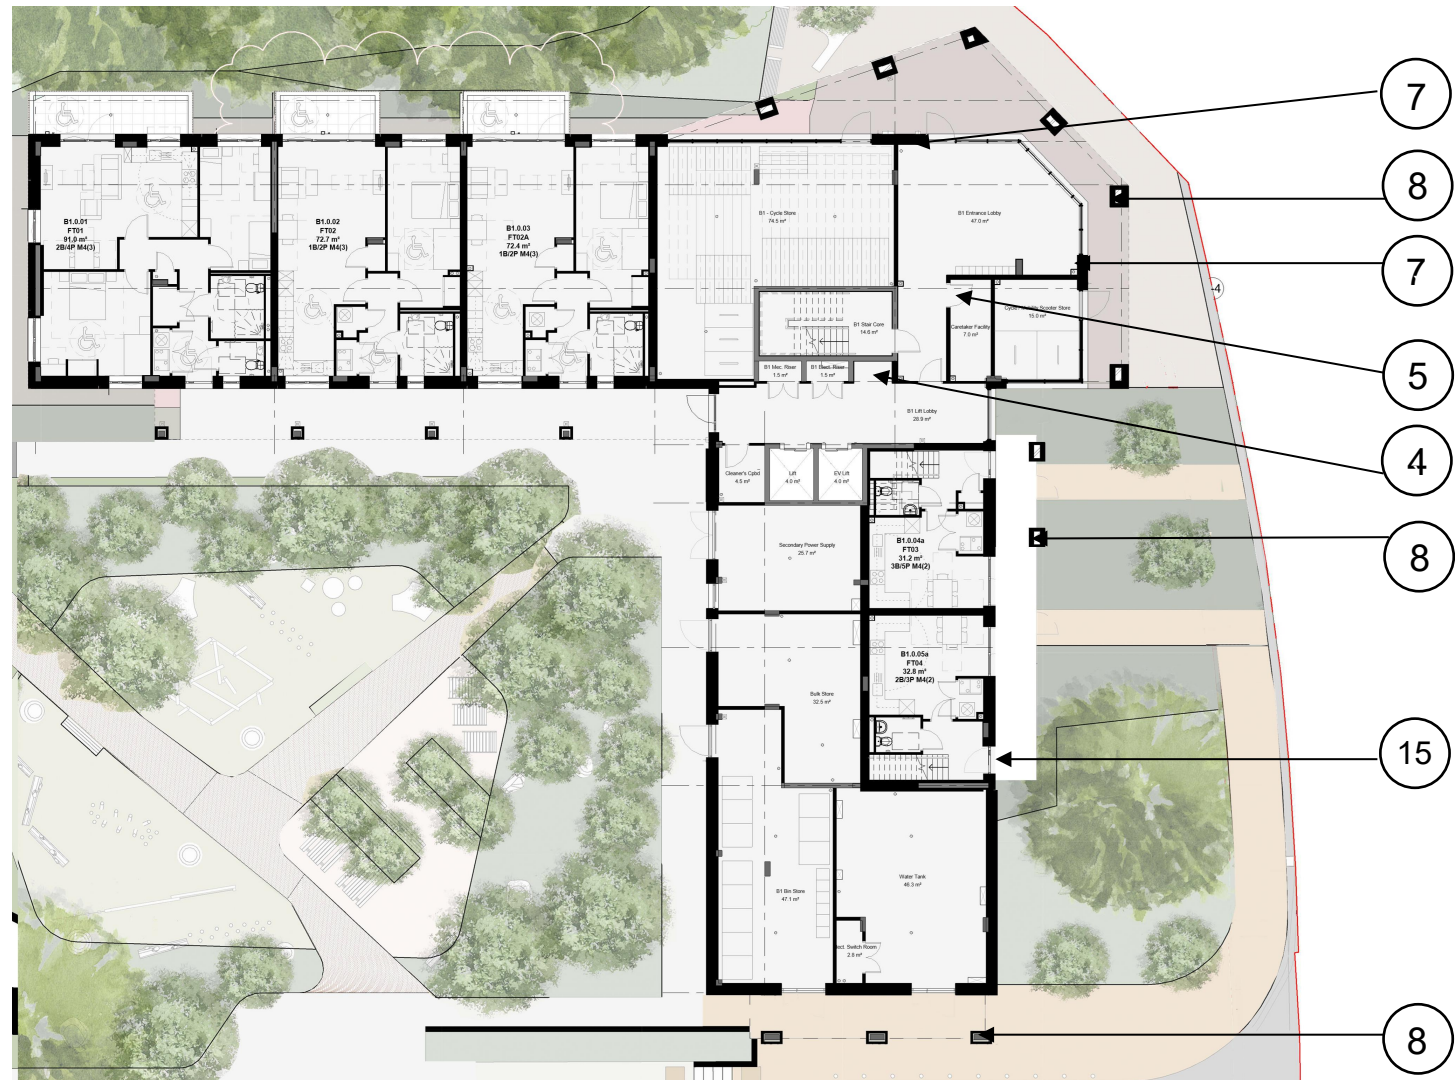
Proposed Scheme

- 4. Lift lobby storage removed.
- 5. Caretaker facility room door relocated.
- 7. Main entrance brick pier for panelling and services installation.
- 8. Ground floor external columns clad in brickwork to match building.
- 15. Canopy over entrance door added.

| ITEM NO. | ITEM | PLANNING PROPOSAL - POTENTIAL ISSUE | PROPOSED CHANGE - MITIGATION PROPOSAL |
|---|---|---|---|
| 4 | Block 1 lift lobby storage at GF level. | General storage proposed next to risers – Fire safety concerns:<br>- Storage located on the fire escape route. | General storage removed to avoid potential fire risk. |

| 5 | Block 1 lift lobby caretaker facility room door. | Caretaker facility room door opens to the protected lift lobby at ground level.<br>- Door located on the fire escape route and off the protected lobby. | Door relocated to avoid potential fire risk. |
| 7 | Block 1 Curtain walling at building entrance. | Full curtain walling enclosure around building main entrance and cycle store elevation – curtain walling did not allow for the installation of required external fire equipment; dry riser inlet, fireman's switch, PIB. | Solid brick wall piers have been added next to access doors to allow for panelling and services installation. |
| 8 | Block 1 external columns at GF level. | Exposed concrete columns. | Columns clad in Ibiza white brickwork to give more resistance and robustness to these elements and ground level. |

| 15 | Block 1 M4(2) unit GF level access | M4(2) unit at ground floor level entrance door on north east elevation not covered by building overhang soffit – not compliant with Part M requirements. | A 1135mmWx600mmD canopy above door entrance added to comply with regulations. |

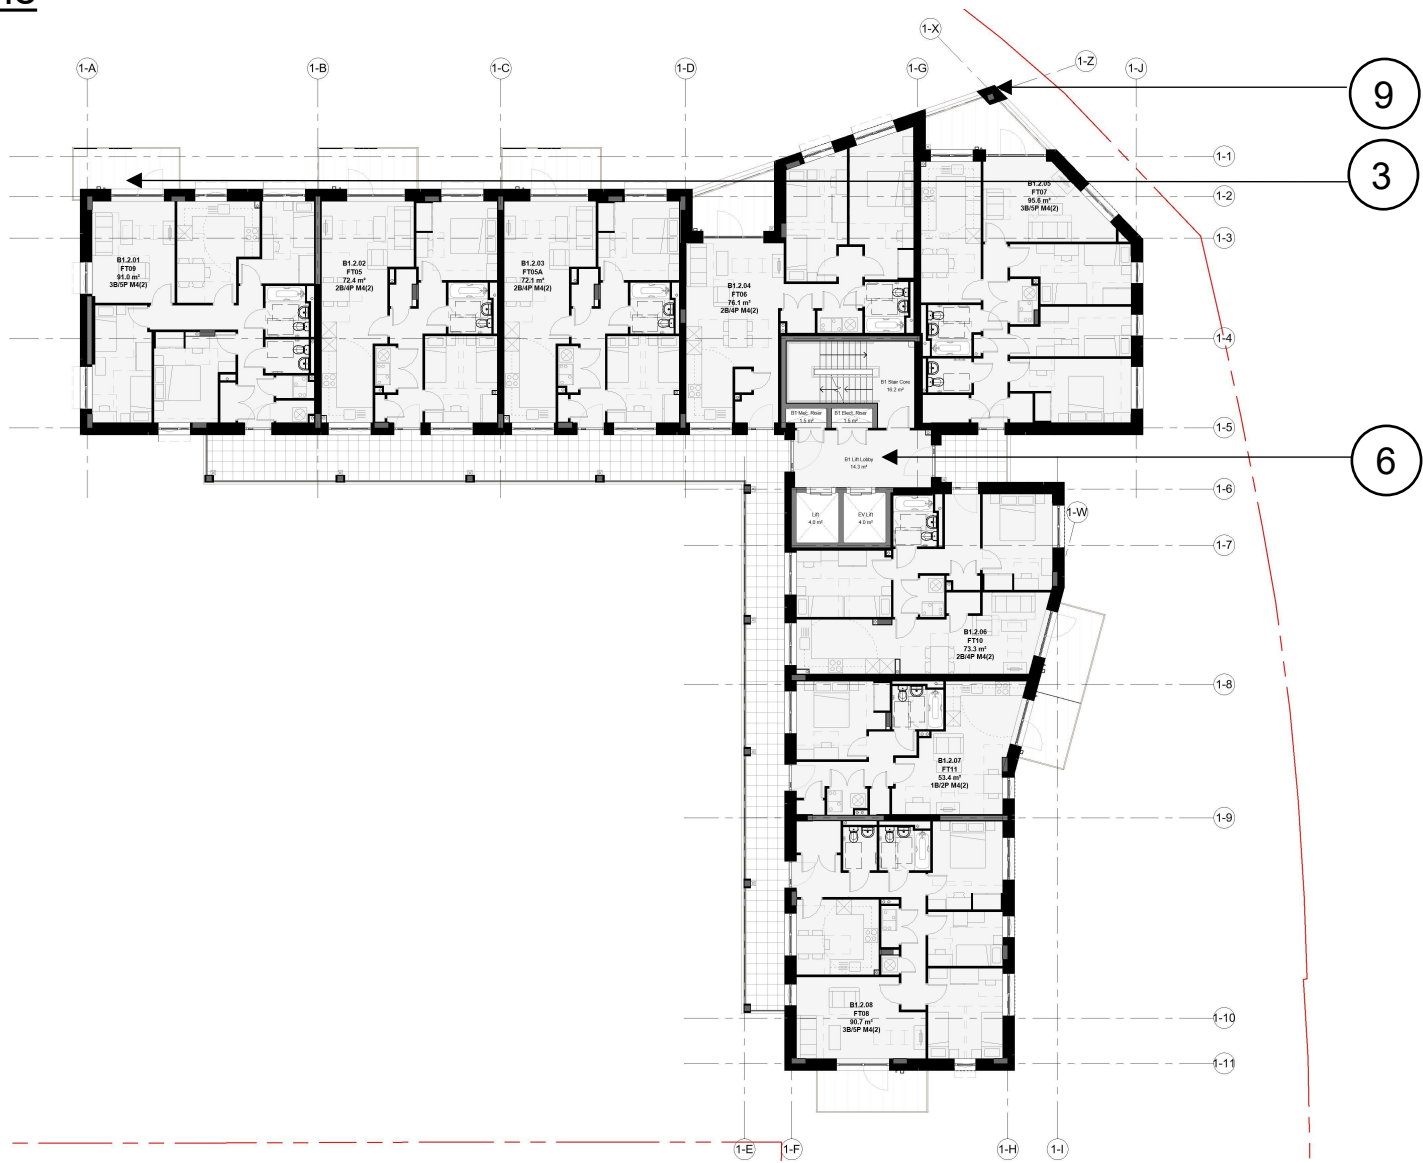
Proposed Scheme

3. Corner bolt-on balconies cantilevered reduction.  
6. Lift lobby enclosure.  
9. Aluminium metal cladding to external columns at inset balcony corner and external walkways in upper levels.

| ITEM NO. | ITEM | PLANNING PROPOSAL - POTENTIAL ISSUE | PROPOSED CHANGE - MITIGATION PROPOSAL |
|---|---|---|---|
| 3 | Corner bolt-on balconies. | Large cantilevered bolt-on balconies at building corner – Specialists confirmed cantilever extent is not achievable with cast-in loading capability. | Reduction in cantilevered length, which is offset in the other direction to maintain balcony size and area. |

| 6 | Block 1 lift lobby enclosure from levels 01 to 05. | Open-air lift lobby – not compliant with BS9991 2024 of the fire strategy. | Lift lobby enclosed to reduce fire spread risk at each level and ensure compliance with BS9991 2024. |
| 9 | Block 1 external columns at inset balcony corner and external walkways from level 01 to 05. | Exposed concrete columns. | Columns clad with metal panels, RAL 9001, not to impact visually on elevation design and to match any other metalwork element present in the building. |

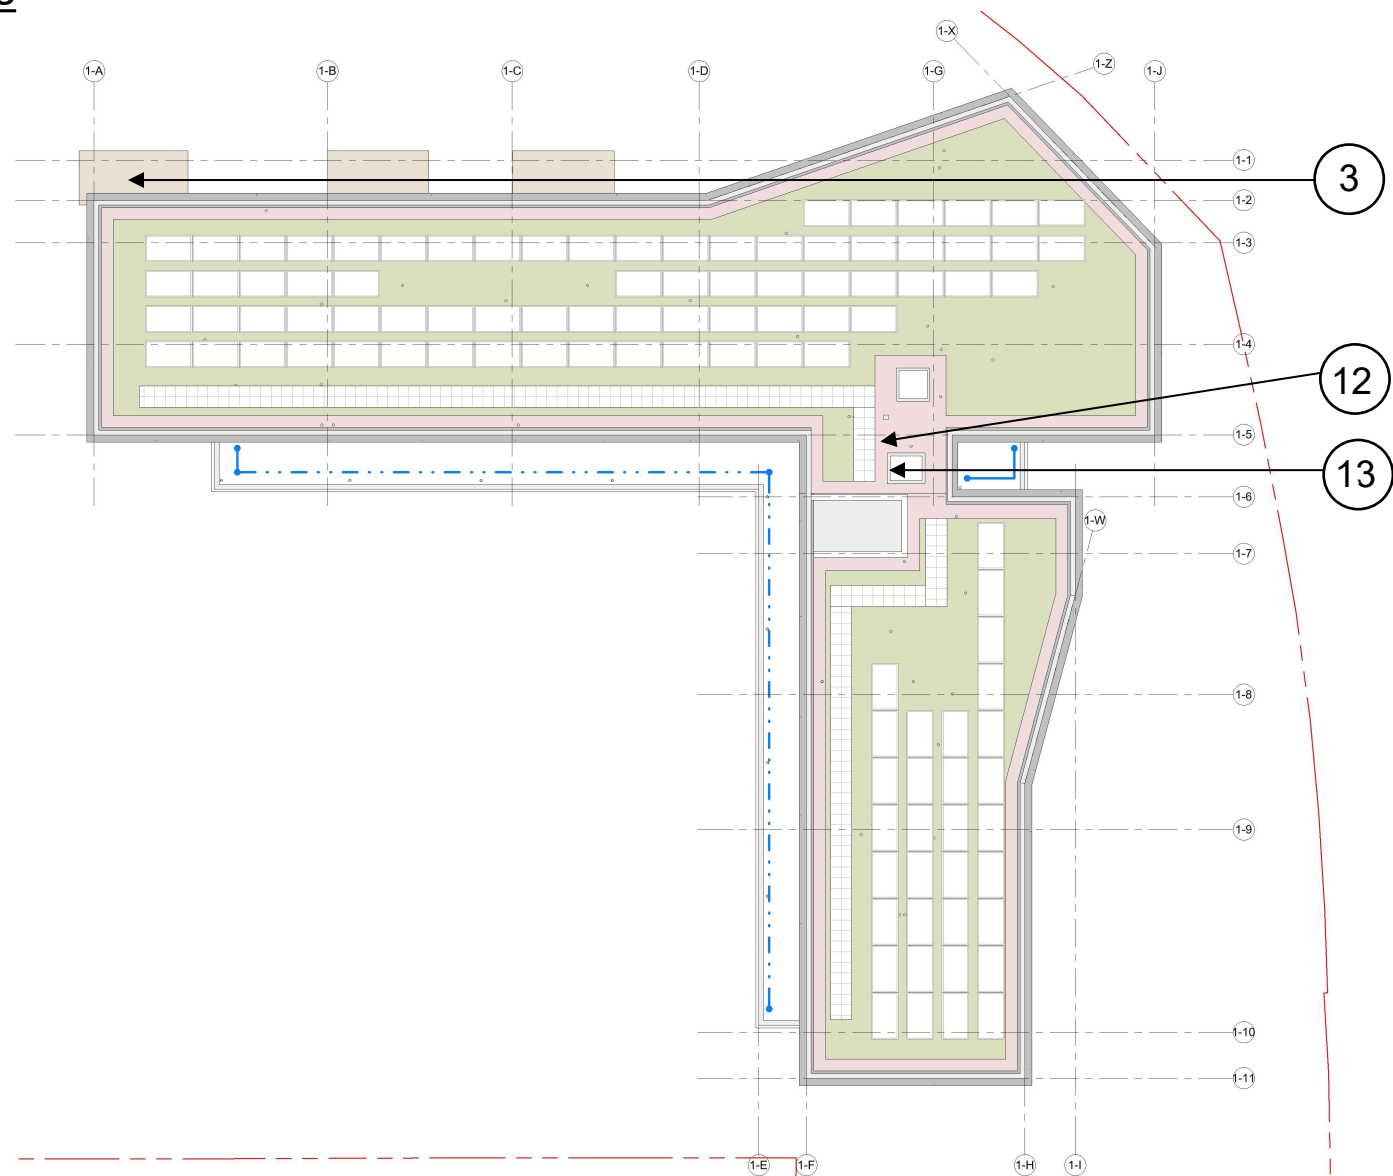
Proposed Scheme

- 3. Corner bolt-on balconies cantilevered reduction.
- 12. Bridge to connect both building wings.
- 13. Roof AOVs on top of stair core and lift lobby added.

| 12 | Block 1 roof bridge. | Bridge to connect both building wings. | Blocks connected to create BS9991 lobby. Bridge has become a joined roof. |
| 13 | Roof AOVs (both buildings). | Roof AOVs on top of stair core. | AOVs for BS9991 compliance added to each stair core for smoke ventilation. |

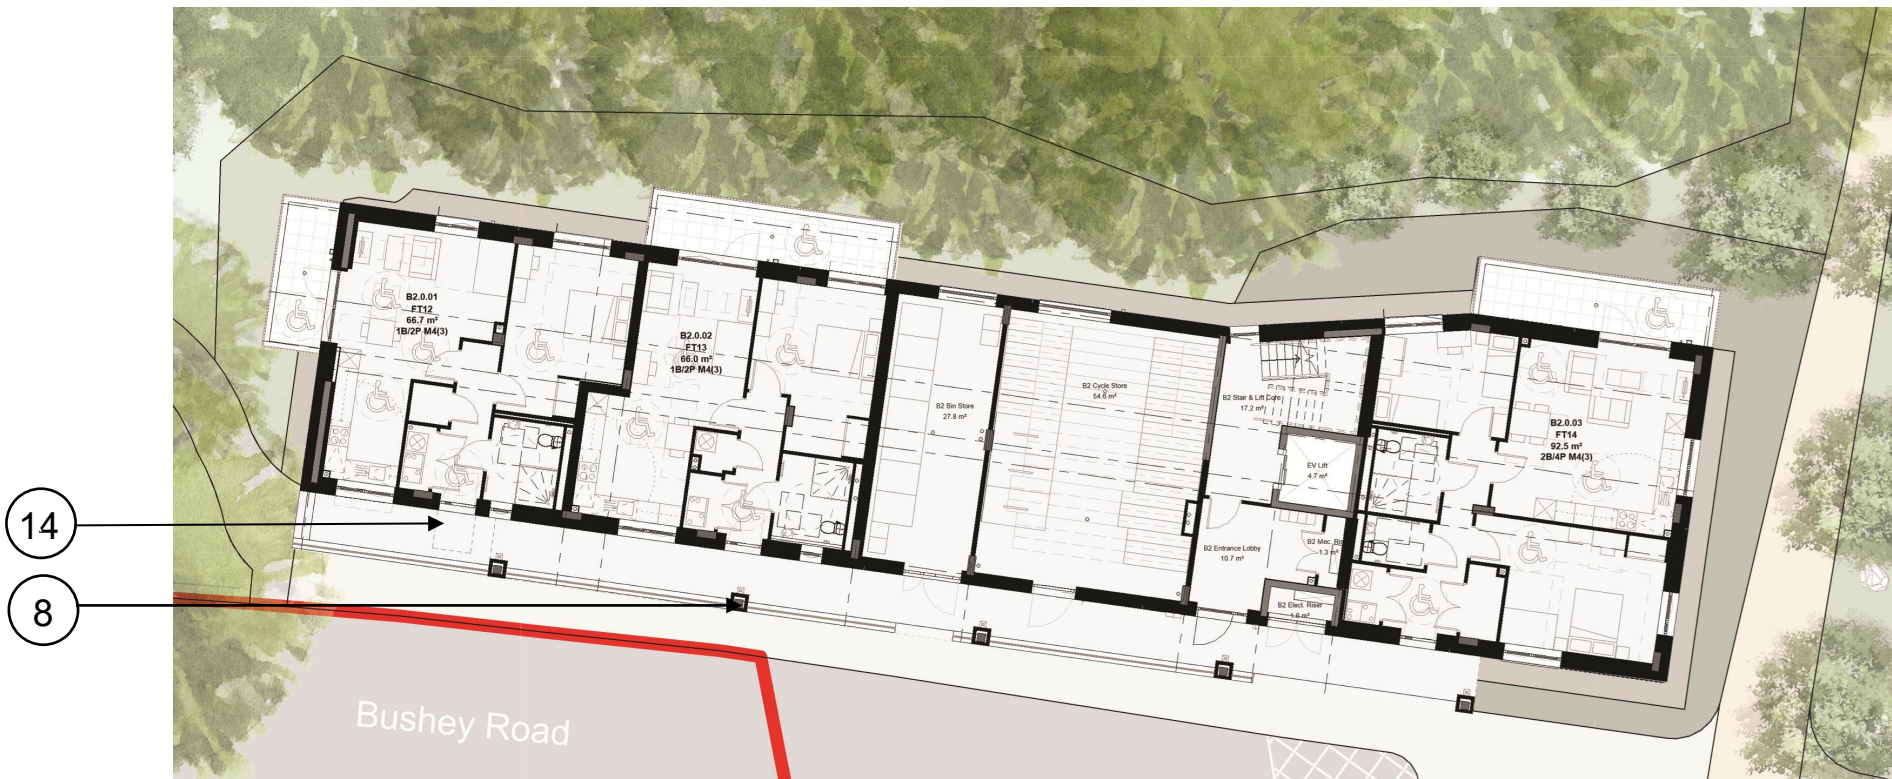
Proposed Scheme

- 8. Ground floor external columns clad in Ibiza white brickwork.
- 14. Canopy over entrance door added.

| 14 | Block 2 M4(3) unit GF level access | M4(3) unit at ground floor level entrance door not covered by the external walkway soffit – not compliant with Part M requirements. | A 1200x1200mm canopy above door entrance added to comply with regulations. |

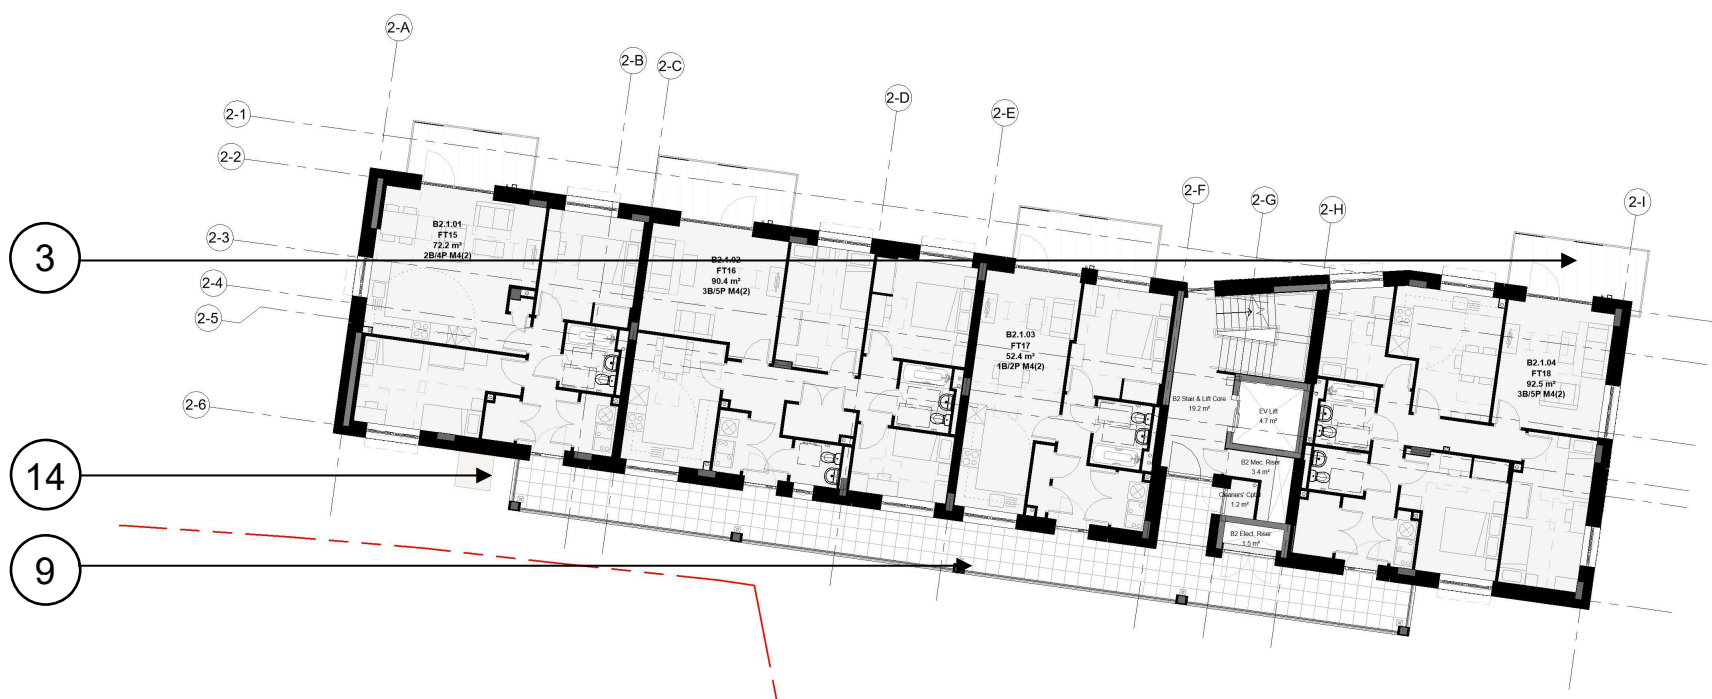
Proposed Scheme

3. Corner bolt-on balconies cantilevered reduction.
