OUTLINE SCOPE OF WORKS:

GROUND FLOOR PLAN - MEND FUNDED WORKS

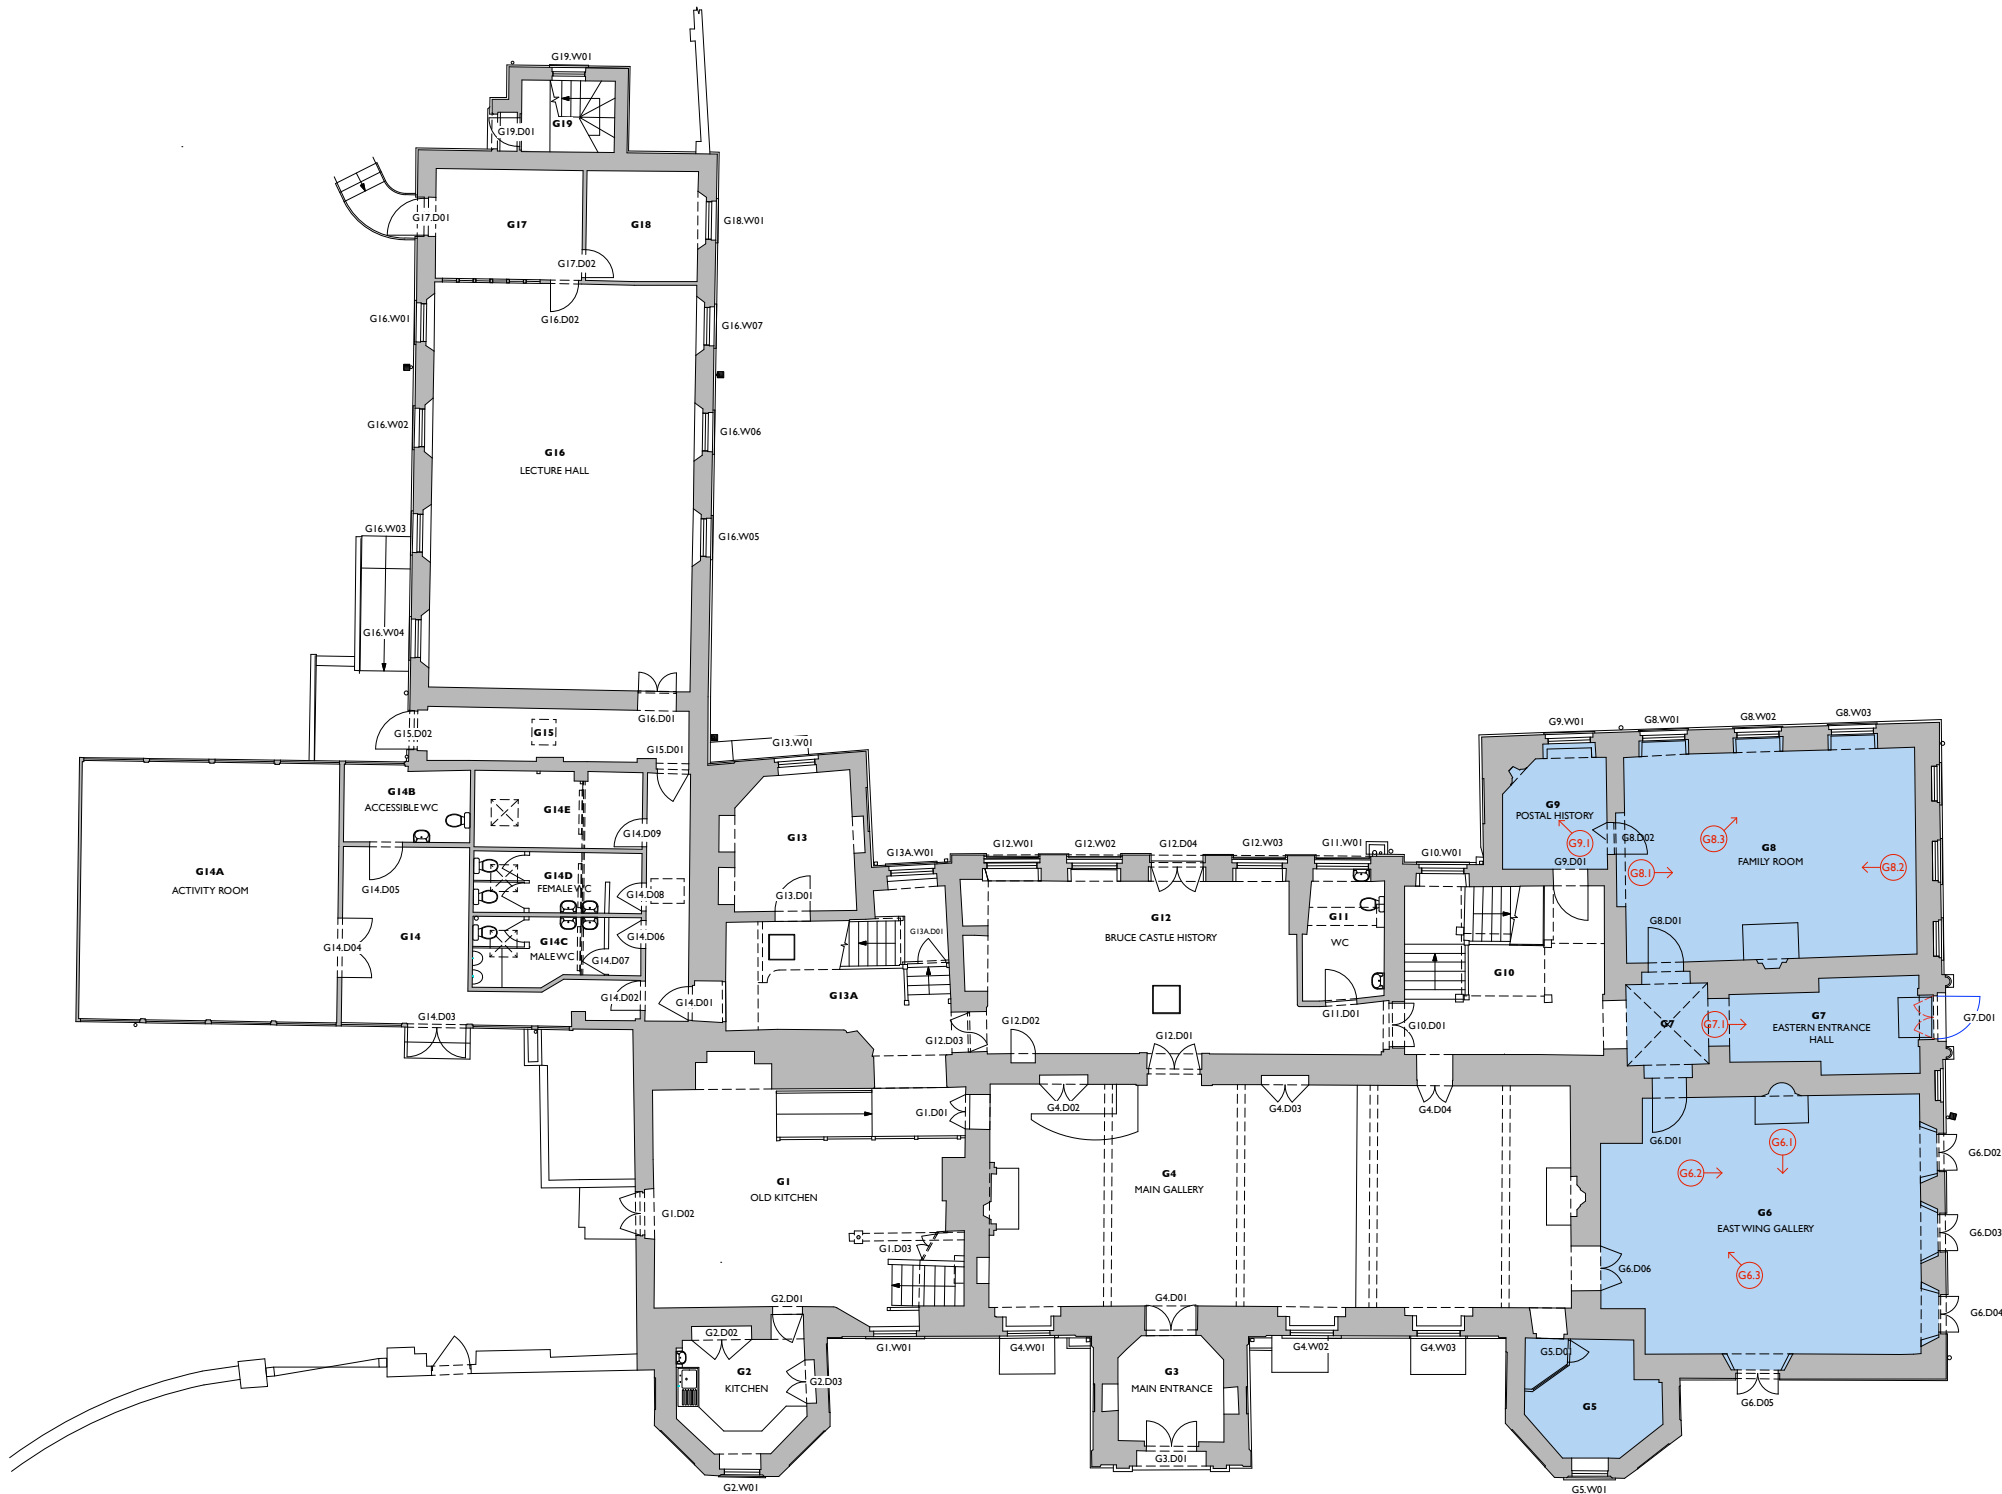
1. Undertake structural repair and strengthening works to the floors of rooms F6-F8 at first floor level and S8-S10 at second floor level, in accordance with the Structural Engineers details. Note the requirement for temporary propping in order to execute these works and agree the necessary methodology with the design team prior to commencement.

2. Ground floor room G6 is to be renovated for use as a gallery space.
3. First floor rooms F6-F8 are to be repurposed to form a new gallery space, including the removal of the existing internal partitions, as indicated. Such works to be set out in the floor strengthening methodology.

4. Provide new lime hair plaster ceilings to rooms G6 and F6-F8, retaining and repairing the existing plaster cornices, with new sections of cast plaster cornices to match. Such works to be set out in the floor strengthening methodology.

5. Overhaul the internal window joinery of all rooms within the MEND areas, as set out in the window schedule and typical repair details. Scope and nature of repairs to be reviewed with the Architect through works to the first 'sample' window.

6. Overhaul external ground floor doors (french windows) within the MEND areas, as set out in the door schedule. Provide a new external door to opening G7.D01, as detailed.
