## BRUCE CASTLE MUSEUM

MEND Funded Project  
Reservicing and Internal Improvement Works  
Design & Access Statement

November 2023  
Version v1

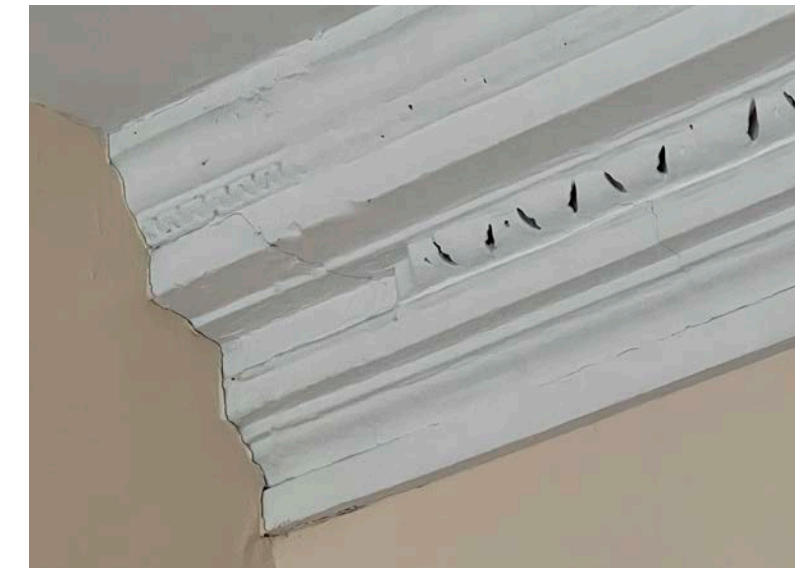
Proposed fabric repairs and downstands in first floor rooms F6, F7 & F8

At ground floor the existing plaster cornice will be repaired and retained, whilst at first floor level, the remains of the extant cornice will be repaired and retained, with new cast plaster cornice sections introduced in place of missing material. The new sections will be modelled on the existing and will also be introduced along the side of the new down-stand ceiling beams.

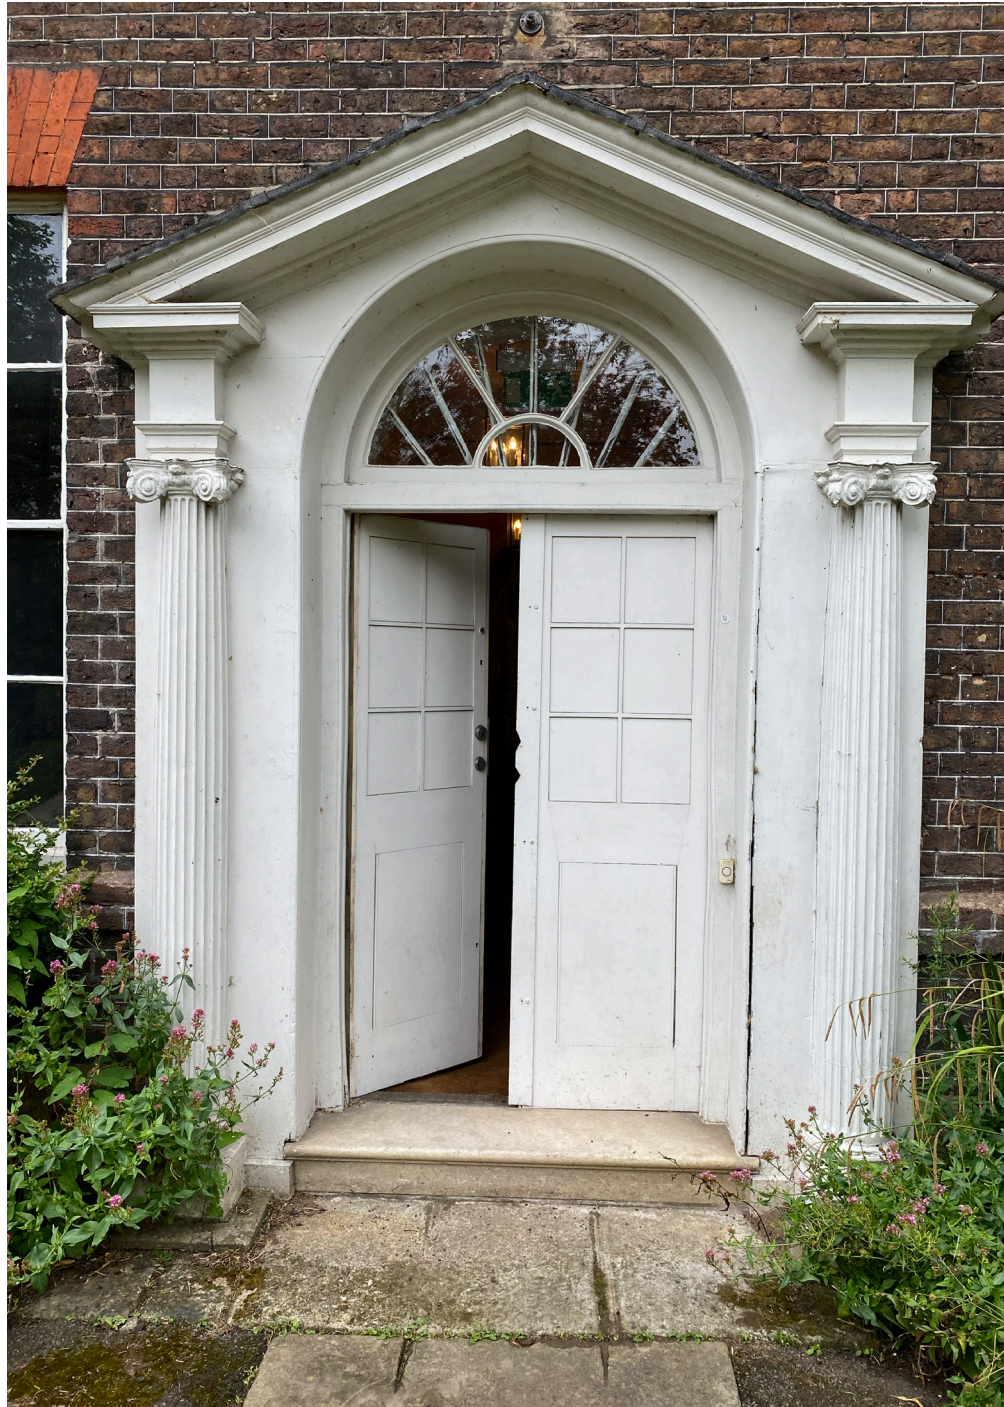
Existing and Proposed Eastern Entrance Door

**New External Door:** In conjunction with the development of the fire strategy, a review of all doors was undertaken, and it was noted that the existing East entrance door Go7.Do1, being the final exit on the emergency escape route was of unsuitable design, consisting of two narrow leaves which open inwards and against the flow of escape. This particular door leaf also appears to be of a later construction reusing ironmongery from an earlier door leaf.

Change of this existing double door, to a new single leaf, outward opening door, with suitable escape ironmongery would be beneficial to health and safety of building occupants, and on the advice of the Consultant Fire Engineer, would avoid the need to introduce an additional internal fire door at the foot of the main staircase. It is therefore proposed to introduce a new door leaf within the existing frame and to retain the fanlight above. (refer to drawing 7440/260)
