#### EXTERNAL REPAIRS SCHEDULE OF WORKS AND SPECIFICATION NOTES:

A-A PROPOSED SECTION A-A LOOKING NORTH  
26330  
Scale 1:50

B-B  
26331  
PROPOSED SECTION B-B LOOKING SOUTH  
Scale 1:50

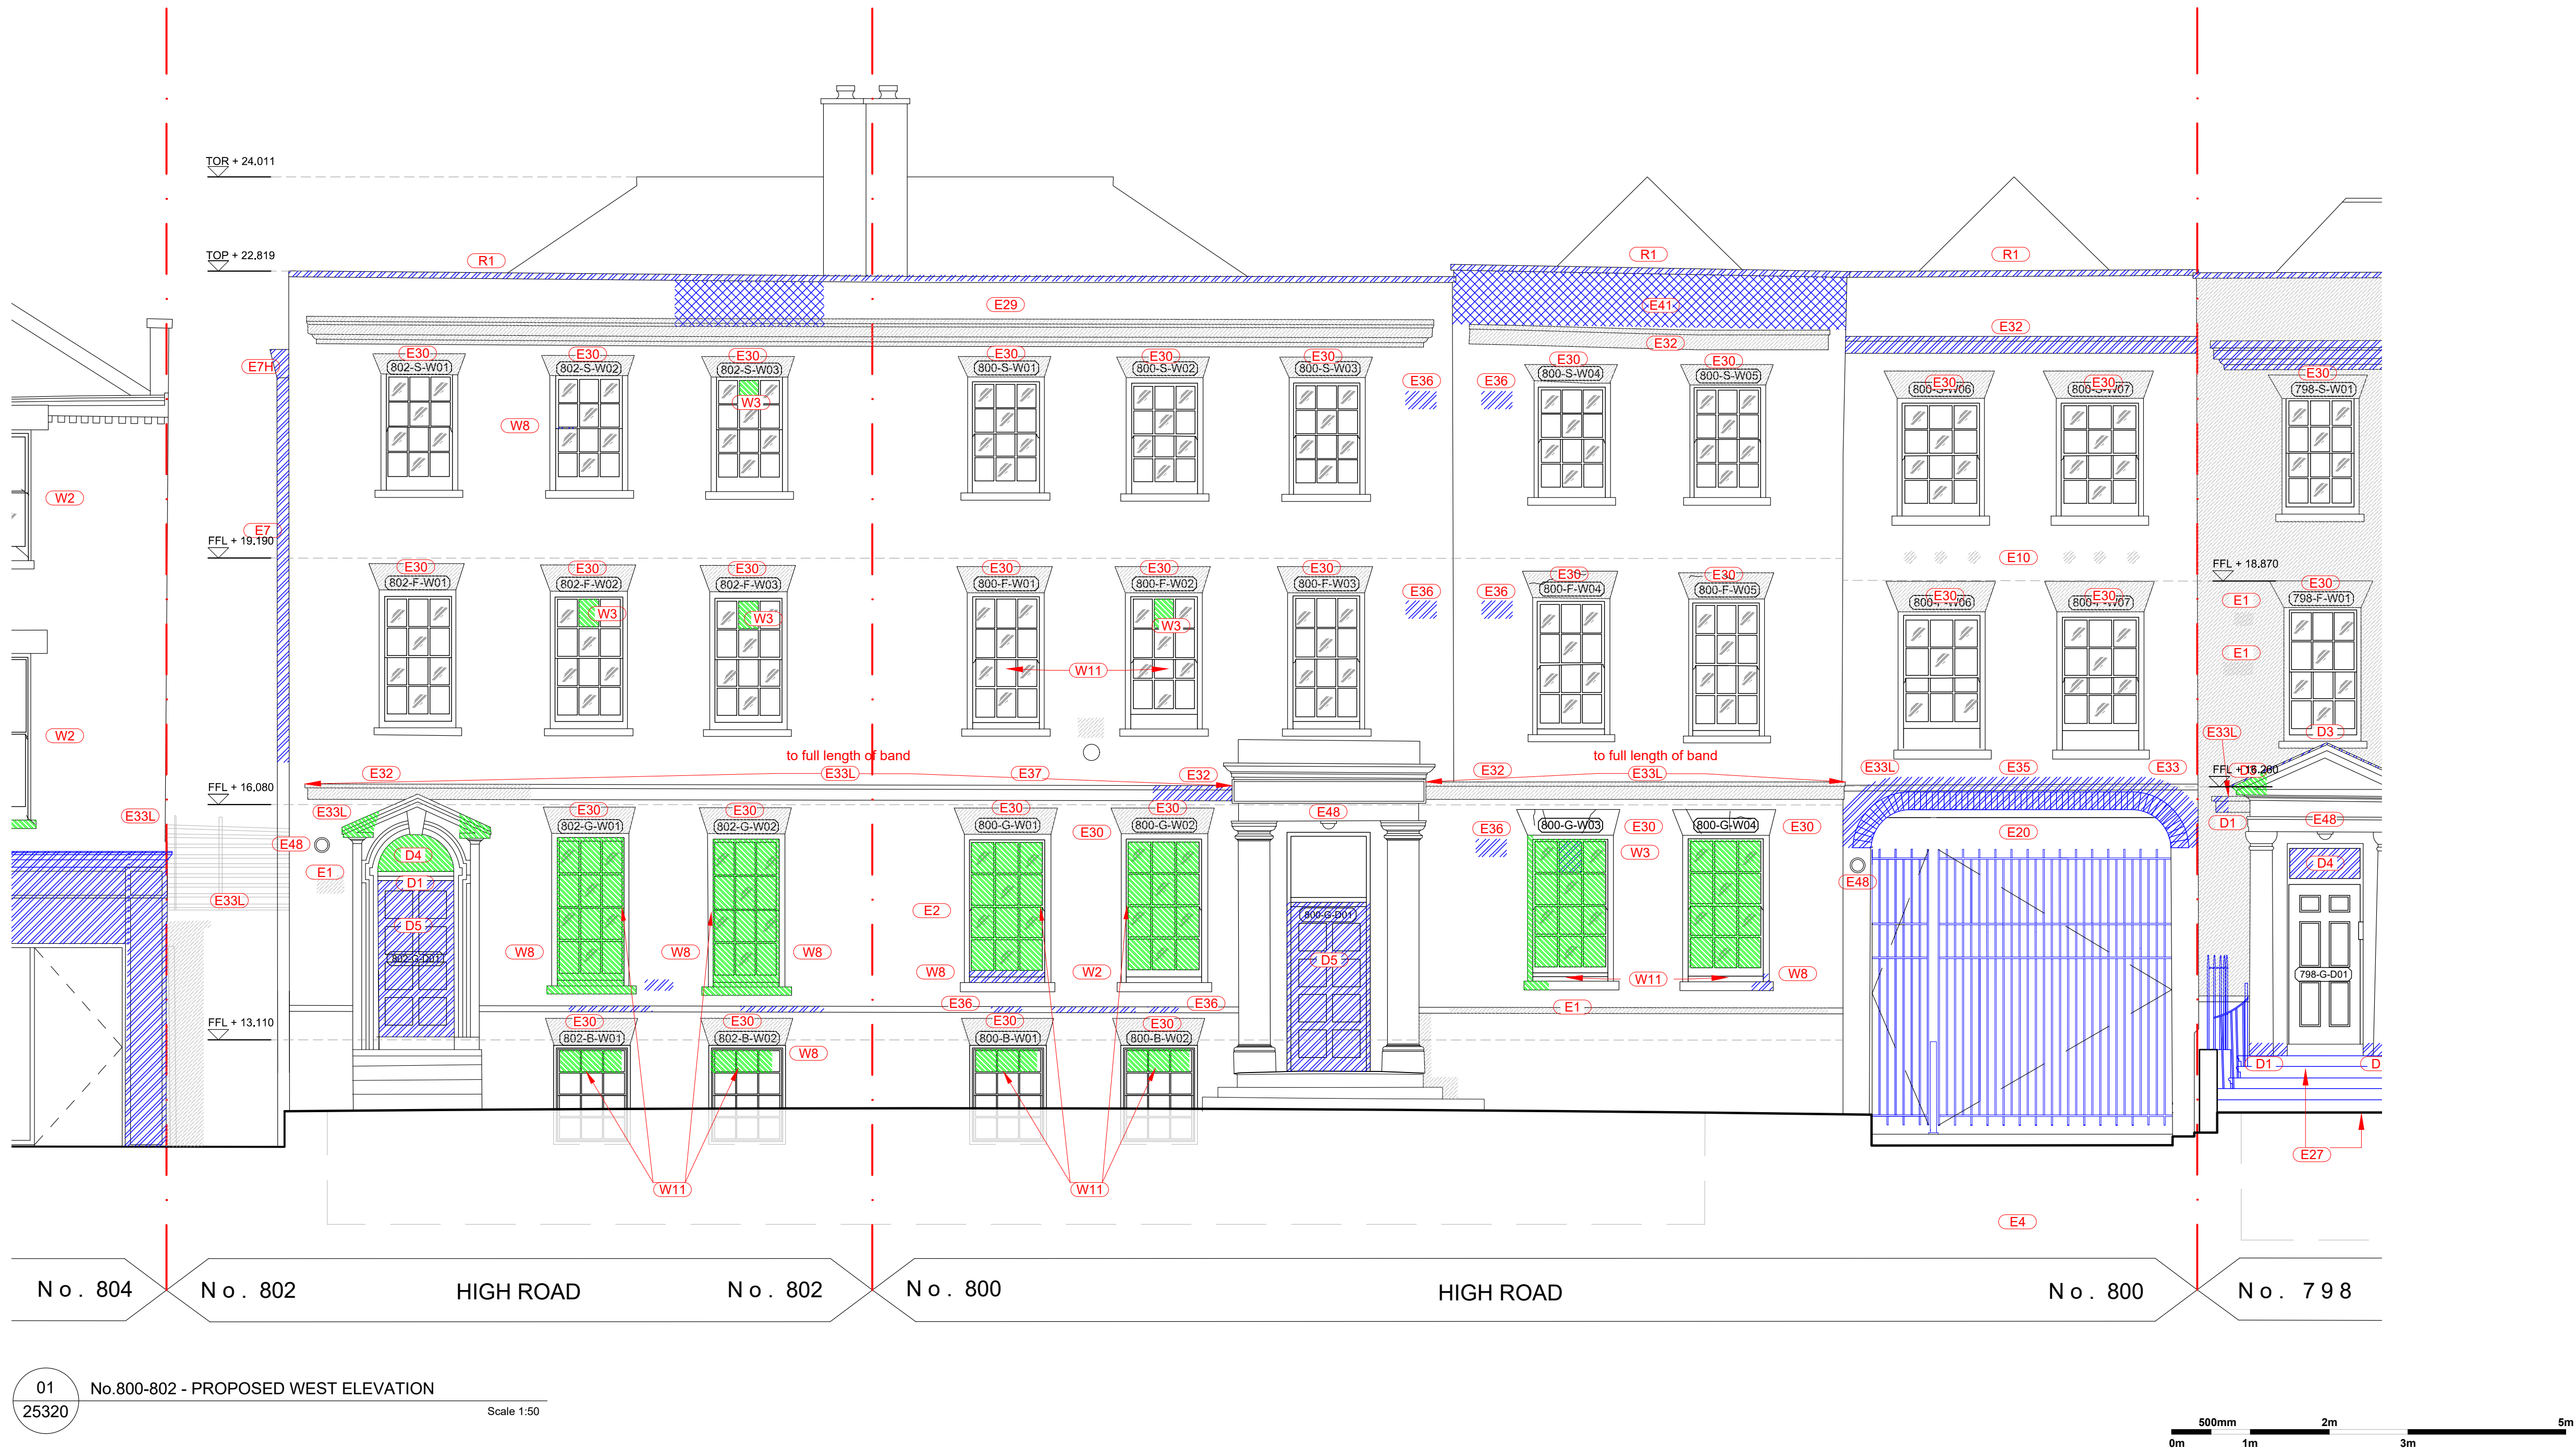
- D1 : Repair doorcase with like for like scarfed timber where timber has rotted or filled.  
D2 : Allow to scarf in base of 2 pilasters, area up to 300mm².  
D3 : Extensive rot to base of 2 pilasters, reveal panels , springing moulding, arch and upper plaster, and back panel.  
D4 : Rebuild modern timber pediment to historic detail on record photographs, to include lead roof.  
D5 : Allow to replace pediment roof in Code 5 lead with lead flashings.  
D6 : Install modern gate and glazed screen entrance door, to match no.810-812 and provide symmetry between the pair of properties.  
D7 : Replace C20 8-panel front door to match Percy House (800 and 802).  
D8 : Reinstall door to rear elevation in C18th design, to match no.810-812

- E1 : Reinstall missing/defective brickwork and previous poor repair.  
E2 : Rake out loose pointing and repoint missing joints and previous poor repointing.  
E3 : Repoint open joint around window.  
E4 : Apply lime fillet to top of projecting brick for weathering 61m (790 - Side Elevation) rear and front of 790 full length ( other than doorway).  
E5 : Install additional fixing ears to match in C1/cast metal to match.  
E6 : Refurbish downpipes and guttering (all).  
E7 : Replace plastic waste pipe in painted cast metal.  
E8 : Replace plastic downpipe in painted cast metal.  
E9 : Unblock gulleys and replace in CI.  
E10 : Replace plastic waste pipe in painted cast metal.  
E11 : Replace plastic vents with CI grilles painted black with insect mesh behind.  
E12 : Brick arch dropped. Allow to install s/s reinforcement in joint above and repoint open joints.  
E13 : Brick arch condition poor - bricks damaged or repaired unsympathetically. Allow to prop as necessary and rebuild to match historic adjacent.

E14 : Cement rendered. Allow to remove unobtrusive sample section of cement render. Assume replace 20% defective brick face like-for-like.  
E15 : Remove modern canopy and fixings, and reinstate pointing to match historic adjacent.  
E16 : Remove satellite dish and make good fixing holes like-for-like to match adjacent pointing.  
E17 : Infill masonry has moved. Allow to install helifix every 3rd course, repoint open joint and monitor.

- E18 : Provide tuck pointing to window arch where missing.  
E19 : Cut back projecting to DPC to face of wall and install peep weeps in open weepholes.  
E20 : Archway (798) - Remove asbestos soft to vehicular arch.Allow to remove existing lintel.  
E21 : Build up over concrete face and pin back using stainless steel helifix bars. Provide metal gates and frames to existing opening, automated with ability to hold open. Reinstall fire resisting ceiling to B Regs requirement in plasterboard with painted and skim finish flush.  
E22 : Scarf in like-for-like section of timber facing to cornice where rotted.  
E23 : Modern render string course extensively cracked. Replace to same profile in hydraulic lime render.  
E24 : Modern render applied to brick plinth, with non-original detail that traps water in the brickwork. Render has extensively cracked. Take off render and investigate. Allow to carefully take off railings and put aside for safekeeping and repair and rebuild brick plinth in exposed brick and lime mortar to match main house. Reinstall railings on completion.

E25 : Replace modern ply gas meter box in oak.  
E26 : Stone steps and platform extensively worn and cracked. Repoint open cracks and holes in lime mortar with stone dust. Allow to piece in like-for-like stone where stone is defective or previously cemented 790 - 4 areas pieced in total 600mm².  
E27 : Part of retaining wall is leaning. Render cement cracked and part missing. Take off sections of render adjacent cracking to investigate condition of wall and extent of defects and carry out like-for-like remedial work.  
E28 : Allow to stitch across 5 full height cracks with stainless steel joint and re-render. Repoint stone capping, monitor cracking and redecorate.  
E29 : Existing modern concrete entrance steps. Take off cement pavers and bedding to reduce height and clad treads and risers in limestone to match historic steps.  
E30 : Carefully remove handrails and bootscraper and reinstall on completion)

E31 : Retain historic pavement: (flight of 3 steps) side steps infill gap in risers using stone slips and apply new stone to 5 upper steps.  
E32 : Piece in section of missing stonework moulding like-for-like to match adjacent profile.  
E33 : Carry out conservation like-for-like, repair to decorative rubbed red brick moulding. Replace defective lead flashing and piece in missing brick where practical and carry out localised pinning, lime mortar infill and weathering as necessary and finish with tuck pointing where original is missing.  
E34 : Subject to sample area investigation to LPA agreement , allow to rake out cement pointing and repoint elevation in flush pointed lime mortar.  
E35 : Reinstall decorative rubbed red brick moulding where missing, to match the historic detail and profile on the adjacent buildings. Include lead flashing to match.  
E36 : Include lead flashing to match.

- E37 : Remove unsympathetic modern signage and install mid C18 style historic building name and number. Allow for brass numbers to all Georgian front doors and within shop-fascia.  
E38 : Allow to remove unsympathetic modern signage to expose historic shopfronts. Allow to make good like-for-like painted timber to match.  
E39 : Remove unsympathetic wall vents and repair brick and pointing like-for-like. Replace in decorative cast iron with insect mesh behind.  
E40 : Assume to relocate boiler vent away from front elevation and repair brick and pointing like-for-like.  
E41 : Carry out conservation repair to reinstate decorative plaster pilasters from C 1900.  
E42 : Remove cracked terrazzo panel to expose plaster pilaster for inspection. Subject to LPA approval reinstate plaster.  
E43 : Structural crack. Allow to carefully take out individual cracked bricks and reinstate to match adjacent bricks and build in stainless steel reinforcement in every third vertical joint. Repoint as required.

E44 : Deformed brickwork. Provide access to inspect. Allow to replace rotted wall plate and rebuild brickwork like-for-like.  
E45 : Remove plant growth and point in missing joints and flaunching like-for-like in line with E33.  
E46 : Replace leadwork to discharge to hopper.  
E47 : Rebuild leaning chimney like for like.  
E48 : Remove external metal security bars. Make good damaged surfaces and fixing holes to match adjacent historic fabric like-for-like.  
E49 : Area of modern brickwork to be tinted to match adjacent historic like for like.  
E50 : Reinstall rear elevation to original C18th design, following demolition of later extensions and / or alterations.  
E51 : Install CCTV Camera

- L1 : Take up dislodged and deformed stone paving. Carry out prior record in order to re-lay like-for-like. Make good with stone to match where existing slabs have previously been replaced in concrete and where slabs are incomplete or defective.  
L2 : Take up concrete paving and replace with limestone.  
L3 : Allow for stone path to entrance and basement access , and soft landscaping elsewhere.  
L4 : Add take up and planter)  
L5 : Replace modern railings, gate and wall plinth to match C19 photographs of frontage. (792 - frontage railings retain. Replace basement railings).  
L6 : Subject to sample area investigation to LPA agreement , allow to rake out cement pointing and repoint elevation in flush pointed lime mortar.  
L7 : Allow to rebuild entrance steps in stone (and brick arch where applicable).  
L8 : New side gate to match railings in C18th design.  
L9 : Replace modern handrail to front steps and balustrading with C18th design.

- R1 : Point in open joints in coping.  
R2 : Replace loose and damaged lead.  
R3 : Replace cement copings in stone.  
R4 : Rebuild loose brick hopper outlet like-for-like and re-lead.  
R5 : Unstable chimney to be photographed, carefully reduced to roof finish level. Rebuild upright reusing sound bricks in lime mortar. Make good using like-for-like stock second hand bricks. Form hydraulic lime haunching and re-fix sound pots. Allow to replace 1 terracotta pot to match.  
R6 : Carefully turn back adjoining lead flashings as necessary for access and take up asphalt valley gutter finish and dispose. Allow to scarf repair timber valley boards to match like-for-like where rotted and provide new Code B stepped valleys. Renew defective Code 3 soakers and Code 4 lead flashings and drips, all in accordance with the recommendations of the Lead Sheet Association. Allow provisional replacement of 40% flashings, 25% replacement boards and 10 metres of total replacement valley timbers like-for-like, scarfed to existing.

R7 : Rebuild defective access dormer like-for-like.  
R8 : Allow to rebuild defective lead roof to bay window, all in accordance with the recommendations of the Lead Sheet Association.  
R9 : Replace rusted Velux roof window, with conservation rooflight to fit existing structural opening. Make good like-for-like finishes.  
R10 : Re-tile using existing handmade clay tiles where sound. Allow to replace where tiles do not match, or are unsound, in tiles like-for-like. Allow 20% replacement tiles within hatched areas.  
R11 : Re-slate using existing natural welsh slates where sound. Allow to replace where small sections are unsound in second hand welsh slates to match and allow 40% replacement using slate from area to be demolished under HG16/3310. Where a whole pitch is hatched as defective or in modern concrete, allow to replace in new natural welsh slate.  
R12 : Allow to replace modern bonnet hip detail and defective tiles using half round terracotta hip tiles to match number 794.

R13 : Renew defective Code 3 soakers and Code 4 lead flashings and drips, all in accordance with the recommendations of the Lead Sheet Association.  
R14 : Replace cracked haunching using hydraulic lime.

- W1 : Remove loose paint and refurbish putty and paintwork.  
W2 : Allow to tighten bottom joints of sash.  
W3 : Remove inset fan, re-glaze.  
W4 : Allow to install CI brick vent in adjacent modern brick.  
W5 : Clean paint from stone cills.  
W6 : Replace window complete.

- W7 : Replace stone cill.  
W8 : Pin and repair crack in stone cill.  
W9 : Carry out minimal like-for-like timber scarf repair to bottom rail and bottom of stile.  
W10 : Re-putty.  
W11 : Re-glaze to replace modern obscure glass in clear conservation glass (single glazed). Apply removable frosted film if required for amenity.  
W12 : Replace UPVC windows as painted sash windows to match original on North elevation.  
W13 : Reinstall sash window to C18th design.  
W14 : Proposed bay window, to match no.810-812 and provide symmetry between the pair of properties.  
W15 : New Slimline glazing system

| E1: | Reinstate missing/defective brickwork and previous pour repair. | E26: | Part of retaining wall is leaning. Render cement cracked and part missing. Take off sections of render adjacent cracking to investigate condition of wall and extent of defects and carry out like-for-like remedial work. |
| E2: | Rake out loose pointing and repoint missing joints and previous pour repointing. | E27: | Existing modern concrete entrance steps. Take off cement pavers and bedding to reduce height and clad treads and risers in limestone to match historic steps. |
| E2W: | Repoint open joint around window. | E28: | Carry out new section of missing stonework moulding like-for-like to match adjacent profile. |
| E6: | Replace plastic waste pipe in painted cast metal | E32: | Reinstate decorative rubbed red brick moulding where missing, to match the historic detail and profile on the adjacent buildings. Include lead flashing to match. |
