Site: 54 Cecile Park, N8 9AT

## Conservation and Heritage Statement

February '24

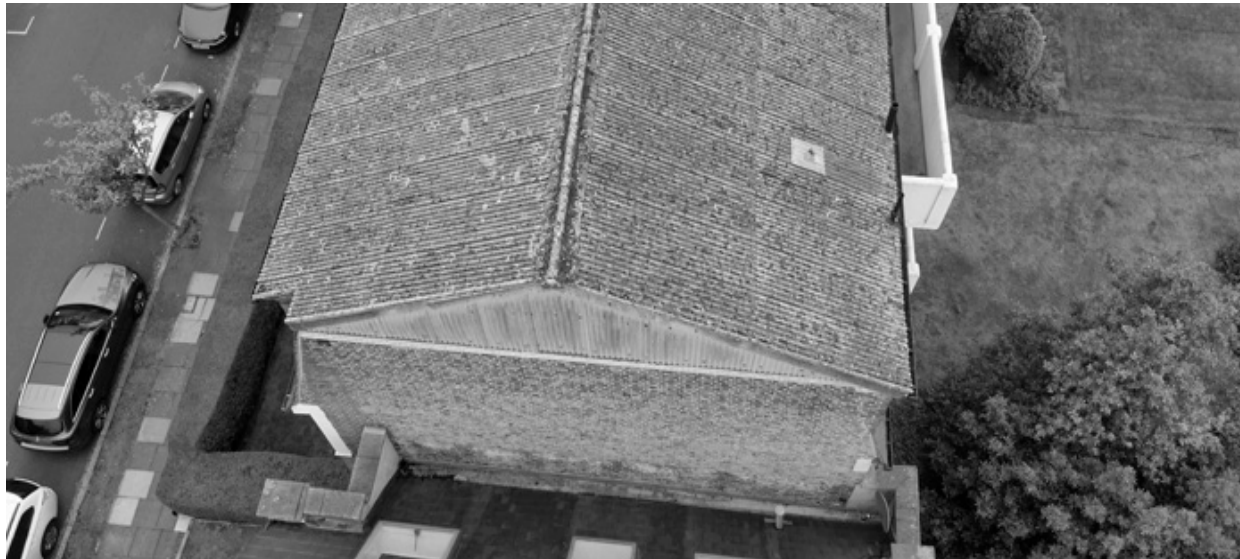
**C** - View looking west at gable end

Oblique views of the end elevations allow the vertical sheet roofing to be seen from the street on the western end, and also to a lesser extent from the eastern end where n.56 Cecile Park abuts the block.

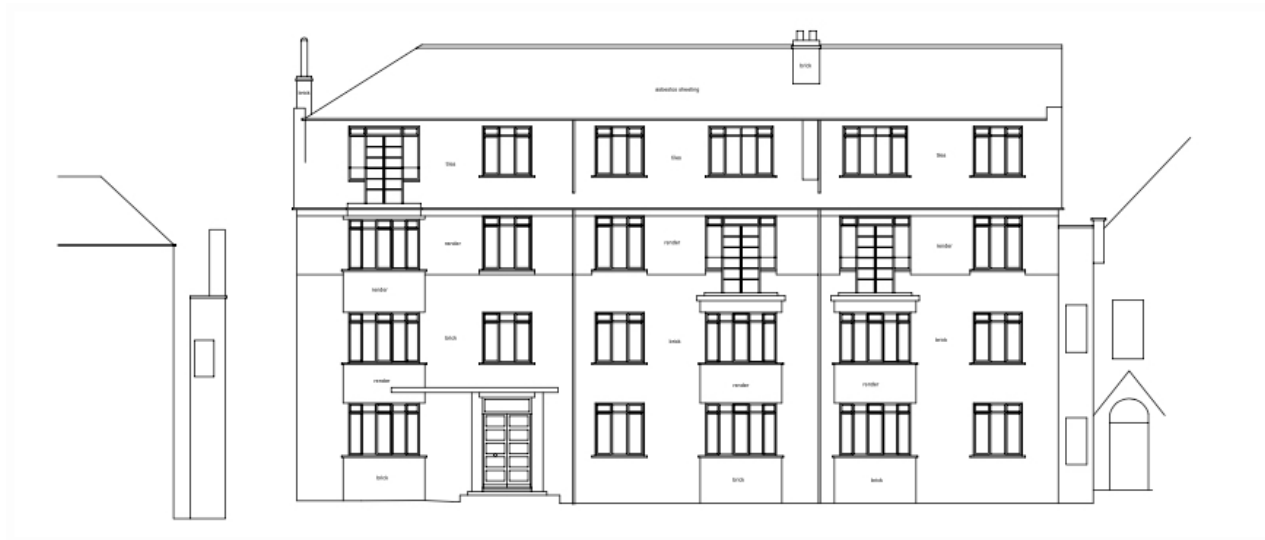
**A** - Derwent Court, 54 Cecile Park - Street elevation (survey)

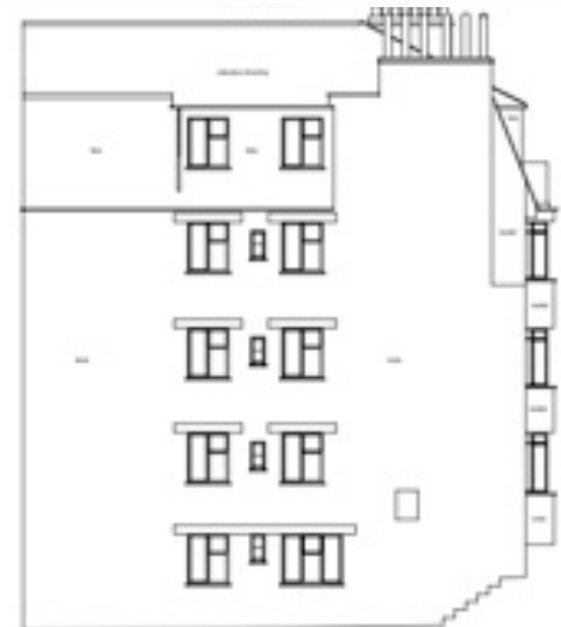
**C** - Section elevation view looking east (survey)

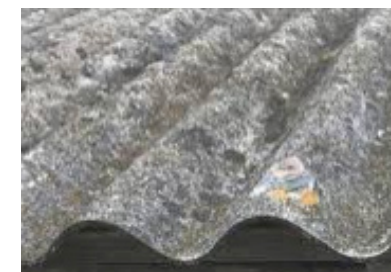
Corrugated Chrysotile sheet roofing

On 16th August 2023 the results of the test were issued and the certificate shown on this page indicates the material as "Chrysotile". The covering letter by Crucial Environment's asbestos removals manager states that the material is a low grade (low risk) asbestos cement. The roofing remains operative and is not damaged, although some leaks have been experienced, causing problems into flats below.
