## Design & Access Statement

42 Southwood Lane  
London  
N6 5EB

Listed Building Application

SEPTEMBER-2022

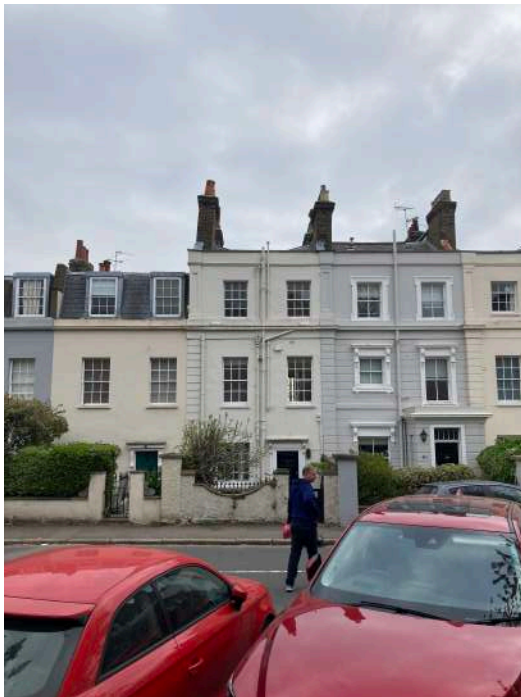
Figure 1 – Front Elevation

1.3. It is a 4 storeys house including lower ground floor with lightwell at front. It consists of slate butterfly roof and 2no chimneys. Front of house is stuccoed, and parts cemented with paint finish in white.

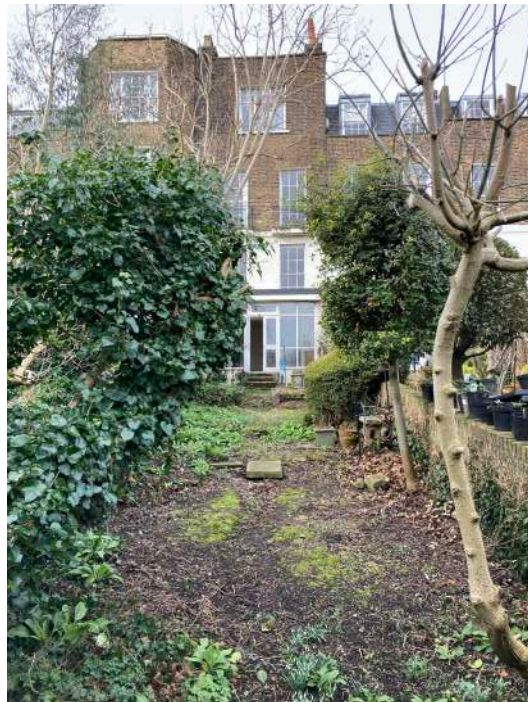
Figure 2 - Rear Elevation

1.5. The back of house is brown brick with stuccoed at lower ground and ground floor levels. Iron balconies to first floor windows.

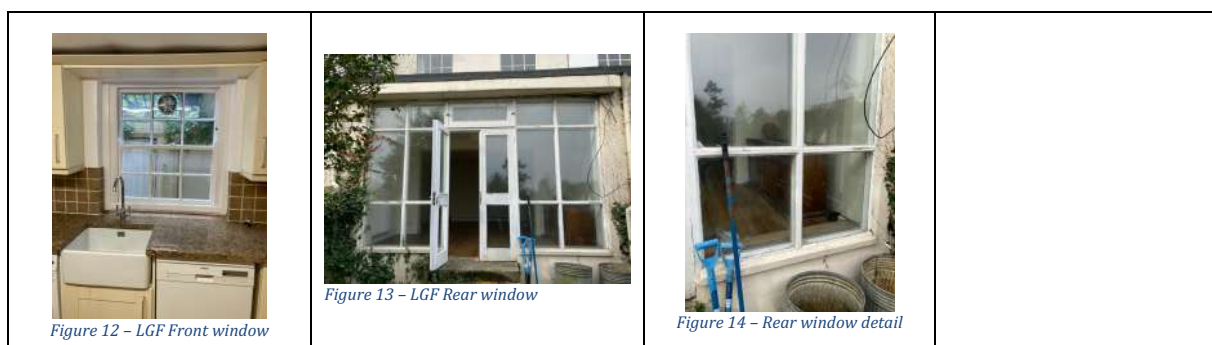
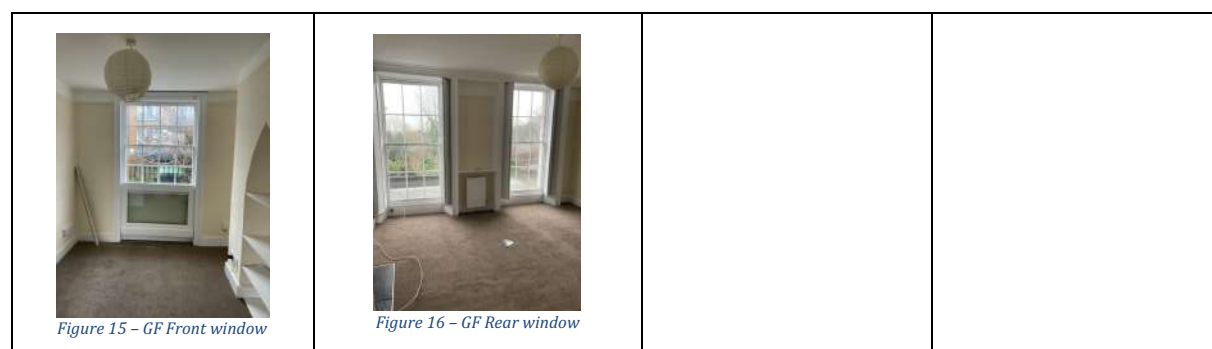
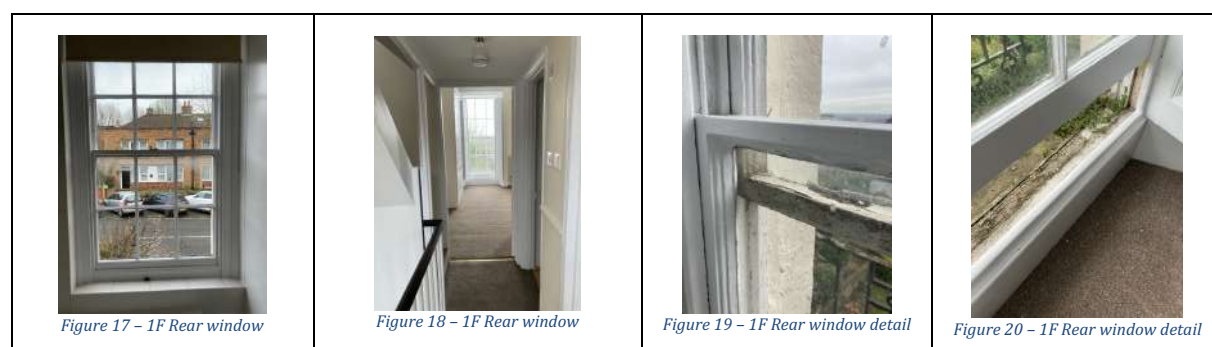
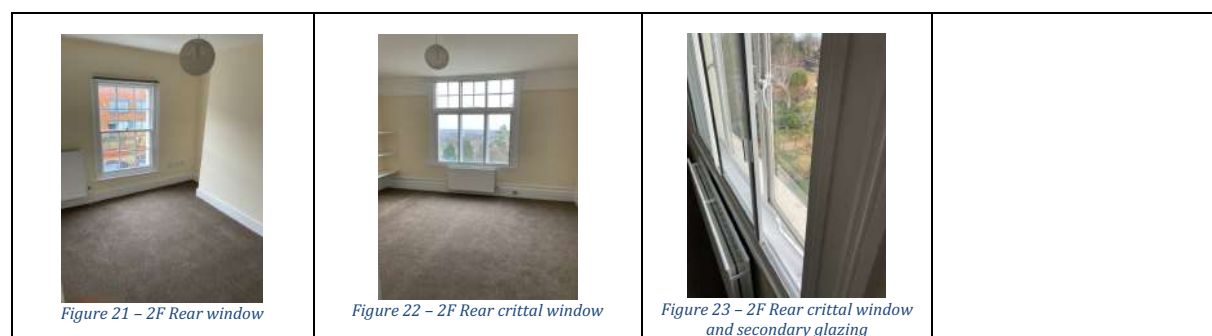
- Repairing of existing GF and 1F rear windows, shutters, frames, and sash boxes, please refer to *figure 16 and 18*.
- Replace front sash windows from single glazing to slim double glazing – please refer to existing windows *figure 12, 15, 17 and 21*.
- Remove LGF rear patio door / window and install new timber framed double glazed patio door. Details to be sympathetic to existing GF and 1F rear windows – please refer to existing windows *figure 13 and 14*.
- Remove 2<sup>nd</sup> floor rear crittal window and install new timber framed double glazed window. Details to be sympathetic to existing GF and 1F rear windows – please refer to existing windows *figure 22 and 23*.

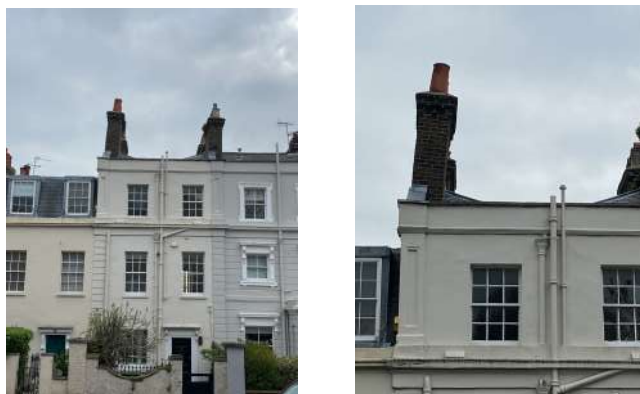
*Figure 24 – Showing distorted roof and chimney stack*

- Retaining and repairing of existing butterfly roof and chimney stacks. Please refer to *Figure 24* and the associated document - Structural Inspection Report 824-22 prepared by Winiecki Associates Ltd.
- Removing existing tiles and installing new quality slate tiles
- Installing 1 no skylight to main roof
- Install 1 no skylight and green roof over the extension built in 1966

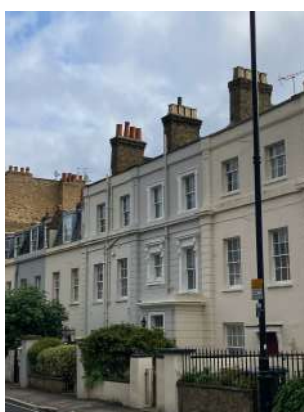
*Figure 25. – Front façade no 46 – 38 (from right to left) indicating there are less pipes visible from their front façade*

- Remove plastic drainage pipes and retain central cast iron pipe like neighbouring properties. Please refer to *figure 25 and 26*.
- Re-paint façade
- Remove roof over light well at front porch

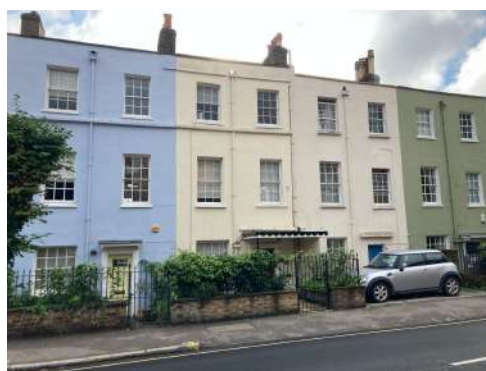
*Figure 26. – Showing front façade of no 30 – 24 (from left to right), whose roofs are traditional butterfly roof*

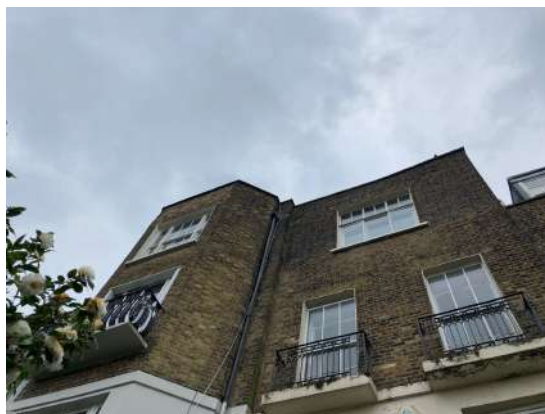
Figure 6. - Showing damaged balconies

- New patio door and widen landing of steps at LGF level
- Refurbish first floor iron balconies. Details to match existing. Please refer to figure 6 showing how damaged existing balconies are.
