EXISTING KITCHEN/BATHROOM  
REFURBISHMENT  
PLANS & PHOTOS

203 GLADSTONE AVENUE  
BARBARA TIERNEY

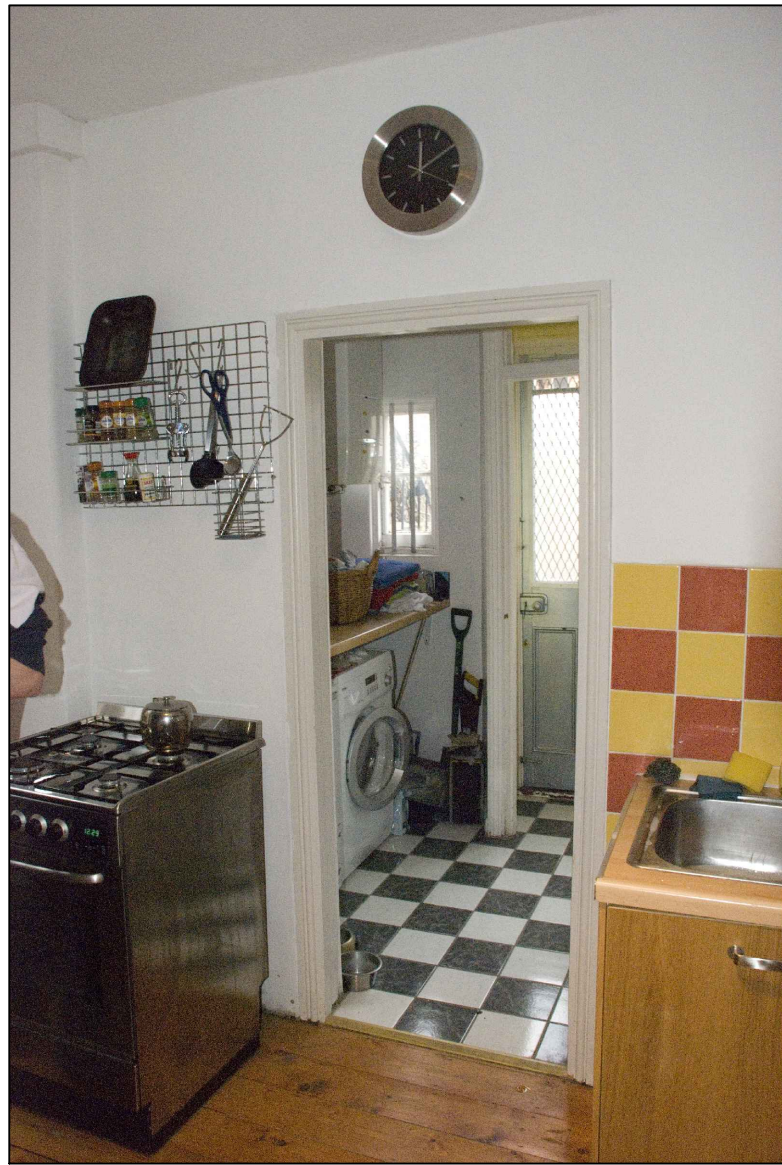
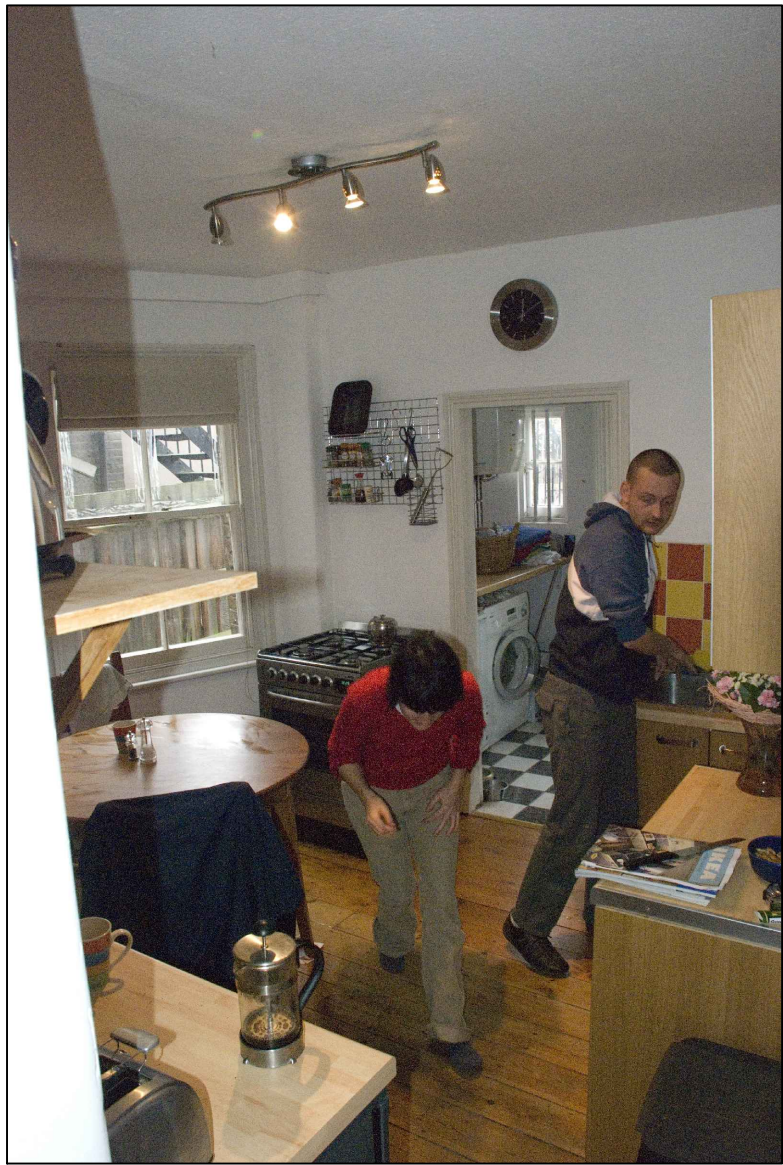
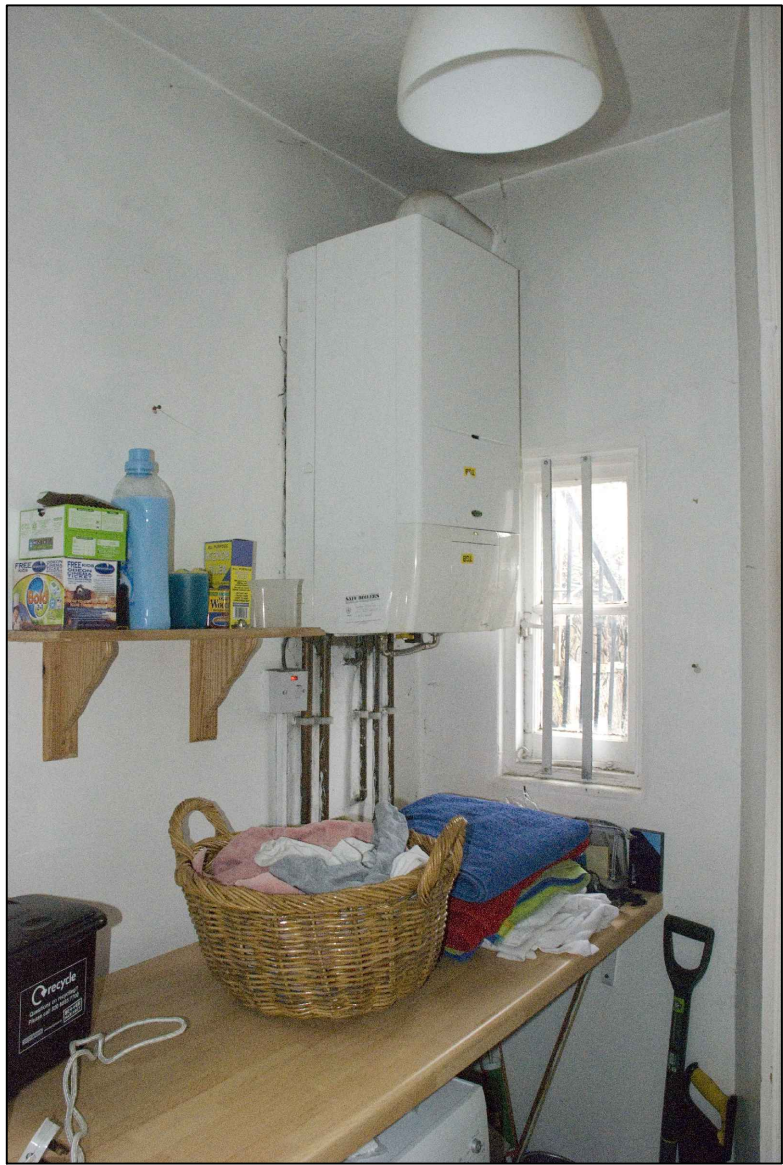
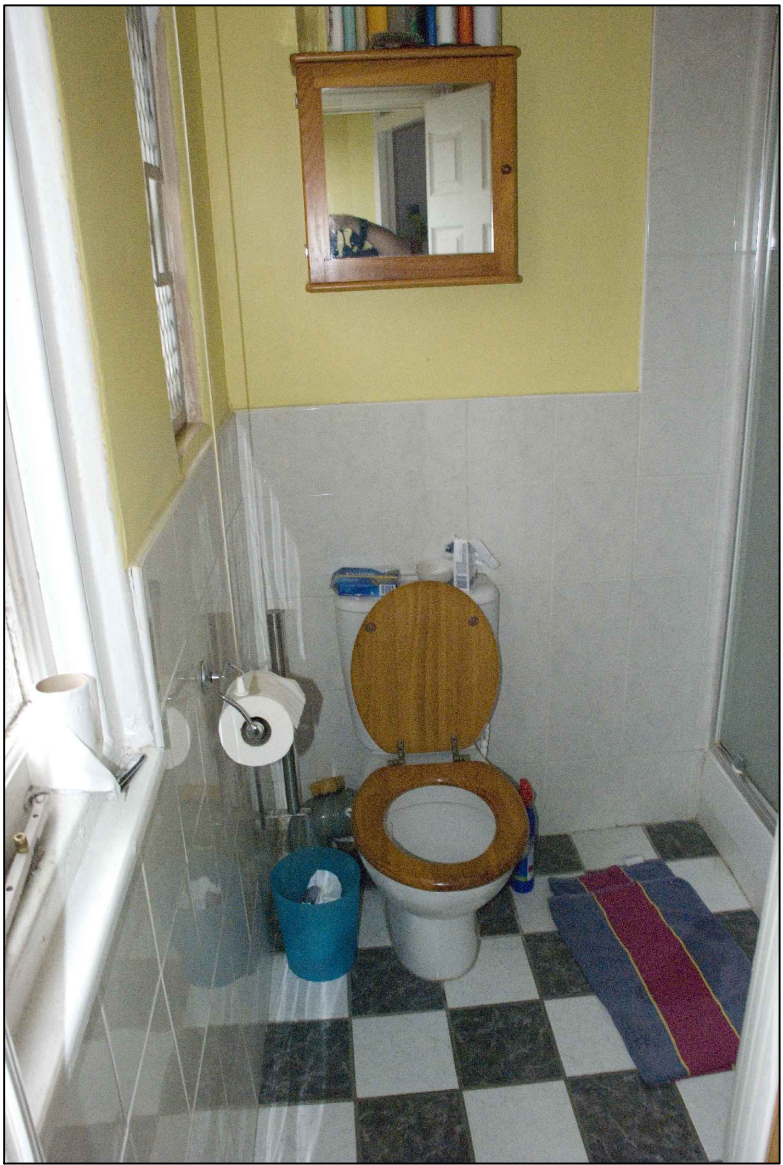
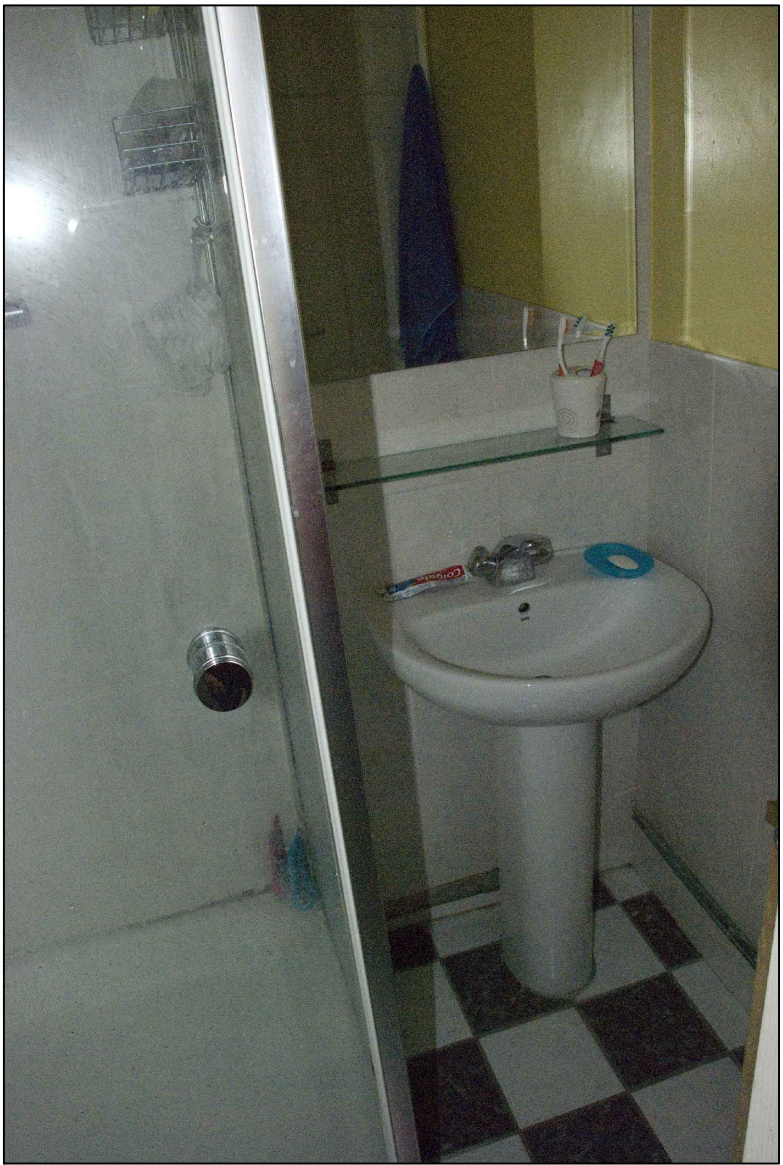
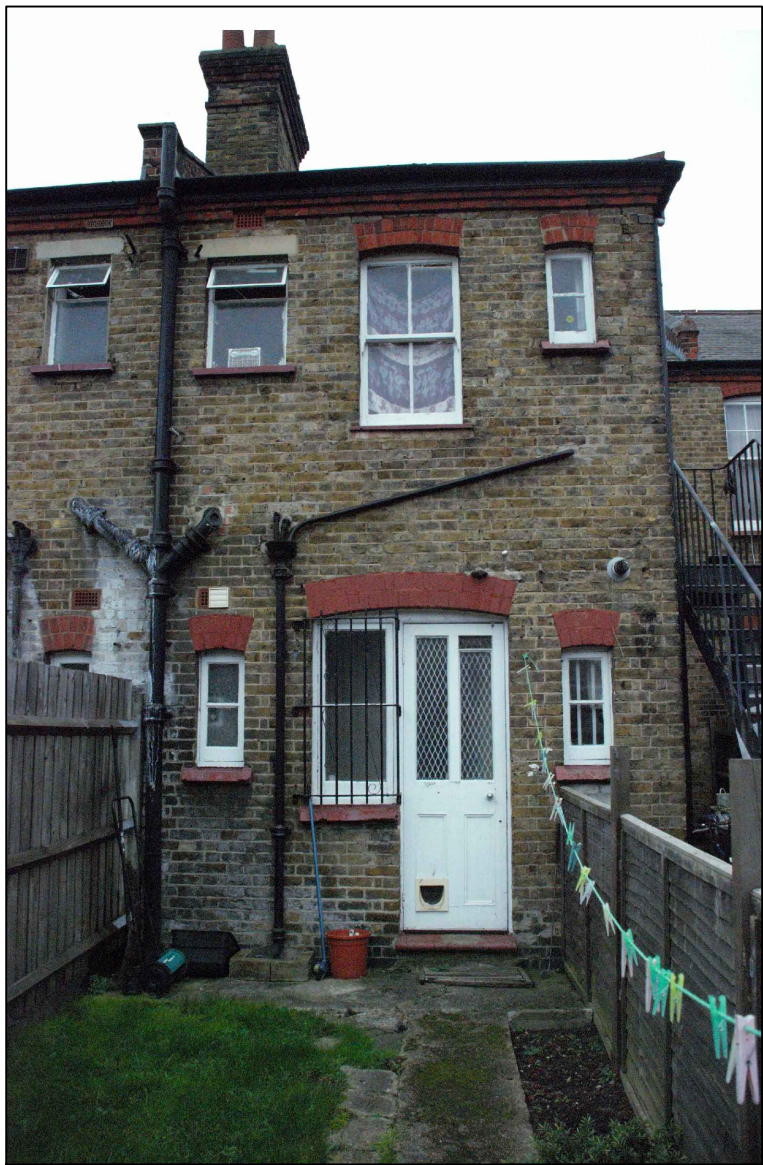
AS EXISTING

- DESIGN ANALYSIS & CONSIDERATIONS
1. THE SPACE PLANNING OF THE EXISTING LAYOUT IS CONSIDERED POOR.
  2. MINIMAL SPACE BEHIND THE KITCHEN SINK FOR WASHING UP.
  3. SMALL FRIDGE FREEZER POSITIONED OUT OF EASY ACCESS OF THE MAIN KITCHEN AREA.
  4. SHOWER ROOM ACCESS IS RESTRICTED THROUGH LIMITED SPACE BETWEEN DOOR OPENING AND W.C.
  5. SHOWER DOOR HITS W.C. ON OPENING AND CLIENT HAS TO MANOUVRE BETWEEN SHOWER & W.C. IN ORDER TO CLOSE DOOR AND ACCESS W.H.B.
  6. NO DOOR BETWEEN EXISTING KITCHEN & SHOWER/W.C. ROOM TO COMPLY WITH REGULATION FOR A VENTILATED SPACE BETWEEN THE TWO.
