# LEVEL MONITORING

## for Subsidence Management Services

**2 Elms Avenue, Muswell Hill, London, N10 2JP**

| Our Ref: | M18000 |

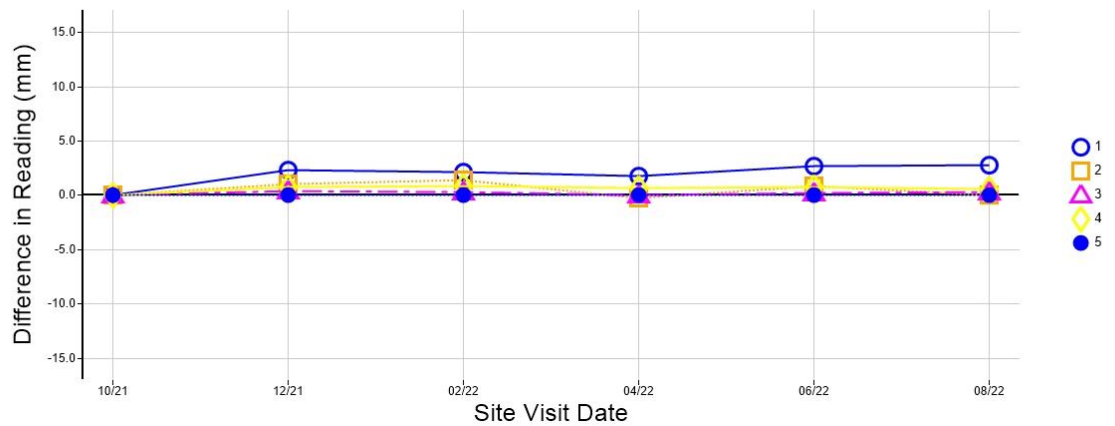
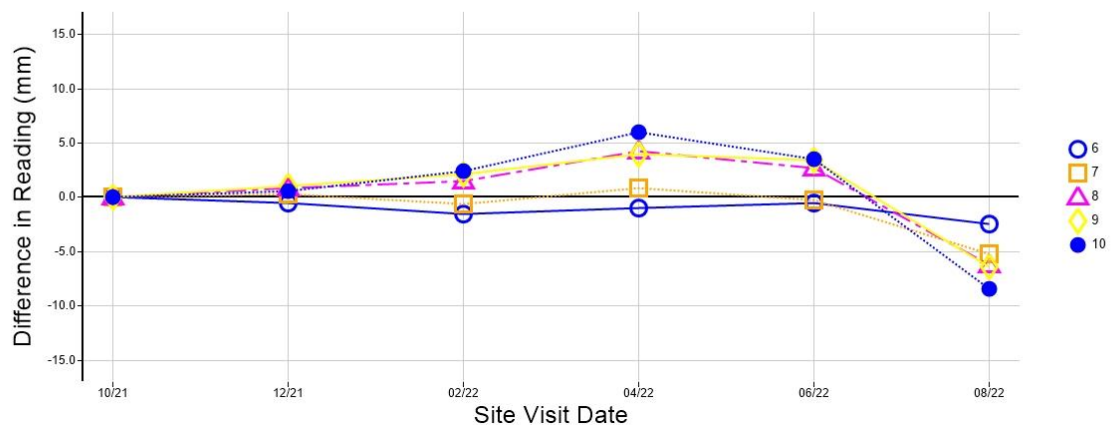
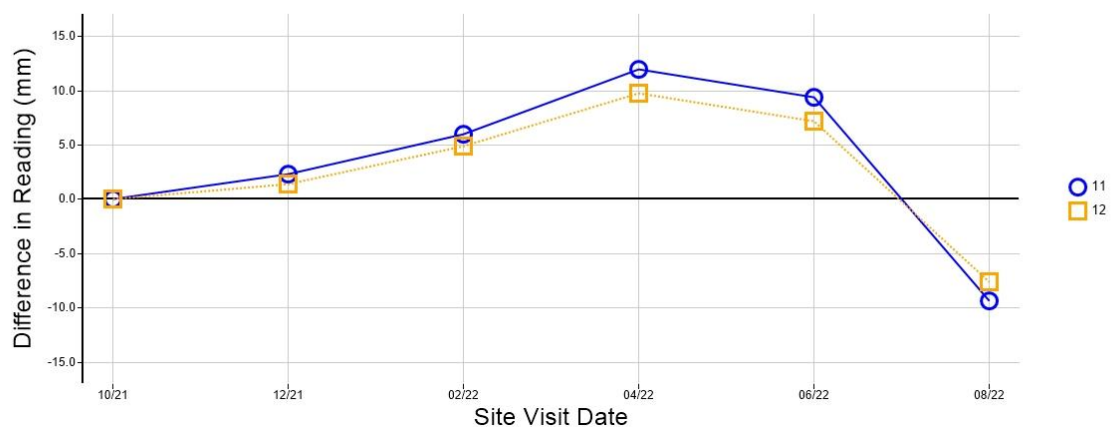
## Level Monitoring Difference Graphs

The following graphs display the progressive movement that each Level Monitoring Station recorded at each separate site visit date to give an overall look at how much the property is moving.

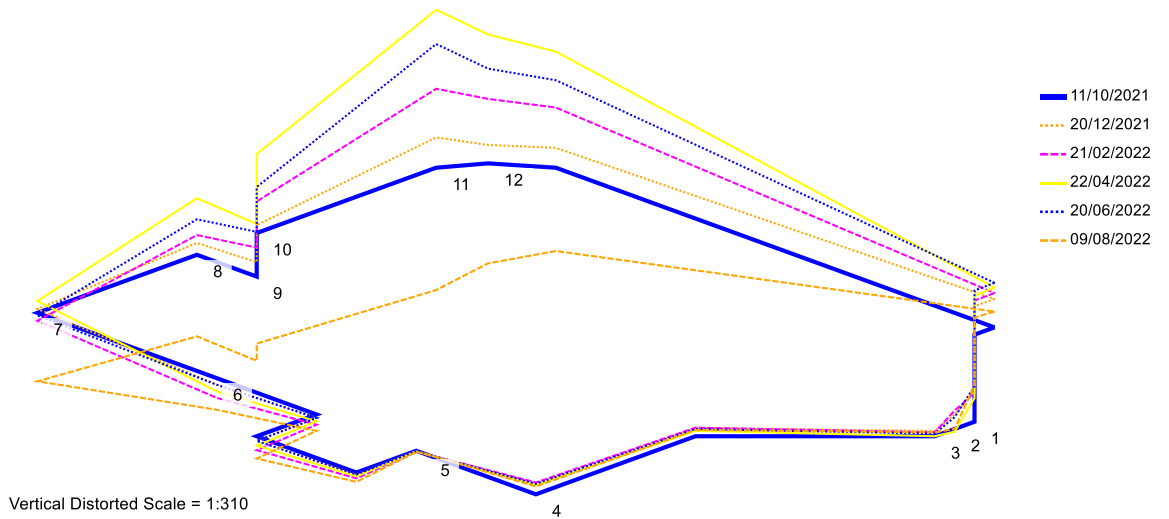
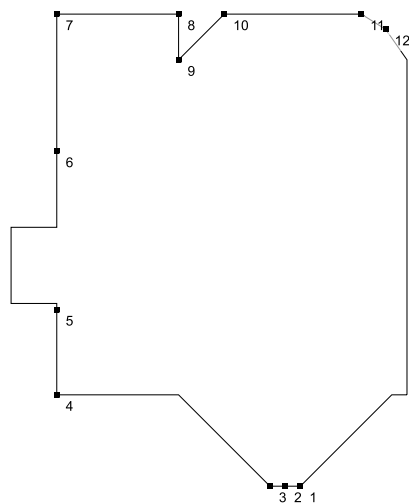
## Level Monitoring Displacement Map

The following image shows an isometric representation of the movement of the property, based on the Level Monitoring Stations that were installed.

FRONT

Datum is relative to point 5. It has an assumed value of 10.0000m. There is no suitable remote datum available. If this is not suitable, a deep datum is recommended.
